Damages in Wooden Roofs over Heated Rooms

By **TRYGVE ISAKSEN**

Norwegian Building Research Institute

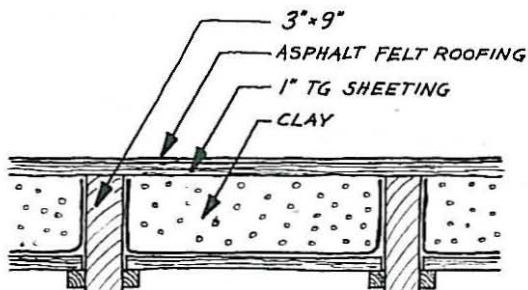
An ordinary pre-war construction is presented in Fig. 1. The thermal insulation was heavy, f.i. dry, pulverized clay, sand, slag etc. The joists were high even over spans less than 4 metres and a spacing of 60 cms.

Sometimes a vapour barrier of an asphalt roofing felt was laid under the insulation when the owner was afraid of fungi attack because of wet clay or slag insulation. Usually, however, an ordinary impregnated building paper was laid down on the 1 in. boards, turned up along the joists, and the insulation was then filled flush with the upper joist surface.

There was no ventilation space above the insulation, and the gutters were mounted along the eaves because most people did not trust the interior downspouts.

Figure 1. Flat wooden roof before 1938.

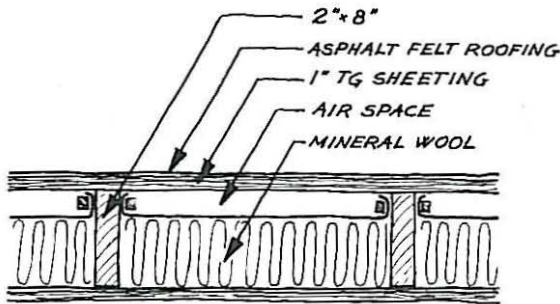
Fig. 2 shows a section of a flat roof construction frequently used after 1960. To avoid failures three main principles are followed:

Figure 2. Flat wooden roof after 1960.

opposite edges are made as big as the section of this space, the O/A ratio¹⁾ for a 10 m wide house is 1/100 for a distance = 55 cms between the joists. (15 cm of insulation). This rather great ventilation rate is not sufficient to prevent snow melting on roofs in sheltered areas, even not in cold periods, and certainly not when there are air leakages in the vapour barrier and in the wind barrier.

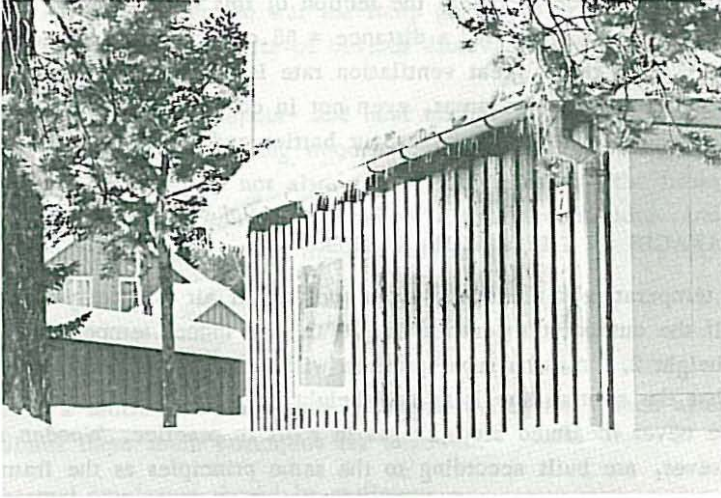
Figure 3. Ice melting on a gently sloping roof destroys gutter and leader.

Fig. 3 presents a gently sloping roof on a villa in Trondheim. The thickness of the ice under the snow is approximately 20 cms. The thermal insulation is 10 cms of rockwool, the vapour barrier is a plastic foil pressed against the underside of the joists by the ceiling panel. The wind barrier is a building paper fastened to the joist sides by nailed battens.

The indoor climate is normal, no excess humidity could be measured in the living room. In spite of this, condensation occurs in the roof and ice is formed in cold weather. The amount of water running down along the inner surface of the lower wall (on Fig. 3) can rise to 5-6 litres per winter along the 4 m cornice, according to the owner.

Similar cases are rather few in Trøndelag, this house is, however, situated in an area sheltered against wind. In return, the snow layer can be rather thick, and the ice destroys gutter and leader. - During the winter 1963-64 hundreds of complaints came to the NBRI in Oslo from the south east part of Norway where calm, cold winter weather is usual. In most cases air leakages were found, and some methods of repair proposed.

The owner of the house presented in Fig. 3 does not want to destroy the ceiling to seal the vapour barrier, and considers a rebuilding from above. He wants to tear off the roofing, take up the wind barrier and the insulation and inspect the vapour barrier between every pair of joists. Then all gaps will be sealed with suitable materials, insulation laid down again, and another 10 cm bat laid upon it, thus

filling the joist space with insulation. On top of the joists a new wind barrier will be laid, and 2 in. x 3 in. wooden battens then will be fastened across the joists. Then the old sheeting will be used again and a new roofing laid upon it. The ventilation space, 3 in. high, will be shortened from about 9 meter to 7 meter, and the new O/A ratio will be less than 1/50. In this way the owner hopes to avoid future damages on outside gutter and leader.

A cheaper solution is to use a small medium pressure fan to blow in cold air above the insulation in the existing roof, creating a super pressure in the air space to prevent air leakages from beneath. In this case the lower ventilation openings of the roof would have to be closed.

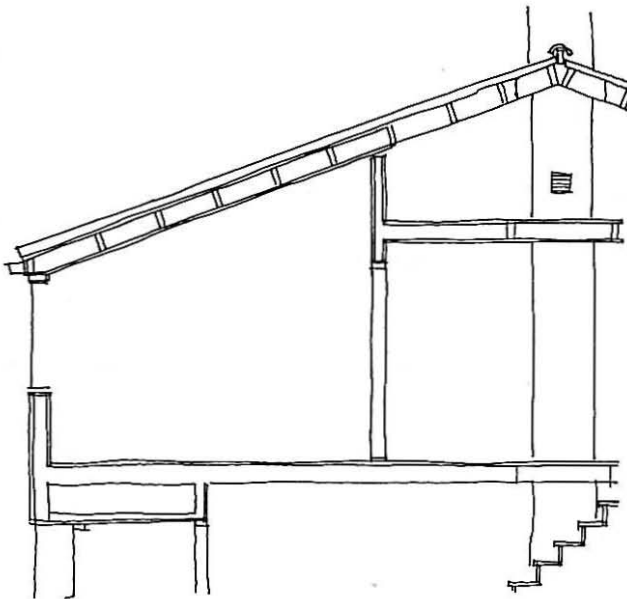
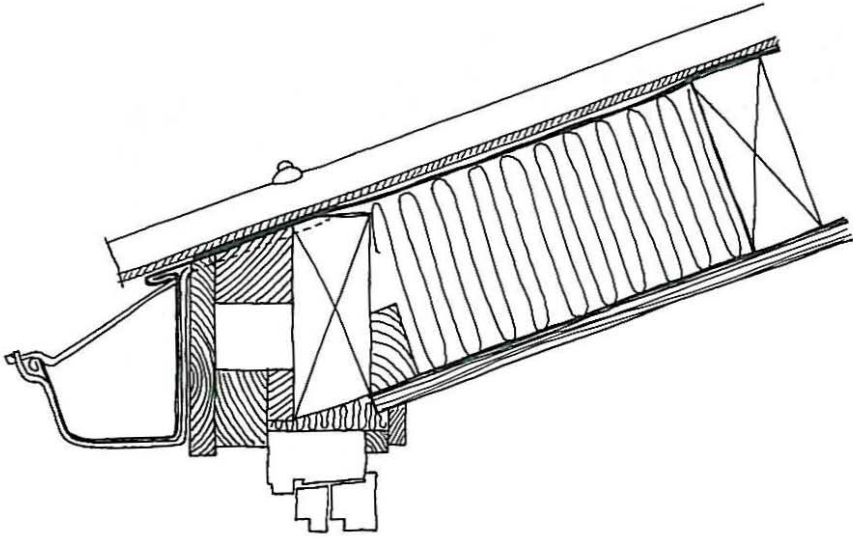
A rather peculiar case of air leakages and water vapour diffusion is presented in Figs. 4 and 5. The joists are laid parallel to the eaves that have been cut flush with the exterior wall according to fashion. Thus a proper ventilation above the insulation is prevented. The architect, however, had considered vapour pene-

Figure 4. Section of an unventilated roof. Air leakages from bedrooms to insufficiently ventilated attic.

Figure 5. Detail of roof in Fig. 4 near the eaves.

tration, and did not use a board sheeting and a roofing felt on top of the joists, he simply fastened the building paper, the wind barrier on the joists and chose corrugated asbestos cement plates for roofing. Over the little attic, only the wind barrier and the corrugated roofing was used above the joists, insulation and ceiling was omitted.

Now, the partition walls surrounding the attic against the bedrooms are not load bearing, they stand on the wooden tile of beams between ground floor and first floor. Shrinkages both in beams and within the partition walls lead to great air leakages between roof and partition walls.

Since the attics are badly ventilated, some fungi occurs in the joists. The most severe attacks were found in the new houses where the authorities demand was followed. There was no fungi at all in one of the elder houses (without sheeting and asphalt felt) where one of the ridge tiles was broken!

Obviously the architects own solution was not bad when the insulated part of the roof is considered. He should, however, have foreseen coming air leakages over the partition walls and also made a better ventilation of the attic. It is also clear

Since the insulated part of the roof can not be ventilated, the cheapest repair is to return to the original solution, take away sheeting and asphalt felt roofing and replace a diffusion open building paper. - The gaps between partition walls and roof have to be sealed completely, and stacks should be placed near the ridge to dry out the attic.

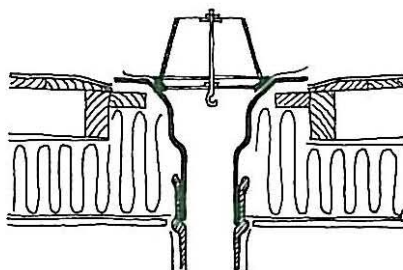
Shrinkage of joists, sheeting and sills sometimes creates a situation as in Fig. 6, the gully is no longer effective and water leakages occur around it. When the plumber instals the CI leader in the house, he forgets that wooden materials are still wet, and make no clearance between the gully and the upper socket of the CI leader.

Figure 6. CI-gully stands proud of the roof due to drying out of wood constructions.
