# Durability of ETICS with Rendering in Norway—Experimental and Field Investigations

**Abstract:** External Thermal Insulation Composite Systems (ETICS) with Rendering are widely used in both rehabilitation and new building projects, even in areas with harsh climates such as the western regions of Norway. However, we have seen extensive cases of defects involving such systems. This paper presents a comprehensive review of Norwegian experiences regarding the durability of ETICS on walls. The presented results are based on building research conducted by SINTEF 61 as well as 30 accelerated climatic laboratory experiments over the last 25 years on similar façade systems. These systems generally perform satisfactorily if thoroughly designed and carefully erected. However, according to the survey, the systems are not very robust. Even minor errors in design techniques and/or craftsmanship can lead to rendering defects. The investigations clearly show that ETICS is particularly vulnerable when exposed to severe driving rain conditions. ETICS provides only a single-stage protection against wind and precipitation and do not dry effectively after being wetted. Hence, the resultant cracks an

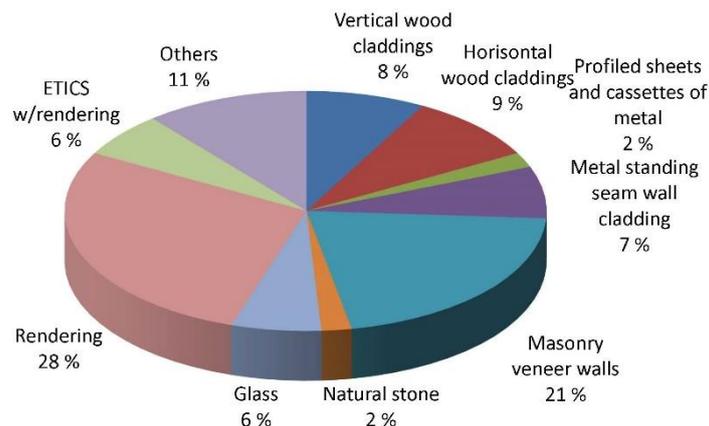
A total of 61 buildings with cases of defects involving ETICS (investigated in the period 1993–2017) were analysed in connection with this investigation. A former study, carried out by Lisø et al. [14] and Lisø and Kvande [20], on the total 1993–2002 selection of building-defect cases, reveals that ETICS comprised 6% of the defect cases SINTEF analysed in connection with external walls above ground during that period (see Figure 5).

**Figure 5.** Distribution of defect cases to external walls above ground depending on the type of cladding. Taken from SINTEF Building Defect Archive (period 1993–2002) [20].

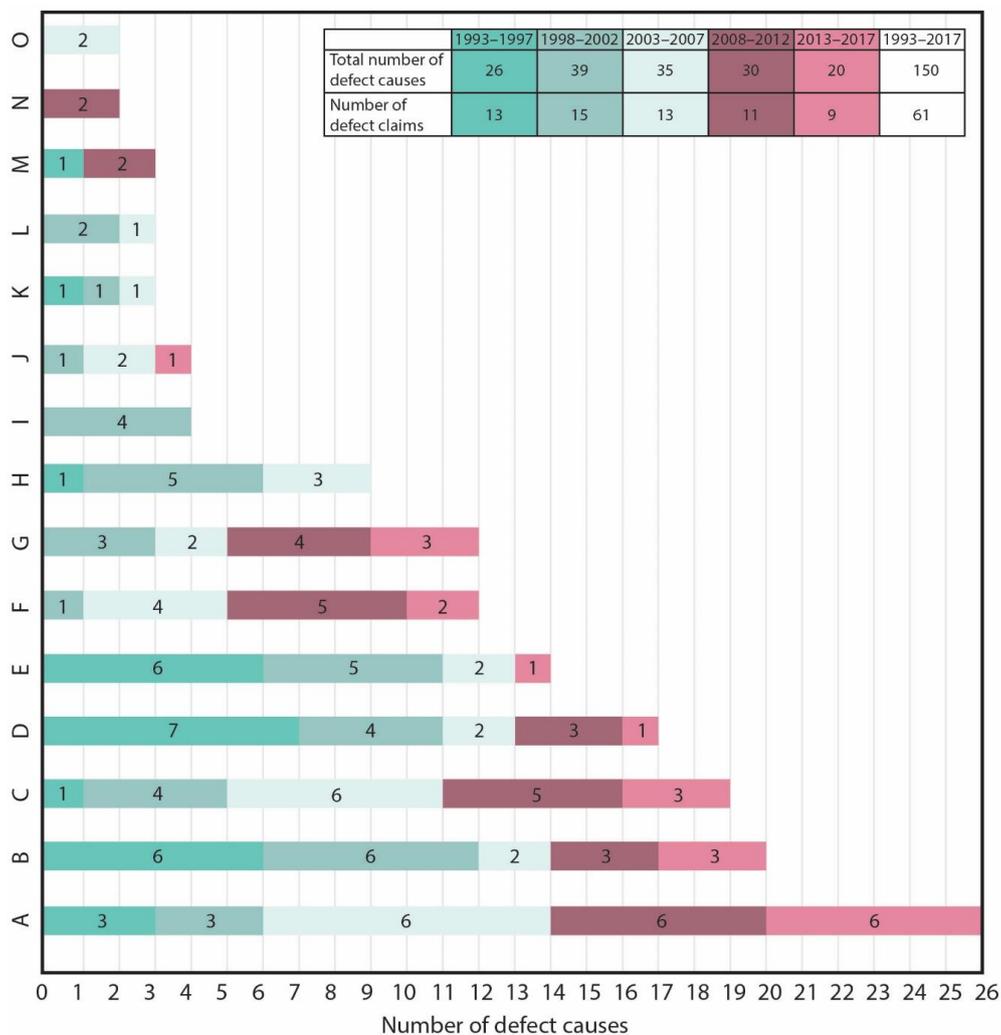
Each of the reports included in the SINTEF Building Defect Archive relates to one defect object (building). The majority of defect cases have been complex, with several causes of defect. Therefore, with regard to ETICS, 150 causes of defect were registered for all 61 defect reports (defect objects). Deficient solutions and/or poor execution were demonstrated by the fact that several conditions failed at the same time. The most prevalent causes of defect for ETICS are ranked in Figure 6. The ranking is based on the total number of defect registrations in the period 1993–2017, but the Figure also gives an indication of the trends by listing the number of defect registrations in five-year periods, e.g., 1993–1997, 1998–2002, 2003–2007, 2008–2012, and 2013–2017, respectively. The causes of defect are grouped together as they appear in the individual defect reports. A short description of the most prevalent causes of defect (A to O) is given in the following:

**Figure 6.** Ranking of the most frequent building-defect causes for ETICS in SINTEF Building Defect Archive (period 1993–2017). See description of defect causes A–O in the text.

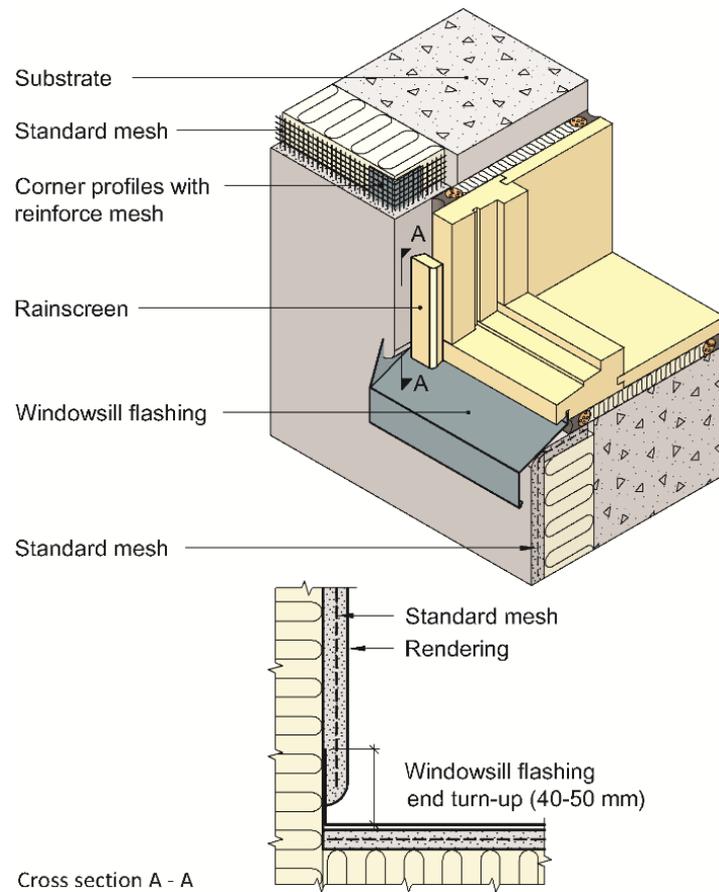
Defective forming and/or execution of cornice, horizontal, parapet, and windowsill flashings are repeated items. Similarly, deficient execution of end flaps against flashings frequently occurs. In addition, deficient roof gutters and drainpipes can impose heavy local loads. Frequently, flashings against precipitation are not adapted to the façade system but are confronted on an individual basis, as seen in the fortunate window solution in Figure 7. Selected references on the causes of defect include Lisø et al. [21].

**Figure 7.** Recommended installation of window in a brick or concrete wall with ETICS. The flashing variant is adapted to the render system in question and is most applicable for render mortars based on organic binding agents (plastic).

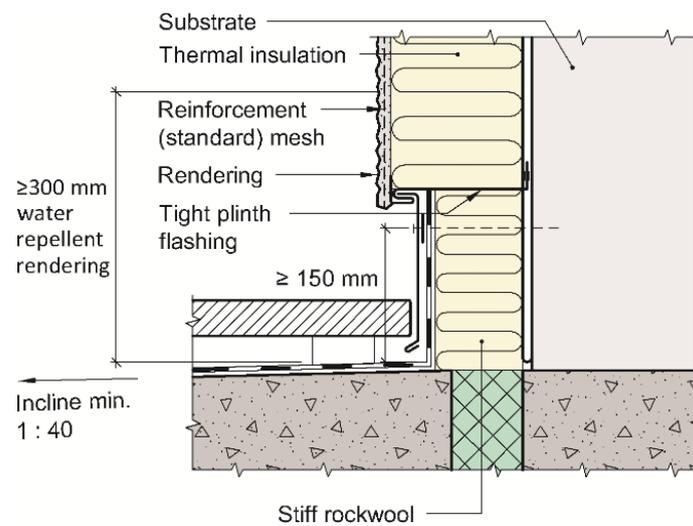
Insufficient transitions to balconies and other façade materials often lead to moisture problems in the structure. Examples of fortunate transition solutions are provided in Figures 8 and 9. Selected references on the causes of defect include Kvande et al. [28].

**Figure 8.** Example of a moisture-resistant wall finishing against a balcony.

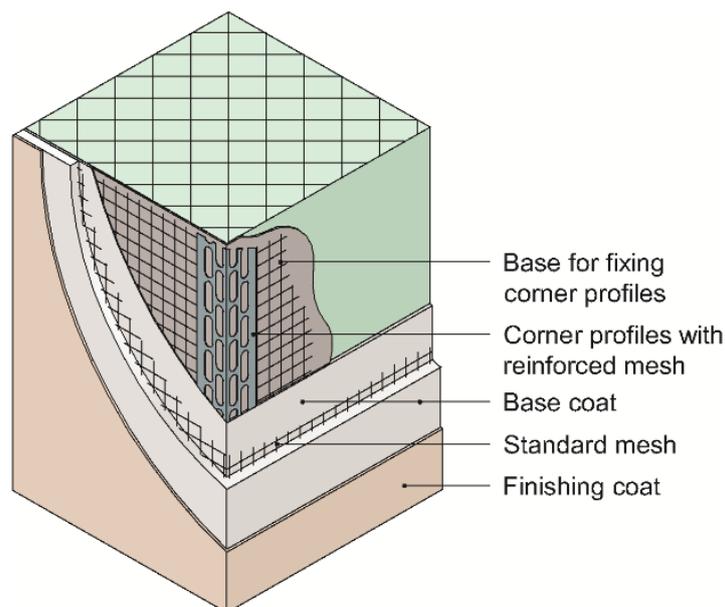
- The most vulnerable points for a façade system are the edges/corners. It is imperative to use corner profiles and plinth flashings that work well with the render and give reduced risk of cracking. Figure 10 shows an example of recommended corner reinforcement which was developed based on the laboratory testing and field experiences.

**Figure 10.** Example showing how effective corner reinforcement can be achieved.
