## MonArc Project Report 2019

Monitoring of Arctic Infrastructure  
(MonArc – project duration 2017-2019)

**KEYWORDS:**Infrastructure,  
permafrost,  
foundations,  
monitoring, climate  
change, Svalbard,  
Arctic.**VERSION**

2019:01231

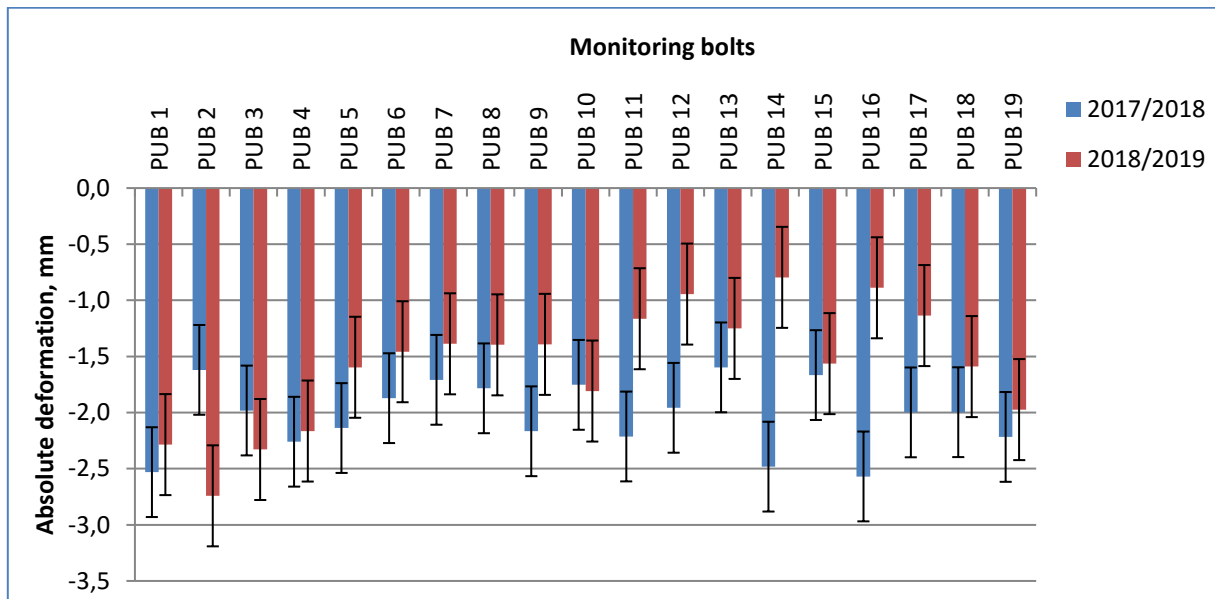
Absolute displacement and errors of measurements of the monitoring points under the multi-purpose garage are in the range 1-2,5 mm/year, with decrease in magnitude for 2018–2019 in comparison to 2017–2018. The latter is opposite to the situation at the outer walls. Settlements under the central part of the garage are smaller than at the outer walls. One may suggest that permafrost conditions are colder (and hence the settlements of piles are smaller) under the building compare to the outer walls due to drier conditions and better surface conditions (absence of snow in the wintertime).

Figure 7. Absolute displacements of monitoring points (and errors of measurements) under the multi-purpose garage in Pyramiden in 2017-2018 and 2018-2019.

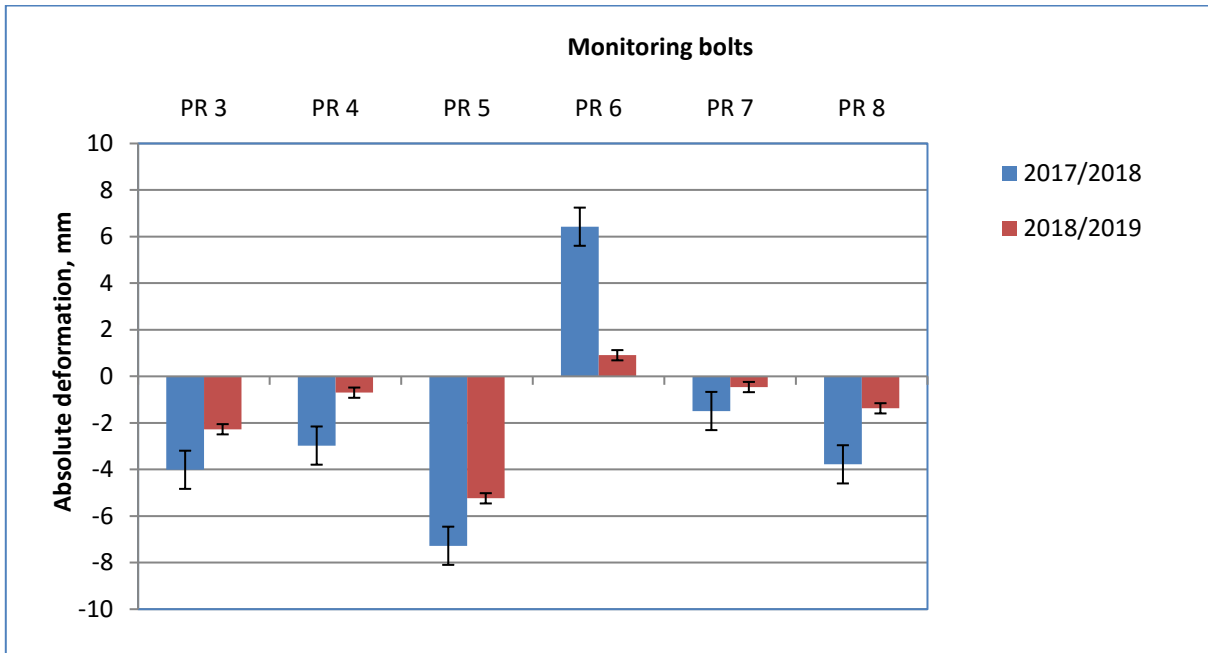
Settlements on stretch of the road were 1,5–7 and 0,5–5,2 mm/year in 2017–2018 and 2018–2019 respectively, frost heave was identified in the middle part of the stretch (monitoring point PR6) near a drainage culvert.

Figure 8. Absolute displacements of monitoring bolts on stretch of the road in Pyramiden.

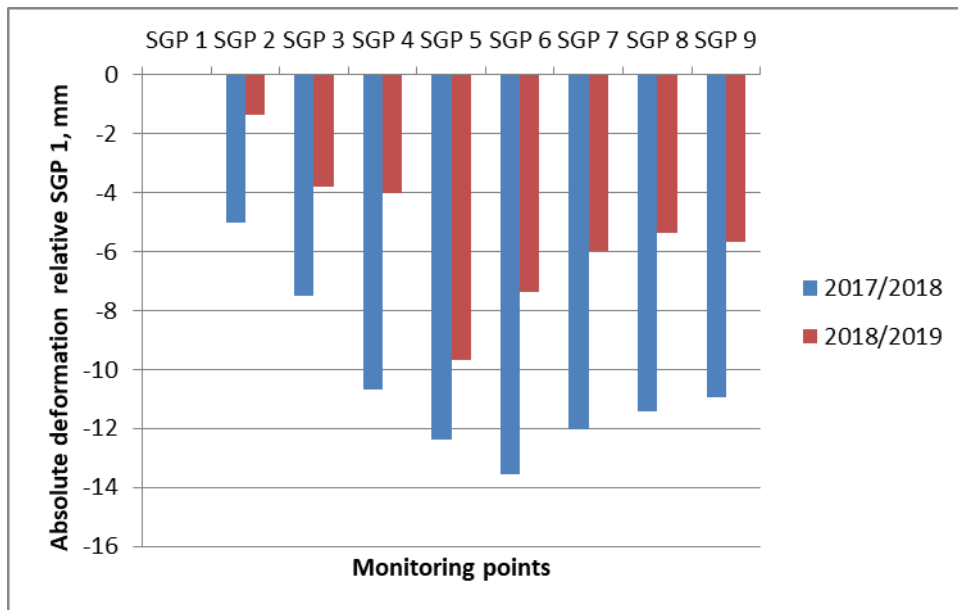
Absolute displacements on both sides of the garage (relative to the first points on each side) are presented in Figure 12–Figure 13. One can see significant differential (1–14 mm) vertical displacements on both sides of the garage in 2017–2018 and 2018–2019. Displacements were higher in 2017–2018. Largest displacements are noted on the right-hand side when one facing entrance of the garage (the entrance towards the airport).

Figure 12. Absolute displacements (SGP 1–SGP 9) at right-hand side of multi-purpose garage “Magnetittlageret”.

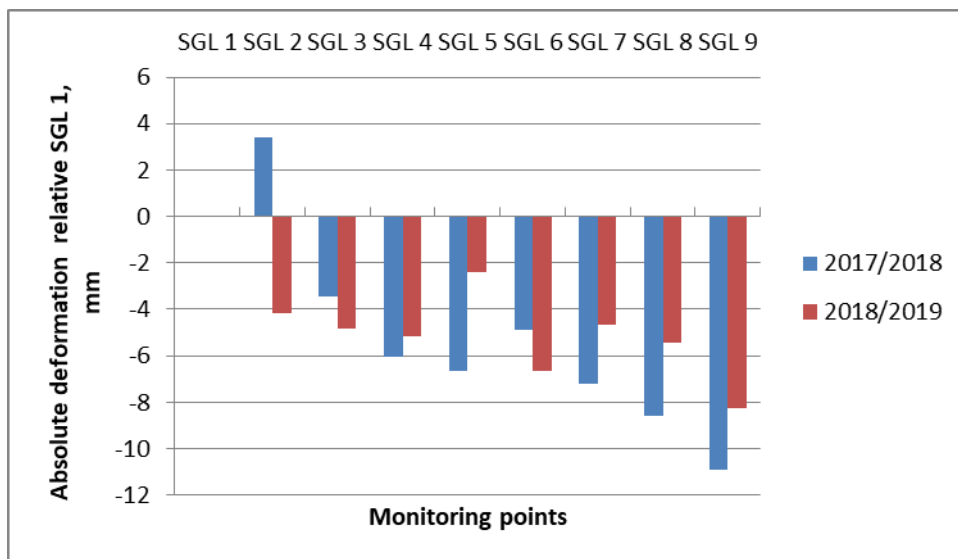
Figure 13. Absolute displacements (SGL1–SGL 9) at left-hand side of multi-purpose garage “Magnetittlageret”.

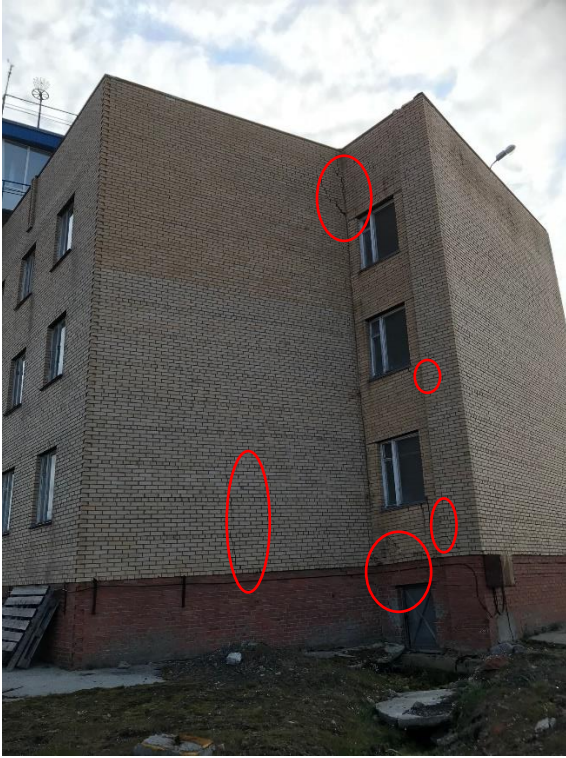
Cracks were observed in the northern part of the building, on the north (Figure 14) and east-facing walls (Figure 15). Drainage coming out from under the building was also observed at the north-facing wall (Figure 16–Figure 17). It seems that the drainage pattern might go somewhere under the building. However, no cracks were observed on outer walls in other parts of the building, hence presence of continuous drainage pattern under the building is questionable. Most probably this drainage also serves for water collected on the roof as the outer downpipes are absent; hence water must be conveyed by some downpipes located inside the building.

Observed cracks are thought to be caused by excessive settlements of foundation. Settlements of foundations were probably caused by thawing/warming of permafrost due to surface drainage mentioned above, or due to other reasons (as leakage of warm water). One can see that the cracks are located in the northern part of the building. Accumulation of cracks in one particular part of the building probably relates to maintenance issues rather than possible impacts of climate warming.

**Figure 14. Cracks (highlighted with red circle) on the north-facing wall of the building "Komplex GRZ" in Barentsburg.**

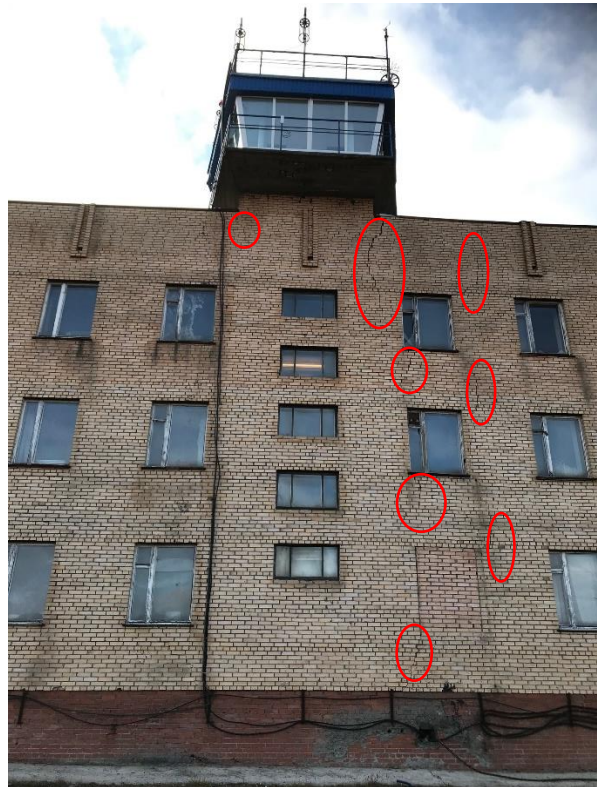
**Figure 15. Cracks (highlighted with red circles) on the east-facing wall of the building "Komplex GRZ" in Barentsburg.**

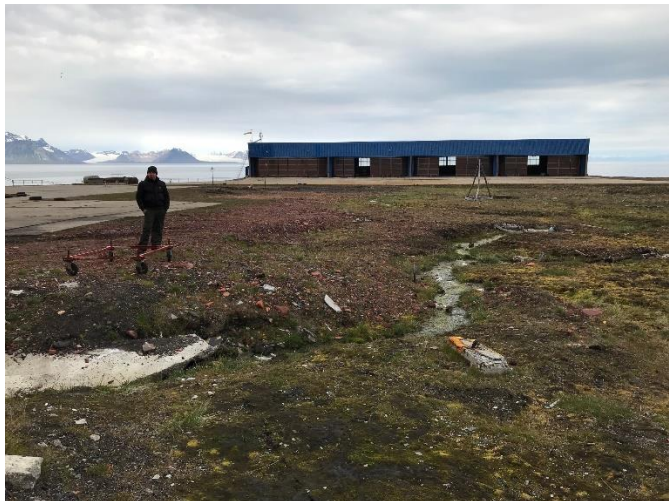
**Figure 17. Drainage coming from under the building "Komplex GRZ" in Barentsburg (continuation, building is behind the photographer).**

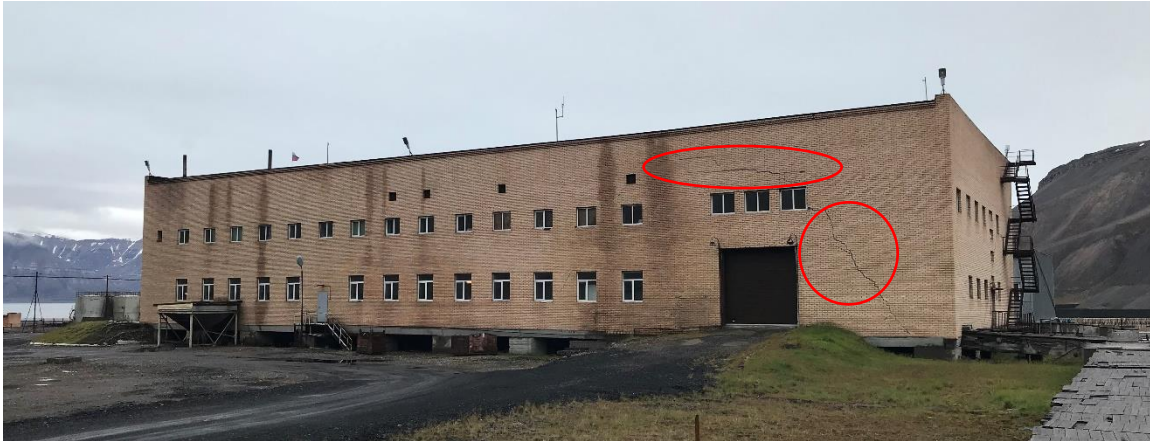
Cracks were observed in western part on the multi-purpose garage, on its north- (Figure 18) and south-facing walls (Figure 19). The following reasons might be outlined among the ones caused the cracks:

- Water leakages in the past (as warm water, sewage water) might be also among the reasons for settlements. Happening of water leakages (in ca. 2010) was mentioned by the maintenance staff, they told that water from the shower room was drained in the western part on the building for some time (perhaps weeks?).

- Possible presence of a talik zone under the western part of the building was pointed out by the owner of the building [4]. This idea may be supported by the fact that the thermosyphons were installed around several buildings in Pyramiden to improve permafrost conditions locally.

Figure 18. Cracks (highlighted with red circles) on the north-facing wall of the multi-purpose garage in Pyramiden.

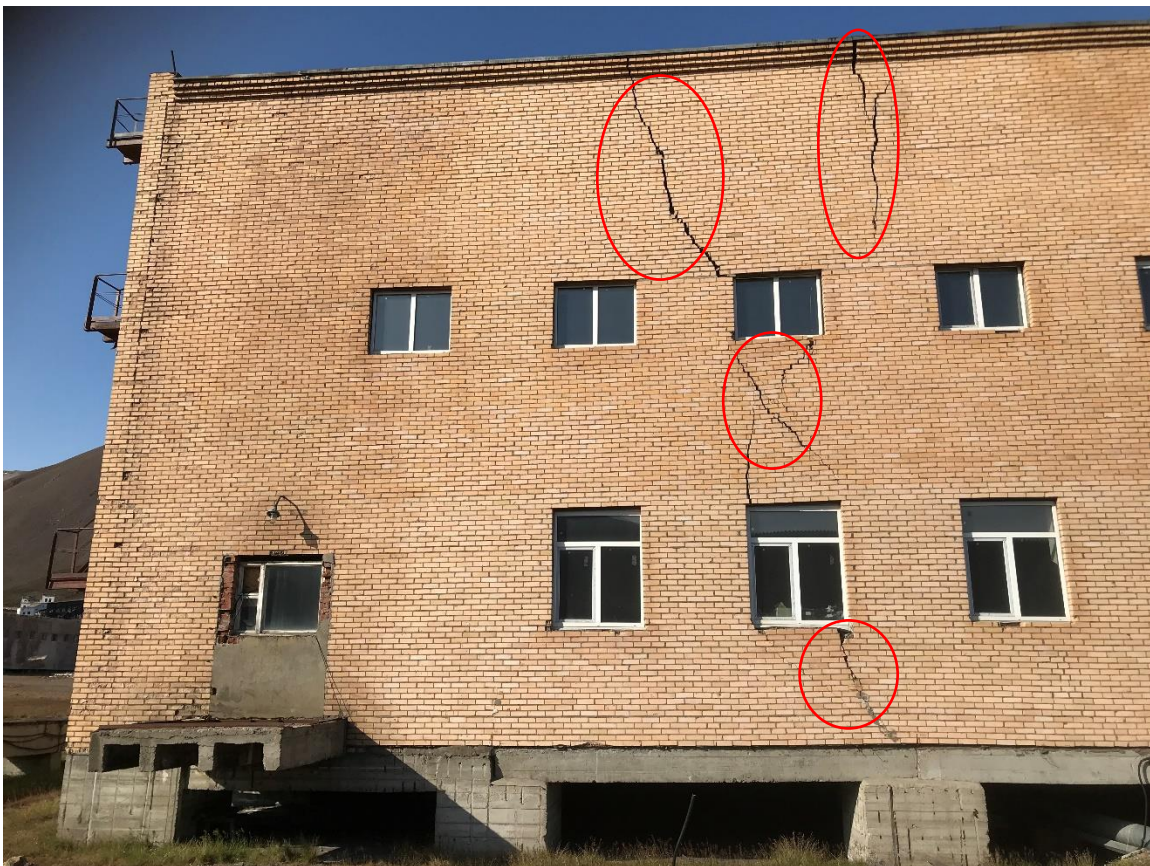
Figure 19. Cracks (highlighted with red circles) on the south-facing wall of the multi-purpose garage in Pyramiden.

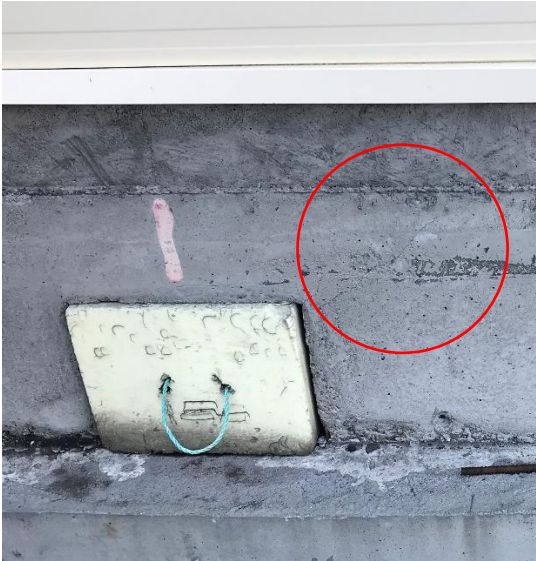
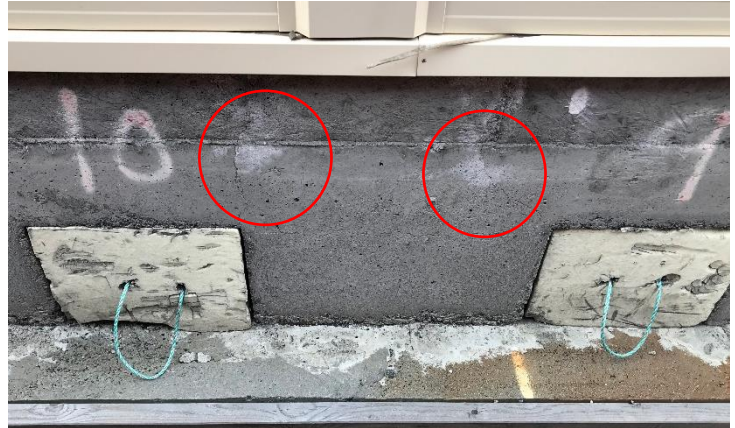
Only minor cracks were observed in several locations of shallow foundation of multi-purpose garage “Magnetittlageret” in Svea (Figure 20–Figure 23).

Figure 20. Cracks (highlighted with red circles) on foundation of the “Magnetittlageret” garage.
