Structural health monitoring of a buttress dam using digital image correlation

C. Popescu, G. Sas & B. Arntsen
Norut Narvik, Narvik, Norway

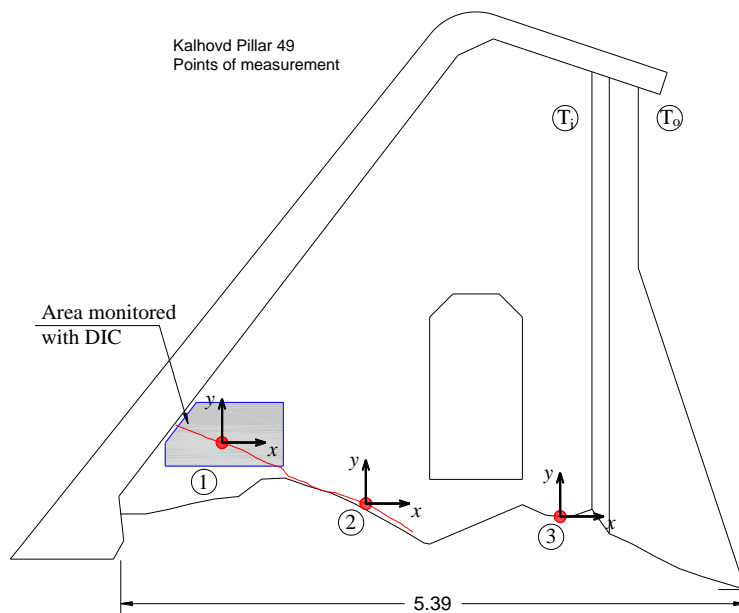
The selection was based on field inspection notes, freehand sketches and photographs available from a preliminary visit. The following pillars were selected as good candidates: Pillar #33, Pillar #49, Pillar #44, Pillar #59 and Pillar #63. The final pillar to be instrumented had to be decided on site depending on the topography of the rock. This condition was important as one of the objectives was monitoring using a tailor-made DIC system. This meant that conditions of the test site had to be favorable for positioning the camera in a stable location. In addition, it should be possible to capture an existing crack. Pillar #49 fulfilled all abovementioned conditions, and therefore was selected to be instrumented. A schematic view of the instrumented pillar is shown in Figure 2.

Figure 2. Monitoring plan of pillar #49 from Kalhovd Dam.

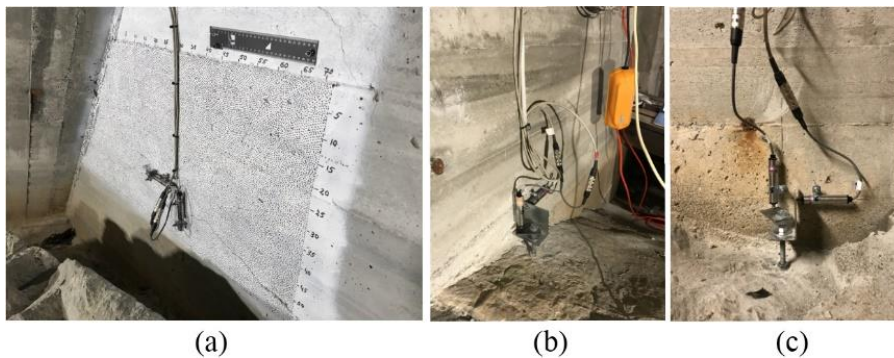
The displacement was monitored along an existing crack at three discrete points numbered 1-3 in Figure 2. At each measurement point both vertical and horizontal displacements are monitored. The displacement is measured relative to the fixed part, i.e. the rock (point 2 and 3 in Figure 2) or the concrete block below the main crack (point 1 in Figure 2). In total, six displacement sensors were installed. A general view of the LVDTs installed on all three locations is shown in Figure 4.

Figure 4. Installation of LVDTs: (a) LVDT #1 (horizontal and vertical displacements); (b) LVDT #2 (horizontal and vertical displacements); (c) LVDT #3 (horizontal and vertical displacements). #1, #2 and #3 refer to displacement sensors at indicated positions (Figure x for details)

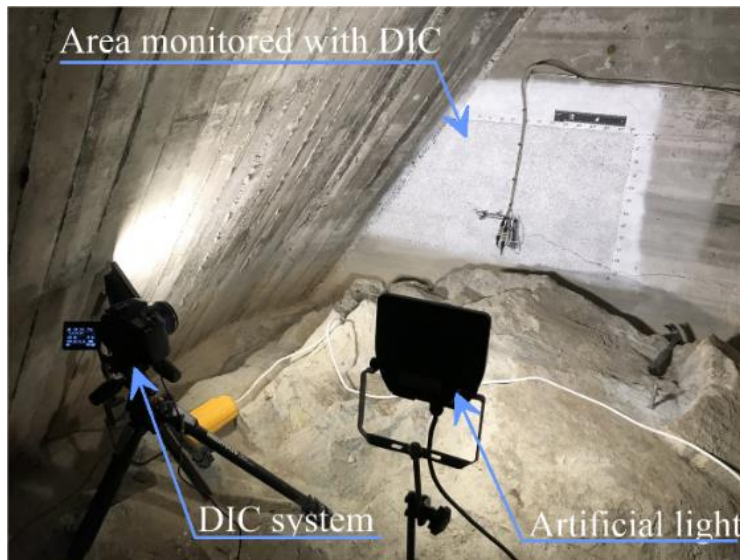
Figure 5. Digital image correlation setup

Only 2D measurements were acquired in the pillar's strong-axis plane. The area monitored (700×550 mm) was chosen near the pillar's toe to be able to capture the crack starting from the plate and developing downwards along the interface. The equipment consisted of a digital single-lens reflex camera (DSLR), a Canon 80D. This is equipped with an APS-C (22.3×14.9 mm) complementary metal-oxide-semiconductor (CMOS) optical sensor giving 24 megapixels (6000×4000 pixels) resolution. The camera was equipped with a Canon EF 35mm wide-angle prime (fixed zoom) lens. The camera was set to ISO 100 exposure with an $f/2.8$ aperture and a shutter speed of $1/30$ sec. Two led lamps were used to create adequate artificial light. To avoid interference with the lightning, the illumination system of the dam was disconnected in the bay where the measurements are taken. The camera was fixed 1.65 m away from the pillar using a Manfrotto carbon-fiber tripod. The camera was accessed through the computer using the Canon's remote app. The photos were taken one every 90 minutes. However, only one photo/day was used in the post-processing. The computation was done in GOM Correlate software (GOM).

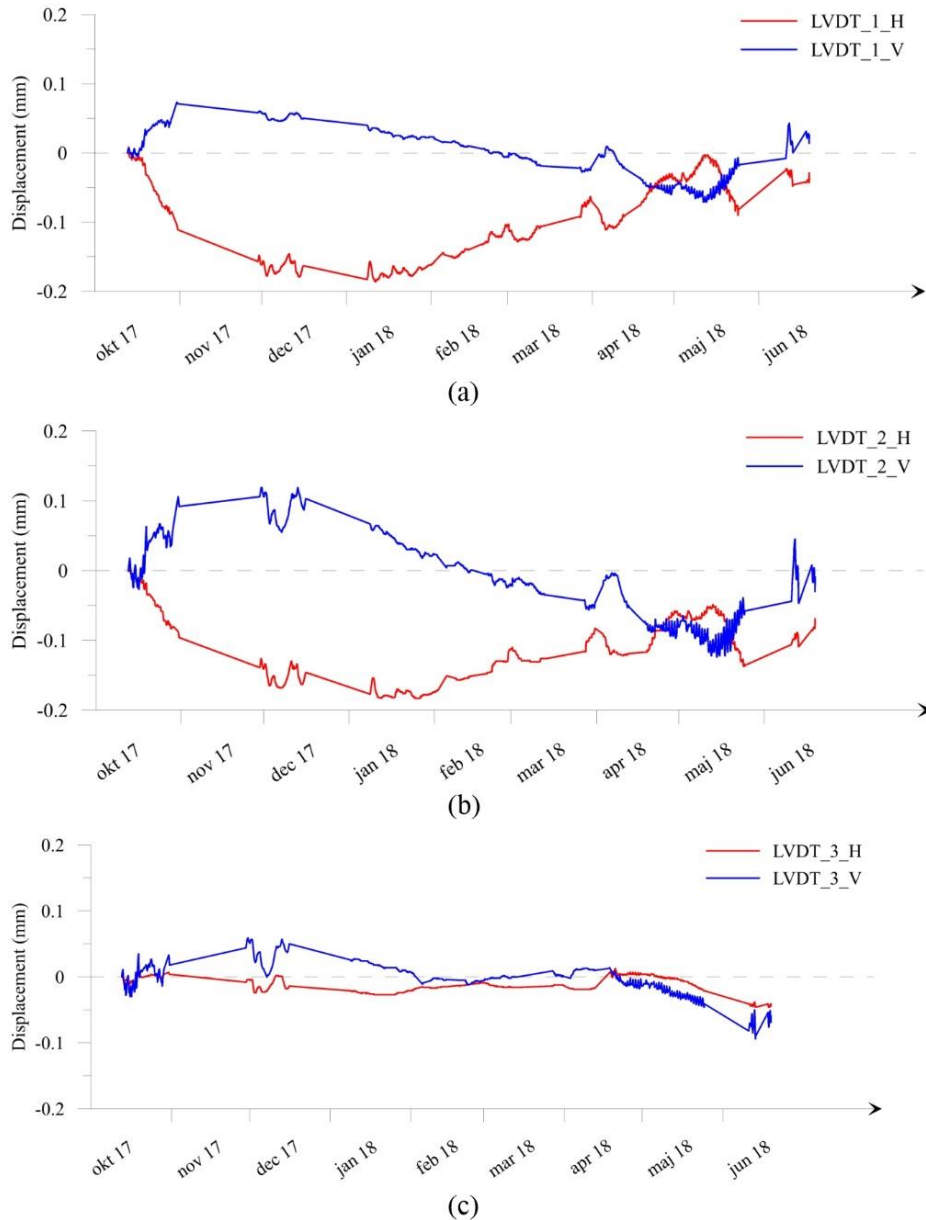
Figure 8 shows displacement time histories for the pillar #49 at the measurement points indicated in Figure 2. The displacement is divided into horizontal (H) and vertical (V) components. The negative values of the measurements corresponds to a lateral displacement from upstream to downstream for horizontal component, and an uplift of the pillar for the vertical component. Following the convention, one can identify two feasible “movement” mechanisms: (1) negative H + positive V = pillar sliding and (2) negative H + negative V = pillar rotation

Figure 8. Displacement measurement for LVDT: (a) no. 1; (b) no. 2 and (c) no. 3

On all three locations where displacements are monitored, negative horizontal displacements are accompanied by positive vertical displacements. This corresponds approximately for the period October to mid-February. During this time the water level is at its maximum with the ice loads peaking at about 100 kN/m. Following the convention made (negative H + positive V = pillar sliding) we can assume a predominantly sliding movement of the pillar. The results are in line with those obtained from DIC (see Figure 9).

From mid-February onwards, the horizontal displacements remained negative on a descending trend towards zero displacement, while the vertical displacements dropped from positive to negative values. During this time, the water level dropped markedly (with a minimum in the beginning of May, i.e. 6 m drop) followed by a rapid increase to the same maximum level in just one month. From mid-February, the ice loads continued to increase up to a level of 160 kN/m in the beginning of April and decreased to zero shortly thereafter. Although there are still recorded negative horizontal displacement, the descending trend suggest the pillar is “sliding back” towards its original position.

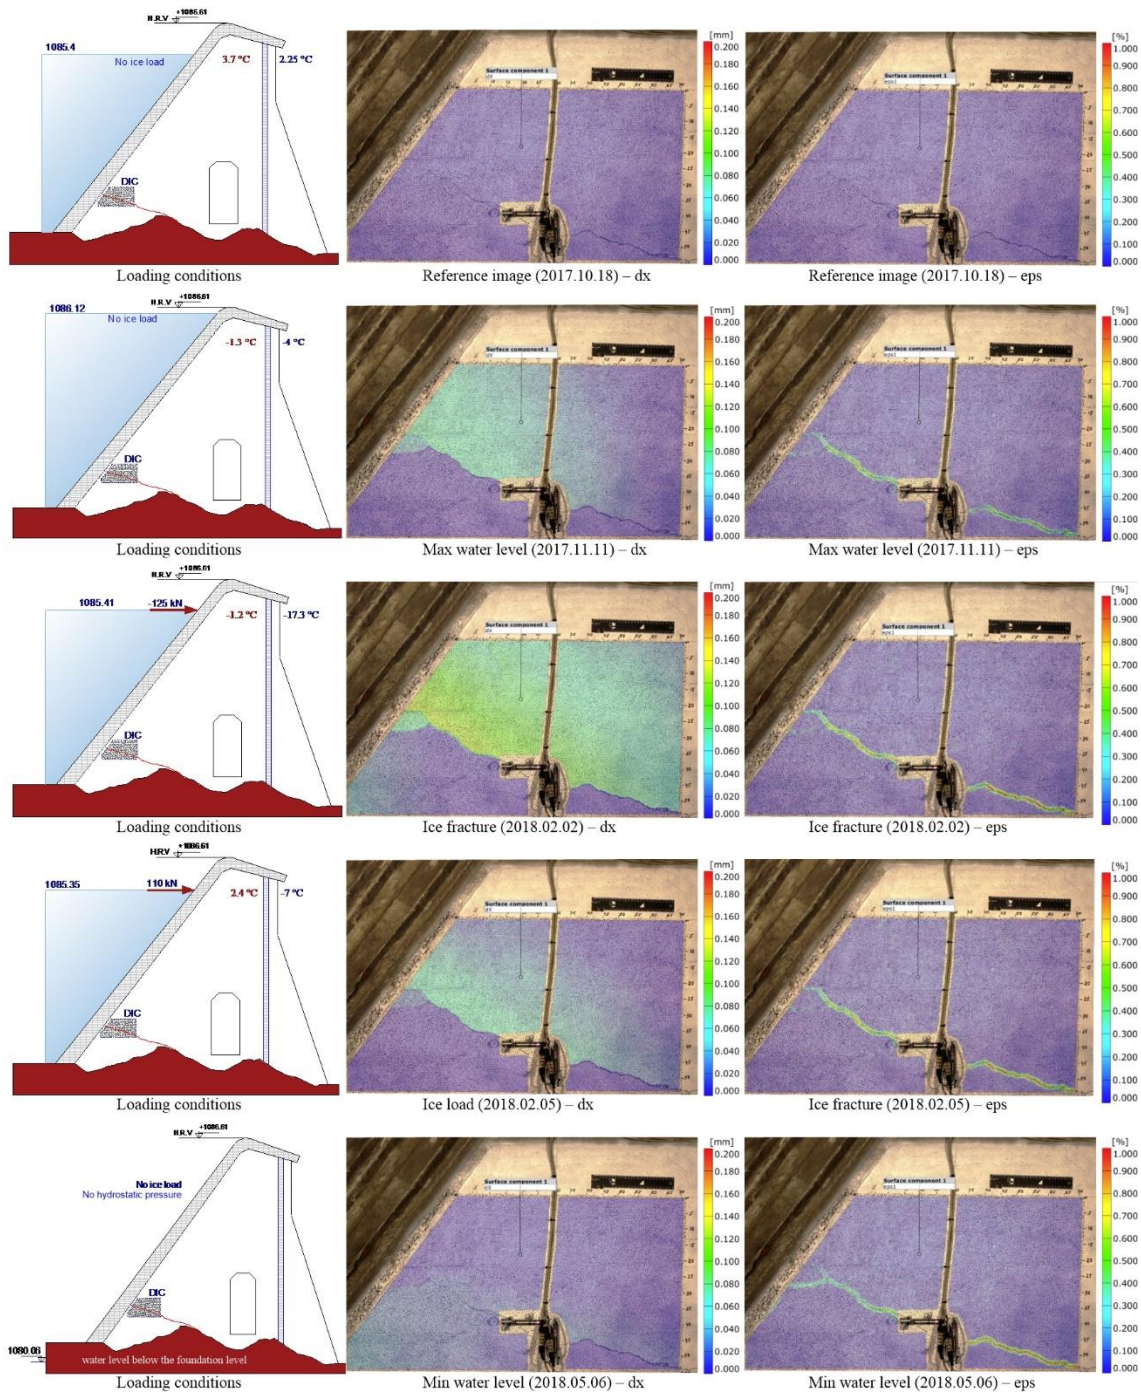
In addition to traditional sensors, a contactless technique, i.e. DIC, able to monitor cracks' progression was supplementing the monitoring plan. The method will show whether the monitored crack is active or not. Major strains and horizontal displacement around the main crack were extracted from the image analysis and plotted for selected dates in Figure 9. These dates are related to the maximum/minimum load conditions as follows: (1) min/max water level and (2) min/max ice load.

Figure 9. Actual loading conditions and image analysis using digital image correlation at selected dates

The DIC system enabled us to investigate two main aspects: (1) evaluate the feasibility of using an optical method over a long-term period in outdoor environment and (2) whether the crack is active or not. Given the harsh environment, the system proved to be robust enough to provide the necessary data. The analysis of the images acquired proved that the method is well suited to follow the evolution of the crack throughout the whole monitoring period. Moreover, cracks that were not visible by naked eye could also be detected (see Figure 9 on the 2018.05.06). It appears that the crack monitored was active throughout the whole period, with its maximum width developed during November – January month, being in line with LVDTs measurements.
