# Experiences with Thermal Spray Zinc Duplex Coatings on Road Bridges

Ole Øystein Knudsen <sup>1,\*</sup>

**Abstract:** Road bridges are typically designed with a 100-year lifetime, so protective coatings with very long durability are desired. Thermal spray zinc (TSZ) duplex coatings have proven to be very durable. The Norwegian Public Roads Administration (NPRA) has specified TSZ duplex coatings for protection of steel bridges since 1965. In this study, the performance of TSZ duplex coatings on 61 steel bridges has been analyzed. Based on corrosivity measurements on five bridges, a corrosivity category was estimated for each bridge in the study. Coating performance was evaluated from pictures taken by the NPRA during routine inspections of the bridges. The results show that very long lifetimes can be achieved with TSZ duplex coatings. There are examples of 50-year old bridges with duplex coatings in good condition. Even in very corrosive environments, more than 40-year old coatings are still in good condition. While there are a few bridges in this study where the coating failed after only about 20 years, the typical coating failures are due to application errors, low paint film

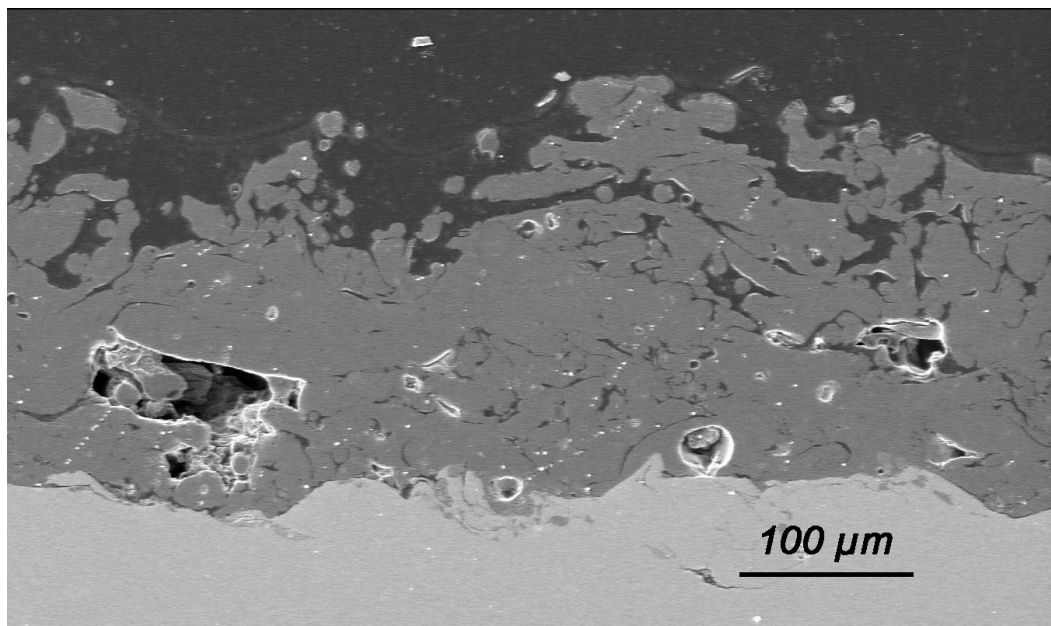
Another reason for low film thickness that is specific to TSZ duplex coatings is the lack of an instrument that can measure paint film thickness over TSZ. The commonly used magnetic film thickness gauges will measure the total duplex film thickness, i.e., both TSZ and paint. The eddy current thickness gauges that will measure thickness over the first electrically conducting layer, i.e., the zinc coating, does not work well with TSZ due to its rough microstructure and porosity (see Figure 5). This makes large variations in conductivity and unstable measurements. The magnetic thickness gauge is, therefore, presently the only option. Ideally, each coating thickness should be measured as applied to ensure the coatings meet specifications.

**Figure 5.** The cross-section of Thermal spray zinc (TSZ) coating. The very rough microstructure affects the conductivity of the coating, which results in a very large variation in paint film thickness measurements with Eddy current gauge.

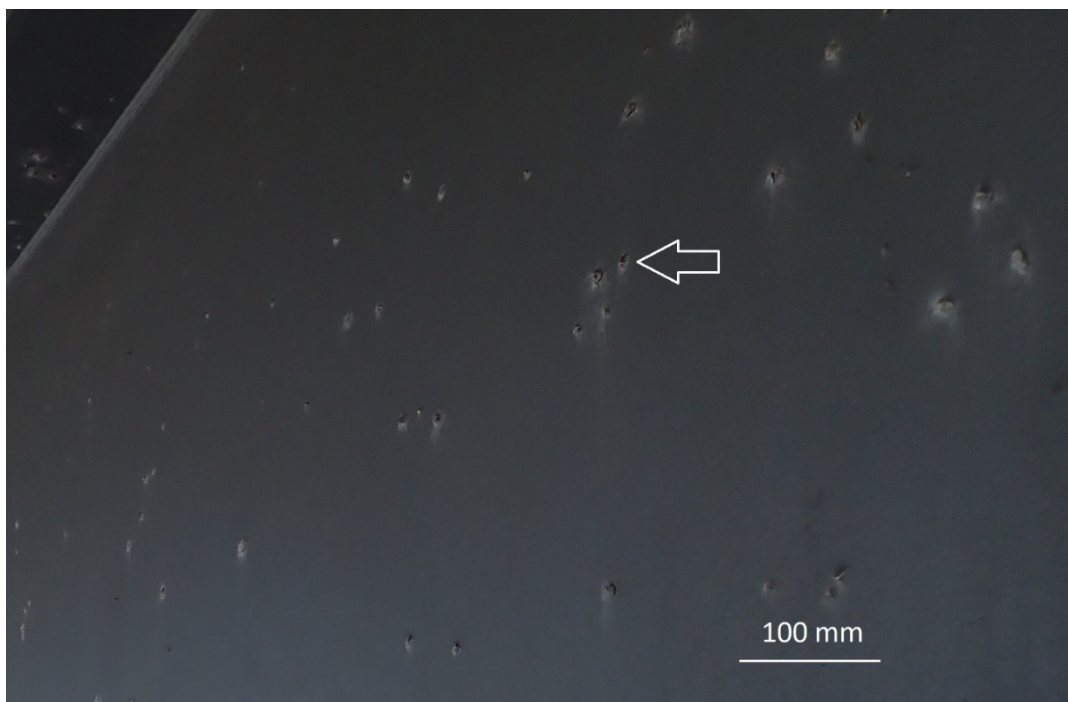
The third failure mechanism found was “spitting” during thermal spraying. If the arc spray gun is not properly adjusted, there will be incomplete melting of the zinc wire. These pieces of solid zinc will be sprayed along with the melted zinc but may protrude from the surface as tall peaks. When the paint is applied, the film thickness will be too low over these peaks and the paint will fail during exposure. A typical example is shown in Figure 6.

**Figure 6.** The corrosion of the TSZ due to “spitting” during thermal spraying. All the protrusions in the coating, one of them marked with an arrow, is due to spitting during thermal spraying. The paint film is too thin over the zinc protrusions and the zinc starts to corrode. Photo: NPRA.

The coating failure mechanisms that were identified have different origins. Pinholes and spitting are typical application errors with TSZ duplex coatings. When coating a large bridge, such errors are likely to appear occasionally. By adjusting the application parameters immediately to prevent further formation of such errors, and light grinding with sandpaper before application of the next coat, the quality of the coating will improve significantly. Mainly pinholes and spitting were responsible for the degradation at Bergsøysundbrua and large amounts of pinholes were also found at Nordhordlandsbrua. In the very corrosive C5 environment, the TSZ started to corrode locally shortly after the bridge was built. The TSZ was protecting the steel, but the TSZ has a certain capacity for protection and when it is consumed, the steel starts to corrode.

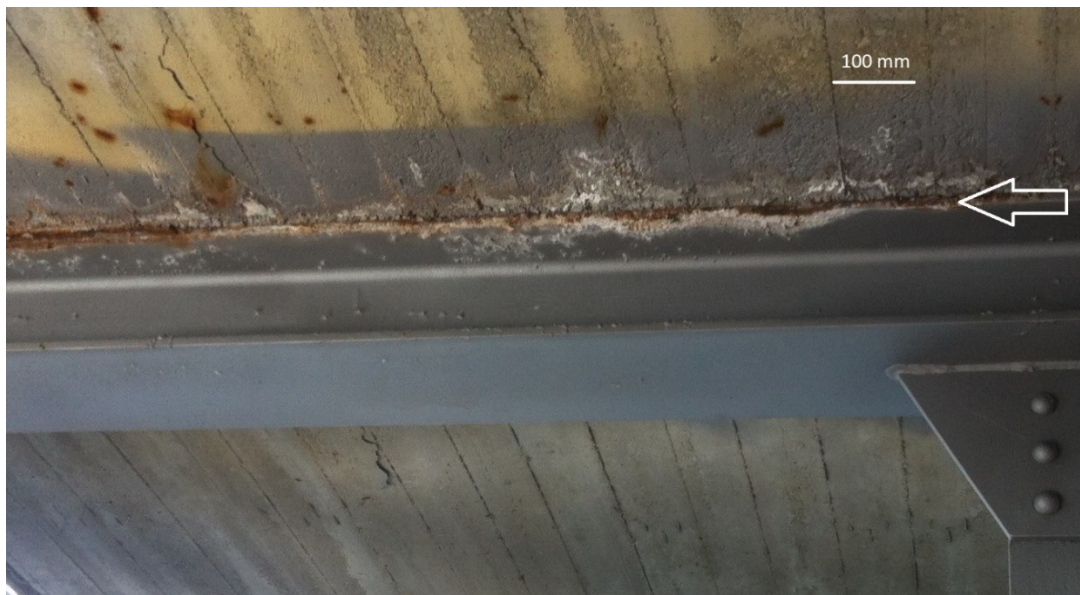
The fourth failure mechanism is the hydrolysis of the alkyd paint in contact with concrete. The ester bonds in the alkyd binder are broken when exposed to an alkaline environment. This is also called saponification and is a well-known degradation mechanism for alkyds [14]. This was typically found on the upper flange of H-beams carrying a concrete bridgeway, see Figure 7.

**Figure 7.** The saponification of alkyd paint where the painted H-beam is in contact with the concrete (marked with an arrow) and subsequent corrosion of zinc and steel.

The saponification problem was found on most bridges where a concrete bridgeway was resting on a coated H-beam. This problem was eliminated when the NPRA paint specification was changed from alkyds to epoxies. Epoxies are very tolerant to the alkaline conditions in concrete.
