TECHNICAL REPORT

Extreme Overheating in Self-regulating Heating Cables

Tranberg AS

TR NO. TR A5943	DATE 2004-03-04	CLIENT'S REF. Dag Kjosavik	PROJECT NO. 14X20601
ELECTRONIC FILE CODE 040227bm83735		RESPONSIBLE (NAME, SIGN.) Hallvard Faremo <i>HF</i>	CLASSIFICATION Unrestricted
ISBN NO. 82-594-2629-3	REPORT TYPE	RESEARCH DIRECTOR (NAME, SIGN.) Hallvard Faremo <i>HF</i>	COPIES 6
			PAGES 31
DIVISION Electric Power Technology	LOCATION Sem Sælunds v. 11	LOCAL FAX +47 73 59 72 50

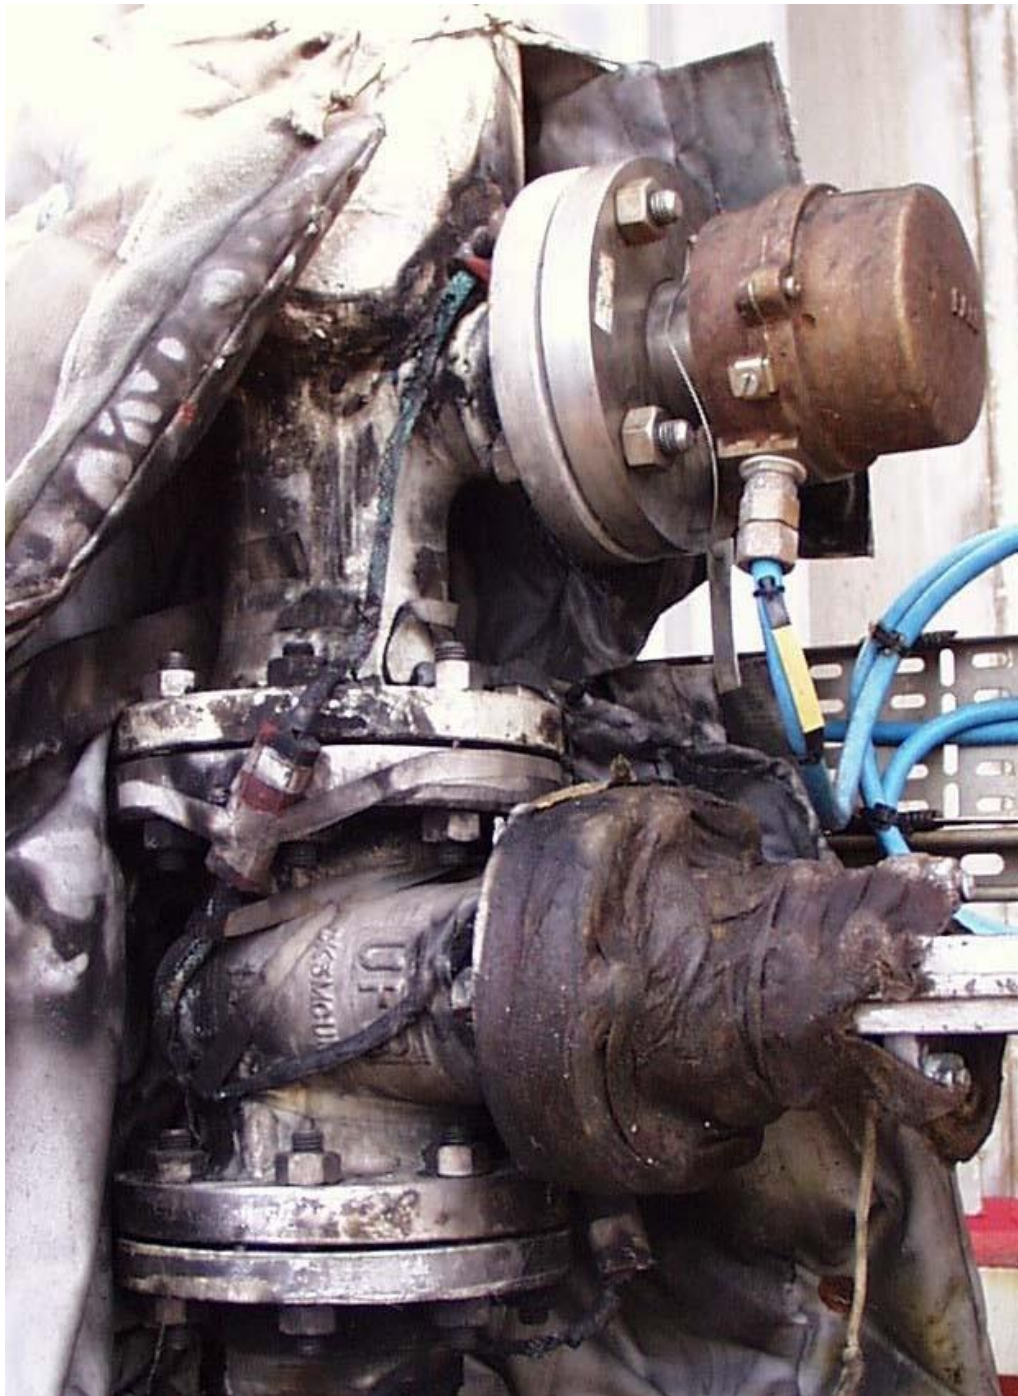
Figure 1: Burned cable, 3BTV2, at firewater pump at Heidrun.
The cable is destroyed by fire and thereafter pulled down by the insulating mat.

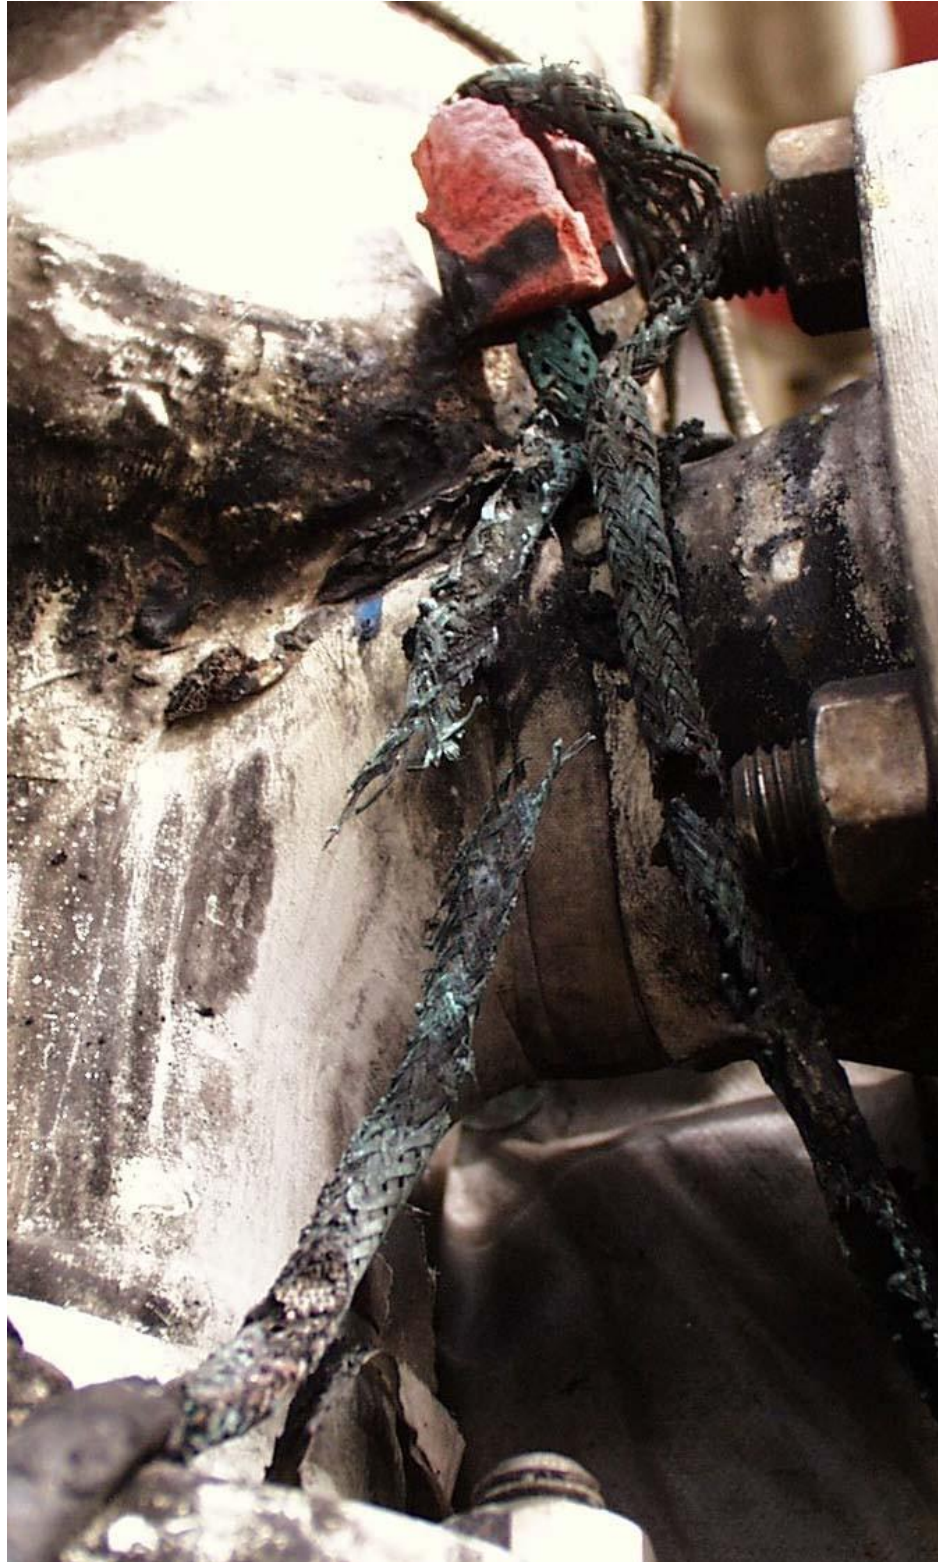
Figure 2: Same cable as shown in Figure 1.
The cable is completely burnt-out, only the metal screen is left. At the same time we also see a somewhat irregular installation of the cable.

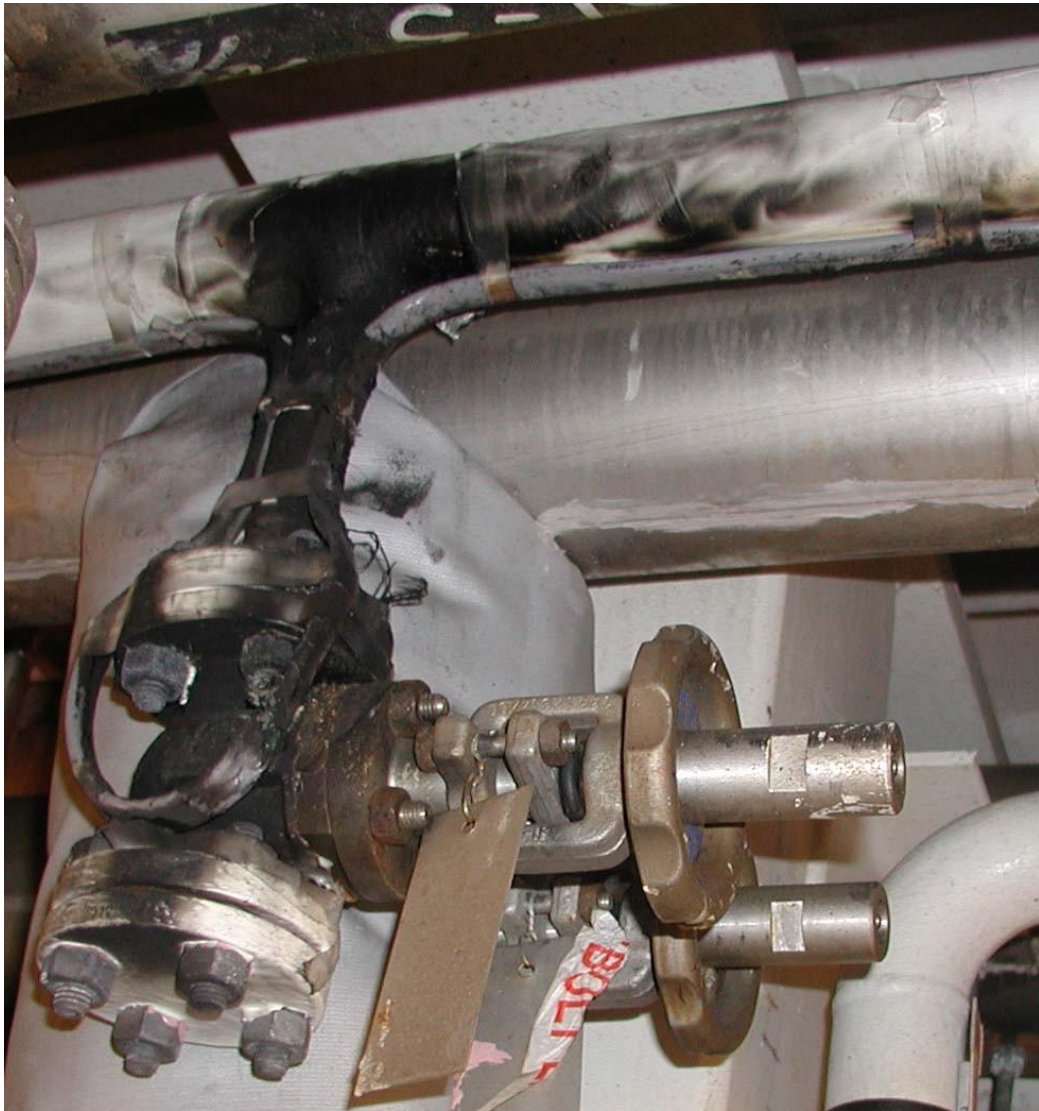
Figure 3: Burnt-out cable, BSX3-2, on a firewater pipe at Snorre B. A loop of the cable is laid around a flange. The point of failure on the cable seem to be situated close to the edge of the flange. An earth fault alarm led to detection of the failure.

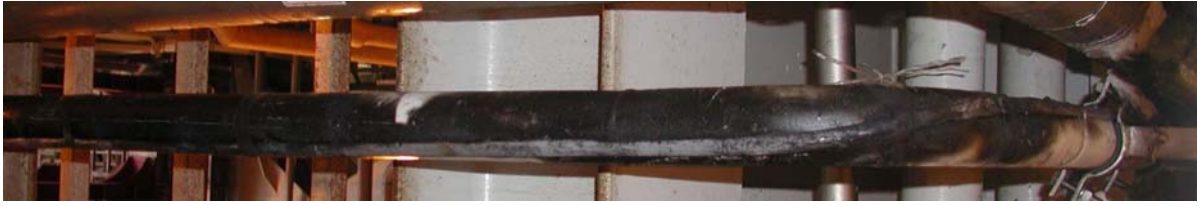
Figure 4: Same cable as shown in Figure 3.
From the point of failure close to the flange the cable was burnt-out in length of four meter (from the point of failure in the direction to the coupling box).

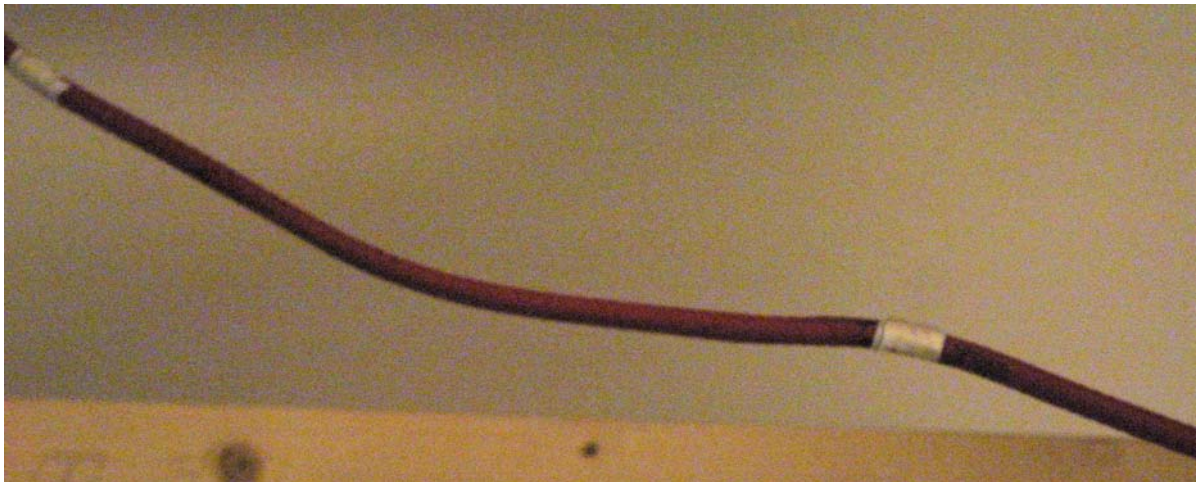
Figure 5: Cable 8XTV2, from Åsgård B. Production workers had observed bright flares from the cable during operation. The picture is showing the cable with voltage applied in the laboratory of SINTEF Energy Research. No visible activity in the cable.

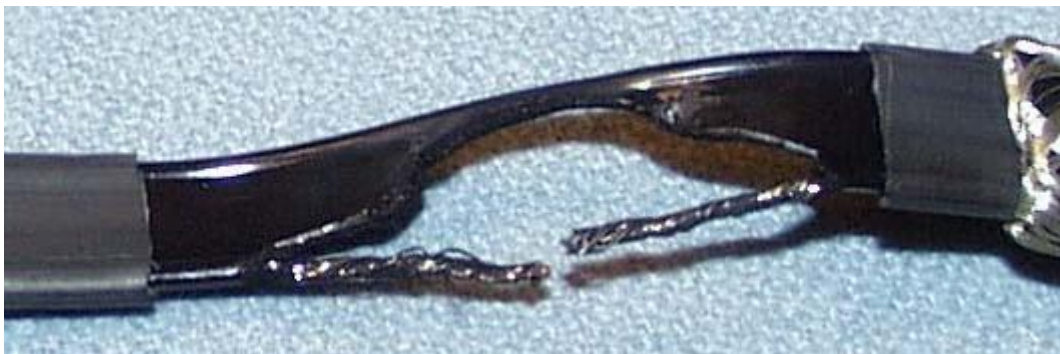
It should here be pointed out that the inflammation most probably was caused by plenty access of air (oxygen). This would not have been the case if the arc was closed in an unopened cable.

Figure 6: Combustion of the semi-conducting material in a self-regulating heating cable after a provoked serial arc.

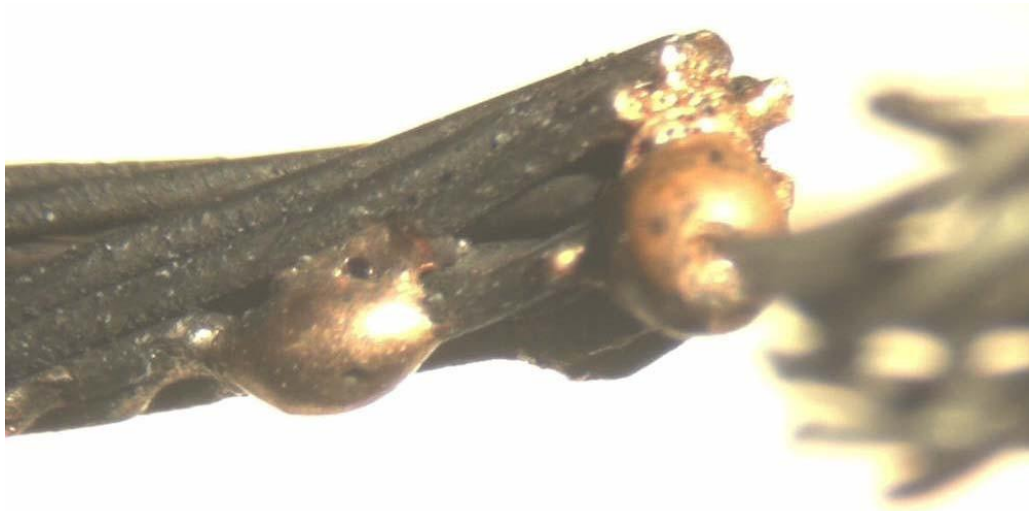
Microscope picture of the rupture location where a serial arc has occurred, see Figure 7, clearly show that heat generation has been so intensive that the copper strands of the conductor has started to melt. Melting point of copper is 1083 °C.

Figure 7: Microscope picture of the rupture location where a serial arc has occurred (6 x magnification).

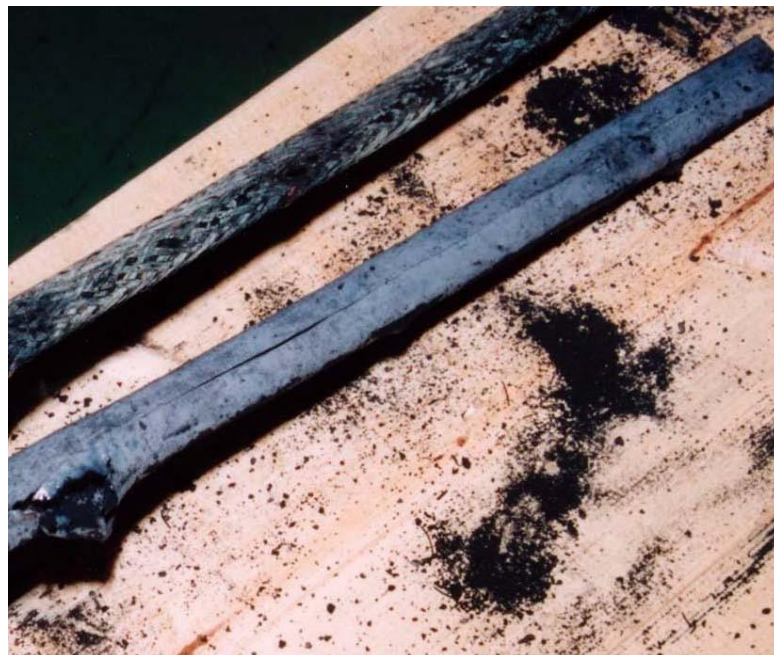
The opening of the damaged cables from Snorre B and Heidrun indicate almost totally burnt-out cables. Figure 8 is showing the Snorre B cable where the overjacket is removed. There are almost only carbonised remainings left. Figure 9 is showing the same cable. Here the copper braid is opened. Notice that only one conductor is left, the others are melted away.

Figure 8: Outer sheath from Snorre B cable.

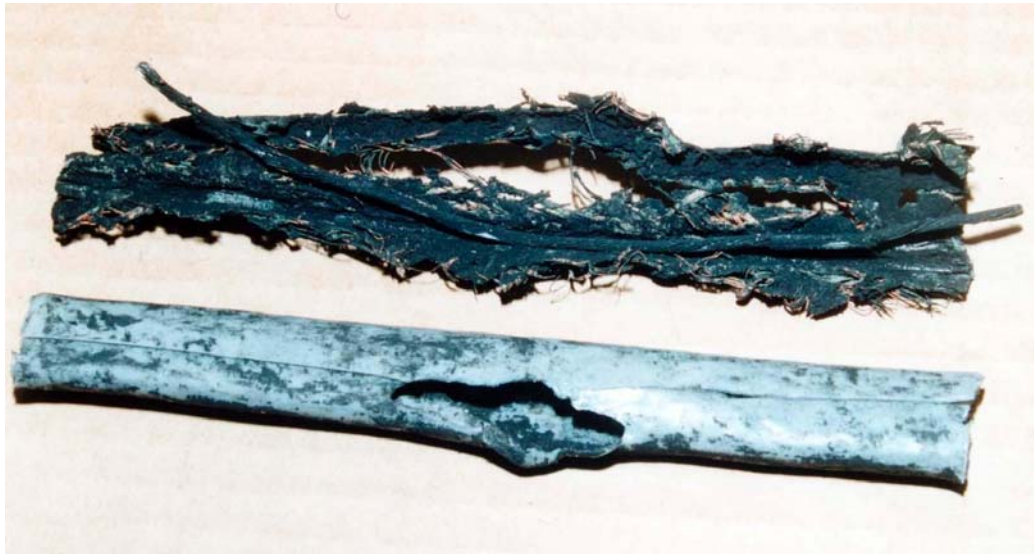
Figure 9: Copper braid of Snorre B cable opened. Just one conductor is remaining.

The following is to be mentioned here: Upon arrival of the Snorre B cable at SINTEF Energy Research it was observed that the specified cable termination (power boot) on the voltage side of the cable was not installed. Such a termination shall protect the cable against water penetration. Whether the cable termination was removed during disassembly or if it has been lacking all time is not known.

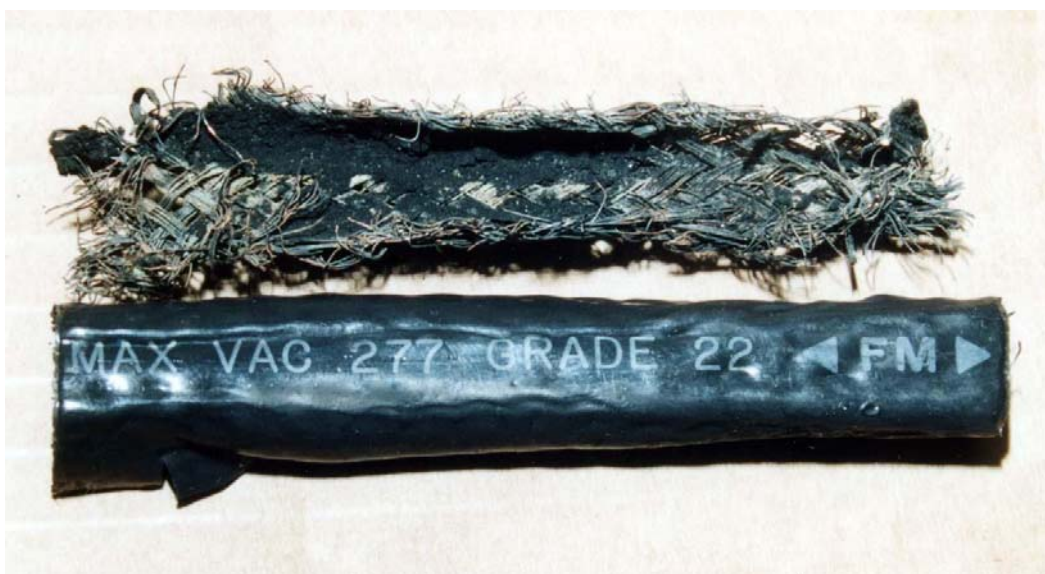
Figure 10 is displaying a piece of the cable from Heidrun. The overjacket is removed and the braid is opened. Here both the conductors are disappeared. As mentioned earlier the melting point of copper is 1083 °C. The temperature of both the two cables must therefore have been even higher, because the copper is almost vaporized.

Figure 10: A piece of the cable from Heidrun. Overjacket is removed and braid opened. Both conductors are disappeared.

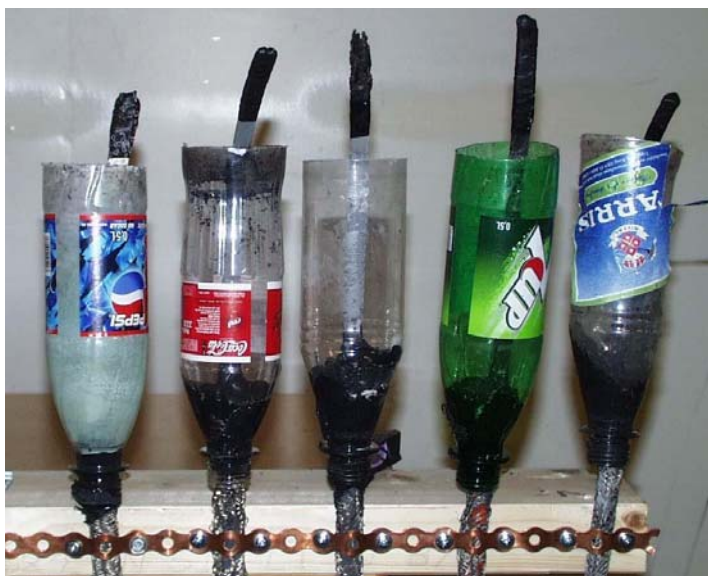
Lifetime of the cables has varied from 300 to 700 hours. Two cables have broken down because the cable ends have caught fire; three cables have broken down because they have caught fire both in ends and under the salt-water surface. Four cables have broken down by catching fire under the water surface. All ends have been about 50 mm above water surface. Saline water coming up to these ends is probably caused by capillary attraction.

Figure 17: Examples of damaged cables. From left to right:

- 1: Cable caught fire in at the end.
- 2: Cable caught fire under the water surface.
- 3: Cable caught fire under the water surface and in the end.
- 4: Cable caught fire under the water surface.
- 5: Cable caught fire under the water surface.

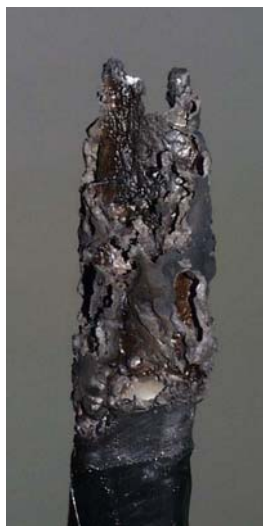
Figure 18: Close-up picture of the end of Cable 3 in Figure 17.

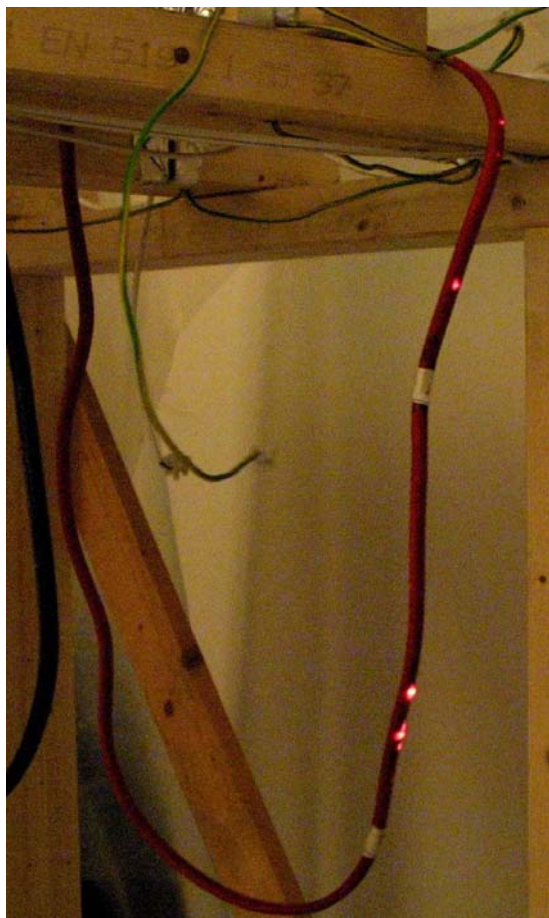
During a meeting with manufacturers, suppliers and project employers the free end of the cable was accidentally raised and placed over the framework in the test rig so that the free end was situated higher than the end having voltage applied. After a few minutes an intense light showed up under the outer sheath of the cable. See Figure 19.

Figure 19:
Flares from cable 8XTV2 after the free end of the cable was raised.

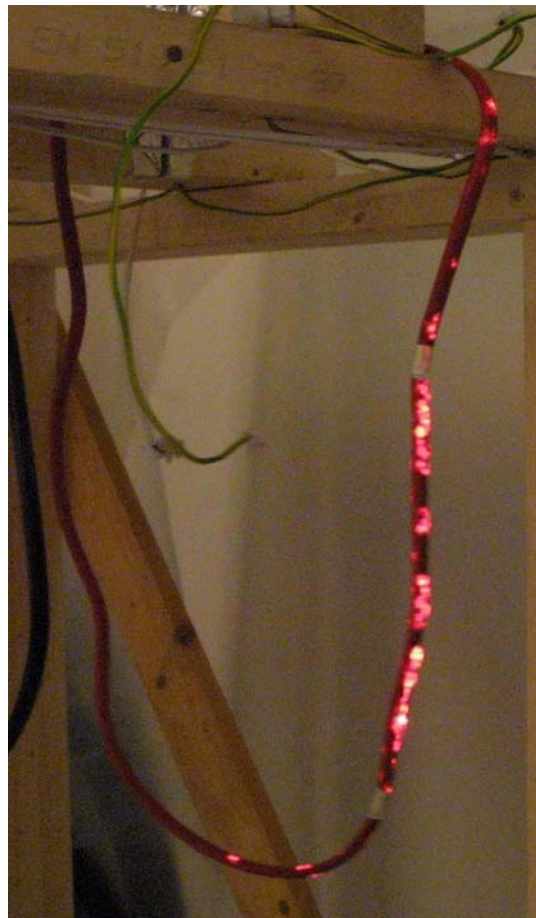
Figure 20:
Flares evenly distributed along the cable after the cable has been snapped several times.

After a few minutes the flares came to an end. By snapping the cable by the finger the flares returned. The three following days the cable was snapped three times a day. Finally the flares were evenly distributed along the whole cable, and remained flaring (see Figure 20).

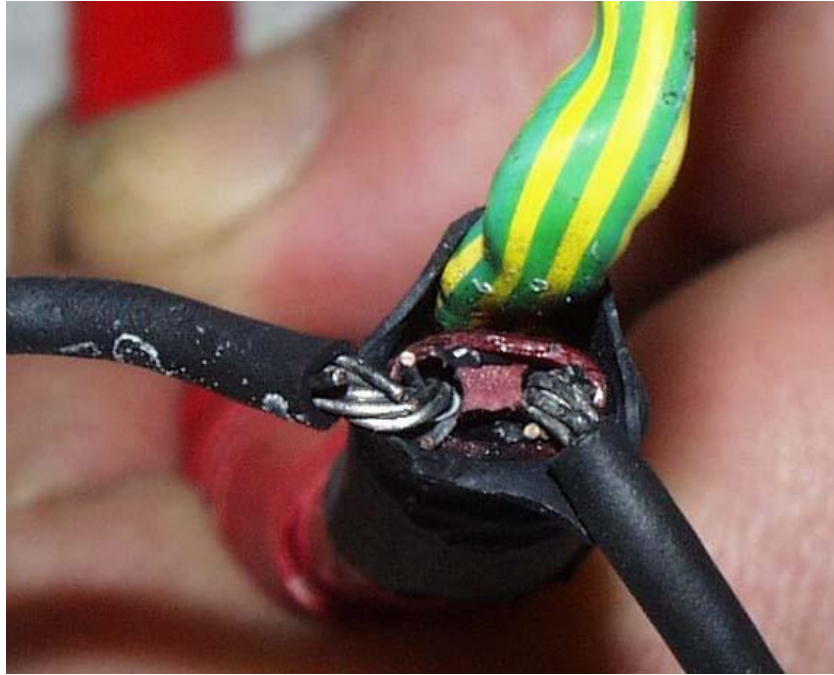
Pictures from the opening of the cable are showed in Figure 21 and 22. Figure 21 shows the end of the cable where voltage is applied. When SINTEF Energy Research received the cable the cable termination was lacking at this end. The cable termination shall, among other things, protect the cable against water penetration. Whether the specified termination had been removed at the dismounting or if it was lacking the whole time is not known.

Figure 21: Cable end for voltage connection. Specified cable termination is lacking.

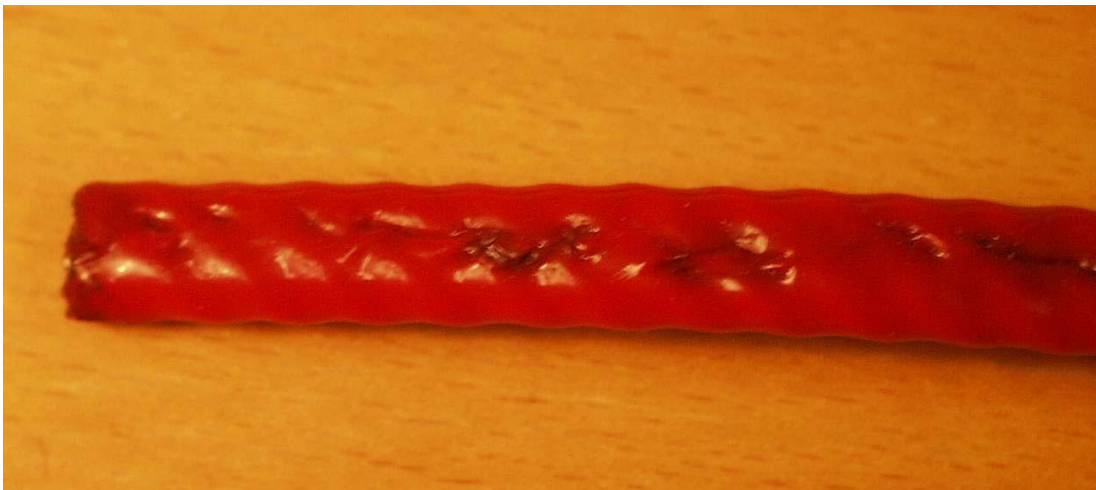
Figure 22 is showing a piece of cable where the outer sheath and braid are removed. It is evidently that the inner sheath has several points where the plastic show traces of melting.

Figure 22: A piece of cable 8XTV2 with inner sheath. Distinct hotspots.

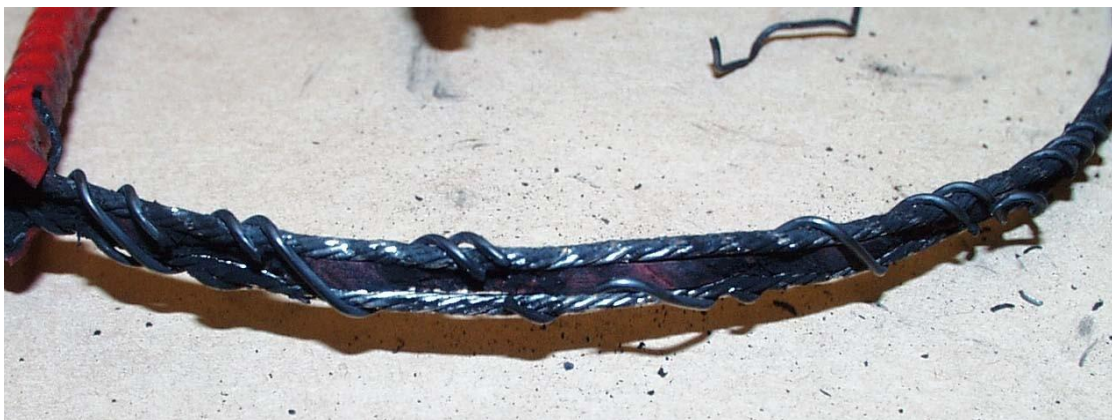
Figure 23 is showing the cable fully opened. The heat generating part of the cable consists of an insulating spacer keeping the two conductors apart. Around this is “wrapped” self-regulating conductive fibres. From the figure are seen ruptures in several windings. All ruptures are at the flat side of the cable, which is between the live conductors. There is also plenty carbon along the whole inner part of the cable.

Figure 23: Cable 8XTV2 opened. There are several ruptures in the self-regulating conductive fibres “wrapped” around the live conductors. There is also plenty carbon along the whole inner part of the cable.

The temperature inside the cable has evidently been high. There may be several reasons for this, but at date we have no special theory that points out to be the most probable.

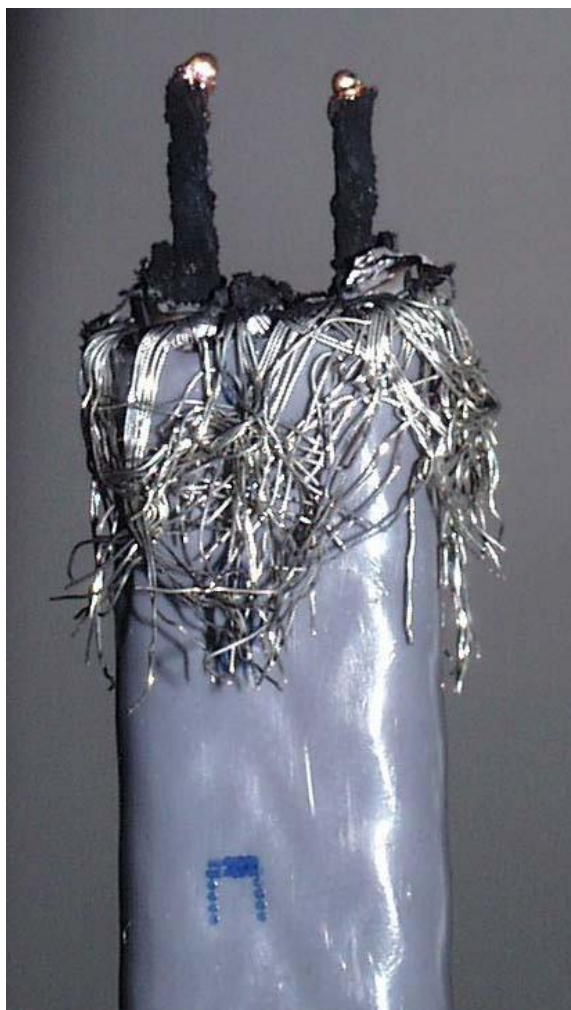
The cutting surface of the out sticking end was then moistened with saline water by use of a cotton stick (Q-tip). After a couple of minutes it started to glow in the cutting surface of the self-regulating element between the live conductors. After another half-a-minute the matrix then started to burn, and the end caught fire with flame and smoke development. When the flame arrived the grounded braid both earth leakage circuit breaker and overcurrent circuit breaker disconnected the voltage. See Figure 24 and 25.

Figure 24: Cable BSX-8-2. The cutting surface was gently moistened with saline water, which resulted in glowing in the cutting surface of the self-regulating element between the live conductors. After a short time the matrix started to burn.

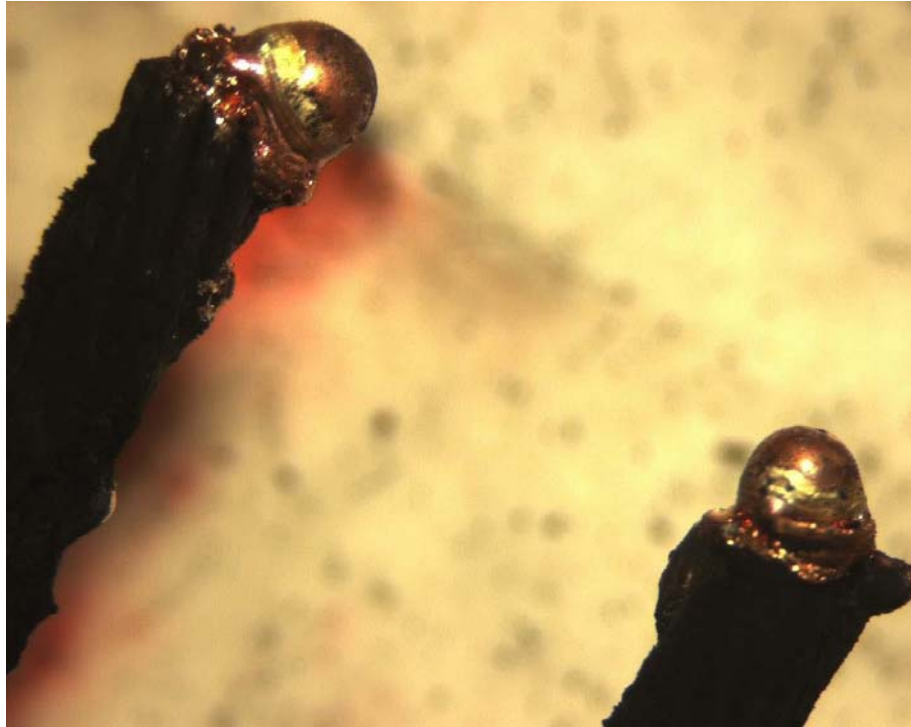
Figure 25: Microscope picture (6x magnification) of cable end in Figure 24. The copper of the live conductors has melted.
