# Root causes for corrosion on painted steel structures in marine environments

Ole Ø. Knudsen<sup>1</sup>

<sup>1</sup>SINTEF, Trondheim, Norway

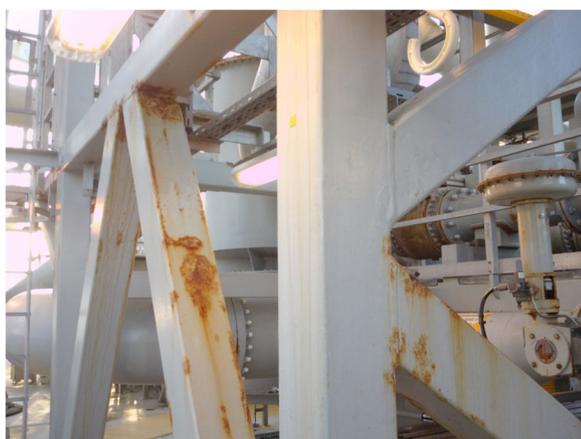
Several corrosion attacks can be seen on the steel structure in Figure 2. The picture shows a support structure for process equipment made from rectangular

**FIGURE 2** Corrosion attacks on painted steel structure. Attacks typically initiate at welds and edges, but in this picture we also see attacks on flat surfaces, indicating that the film thickness is below specification. [Color figure can be viewed at [wileyonlinelibrary.com](http://wileyonlinelibrary.com)]

hollow section (RHS) steel beams. Corrosion has initiated at the edges of the RHS beams and in the weld joints. Corrosion attacks have also initiated on flat surfaces, indicating that the film thickness of the paint is below specification. The RHS beams are produced with a longitudinal weld on one side, and corrosion has also initiated at this weld. Low film thickness in general has probably contributed to the coating failures over edges and welds as well. RHS profiles are also delivered with a specified outer edge radius, typically in the range 5–30 mm depending on their dimensions. The beams in the picture have an edge radius of at least 10 mm, which should decrease the edge retention problem significantly.

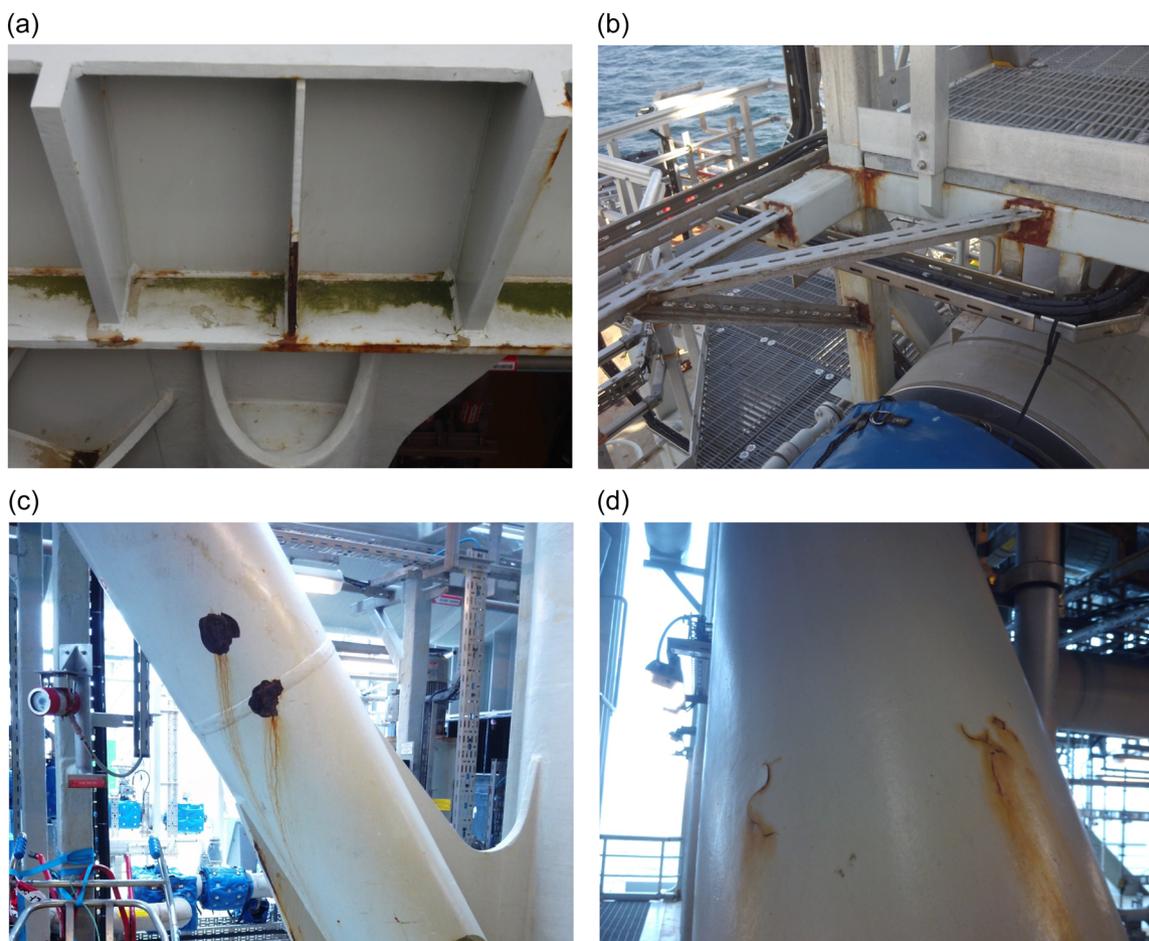
Figure 3 shows various corrosion attacks with different root causes. Figure 3a shows initiations mainly along edges, but also emerging corrosion on welds in the inner corner. Figure 3b shows galvanic corrosion around stainless steel profiles. The stainless steel profiles should

**FIGURE 3** Corrosion attacks on painted steel on offshore installation with different root causes. (a) Corrosion attacks initiating from edges; (b) galvanic corrosion around stainless steel welded into the structure; (c) poor pretreatment before paint application; (d) the paint is cracking and corrosion initiates in the cracks. [Color figure can be viewed at [wileyonlinelibrary.com](http://wileyonlinelibrary.com)]

have been painted 50 mm beyond the weld to minimize the cathodic surface area, but this has not been done, resulting in widespread corrosion around the weld. Figure 3c shows corrosion rapidly spreading under the paint due to poor surface pretreatment. The corrosion products strain the paint film and cause the paint to break off in pieces. Figure 3d shows cracking of the paint, and subsequent corrosion in the cracks. To explain what caused the cracking is beyond the scope of this work, but internal stresses seem likely, since no signs of mechanical damage can be seen.

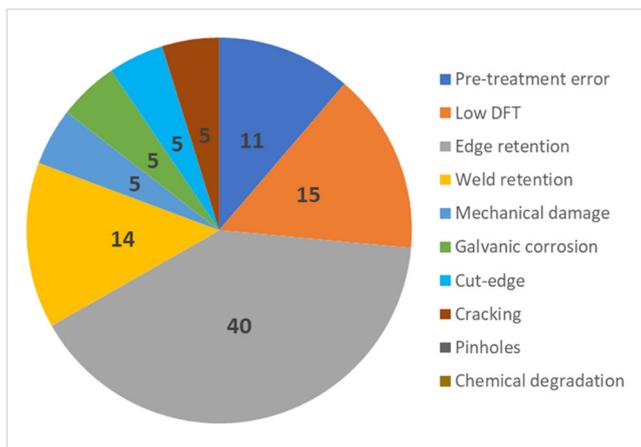
FIGURE 4 Percentage distribution of root cause for corrosion on painted steel on topside oil and gas offshore installation. [Color figure can be viewed at [wileyonlinelibrary.com](https://onlinelibrary.wiley.com/doi/10.1002/maco.202314046)]

The percentage distribution of failure mechanisms for all the corrosion attacks are shown in Figure 4. Pretreatment errors and low DFT (application errors) explains about 25% of the corrosion attacks, while edge and weld retention caused about 55% of the attacks. Edge and weld retention failures are caused by the same mechanisms. After application, the wet paint will try to reduce its surface area on the structure due to its surface tension. The paint will therefore be thinner over any protrusion or irregularity in the substrate, like edges and welds. The final dry film will therefore be thin and have inferior barrier properties, allowing ions to penetrate and initiate corrosion.<sup>[16]</sup> The remaining corrosion attacks were caused by mechanical damages, galvanic corrosion, cut-edges, and cracking. Pinholes and chemical coating degradation were not found on this installation.

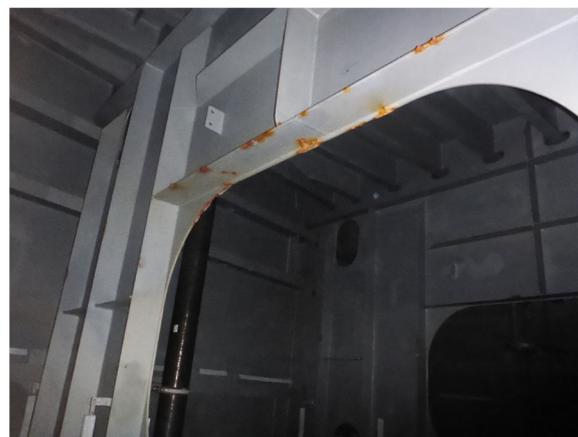
The coating was specified and prequalified according to NORSOK M-501 System 3B. The ballast water tanks were attacked by corrosion mainly on edges, as shown in Figure 5.

FIGURE 5 Typical corrosion attacks in ballast water tank after 6 years in service. [Color figure can be viewed at [wileyonlinelibrary.com](https://onlinelibrary.wiley.com/doi/10.1002/maco.202314046)]

Some attacks were also found on welds, and some attacks were attributed to low film thickness. Figure 5 shows several smaller areas with a brighter shade of gray, indicating that touch-up repairs were performed in the yard. No coating repair has been done after the ballast tanks were taken in use. Figure 6 shows the percentage distribution of corrosion attacks. Edge retention errors accounted for 78% of the coating failures, while weld retention and low film thickness explained the remaining attacks.

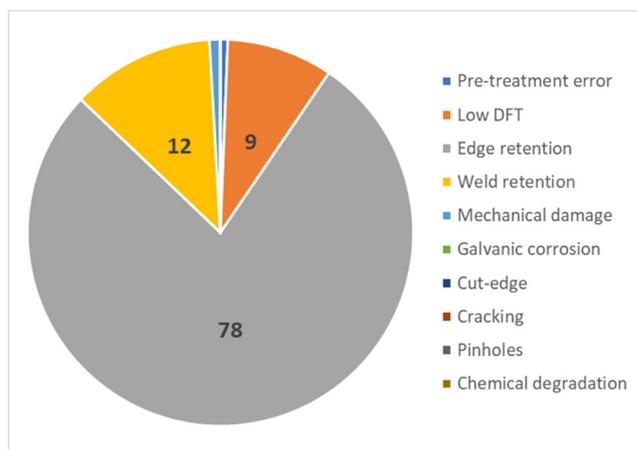
FIGURE 6 Percentage distribution of root cause for corrosion on painted steel in ballast water tanks. [Color figure can be viewed at [wileyonlinelibrary.com](https://onlinelibrary.wiley.com/terms-and-conditions)]

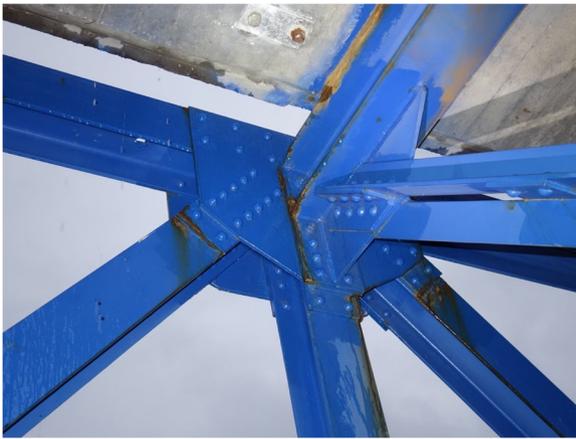
The coating system on this bridge was similar to the system on the offshore installation, see Table 1. Figure 7 shows a

**FIGURE 7** Typical corrosion attacks on bolted truss work on a coastal steel bridge protected with a three-coat paint system. [Color figure can be viewed at [wileyonlinelibrary.com](https://onlinelibrary.wiley.com/doi/10.1002/maco.202314046)]

connection at the upper chord of the truss work that illustrates the corrosion attacks on this bridge well. Several corrosion attacks have initiated from edges on the members and the plates in the connection. Since this bridge was not welded but bolted, many of the corrosion attacks initiated from the overlapping bolt joints. The paint has not penetrated the crevices in the many lap joints, resulting in corrosion as shown in the picture. The crevice between the concrete bridge deck and the beam it is resting on, is also an area with many initiation points for corrosion.

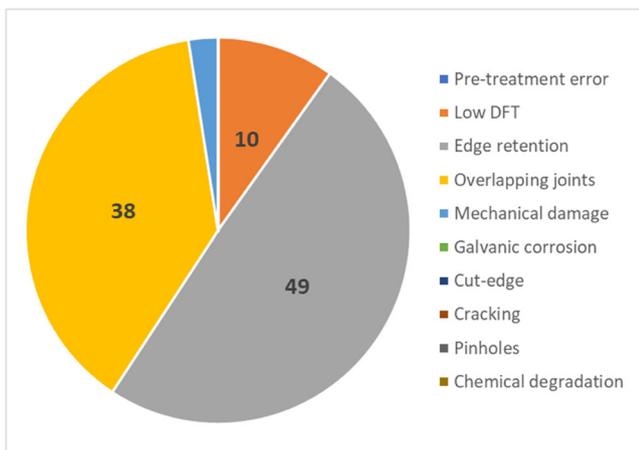
**FIGURE 8** Percentage distribution of root cause for corrosion on painted steel on bolted truss work on a coastal steel bridge protected with a three-coat paint system. [Color figure can be viewed at [wileyonlinelibrary.com](https://onlinelibrary.wiley.com/doi/10.1002/maco.202314046)]

Figure 8 shows the percentage distribution of corrosion attacks estimated from the inspection pictures of the bridge. Edge retention (49%) and poor penetration into overlapping joints (38%) explains most of the corrosion attacks on the bridge. Low DFT and

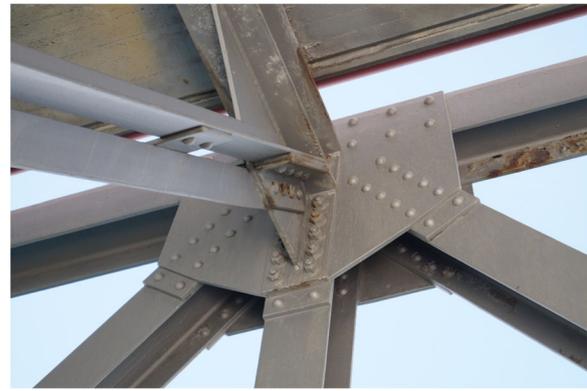
**FIGURE 9** Typical corrosion attacks on bolted truss work on a coastal steel bridge protected with a TSZ duplex coating system. [Color figure can be viewed at [wileyonlinelibrary.com](https://onlinelibrary.wiley.com/doi/10.1002/maco.202314046)]

The truss structure of this bridge has an identical design to the bridge discussed above, but the steel was protected with a TSZ duplex coating system from the start. Figure 9 shows a connection in the truss work, identical to the one shown in Figure 7 for the other bridge. Comparing the two pictures, we see that the two coating systems have quite different weaknesses that result in corrosion. There is less corrosion initiating from edges, and corrosion from the lap joint crevices is almost completely absent.

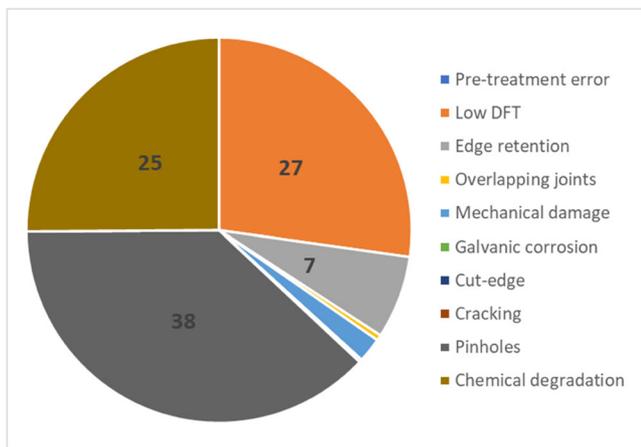
**FIGURE 10** Percentage distribution of root cause for corrosion on painted steel on bolted thross work on a coastal steel bridge protected with a thermal spray zinc duplex coating system. [Color figure can be viewed at [wileyonlinelibrary.com](http://wileyonlinelibrary.com)]

Figure 10 shows the distribution of root cause for corrosion on the TSZ duplex coated bridge. Low DFT, pinholes, and chemical degradation of the paint explain most of the attacks.

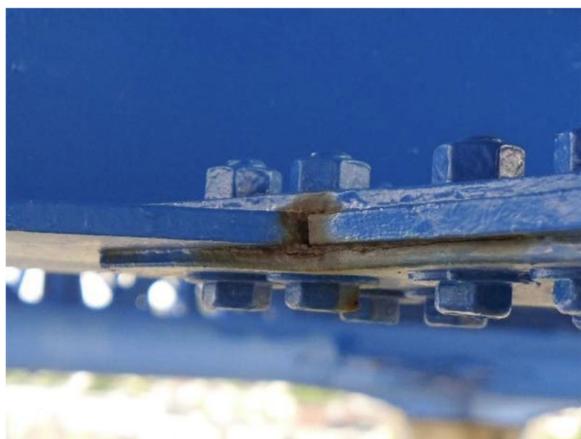
**FIGURE 11** Corrosion products breaking the overlapping joint apart. [Color figure can be viewed at [wileyonlinelibrary.com](http://wileyonlinelibrary.com)]
