# Carbon Cathode Wear in Aluminium Electrolysis Cells

Samuel Senanu<sup>1\*</sup>, Zhaohui Wang<sup>1,2</sup>, Arne Petter Ratvik<sup>2</sup> and Tor Grande<sup>1</sup>

1. Department of Material Science and Engineering, NTNU Norwegian University of Science and Technology, NO-7491 Trondheim, Norway

2. SINTEF Industry, NO-7465 Trondheim, Norway

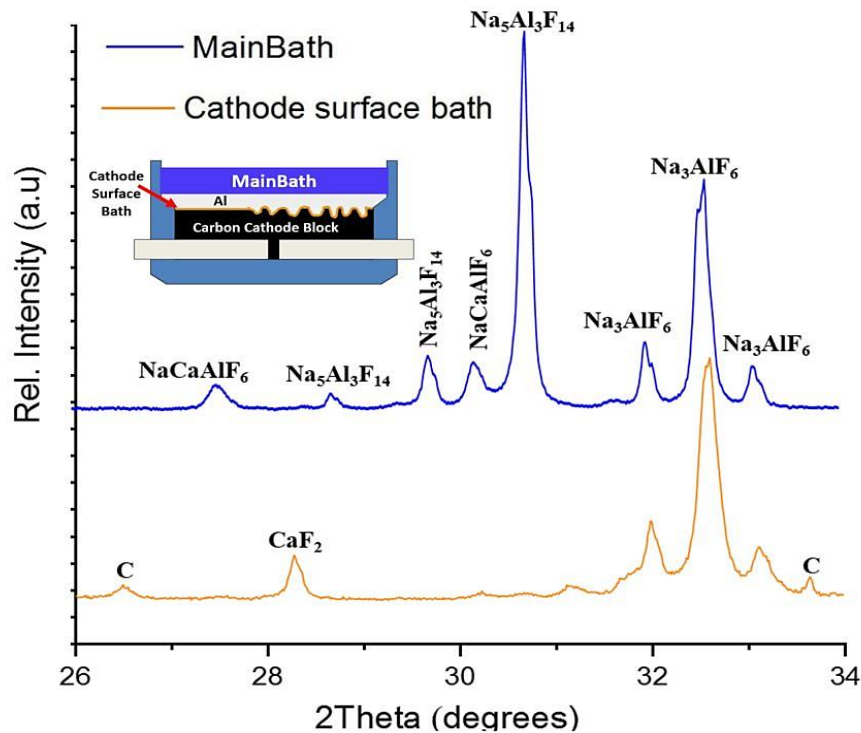
**Fig. 1** X-ray diffraction patterns of bath samples collected from the bath on top of the metal pad and on top of the cathode surface. Insert: sketch of an electrolysis cell showing locations of the solid bath samples.

The phases present in the bath from the cathode surface suggests a relatively low acidic bath as compared to the main bath. Reduced acidity of the bath on the cathode surface might be due to electrochemical reactions occurring on the cathode surface. Reaction 1 might lead to depletion of  $AlF_3$  content in the bath on the cathode surface.
