FORMATION OF CARBON BUILD-UP ON THE FLUE WALL OF ANODE BAKING FURNACE

Zhaohui Wang^{1,2}, Stein Rørvik¹, Arne Petter Ratvik¹ and Tor Grande²

¹SINTEF Materials and Chemistry, NO-7465 Trondheim, Norway

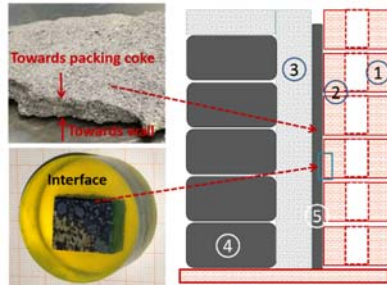
Refractory bricks together with carbon build-up layer were collected from a spent flue wall during an autopsy of an open baking furnace with a lifetime of about 4000 days. The carbon build-up layer was around 1-2 cm in thickness. Samples, including the interface between the refractory and the carbon build-up layer, were collected to investigate microstructure evolution and mineralogical phase transformation taking place at the interface. Cross-section samples and powder samples were prepared for characterisation. A piece of carbon build-up layer and a polished interface cross-section sample are shown in Figure 1. A thin black carbon build-up layer could be observed at the refractory interface. Figure 1 also illustrates a schematic drawing partly showing an open top furnace structure including the hollow refractory flue wall, the packing coke and the anode, which are relevant for the present work. The sampling positions are marked in the drawing. Pristine packing coke particles were collected for comparison.

Figure 1. Carbon build-up sample (left top), interface sample (left bottom), and a schematic drawing (right) partly showing an open anode baking furnace structure which is relevant to the present work. 1 - hollow flue wall bricks, 2 - gaps in flue walls to exhaust the volatiles, 3 - packing coke, 4 - green anodes, and 5 - carbon build-up on flue wall surface. Figure only for illustration and not in scale.

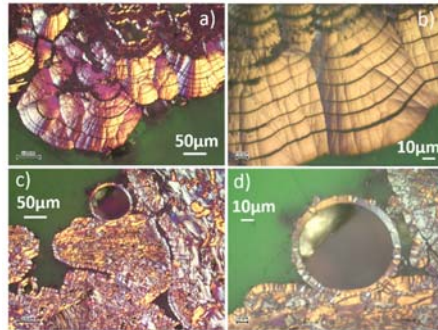
The thickness of the pyrolytic carbon layers varied along the carbon build-up cross-section. Thicker layers around 100 µm were observed near the flue wall surface as presented in Figure 4 a)-b), while slightly into the packing coke the layers were thinner and less than 10 µm as shown in Figure 4 c)-d). Micro-cracks inside the pyrolytic carbon crystals along the cleavage plane are clearly visible in Figure 4 b).

Figure 4. Polarized light micrographs of cross-section of carbon build-up. a) – b) position towards flue wall, and c) - d) position towards packing coke

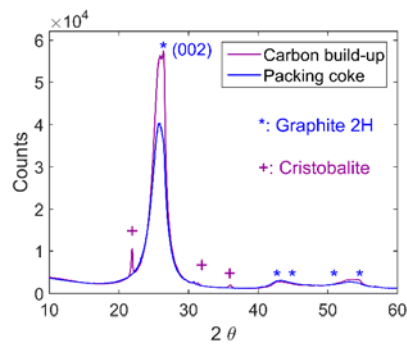
The main phases detected by powder XRD in the carbon build-up layer were graphite and cristobalite, which was in agreement with SEM/EDS results. XRD diffractograms are shown in Figure 5. Pristine packing coke is also shown for comparison. The splitting of the C₀₀₂ peak is pronounced compared to pristine coke, which is due to the presence of pyrolytic carbon with higher crystallinity.

Figure 5. XRD diffractograms for carbon build-up and pristine packing coke

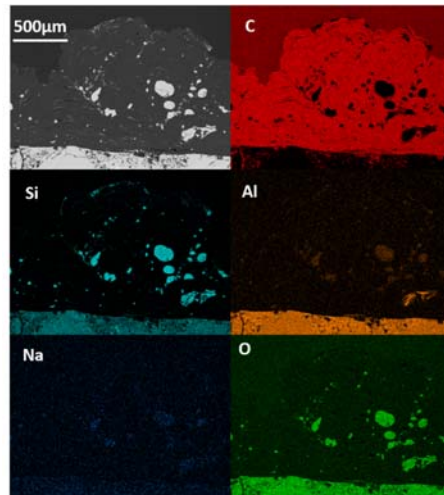
The dark areas embedded in pyrolytic carbon crystals shown in Figure 6 correspond to the white spots in SEM images shown in Figure 7. Element mappings demonstrated that the spots are rich in Si and oxygen content and poor in Na and Al content. The spherical structures imply that they were liquid at elevated temperatures corresponding to a silica-rich glass formed during the anode backing process. Point analysis confirmed that the Na and Al content in the silica droplets was less than 1 at% and 5 at%, respectively. Silica droplets solidify when the flue wall cools down, which seems to serve as nucleation and deposition surface for pyrolytic carbon to grow during the next firing cycle. Different phases observed in the sample were not necessarily formed at the same time.

Figure 7. Backscatter SEM image and element mapping of C, Si, Al, Na and O. The spots on refractory surface were silica.

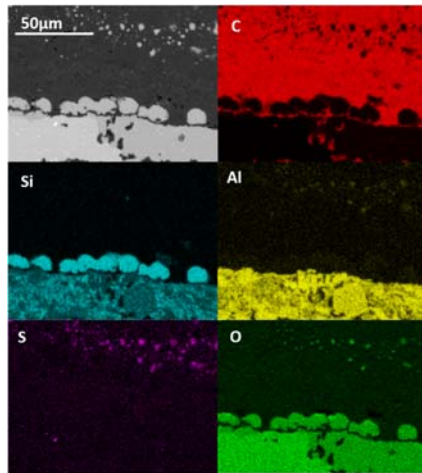
Silica spots were also observed in the vicinity of the refractory surface. The electron image and element mapping of C, Si, Al, S and O are presented in Figure 8. The formation of the silica phase is proposed to contribute both to the formation of carbon build-up layer and the degradation of the refractory materials. The mechanism for transporting silicon to the deposition sites, where pyrolytic carbon is formed, needs further studies.

Figure 8. Backscatter SEM image and element mapping of C, Si, Al, Na and O showing silica spots on the refractory surface

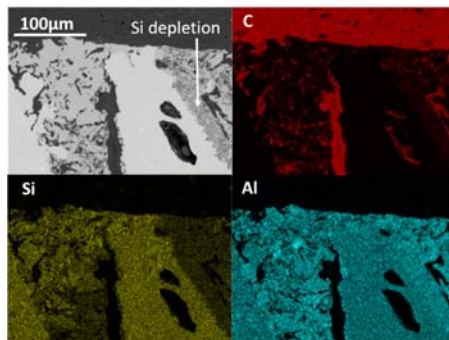
Figure 9 shows an electron image of mullite grains together with element mappings. A Si depleted region along the mullite grain surface is evident in the Si element mapping, which indicates that the mullite grain has been attacked with loss of Si. The lost Si from mullite grains is suggested to contribute to the formation of silica droplets in the carbon build-up layer. Carbon deposition on pore surfaces was also evident in the C element mapping. Gaseous degradation of the mullite is proposed to be the underlying reason, which will be discussed later.

Figure 9. Backscatter SEM image and element mapping of C, Si, Al and O showing Si depletion region on the mullite grain surface

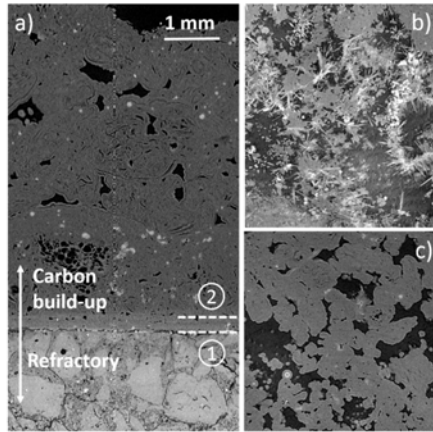
A cylindrical sample was drilled from the spent flue wall brick with a layer of carbon build-up attached to the refractory. The sample was analysed using X-ray CT scanner to see the microstructure evolution in the interior of the material. Images of CT scan are shown in Figure 10 where orthogonal views of the xz plane is shown in a) while the xy plane is shown in b) and c). The brighter the colour in the figures are the heavier are the element phases. The darker colour corresponding to less heavy element phases is explicitly carbon in this sample. Delamination was observed at the refractory interface probably due to the thermal history. Many white spots were found in the carbon build-up layer, which were silica droplets according to the previously mentioned SEM/EDS analysis. At the exact interface, in the gaps, white needles/rods phases were observed as shown in Figure 10 b). Cylindrical sample was carefully broken along the interface for further SEM/EDS analysis to investigate the phase composition of the needles/rods.

Figure 10. X-ray computed tomography images of carbon build-up at the refractory interface. a) xz cross-section, b) and c) xy cross-section along line number 1 and 2 in a). Needles or rods were found in the gaps as shown in b).

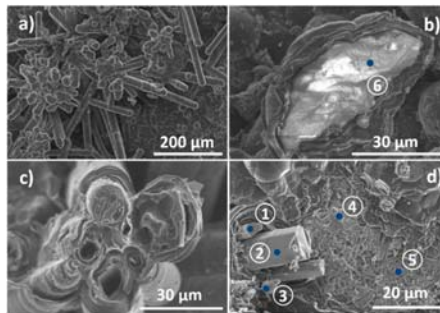
Figure 11 a) shows a rich rods area corresponding to the white needles/rods in the CT scans. The surface of the rods contains mainly carbon. Figure 11 b) and c) display the broken particle with the rods. A core-shell structure is evident with a solid core wrapped in shell layered pyrolytic carbon. The hexagonal cores are clearly shown in Figure 11d).

Figure 11. SEM images of rods at the refractory and carbon build-up interface. a) bunch of rods; b)-c) broken particle and rods with layered pyrolytic carbon shell and solid cores; and d) hexagonal core structure. Number 1-6 are positions for point analysis.

Point analysis was performed to check the elemental compositions of each phase. Results of points 1-6, highlighted in Figure 11, are summarized in Table 1. The hexagonal rods (point 1-2) and the smaller grains at the background (point 4-5) had significantly higher Al content compared to the previously mentioned silica droplets away from the refractory surface. They are close to the mullite composition as listed at the bottom of Table 1. The irregular big grain (point 6) and the small droplet (point 3) are silica phases. The sample used for illustration has fractured surface to better display the morphology. Some uncertainties in the element analysis must be expected due to the sample topography.

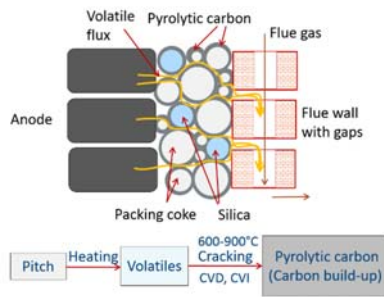
Hydrocarbon volatiles are released from the pitch during heating of the green anodes. Once released, the volatiles are sucked into the flue cavity through open slits and porosity in the flue wall. The burning of the volatiles from the pitch contributes around 40 % to 50 % of the total furnace energy input. A reduced pressure in the flue is maintained for sucking the volatiles [4] out of the pits. This also gives sufficient mass flux for the deposition of pyrolytic carbon by the CVI route. Sufficient mass flux is necessary for yielding pyrolytic carbon instead of carbon black, which normally nucleates in the gas phase and not on a hot surface [7]. The deposited pyrolytic carbon then gradually fills up the voids between the flue wall and packing coke, as well as the voids between packing coke particles. As a result, the packing coke particles fuse together and bind to the refractory surface. In the course of time, a hard carbon build-up layer accumulates on the flue walls. Volatiles also infiltrate the refractory through pores and cracks leading to the observed pyrolytic carbon deposition in pores. A schematic drawing illustrating the build-up formation mechanisms is shown in Figure 12. In addition to the packing coke particles, solidified silica droplets and the mullite like rods at the refractory interface are also important sources for pyrolytic carbon deposition and subsequent growth. Na seems to have no or limited contribution in the formation of build-up.

Figure 12. Schematic drawing illustrating the carbon build-up mechanisms. Figure not in scale.

Packing coke particle size distribution is another parameter influencing the carbon build-up formation. Fines or smaller particles partially fill the voids between larger particles and the space between the coarser coke particles and the flue wall, as illustrated in Figure 12. The remaining free space will be significantly smaller compared to the case with only large particles, while the surface area will be much larger. The increased surface area will increase the driving force of fusing. Therefore, coke particles with fines or small particles will be easier to fuse together and fix to the flue wall to form a solid attached build-up layer when all the free spaces are filled up by carbon. Logically, the process will be much faster when the packing coke consists of a finer fraction due to the less free space. Large surface area, associated with fines, also provides more nucleation sites for pyrolytic carbon deposition. Removing the fines in the packing cokes is recommended for reducing the carbon build-up.

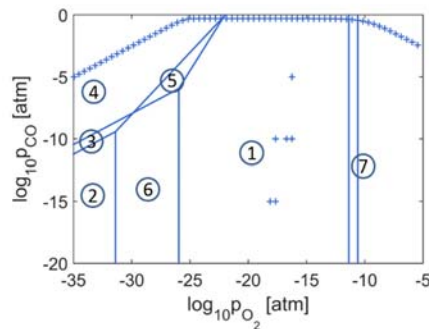
Mullite decomposition Reactions (2-4) are energetically unfavoured in the standard states. By lowering the partial pressure of SiO (g), however, the reactions will shift to the right hand sides and cause decomposition of mullite. The large pressure drop in the open baking furnace, sucking the gaseous products from the reaction site into the flue cavity, will contribute to a low SiO pressure and thereby promote the mullite decomposition. A predominance diagram of Al-Si-C-O system at 1300 °C is shown in [Figure 13](#). The diagram presents the stable field of each phase as a function of chemical potentials. The partial pressure of SiO (g) was fixed at 1×10^{-8} atm in the calculation. Under this situation, mullite is unstable when the oxygen partial pressure is lower than $1 \times 10^{-11.4}$ atm. Corundum and SiO (g) will be the stable phases at oxygen partial pressure in the region of 1×10^{-26} to $1 \times 10^{-11.4}$ atm.

Figure 13. Predominant phase diagram of Al-Si-C-O system at 1300 °C. $0.3333 < Si/(Si+Al) < 0.5$, $p_{SiO_2} = 1 \times 10^{-8}$ atm. 1. Al_2O_3 -SiO(g); 2. Al(l)-Si(s); 3. Al(l)-SiC(s); 4. $Al_3C_3(s)+SiC(s)$; 5. $Al_3C_4(s)+SiO(g)$; 6. Al(l)-SiO(g); 7. $2Al_2O_3-2SiO_2$; and "+" denotes 1.0 atm isobar. Calculated using FactSage [6]
