# Moisture safety strategy for construction of CLT structures in a coastal Nordic climate

**Abstract:** To reduce the carbon impact of new buildings, wood is seeing increased use as a structural material. Cross-laminated timber (CLT) and glue-laminated wood (glulam) elements allow the construction of multi-storey buildings. However, wood is vulnerable to moisture, especially when naked wood is exposed to weather during the construction process. This paper presents the moisture strategy employed during the construction of a four-storey CLT/glulam building in Trondheim, Norway. The building was constructed without the use of a weather-protective tent, requiring alternative protective measures. The construction of the main structure was scheduled to be as short as possible. Local protective measures were employed to protect the structure from rain and free water was removed after rain events. The project was closely supervised by the client, with particular care for moisture control. Moisture was regularly measured at 50 points throughout the building. No wooden surfaces were encapsulated until a wood moisture content below 15 weight-% was measured. The performance of the moisture st

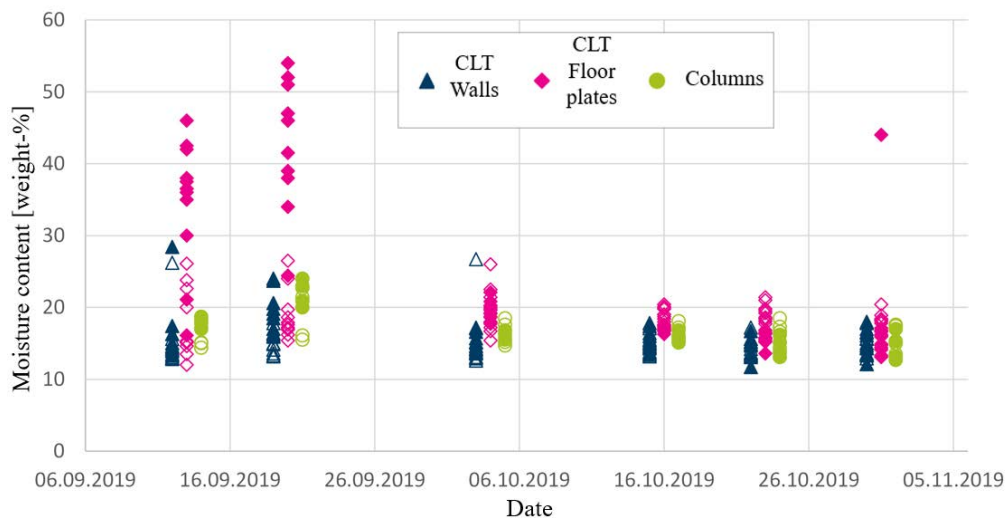
Figure 2 shows the dates and results of the manual wood moisture measurements, as well as the temperature and precipitation in the final weeks of building envelope assembly. Figure 3 shows the results of the manual wood moisture measurements. The outlying data point in the final set of measurements (October 31) was caused by a puddle that had formed on the floor plate, as the door to the exterior scaffolding elevator had not been closed properly overnight.

Figure 3: Measured wood moisture content, in weight-%, at the six times of manual measurement (M1-M6).

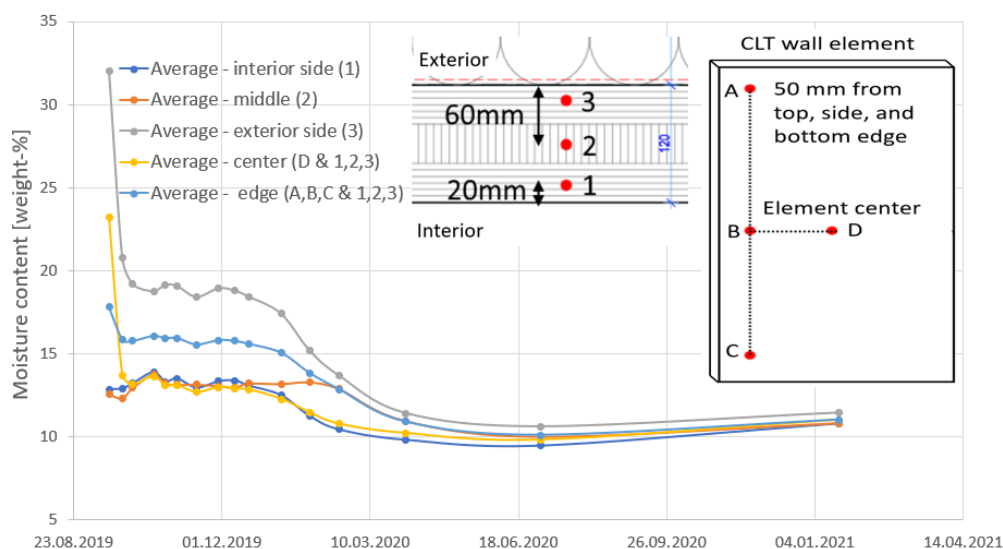
Figure 4 shows the moisture measurements from the fixed moisture sensors in the CLT wall element, and their placement. The measurements indicate that the structure dried quite quickly after assembly and remained at acceptable levels of moisture in the long term. The exterior side and edge exhibited higher moisture levels initially. Moisture levels across the whole element converged relatively quickly after the building envelope was completed in November 2019.

Figure 4: Moisture development in a CLT wall element, measured by fixed sensors.

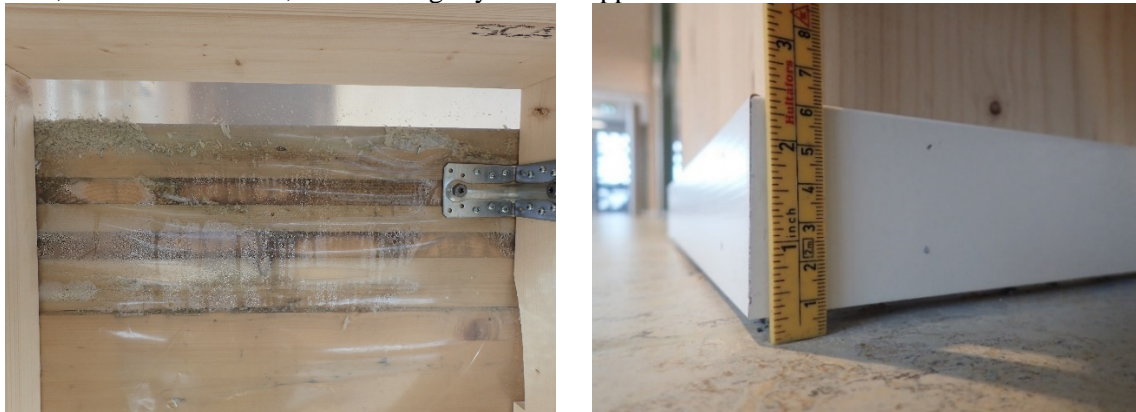
Minor moisture damage was observed during the construction phase. The vapour barrier was mounted along the edge of the CLT floor plates early during construction as seen in Figure 5. Moisture was trapped beneath it, and some visible mould growth occurred. The entrapped moisture originated from flowing water on the surface of the floor plates and would not reappear after the building envelope had been completed. Ventilating the space allowed the surface to dry. Additionally, despite the efforts, moisture and solar radiation caused some stains on wooden surfaces. Most of these were sanded off and coated, but some surfaces were inaccessible – for instance, above the drop ceiling or inside technical shafts. The back side of diagonal elements placed in front of windows were also inaccessible, causing stains to be visible from the outside.

Deflection was also observed along the floor throughout the building, requiring some readjustments of baseboards as shown in Figure 5. It could not be determined whether this was caused by contraction of the CLT floor plates, or creep of the acoustic floor. The acoustic floor plate could not be fitted properly along certain portions of the interior walls, due to the insertion of doors or glazing. The floor was expected, and later observed, to creak slightly when stepped on in these locations.

Figure 5: Left: Entrapped moisture behind vapour barrier during construction. Right: Deflection of floor due to creep and shrinkage, necessitating repositioning of the baseboard.
