STEM-EDS of Inception Sites of Vented Trees in a HV XLPE Subsea Cable

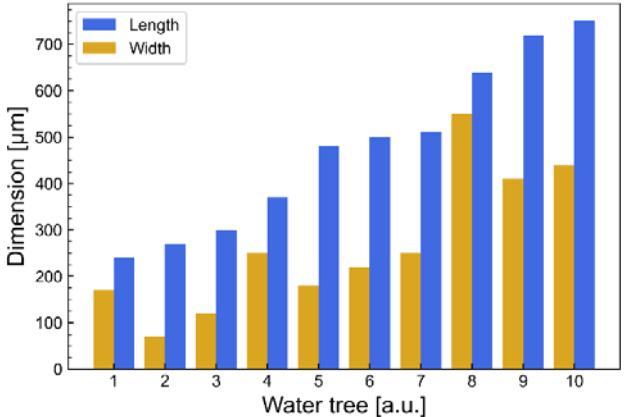
After the accelerated wet ageing, 10 vented water trees were detected in a 10 cm section of the insulation system. The distribution of water tree length and width for the detected trees is presented in Figure 2. The lengths range from 240 to 750 μ m and there is no apparent correlation between length and width. It is likely that several water trees remain undetected because they were too small to be observed.

Figure 2: The maximum length and width of ten vented water trees observed in the analyzed cable section.

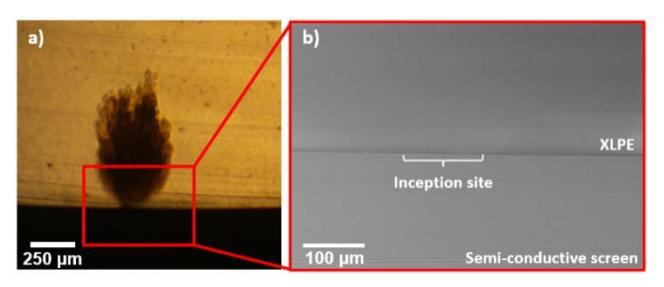
An optical microscopy image of a typical vented water tree is presented in Figure 3a, where the contrast is caused by supersaturation of the water tree. A smooth interface between the XLPE and semi-conductive screen was observed by low vacuum scanning electron microscopy (LV-SEM) examinations at the inception site of the water tree. No apparent defects or contaminants were observed either located on the surface of the sample/materials nor at the interface.

Figure 3: A vented water tree observed by (a) optical microscopy and (b) a LV-SEM micrograph of the smooth interface where the water tree was observed.

Given the absence of microstructural defects at the inception sites of the water trees, the work was focused on the chemical nature of the area close to the water tree inception site.

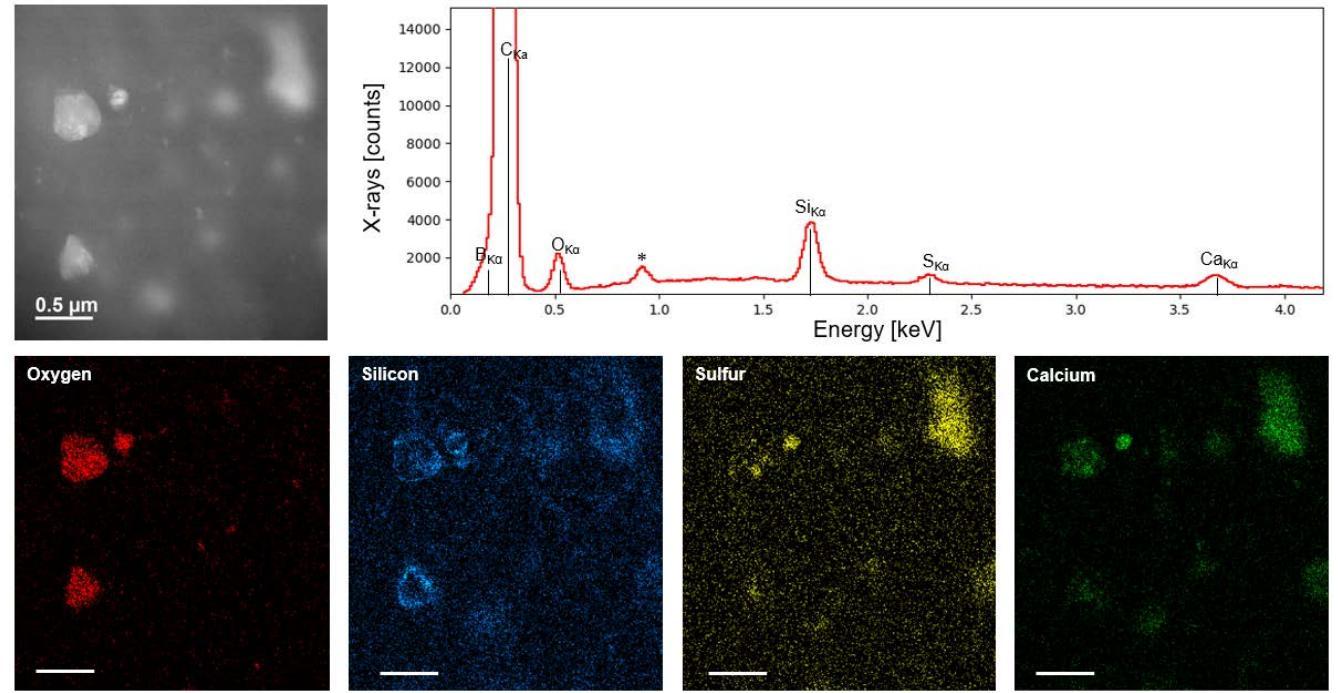
The specimen chosen for STEM-EDS exhibited a homogeneous microstructure across the XLPE material. However, impurity elements were detected within the water tree region approximately 10 μ m from the interface between the XLPE insulation and the semiconductive screen. This is shown by the high angle annular dark field (HAADF) STEM image in Figure 4. The EDS spectrum of the analyzed area shows that O, Si, S, and Ca are present, and B is observed as a weak shoulder on the C peak. The intense C peak has been cut to better visualize the other elements.

The element maps show that regions rich in O also contain Si, indicating that impurities such as SiO_2 or organic Si-O are present in the XLPE insulation. A shell structure of Si is observed in regions with locally increased concentration of Ca at the core. Combined with the O-rich areas and a small amount of evenly distributed O it is expected that CaSO₄ is present. CaS is a likely impurity in regions where only S and Ca are observed. The CaSO₄ could be due to sulfur-containing antioxidants used in the insulation or from the carbon black. Ca may originate from the extrusion of the insulation system, where calcium stearate can be used as a lubricant [15].

Figure 4: HAADF STEM image of the analyzed area in the insulator with the corresponding EDS spectrum and O, Si, S and Ca element maps. $Cu_{L\alpha}$ stray signal from the TEM grid.

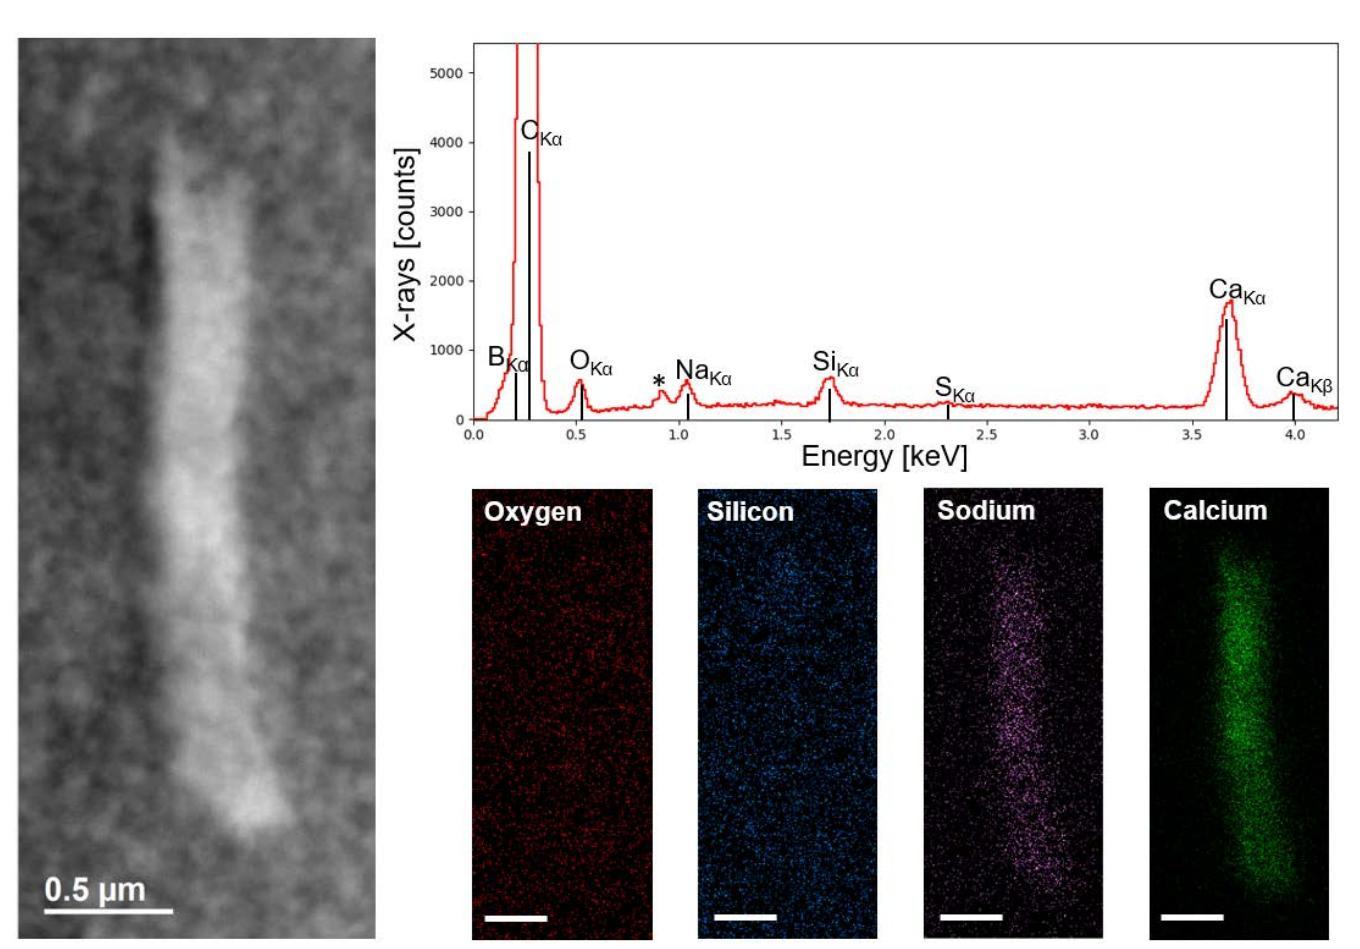
The microstructure of the semi-conductive screen appeared homogeneous with a small concentration of Si and O throughout, with the exception of one particle observed 40 μ m from the XLPE interface. A HAADF STEM

EDS mapping of the particle presented in Figure 5 clearly confirms a high local concentration of Ca and Na. The anionic counterpart to these cations remains unknown but it is suggested that they exist as sodium and calcium acrylate as the resin was produced with ethylene acrylates. O and Si are evenly dispersed through the semi-conductive screen, likely due to additives introduced to the polymer matrix before extrusion.

Several of the ionic impurities related to water treeing in XLPE described in the literature have been detected in this work. However, the compounds observed here are hardly soluble in water and it is therefore challenging to see how they can migrate through the semi-conductive screens and to the insulation-screen interface. More soluble and mobile ionic impurities detected in previous work, such as K and Cl, were not observed.

Figure 5: HAADF STEM image of the analyzed area in the semi-conductive screen with the corresponding EDS spectrum and O, Si, Na and Ca element maps (40 μm from the interface). *Cu_{Lα} stray signal from the TEM grid.
