Energy Procedia 78 (2015) 3342 – 3347

6th International Building Physics Conference, IBPC 2015

## Energy upgrading of a historical school building in cold climate

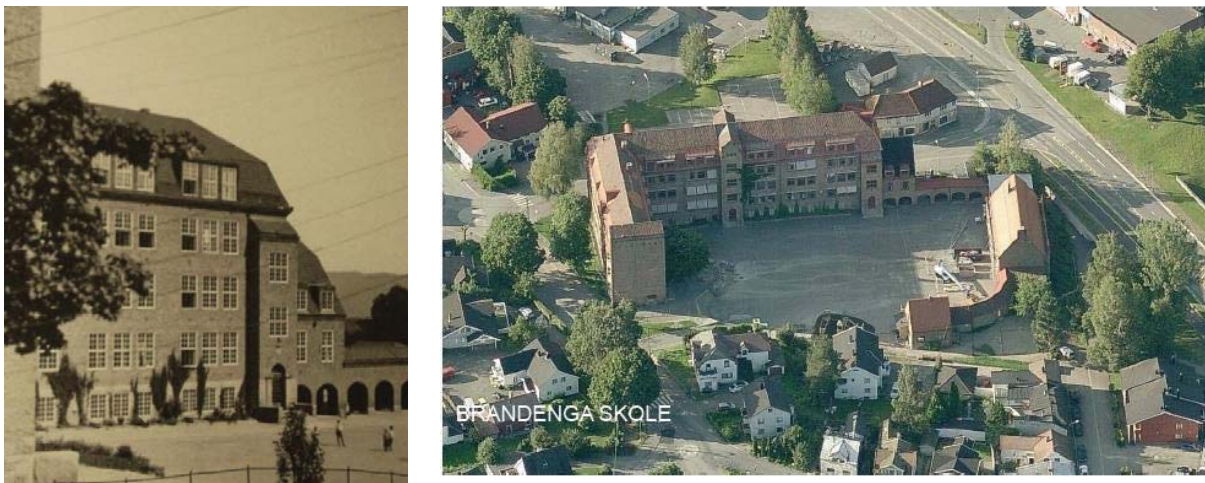
Figure 1 (a): South façade of the main building. Photo from the old days showing the original windows from 1914. Architect Arnstein Arneberg. (b): South façade of the main building showing windows from the 60's and 70's. Note the shading devices. Photo before retrofitting

Figure 1 shows the building at different ages. The following list shows the building characteristics in 2011.

- **Building envelope:** The exterior walls are made of brick, without insulation between the two sidewalls. The windows were mainly from the 1960s. Neither the mansard roof of wooden construction, nor the concrete basement walls, had additional insulation. As the drainage was not sufficient, moisture had penetrated parts of the walls and caused plaster cracking on the inside.

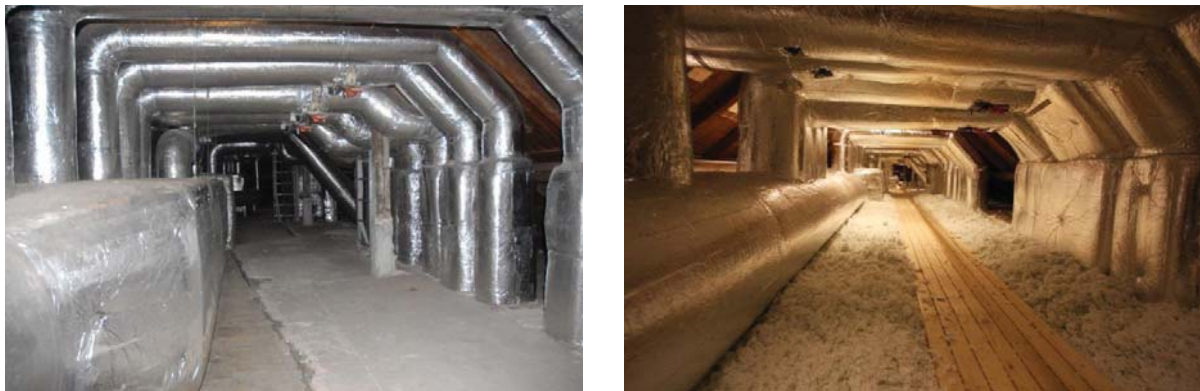
Figure 3 (a): Attic with ventilation ducts before additional insulation. (b): Attic with ducts after insulation. Photo: J. Seehusen, May 2012

In 2001–2003 a ventilation system was installed and ventilation ducts were placed in the attic. These ducts were not so well insulated. In the autumn 2011 a layer of 10 cm additional insulation were wrapped around the ducts. See figure 3.

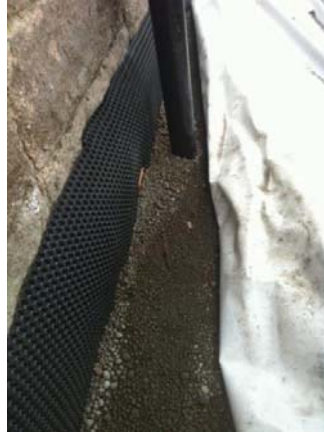
Figure 4: Combined ditch for drainage, exterior insulation and collector pipes

New drainage along the south and east basement walls was necessary to avoid moisture in the basement. The drainage ditches serve several tasks; revealing the basement walls under the ground for external insulation, filled with extruded concrete gravels the ditches provide additional insulation of the basement, and last but not least, the ditches hold collector pipes for the heat pump. See figure 4.

New drainage was necessary to maintain the building, and insulation allowed for a better use of the basement areas. The drainage ditches' primary function is to keep the basement dry. However; the ditches contribute to energy savings.

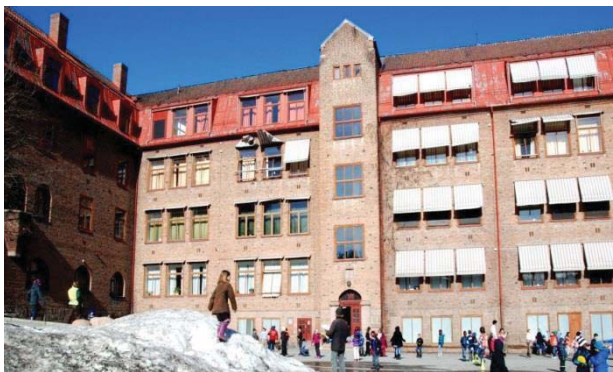
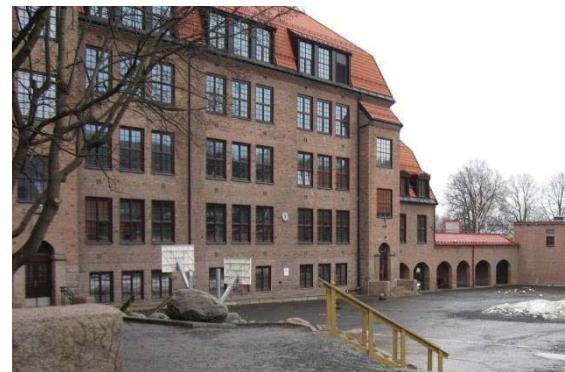
Figure 5 (a): South façade before retrofitting. Photo: G. Andersen, April 211. (b): South façade with new windows and roof cladding. Photo: K. Buvik, April 2013. A-form architects / Nils Herland

«Passive house» windows are now installed. As these windows substantially decrease heat losses (U-value  $\sim 0.8$  W/m<sup>2</sup>K), they contribute to both better indoor thermal comfort and reduced energy bill. Thanks to the glazing's low solar energy transmittance (g-value = 27 % on south and west façades), the exterior sunscreen devices could be removed from the façades, in order to restore the façades' aesthetic close to that of the original historic look.

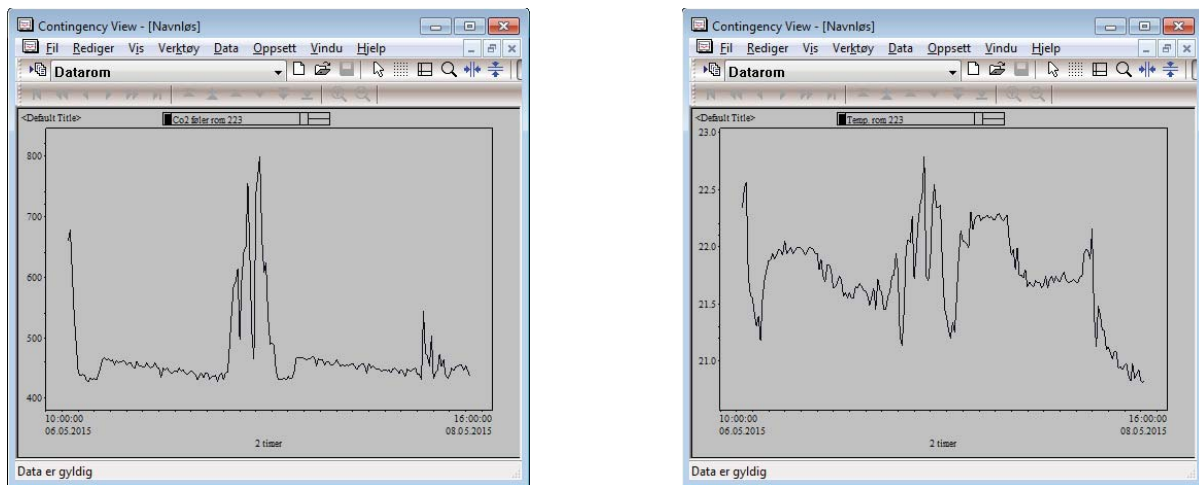
Figure 6 (a): Print from BEMS, covering two days, showing that the CO<sub>2</sub> level is not exceeding 800 ppm. (b): Print from BEMS showing that the temperature level is acceptable. The prints refer to two days in May

Indoor climate is continuously monitored by the building energy management system (BEMS). Examples of print from BEMS are shown in figure 6. A survey on indoor thermal conditions in winter is carried out, and the feedback from users is positive.
