Non-destructive wafer-level bond defect identification by Scanning Acoustic Microscopy

S. Brand, S. Tismer, S.T. Moe, K. Schjøllberg-Henriksen

Metal-based thermocompression bonding enables the creation of hermetic seals formed at relatively low processing temperatures and occupying a small portion of the device area. In the current study we have investigated the application of scanning acoustic microscopy (SAM) for assessing the quality of metal thermocompression bonds, both by evaluating its capabilities of localizing areas of poor bonding, and by finding defects in the integrity of the bond seal. Wafer laminates containing a test vehicle with pre-defined defects in the bond metal layer were sealed by Au-Au and Al-Al thermocompression bonding. Employing SAM, an area of 5 chips of poor bonding was identified non-destructively on the Al-Al laminate. Line defects of width 3.6 μm and point defects of diameter 22.4 μm have also been identified by SAM. The dicing yield for sealing frames was above 96% for all frame structures and both bond metal systems. The average bond strength was 31.5 ± 11.9 MPa for Al-Al thermocompression bonds and 37.3 ± 9.7 MPa for Au-Au thermocompression bonds

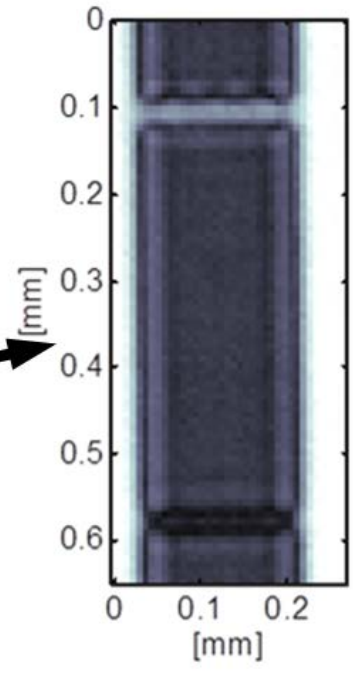
Figure 7: Acoustic micrograph of chip No 146 of type F200R from the Al-Al laminate, showing that approximately 40% of the frame was poorly bonded.

Figures 5 – 8 show acoustic detail micrographs of chips from the Al-Al laminate. Figure 5 indicates the improved imaging resolution achieved by the split-spectrum analysis. Figure 6 also shows the results of the narrow-band spectral imaging and allows the identification of the intentionally introduced bonding line defects of $3.6 \mu\text{m}$ width. The line defects of widths 4.5 , 7.2 , 22.4 , and $52.3 \mu\text{m}$ can also clearly be seen, as well as the point defects of $22.4 \mu\text{m}$ and $52.3 \mu\text{m}$. In Figures 7 and 8, a varying imaging contrast can be identified in the bond frames, indicating a change in acoustic reflectivity which is likely to be related to the condition of the bond seal. Figures 9 – 10 contain acoustic detail micrographs of two selected chips from the Au-Au laminate sample. While Figure 9 shows a chip with a well bonded frame, Figure 10 displays a chip with several poorly bonded areas in the bond frame.

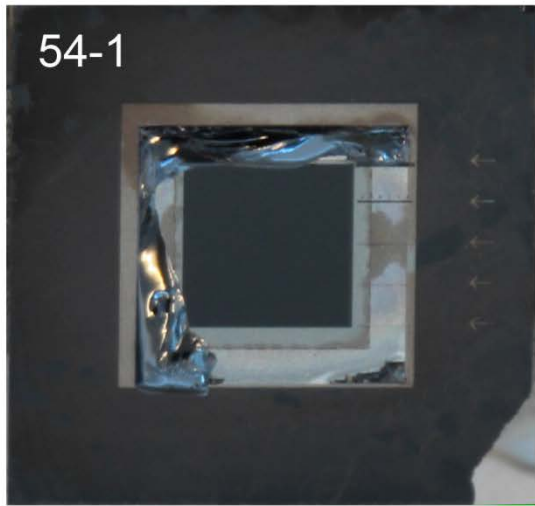
Figure 11: Fracture surfaces of chips 17 (type F100), 54 (type F400), and 146 (type F200R) from the Al-Al laminate. Both fracture surfaces are shown. The arrow in chip No 17-1 points to an area where the Al bond frame had a deviating color. The arrow in chip No 146-1 indicates an area where the enclosed silicon surface had a deviating color.

Inspection of the fracture surfaces after pull testing of chips bonded by Al-Al thermocompression bonding showed that all chips except chip 208 had cohesive fracture in both the silicon and the aluminum seal. Chip 208, of design F100, showed cohesive fracture in the aluminum only. For the other chips, the amount of cohesive silicon fracture ranged from less than 2% to 80%. The three chips with a fracture force below 5 N all had less than 2% cohesive silicon fracture. Figure 11 shows optical micrographs of fracture surfaces of chips from the Al-Al laminate. The chips in Figure 11 are the same chips as in the acoustic micrographs in Figures 5, 7, and 8.

In some of the fractured samples, the bonding Al had a deviating color in a part of the bonded frame. Chip 17 in Figure 11 is one example. The areas of the bonding Al with deviating color are thought to mark drying stains in areas of the bond frames, i.e. indications of water leaking across the bond frame, and hence, a poor seal. This assumption is supported by the acoustic micrograph of the same chip (Figure 5), which does indicate a poor bond in that particular area. In other samples, like chip 146 (Figure 11), a deviating color was observed on the silicon surface near the corners of the bond frame. The scanning acoustic micrographs (see Figure 5) also showed that the area near the corners of the bond frame seem to be different. It is assumed that during SAM, the areas near the corners of the bond frames were showed air bubbles caused by incomplete filling of coupling medium in the volumes enclosed by the frames. These areas are thought to be visible in the fracture surfaces due to drying stains.

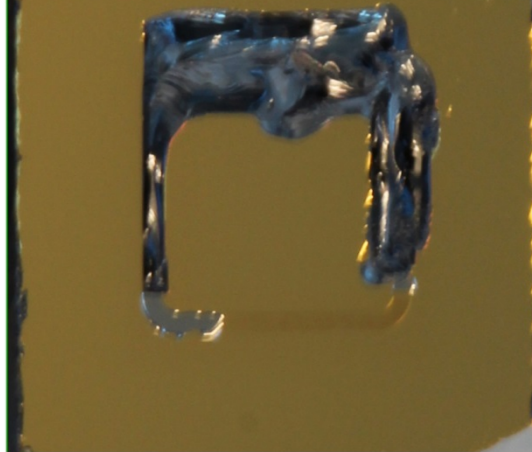
Figure 12: Fracture surfaces of chips No 6 and 31 of type F200R from the Au-Au laminate.

The chips bonded by Au-Au thermocompression bonding all exposed three types of fracture simultaneously: cohesive silicon fracture, cohesive gold fracture, and adhesive fracture at

the interface between TiW and Si. Optical micrographs of the fracture surfaces of the chips from Figures 9 – 10 are displayed in Figure 12.

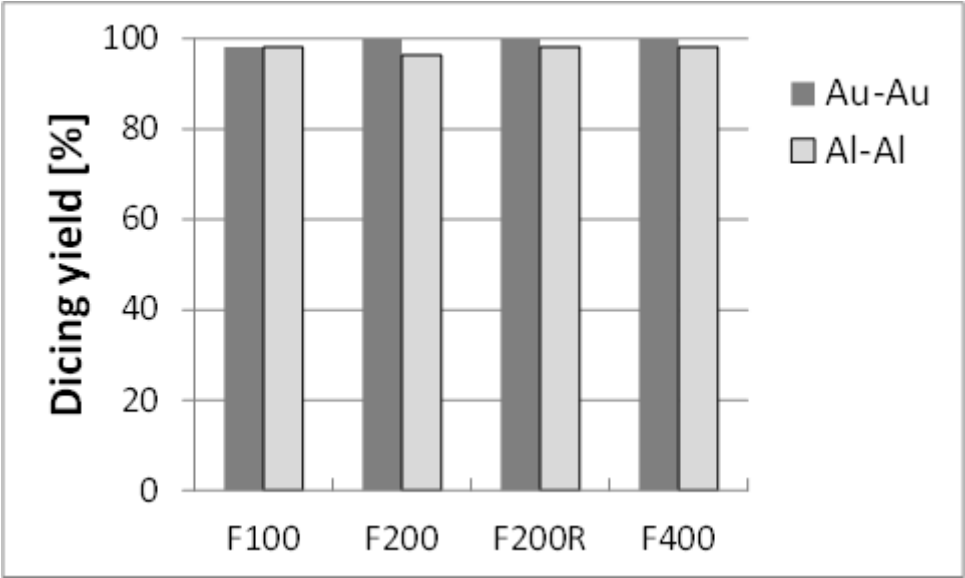
Figure2 13: The dicing yield of the four bond frame types for the two bonded laminates.

The dicing yield for each frame design is plotted in Figure 13. A dicing yield above 96% was obtained for all chip types, regardless of frame width. There was no significant difference between Au-Au and Al-Al bonding with respect to dicing yield. The average values and standard deviations for the fracture forces and bond strengths calculated from eight measured chips are listed in Table 3. The average fracture forces were 79.9 N for Au-Au bonds and 67.4 N for Al-Al bonds. However, student t-testing showed that the bond strengths were not significantly different, even at only 90% confidence level.
