Process-related risks in refurbishment of dwellings using prefabricated wall elements with integrated PV and ventilation ducts

To cite this article: S B Holøs *et al* 2019 *IOP Conf. Ser.: Earth Environ. Sci.* **352** 012047

S B Holøs¹, V Lukina², Å. L. Hauge¹ and Kari Thunshelle¹

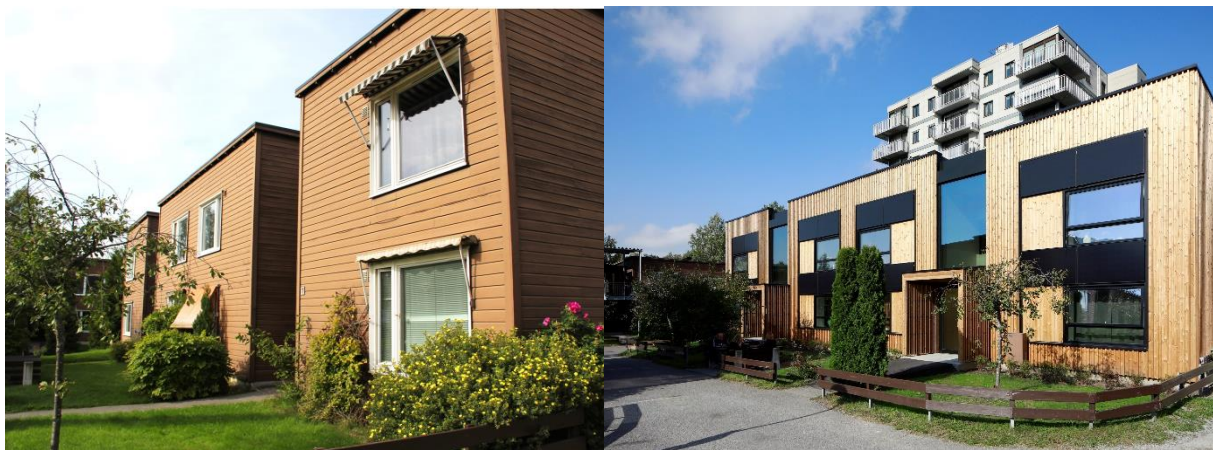
The building selected for deep renovation (Figure 1) is a two-storey timber-frame building from 1971, with only minor later upgrades, owned by Boligbygg Oslo KF. The building contains in total eight apartments, each with a floor area of approximately 42m², distributed around two staircases. The building is situated in a suburban area (Haugerud) in Oslo.

Figure 1a and b. Building before (left) and after (right) renovation. Photo SINTEF (a) and Boligbygg KF (b)
