Failure tests on concrete bridges: Have we learnt the lesson?

Niklas Bagge^{1*}, Cosmin Popescu^{1,2}, Lennart Elfgren¹

Abstract

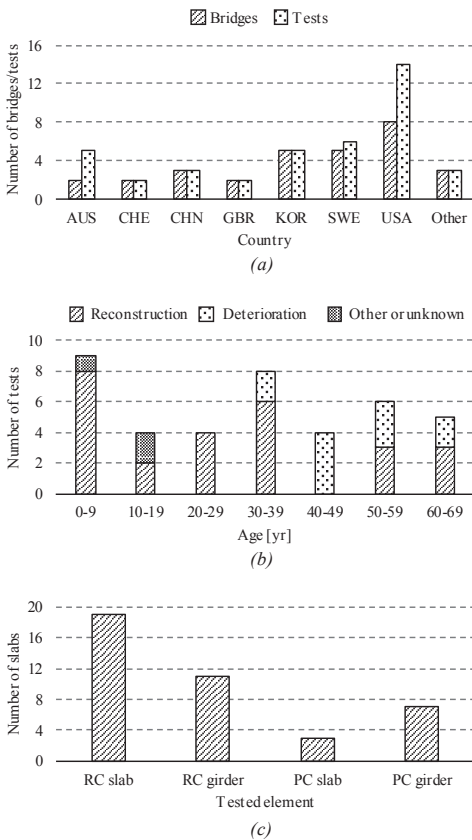
Figure 1. General data about failure tests: (a) country of test, (b) age of bridge at test and reason for test, and (c) type of element investigated.

Figure 1 shows the bridge studies by country, age and type of bridge element tested against number of tests or number of bridges. The United States has an extensive stock of existing bridges with many in need of repair, strengthening or reconstruction (Department of Transport 1990). It can also be seen that smaller countries such as Sweden and Korea have put some effort into this type of research. Notably, shear-related issues were the focus in the majority of the tests in Sweden, representing nearly half of the studies with predicted shear failures. Moreover, a review of the literature shows that a range of other types of bridges (e.g. steel and composite bridges) have been extensively tested in both the United States and Sweden.

In Figure 1(c), the type of tested and failed structural part is shown. Most commonly, RC elements have been tested and particularly RC slabs. The types of

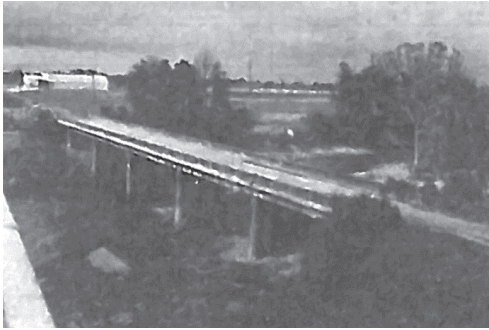
Figure 7. The Elk River Bridge (Burdette & Goodpasture 1973).

The Elk River Bridge was a skew (30°) multi-span (number of spans not reported) RC girder bridge carrying two lanes of traffic, with span lengths of 15.24 m (see Figure 7). The deck, composed of four girders ($457 \times 1\,130\text{ mm}^2$) with a centre-to-centre distance of 2.08 m connected with a slab ($8\,331 \times 260\text{ mm}^2$) at the top, was monolithically cast-in-place and simply supported on abutments and piers. After the area where the bridge was located was inundated, a new highway was built on higher ground. Consequently, several quite new bridges, in good condition, became redundant and available for failure tests. For improved understanding of the failure mechanisms and to provide information

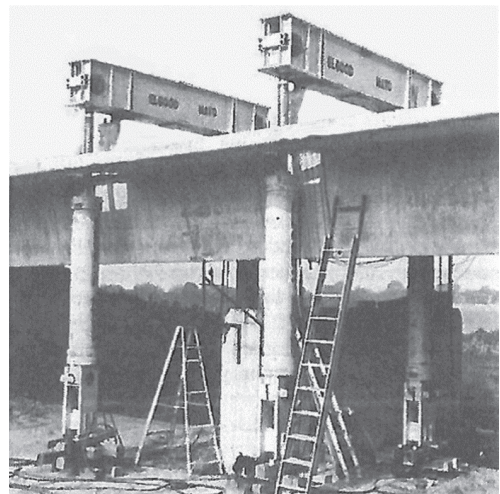
Figure 8. The loading of Pennsylvania State University Bridge (McClure & West 1984).

The investigation at service-load level was based on trucks, similar to the design vehicles HS20-44 (AASHTO 1973), passing over the bridge (McClure & West 1980). Destructive testing was accomplished by two loading systems, centred around the midspan, with loading points above the webs of the girder in order to obtain a flexural failure. Each system consisted of one hydraulic jack on either side of the girder, connected to a bedrock anchor at the base and a hinge connection to a transversally located load distribution beam at the top (see Figure 8). The test was carried out with daily load increments controlled by changing the pressure in the jacks.

For trucks crossing, the bridge remained in the elastic range. The first crack was observed during the failure test in the bottom surface of the girder when the load level was 39.8 % of the load-carrying capacity. Thereafter, further flexural cracking took place and, at a load of 3 896 kN, loud sounds were heard, followed by an opening between two girder segments. At the peak load of 4203 kN, a series of loud sounds occurred, and the load dropped while

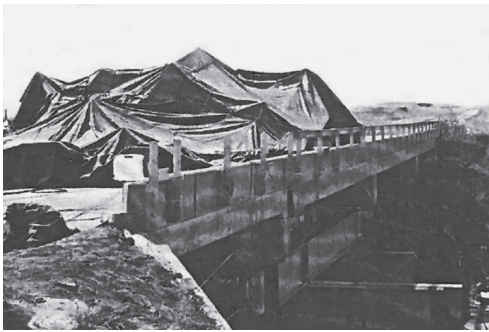
Figure 10. The Niobrara Bridge (Shekar et al. 1993).

The Niobrara River Bridge was further investigated with two failure tests: (1) at the simply supported end-spans and (2) at the outer spans of the continuous part. Based on a bridge design vehicle HS20 (AASHTO 1989) consisting of three axles, the test setup was designed with respect to the position producing the highest flexural moment. Consequently, the simply supported span was subjected to one axle per lane at the midspan, whilst the continuous span was subjected to two axles per lane with the central axle positioned 3.0 m from the abutment. To achieve the loading, hydraulic jacks were used for each wheel with a steel frame transferring the forces to the adjacent piers. With this test setup, it was possible to simulate truck loading in either lane, both lanes or along the longitudinal centre line of the bridge.

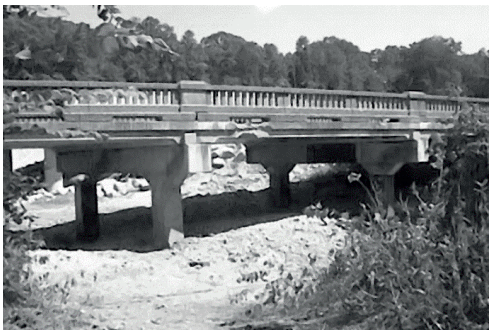
Figure 11. The Lennox Branch Bridge (Alkhrdaji et al. 1999).

The Lennox Branch Bridge was a skew (15°) two-lane simply supported three-span RC slab bridge with equal spans lengths of 7.96 m (see Figure 11). The slab ($7\,620 \times 470 \text{ mm}^2$) was monolithically cast-in-place, supported on piers and abutments, and with curbs on top at either side ($457 \times 254 \text{ mm}^2$). The bridge was considered to be in good condition after an inspection. It was decommissioned due to construction of a new highway. In order to demonstrate and evaluate two strengthening methods using carbon fibre reinforcing polymers (CFRP), a series of tests were carried out. All of the spans were tested to failure; two of them were strengthened to improve the flexural capacity, the first span with near surface mounted (NSM) CFRP rods at the base of the slab and the second span with externally bonded sheets.

The failure tests were carried out by loading each span centrally using four hydraulic jacks transversally aligned 1.2 m apart. Under the bridge deck slab, longitudinal reaction beams between the adjacent supports were used to carry the forces transferred by rods from each jack. The test was

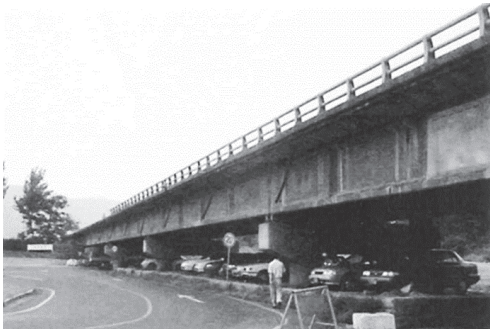
Figure 12. The Seoul-Pusan Highway Bridge (Oh et al. 2002).

composite action of the slab and the girders were unknown. After upgrading the highway to carry increased amounts of traffic, the bridge was used for destructive testing. This bridge was of particular interest since it was one of the most common types of bridges in Korea. An imprecise capacity assessment was expected, so it was considered beneficial to investigate the structural behaviour and load-carrying capacity through a failure test.

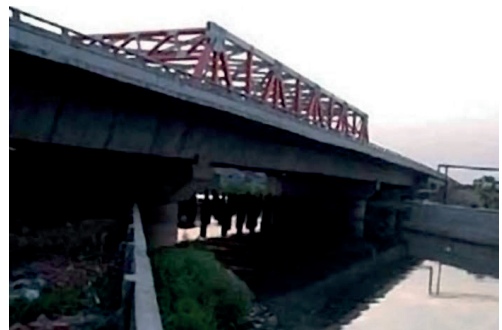
Figure 13. The Xin Xing Tang Bridge (Wenping 2006).

The Xin Xing Tang Bridge was a continuous three-span PC box girder bridge with span lengths of 32 m, 50 m and 32 m (see Figure 13). It was a single box girder with one cell, cantilever flanges, constant height and inclined webs. Inspection of the bridge showed severe concrete cracking of the base plate and the web at one quarter and three quarter length of the interior span. Due to degradation and extension of the highway between Shanghai and Nanjing, it was necessary to replace some bridges. Two common bridge types were selected in order to investigate damage evolution, the correlation between damage and dynamic characteristics and ultimately the load-carrying capacity. Apart from the Xin Xing Tang Bridge, the Xi Cheng River Bridge (described in Section 3.13) was also included in the project.

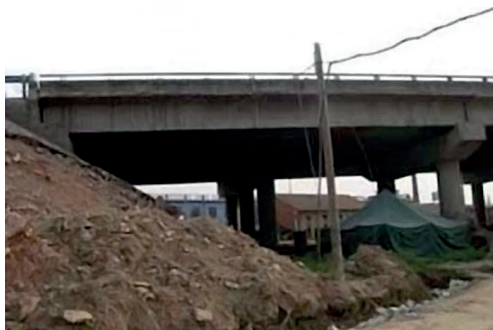
Figure 14. The Xi Cheng River Bridge (Wenping 2006).

The Xi Cheng River Bridge was a simply supported RC girder bridge with six spans of length 20 m (see Figure 14). The deck was 13.0 m wide in total, and consisted of six T-shaped girders connected with diaphragms and to the slab at the top. The girders were supported on abutments. The objectives of the investigation of the Xi Cheng River Bridge were the same as for the bridge summarized in Section 3.12.

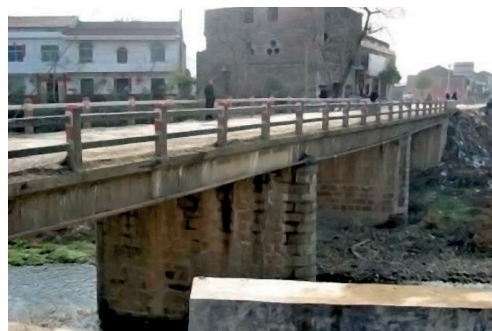
Figure 15. The Nanping Bridge (Zhang et al. 2011b).

also had 200 mm wide curbs. Thus, a system of 340 mm wide girders and a 300 mm thick slab was created. An inspection of the bridge revealed severe deterioration, involving considerable carbonation of the concrete along with reinforcing steel corrosion (12.1 %), which led to concrete spalling and extensive cracking of the beams. As it needed rebuilding, the 43 year-old bridge became redundant and available for destructive testing. The primary aim of the experimental study was to investigate the bridge behaviour at service-load levels (including overloading) as well as to determine the ultimate capacity and failure mechanism.

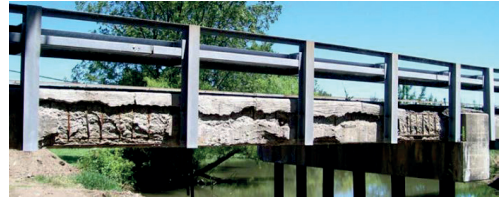
Figure 16. The Paint Creek Bridge (Stillings 2012).

The Paint Creek Bridge was a skew (15°) PC girder bridge with two lanes for road traffic in three 14.58 m long spans (see Figure 16). In total, nine simply supported precast box girders ($914 \times 533 \text{ mm}^2$), placed side-by-side, formed the bridge deck. No material parameters were documented and only the concrete compressive strength (about 70 MPa) was determined from material testing. The structural condition of the bridge was, based on visual inspections, rated as being poor with occurrence of concrete spalling on the extreme web girders and corroded shear reinforcement observed (see Figure 16). Consequently, the bridge was scheduled for replacement. The behaviour of individual box girders is usually well understood, however, how the system of adjacent girders acts as a whole when subjected to ultimate loads was less

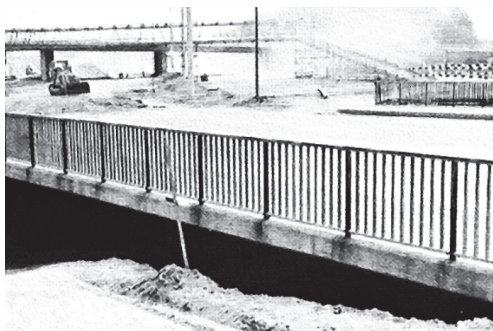
Figure 19. The Glatt Bridge 2 (Weder 1977).

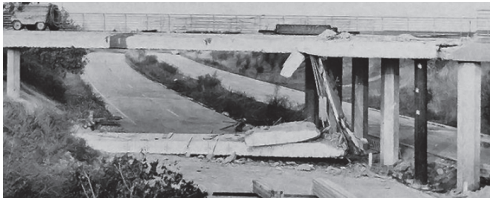
Figure 20. The Brønsholm Bridge after collapse (Pedersen et al. 1980).

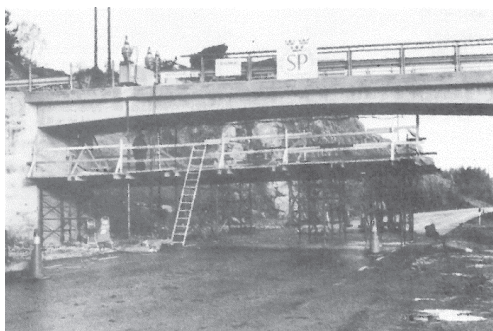
Figure 21. The Stora Höga Bridge 1 (Plos & Gylltoft 1995).

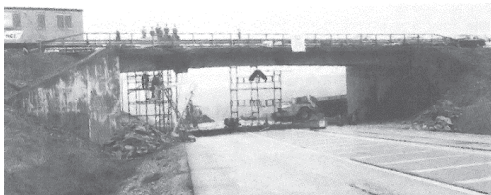
Figure 23. The Stora Höga Bridge 2 (Plos & Gylltoft 1995).

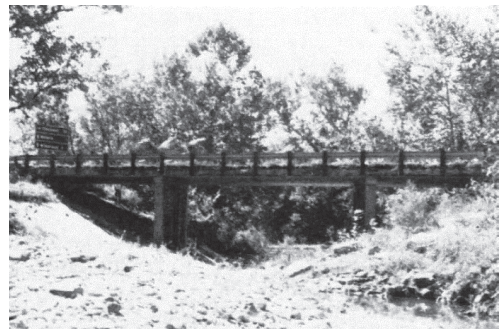
Figure 25. The Batavia Bridge (Aktan et al. 1992).

The Batavia Bridge was a skew (30°) continuous three-span RC slab bridge carrying two lanes of traffic (see Figure 25). The length of the end-spans was 9.754 m and the interior span was 12.19 m. The deck was a 11 125 mm wide slab, supported on intermediate piers and keyed to abutments at the ends. At an age of 38 years, the bridge was to be demolished as a result of its poor structural condition. Prior to testing and the removal of asphalt overlay, non-destructive tests were carried out in order to explore their effectiveness at damage detection, with results, outside the scope of this paper, reported elsewhere (Aktan et al. 1992). When the concrete slab was exposed after removal of the overlay, it was found that the concrete deck was in a relatively good condition over the traffic lane but severely deteriorated in adjacent regions. The deterioration was associated with material degradation due to freeze-thaw cycling, alkali-silica reaction and corrosion.

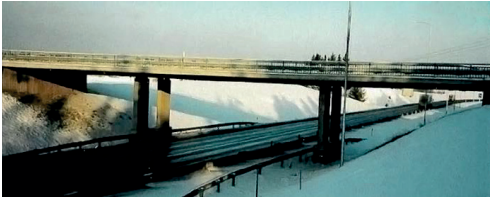
Figure 26. The Smedstua Bridge (Statens Vegvesen 1998).

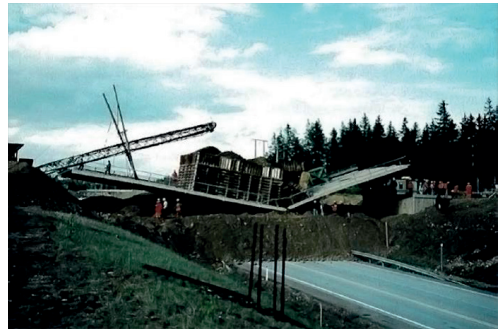
Figure 27. The Smedstua Bridge at collapse (Statens Vegvesen 1998).

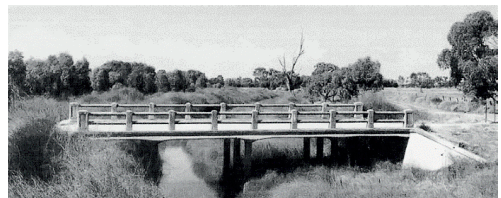
Figure 28. The Barr Creek Bridge (Haritos et al. 2000).

The Barr Creek Bridge was a two-lane continuous four-span RC slab bridge with the end-spans and interior spans having lengths of 3.66 m and 4.57 m, respectively (see Figure 28). The deck was 6 720 mm wide (excluding curbs) slab and monolithically cast-in-place continuously over piers with end-abutments providing rotational restraint. The structural condition of the bridge was rated as being good, however spalling of the concrete cover due to accelerated corrosion was reported on the columns in the splash zone of the creek. Therefore, the bridge was taken out of service in 1971 and, prior to demolition, was wired with instrumentation and tested at the serviceability and ultimate-load limit states, with the aim of improving analytical methods for bridge rating and assessment. Both dynamic and static tests were carried out.

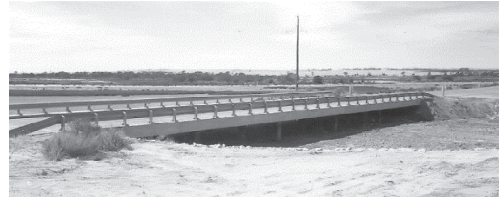
Figure 29. The Baandee Bridge (Pressley et al. 2004).

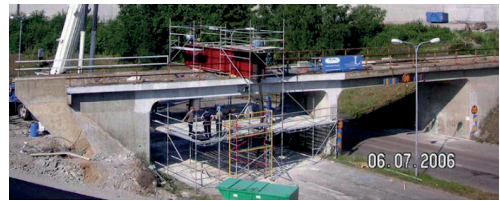
Figure 30. The Örnsköldsvik Bridge (SB 2008).

The bridge was statically loaded in the midspan on top of the trough girders with two hydraulic jacks and a transverse load distribution beam (see Figure 30). Reaction forces from the load produced by the jacks were taken by cables anchored in the bedrock. In loading the bridge to failure, a generally ductile structural behaviour was revealed and the yielding of the longitudinal reinforcing steel was measured. After severe cracking and intermediate crack-induced debonding of the CFRP rods, leading to force redistribution, one of the girders failed in combined flexure and shear at a load of 11 700 kN and 96 mm deflection. At failure, several stirrups crossing the critical shear crack ruptured (see Figure 31).

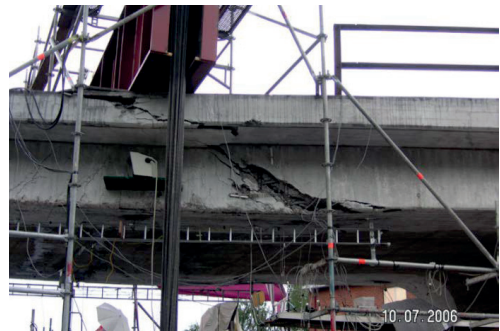
Figure 31. The Örnsköldsvik Bridge after failure of the trough girder (Image by Lennart Elfgrén).

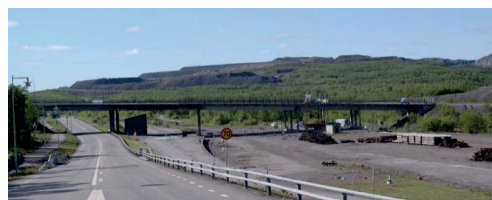
Figure 32. The Kiruna Bridge (Image by Niklas Bagge).

($300 \times 300 \text{ mm}^2$) on each side. The girders had a centre-to-centre distance of 5.41 m and they were reinforced with a BBRV post-tensioning system. Inspection indicated the bridge to be in good condition with existing damage limited to some vertical cracks in the girders adjacent to the intermediate support, assumed to be associated with curtailment of reinforcing steel bars in the bottom of the girders. Due to settlement of the ground, caused by surrounding underground mine workings, the bridge was monitored over a period of eight years before it was taken out of service. Over that time, no additional damage occurred. The bridge was set to be demolished because of relocation of the city, so a test programme was designed to improve methods of assessment of existing bridges. The study included evaluation of methods to determine residual prestress forces in tendons, the usability and impact of two types of strengthening systems using CFRP, and the structural behaviour and load-carrying capacity of the bridge girders and the deck slab. The failure test of the slab is described in Section 4.13.

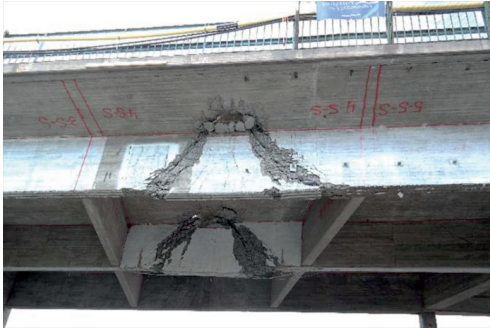
Figure 33. The Kiruna Bridge after shear failure of the girders (Image by Niklas Bagge).

the final phase and stirrups crossing a diagonal crack of the girder ruptured on either side of the loading point; at this juncture, the loading plate punched through the slab.

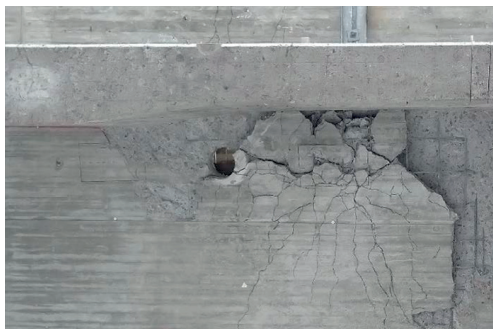
Figure 34. The Kiruna Bridge at shear and punching failure of the deck slab, view from below (Image by Niklas Bagege).
