Structure and Infrastructure Engineering

3D reconstruction of existing concrete bridges using optical methods

Cosmin Popescu, Björn Täljsten, Thomas Blanksvärd & Lennart Elfgren

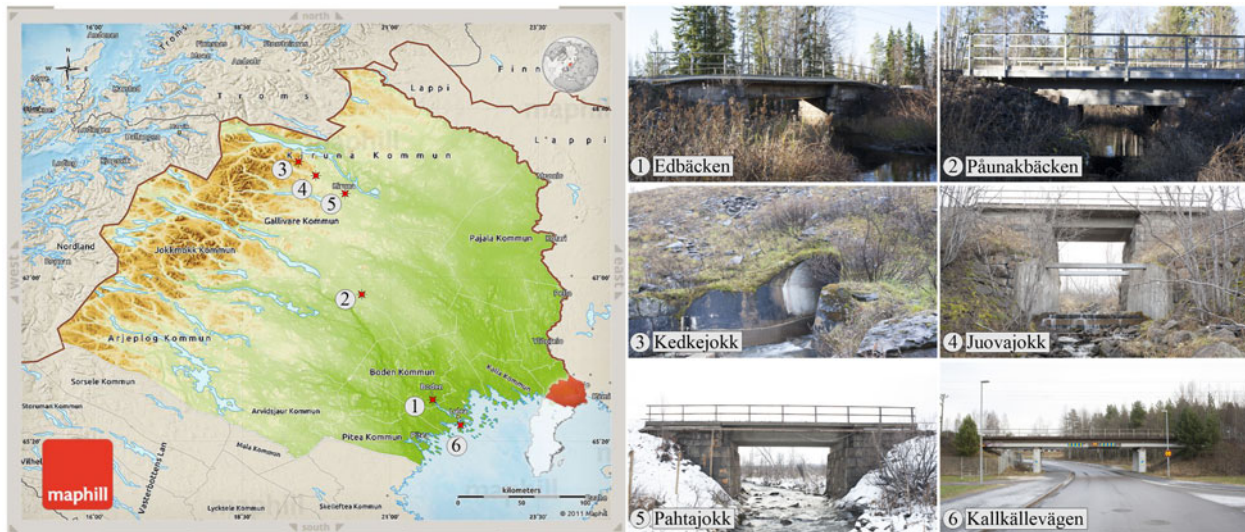
Figure 1. Bridge locations and photos of the bridges taken on the day of scanning 'Map by Maphill'.

Built in 1886 with the superstructure replaced in 1977, the Edbäcken bridge (Bridge 1 in Figure 1) is a simply supported reinforced concrete (RC) trough bridge with a span of 5.8 m and a width of 3.8 m. The bridge spans a stream with a maximum depth of 0.7 m and is surrounded by dense vegetation. Testing was carried out on a sunny day.

Built in 1887 with the superstructure replaced in 1998, the Påunakbäcken bridge (Bridge 2 in Figure 1) is a simply supported RC slab bridge with a span of 2.95 m and a width of 4.5 m. The bridge spans a 0.5 m deep stream. The surrounding area is wet and full of wild bushes and trees. Testing was carried out on a sunny day.

Built in 1906, the Kedkejokk bridge (Bridge 3 in Figure 1) is a concrete arch bridge with a span of 4.0 m and a width of 41.2 m. The bridge spans a fast-flowing stream with a depth of approximately 0.5 m. However, there are narrow platforms for walking on below the bridge. Because the bridge is relatively long, the ambient light level was low. Testing was performed on a cloudy day.

Built in 1902 with the superstructure replaced in 1960, the Juovajokk bridge (Bridge 4 in Figure 1) is a simply supported trough bridge with a span of 5.5 m and a width of 3.8 m. The bridge spans a fast-flowing but shallow stream of water. The surrounding area is densely vegetated and there are steep slopes behind the abutments. Testing was carried out on a cloudy day.

Built in 1902 with the superstructure replaced in 1963, the Pahtajokk bridge (Bridge 5 in Figure 1) is a simply supported trough bridge with a span of 6.9 m and a width of 3.9 m. The bridge spans a fast-flowing stream of water (0.5 m deep). The surrounding area is wet with few trees on one side of the bridge; on the other side, the view is obstructed by dense vegetation. A fence surrounds the bridge to restrict access to the railway, hindering access to the abutments. Testing was carried out on a cloudy day after a heavy snowfall.

Built in 1966, the Kallkällevägen bridge (Bridge 6 in Figure 1) is a three-span RC continuous girder bridge with spans of 9.2 + 14.5 + 9.2 m and a width of 4.54 m. The bridge spans a two-lane road. The bridge is located inside a town, so no vegetation is present and the bridge can be clearly viewed from all angles. Access is restricted by fences, which also cover the abutments. Testing was carried out on a cloudy day.

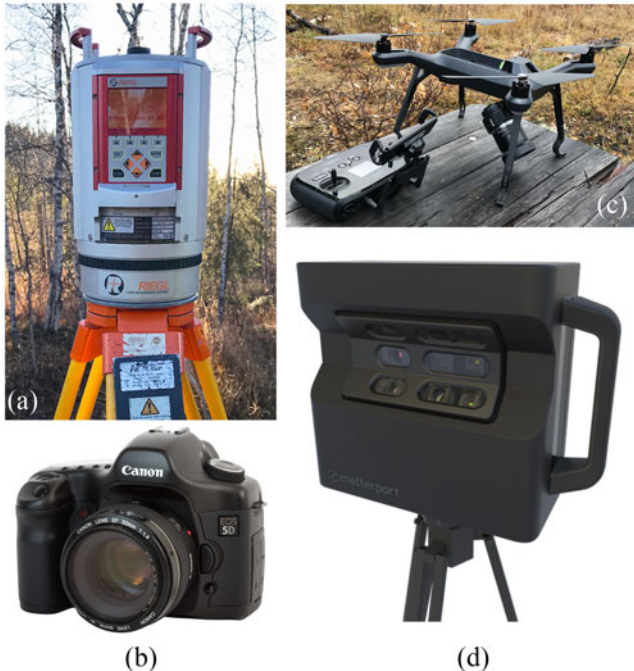
Figure 2. Data acquisition equipment. (a) Terrestrial laser scanning—RIEGL VZ-400, (b) CRP—Canon EOS 5D, (c) unmanned aerial vehicle—3DR Site scan and (d) infrared scanning—Matterport Pro2 3D.

The equipment used in this study was a long-range, RIEGL VZ-400, 3D terrestrial laser scanner (Figure 2(a)). This 3D scanner operates on the time-of-flight principle and can make measurements ranging from 1.5 m to 600 m with a nominal accuracy of 5 mm at 100 m range. It uses near-infrared laser wavelengths with a laser beam divergence of 0.3 mrad, corresponding to an increase of 30 mm of beam diameter per 100 m distance. The instrument's maximum

The equipment (Figure 2(b)) consisted of a Canon EOS 5D digital single-lens reflex (DSLR) camera with a full-frame (35.8×23.9 mm) complementary metal-oxide-semiconductor (CMOS) optical sensor giving a resolution of 12.8 megapixels (4368×2912 pixels). The camera was equipped with a Canon EF 35 mm wide-angle prime (fixed zoom) lens. On a full-frame camera body, this lens gives a large field of view (achieving a 54° horizontal viewing angle) covering a wide area, meaning that fewer images are needed to capture an entire structure.

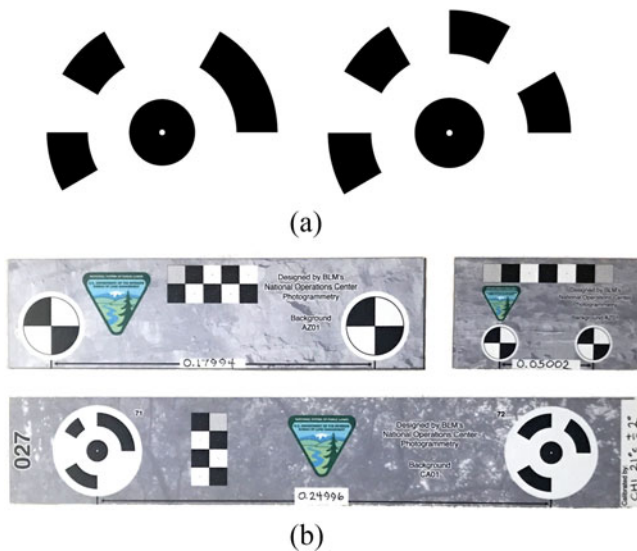
Figure 3. Artificial targets used in the alignment process and for scaling: (a) coded targets and (b) calibration scale bars.

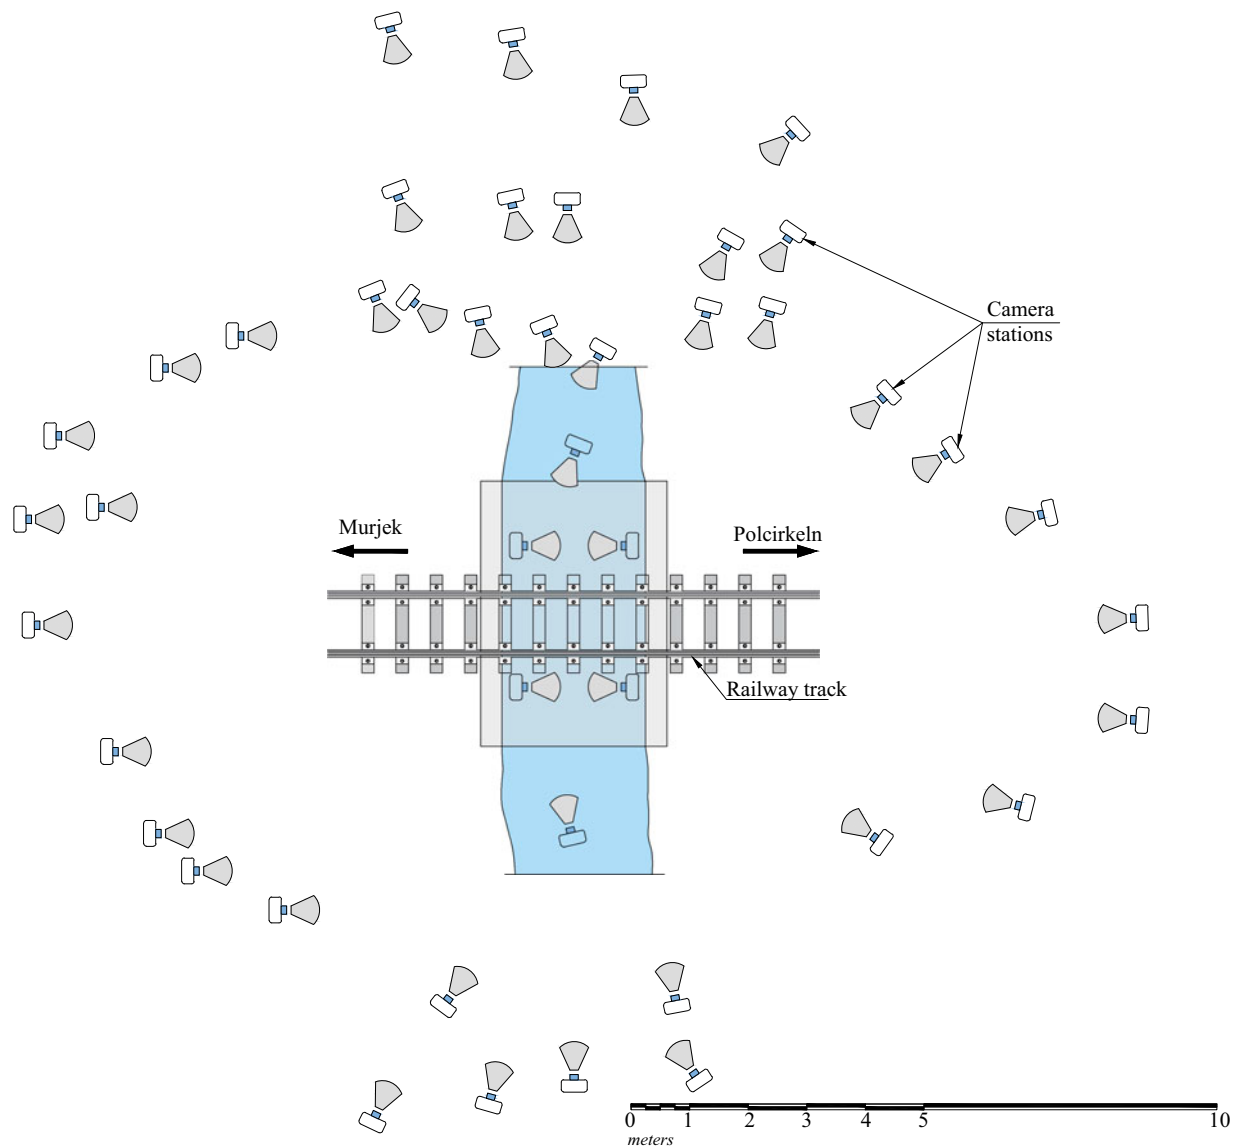
Figure 4. Different viewpoints and the resulting camera position triangulation of Păunakbäcken (modified from Agisoft PhotoScan Pro).

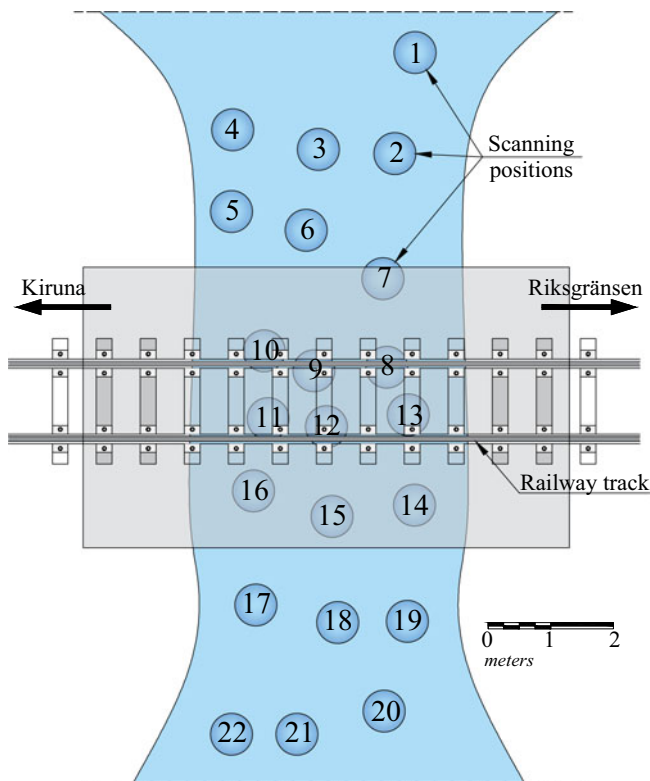
Figure 5. Scanning positions for the Juovajokk bridge (image based on data generated by Matterport app).

not supported by the developer, if scanning is performed outdoors, more scan positions are required. To avoid alignment issues, the scanning must be performed during civil twilight (30 minutes before sunrise or 30 minutes after sunset), or on a cloudy day to avoid infrared light from the sun. When completed, the scans are uploaded to Matterport's cloud service for 3D data registration and the point cloud is obtained. In addition, the scan positions around the bridge can be visualised, as shown for the Juovajokk bridge in Figure 5.

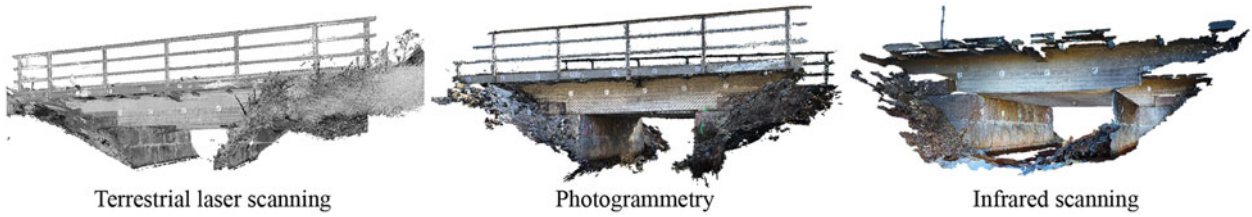
Figure 6. 3D models of Pänakbäcken bridge—differences in level of detail between the tested methods.

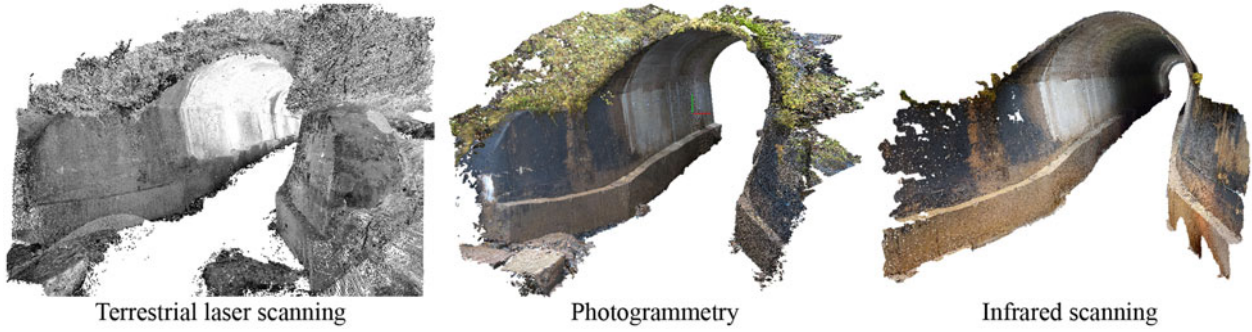
Figure 7. 3D models of Kedkejokk bridge—differences in level of detail between the tested methods.

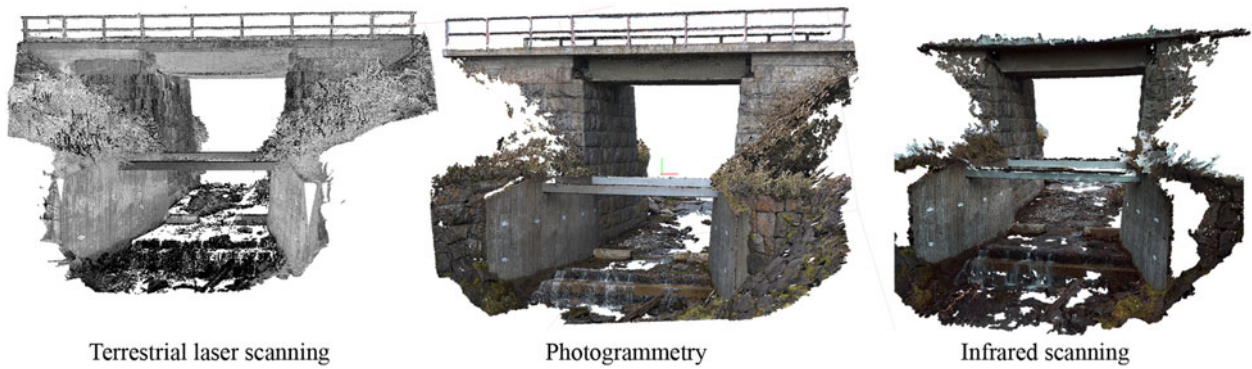
Figure 8. 3D models of Juovajokk bridge—differences in level of detail between the tested methods.

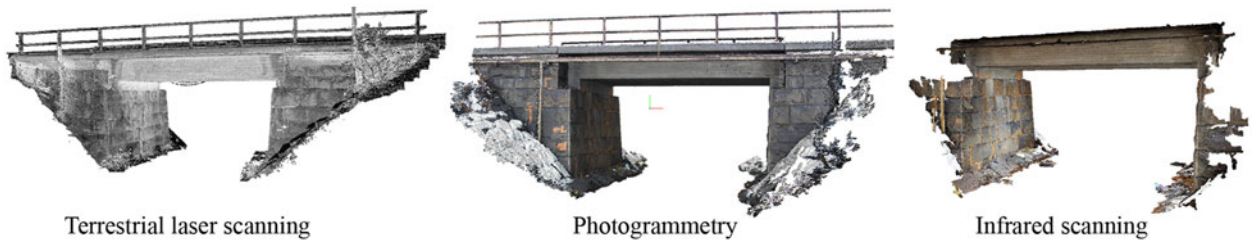
Figure 9. 3D models of Pahtajokk bridge—differences in level of detail between the tested methods.

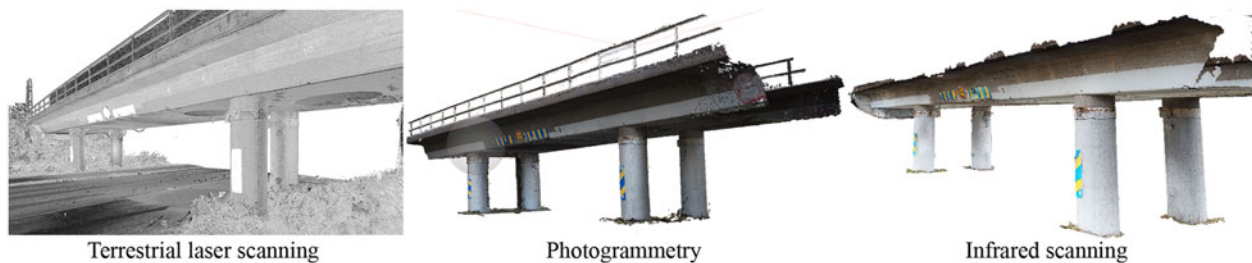
Figure 10. 3D models of Kallkällevägen bridge—differences in level of detail between the tested methods.

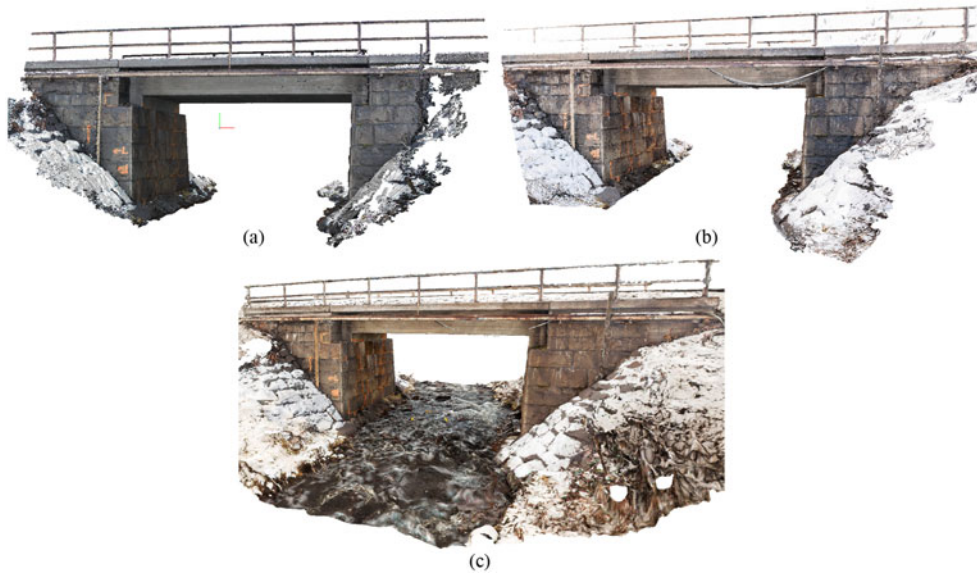
Figure 11. CRP models of Pahtajokk bridge: (a) Model #1, (b) Model #2 and (c) Model #3.

A comparison was also made between the different 3D models of the Pahtajokk bridge. Table 3, and the results presented in Figure 11 suggest that both teams performed the image acquisition process competently. However, there are significant differences in accuracy between Model #1 with Model #2, which were created using the same set of photos. The scanning of the Pahtajokk bridge was performed after a heavy snowfall, which created difficulties for Team 1 in attaching sufficient artificial targets. Consequently, the scaling was carried out with reduced redundancy. In their

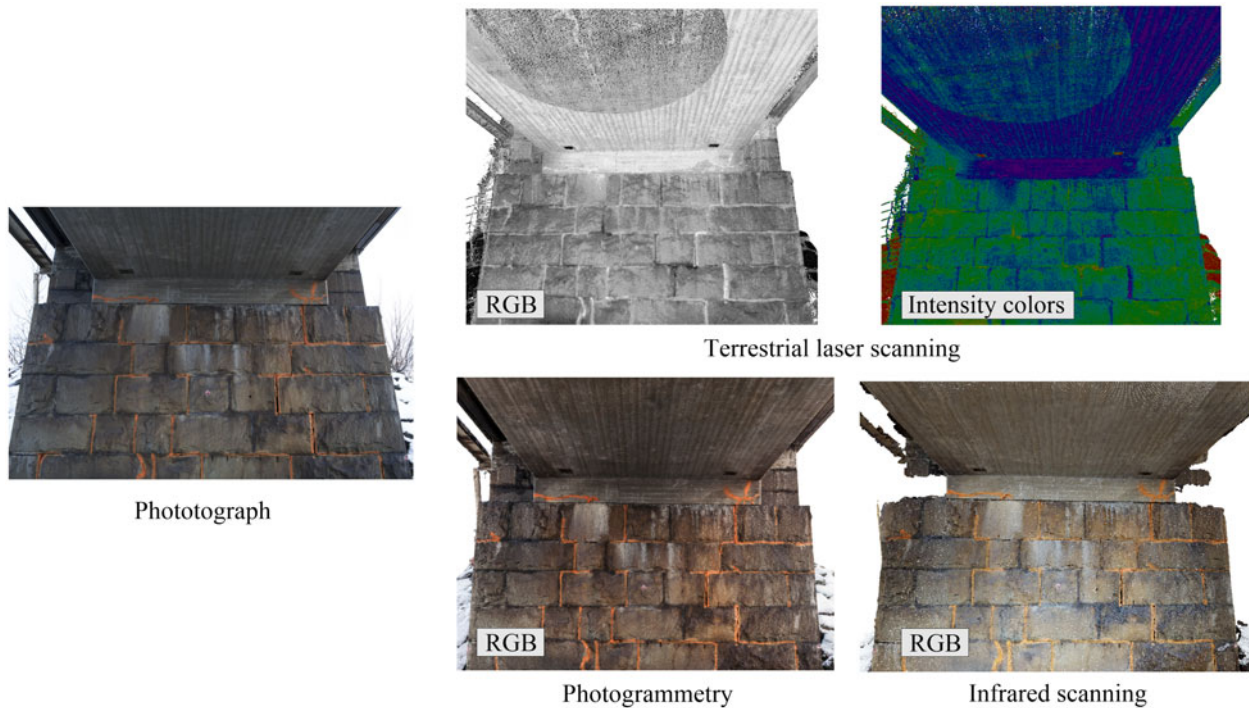
Figure 12. Point cloud visualizations of the abutment of Pahtajokk bridge based on the TLS, CRP and IS models, with a field photograph for comparison.

selected because multiple joint dislocations were noticed during the field survey. Figure 12 compares the rendering capabilities of TLS, CRP, and IS to a field photograph, illustrating the differences in the methods' rendering capabilities. All three methods clearly achieve high levels of detail, although the IS model was less detailed than the TLS- and CRP-based models.

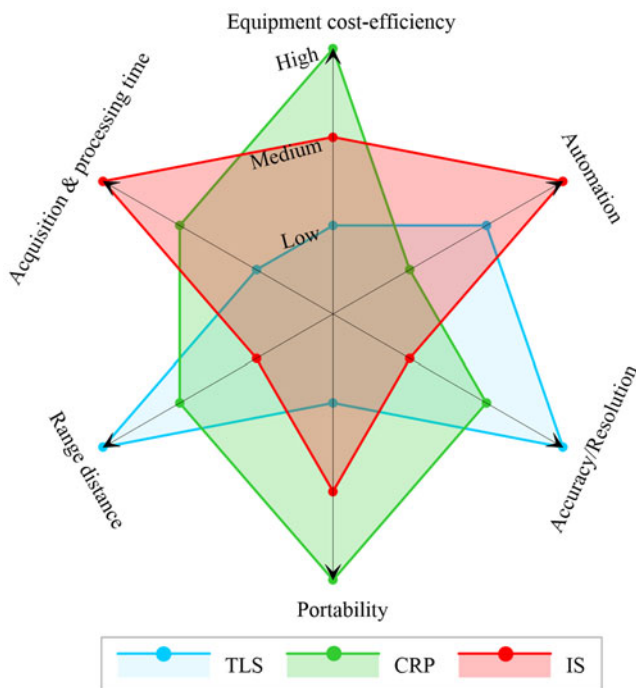
Figure 14. Performance of the 3D imaging methods (the *high* level represents the best performance with respect to the indicated item).

Figure 14 displays a qualitative comparison of imaging techniques used in this study in terms of cost, level of automation, accuracy/resolution, portability, range distance, and acquisition and processing time. Each method was given a grade of low, medium, or high for each item based on its performance, with the high grade corresponding to the best performance. For clarity, the high grade with respect to equipment cost was awarded to the method using the most affordable hardware; the high grade with respect to level of automation was awarded to methods with fully automatic data acquisition and processing; the high grade with respect to accuracy/resolution was awarded to the method with the highest accuracy and densest point cloud; the high grade with respect to portability was awarded to the method using the lightest and most flexible equipment; the high grade with respect to range was awarded to the method with the longest working range; and the high grade with respect to processing time was awarded to the method needing the least time for deployment, acquisition and processing.
