# Compact wooden roofs with smart vapour barrier – Pilot project experiences

**Abstract.** Compact roofs are normally built without organic materials between the vapour barrier and the roof membrane due to moisture safety risks. However, laboratory measurements indicate that organic materials could be used provided that a smart vapour barrier (SVB) is applied at the warm face of the roof construction. The aim of this study is to investigate the moisture and temperature conditions in three full-scale flat compact wooden roofs with SVB. The roofs are part of two pilot projects located in Longyearbyen, Svalbard and Malvik, Norway. The paper presents the two projects including the premises for construction of the roofs and provides preliminary measurement results. The roofs are instrumented to measure moisture content and temperature in the wooden roof beams. The initial results from Longyearbyen show that the moisture content in the wooden beams is low and indicate that compact wooden roofs with SVB may be a solution with acceptable moisture risk in the arctic climate. The initial results from Malvik show that there might be a risk of mould growth in the roof as the built-in moisture

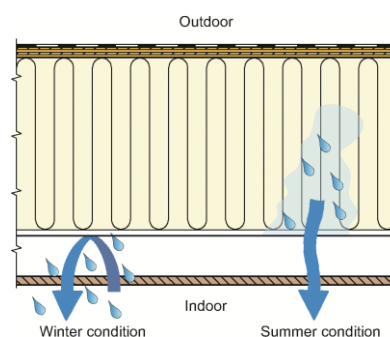
**Fig. 1.** The functionality of SVBs in summer and winter conditions. (Illustration: SINTEF Community)

However, calculations and laboratory measurements [1–5] indicate that compact roofs may be constructed with organic materials provided that a smart vapour barrier (SVB) is used at the warm face of the roof construction. An SVB has the potential to vary its vapour resistance dependent on the surrounding climatic conditions. At low relative humidity (RH) the vapour resistance of the material is high, while it decreases when the RH increases. Hence, during winter when the RH in indoor air usually is low, the vapour resistance of the barrier will be large. In summer, when the RH in indoor air is high, the vapour resistance will decrease and allow for drying of excess moisture towards the interior. See Fig. 1. This possibility for dry-out towards

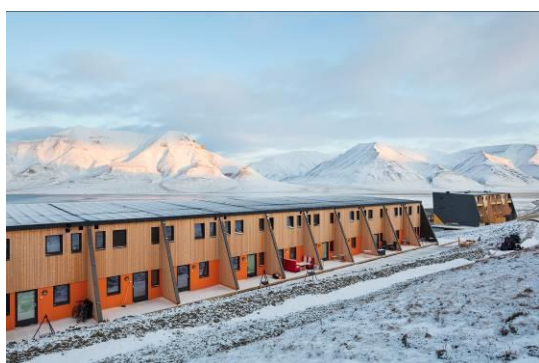
**Fig. 2.** One of the buildings that are part the pilot project in Longyearbyen. (Photo: Trond A. Isaksen)

The pilot project in Longyearbyen at Svalbard consists of six residential buildings (denoted A–F) with a total of 60 dwellings. See Fig. 2. The buildings were constructed with prefabricated modules during autumn 2018 (buildings A–C) and spring/summer 2019 (buildings E–F). Buildings A and F are included in the present study.

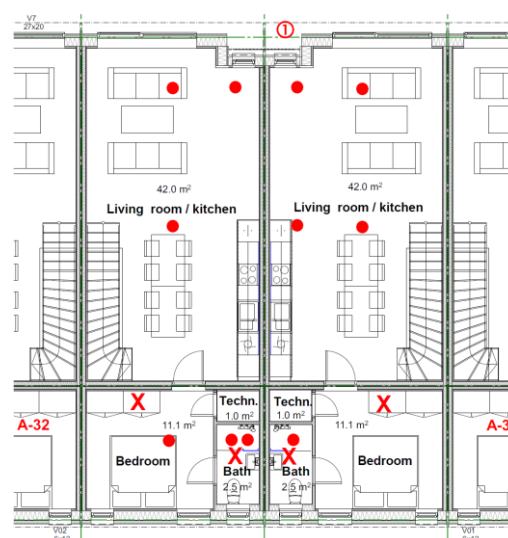
**Fig. 3.** Instrumentation of roof A in the horizontal plane. "X" shows the position of measurements in indoor air, "1" is the position of the sensor in outdoor air, and "•" indicates the localization of sensors in the wooden beams in the roof.

In roof A, 26 sensors are positioned in 13 locations in the beams, as shown in Fig 3. In each of the 13 locations, one sensor is installed in top of the beam (10 mm from the roof underlay) and one sensor is installed in the bottom of the beam (and 10 mm from the SVB), as shown in Fig. 4. Sensors are installed in the roof above rooms with different functions (bathroom, bedroom, living room) to investigate possible differences in moisture conditions. In addition, in total five sensors measure temperature and RH in outdoor air (one sensor) and indoor air (four sensors).

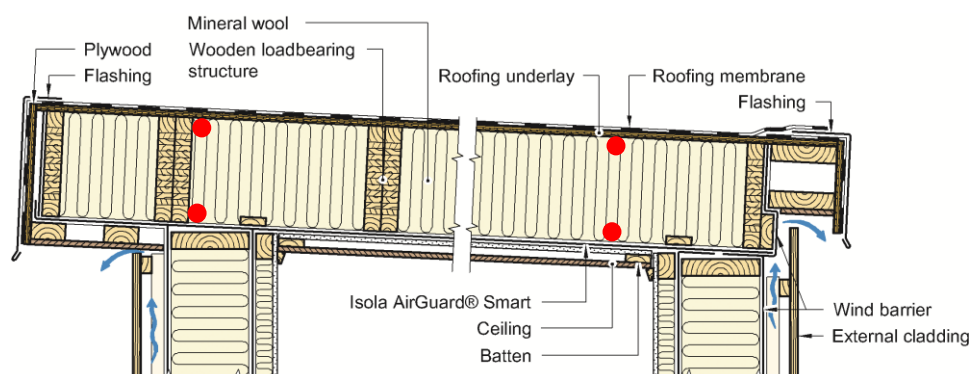
**Fig. 4.** Roof construction and position of sensors ("•") in roof A (left of figure) and F (right of figure). In each measuring point in the horizontal plane of the roof, two sensors are installed in the cross section. Roof A has loadbearing beams normal to the roof inclination, while roof F has loadbearing beams parallel to the roof inclination.

The main difference between roof A and roof F is the direction of the load bearing beams. Roof A has load bearing beams normal to the direction of the roof fall, while roof F has load bearing beams parallel to the direction of the roof fall. See Fig. 4. The installation of beams normal to the roof fall in roof A will reduce redistribution of moisture due to natural convection in the insulation layer. Therefore, it is of interest to compare measurements of MC in roof A and roof F.

In roof F, 24 sensors are installed in 12 locations in the beams, as shown in Fig. 5. As in roof A, two sensors are installed at each of the measuring points – one sensor close to the roof underlay and one sensor close to the SVB. See Fig. 4. Six sensors measure temperature and RH in outdoor air (one sensor) and indoor air (five sensors).

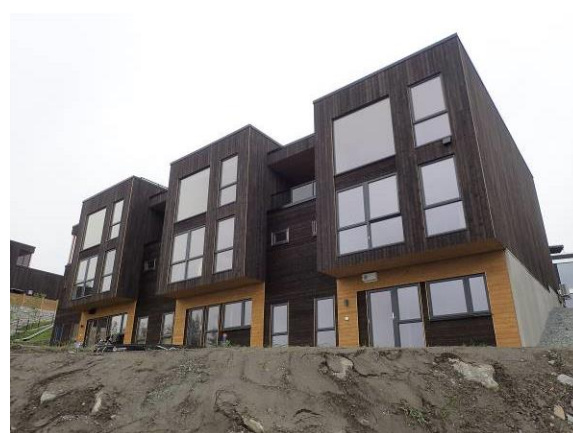
**Fig. 6.** The building that is part of the pilot project in Malvik. (Photo: Tore Kvande)

The pilot project in Malvik (close to Trondheim) consists of a full-scale residential building, as shown in Fig. 6. The building is denoted D1. It is constructed on-site and is built with a compact wooden roof and SVB.

The roof of building D1 is constructed on-site as a flat compact unventilated wooden roof with SVB at the warm face of the thermal insulation. The technical properties of the SVB are presented in [6]. The roof has wooden I-profile load bearing beams, mineral wool insulation between the beams, a wooden roof underlay and black asphalt roofing, as shown in Fig. 7. Compared to solid wood beams, I-profile beams results in a smaller amount of wood in the roof construction and hence probably less built-in moisture for similar climate during construction. The joists are flat, while tapered insulation on top of the roofing gives a roof slope of 1:40. Information about the roof is summarized in Table 1.

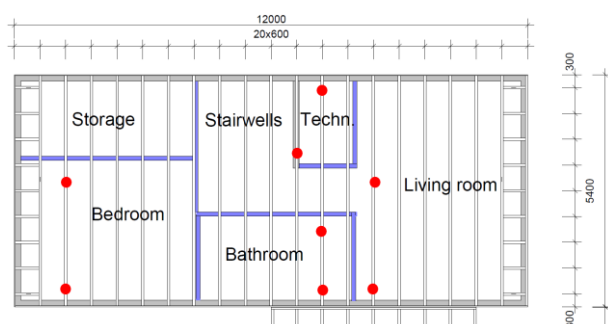
**Fig. 8.** Instrumentation of roof D1 in the horizontal plane.

Roof D1 is instrumented with sensors (Omnisense Hygrotrac S-160-0) in the flanges of the wooden I-profile beams. The sensors and registration system used is equal to those described for roofs A and F. Sensors were installed in the beams 2 weeks after the roof and walls were externally sealed. As for roofs A and F, measurements are evaluated as hourly averaged data. Roof D1 is instrumented with a total of 15 sensors in eight locations, as described in Fig. 8. In each location (except one), sensors are positioned in both the upper and the lower flange of the I-profile beams for measurements close to the roof underlay and close to the SVB, respectively. In one location only one sensor was installed in the upper flange due to a penetration through the lower flange of the beam. The sensors were installed 10 mm from the roof underlay and 10 mm from the SVB. The MC electrodes were screwed 22 mm into the flanges of the beams. Sensors were installed in the roof above rooms with different functions (bathroom, bedroom, living room) to investigate possible differences in moisture conditions.

This section presents measurements from roof D1 in the period 29.11.2018–05.09.2019 (9 months). Table 3 shows minimum, maximum and average temperatures and MC levels measured in the top and bottom of the beams, when investigating all the sensors. Fig. 12 shows variation in temperature and MC in one measurement position (two sensors) in one of the beams in the roof above the living room in building D1 (see Fig. 8).

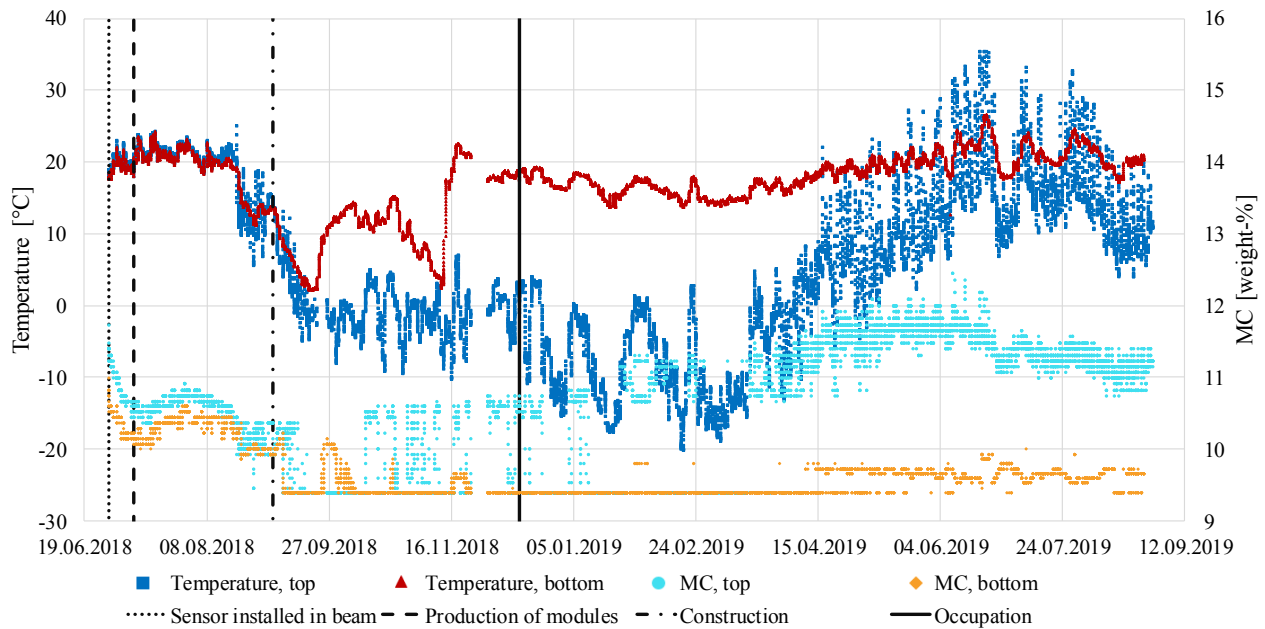
**Fig. 9.** Variation in temperature and MC in one of the wooden beams in roof A (Longyearbyen). Measurements are conducted close to the roof underlay ("top") and close to the SVB ("bottom") in the roof above the living room.

Measurements from roof A in the period 29.08.2018–30.08.2019 (one year) are presented in this section. Table 2 shows minimum, maximum and average temperature and MC in the top and bottom of the wooden beams, investigating registrations from the 26 sensors in roof A. Fig. 9 shows variation in temperature and MC in one of the measurement positions (two sensors). Important dates in the construction process are specified by vertical black lines. Results from both the sensor in the top of the beam (denoted "top") and bottom of the beam (denoted "bottom") are included. The sensors in the example in Fig. 9 are located in the roof above one of the living rooms in building A. See Fig. 4.

The results show that the temperature in the top of the beams varies much more throughout the year than the temperature in the bottom of the beams. Hence, the risk of condensation and moisture uptake is larger in the upper part of the beams. The temperature is higher close to the roof underlay than close to the SVB in some periods during summer months, as seen in the example in Fig. 9. During these periods dry-out of moisture from the top of the beams through the roof construction and SVB will be possible. However, measurements from roof A show that the MC in both top and bottom of the beams is low throughout the first year of measurements, as given in table 2. The sensors are not able to measure MC lower than 7 weight-%, which equals 9.4 weight-% given correction of the measurements using Equation (1). Hence, the actual minimum MC in roof A might be even lower. As expected, the MC is larger close to the roof underlay than close to the SVB. The MC measured throughout the first year implies that a compact wooden roof with SVB may have little risk of moisture failure given the arctic climate of Longyearbyen. However, it should be mentioned that the level of built-in moisture was controlled and held very low in this project, thereby the drying-out capacity to the interior was not relevant or tested.

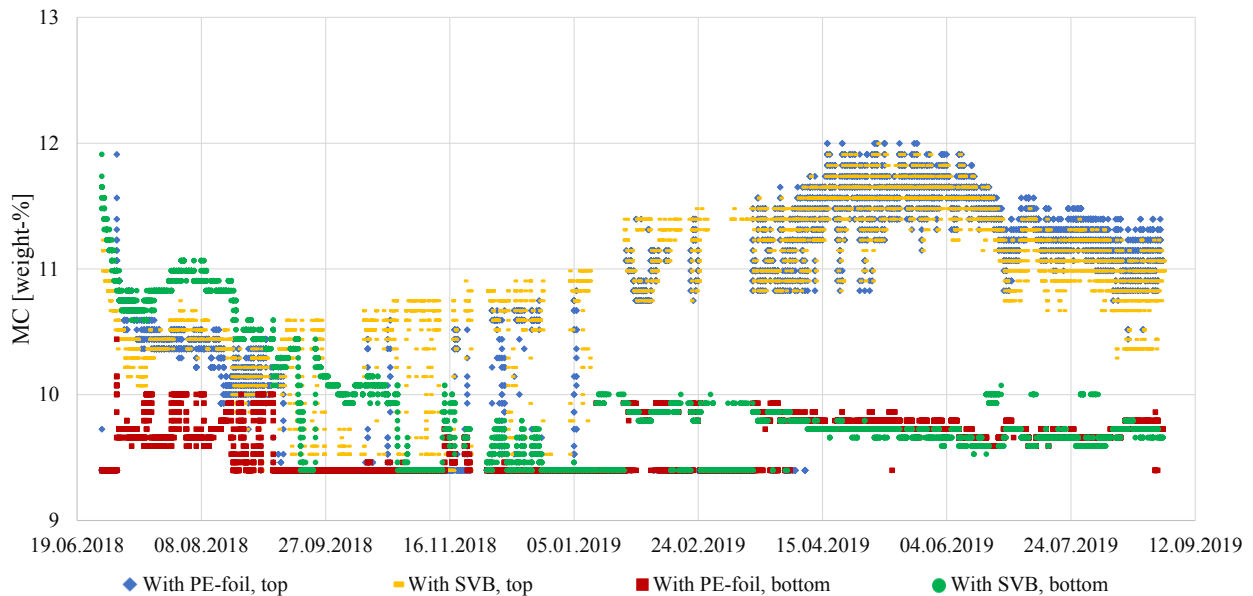
**Fig. 10.** Comparison of MC in the wooden beams in the roof sections above bathrooms with SVB or conventional vapour barrier (PE-foil) in roof A (Longyearbyen). Measurements in the top and the bottom of the beams are presented.

Fig. 10 compares the MC in beams in roof sections above two bathrooms with SVB or conventional vapour barrier (PE-foil), respectively. Results from the sensors in both the top and bottom of the beam are included. The measurements presented in Fig. 10 indicate that the difference in MC in the roof with smart or conventional vapour barrier is small and that the SVB has the required functionality above a room with high moisture loads.

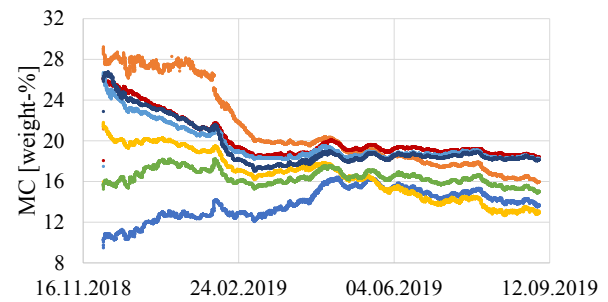
**Fig. 11.** MC variation in all the sensors installed in top of the beams (close to the roof underlay) in roof D1 (Malvik).

Important dates in the construction process are specified by vertical black lines. Results from both the sensor in the top of the beam ("top") and bottom of the beam ("bottom") are included. Fig. 11. shows variation in MC for all sensors installed in the top of beams in roof D1.

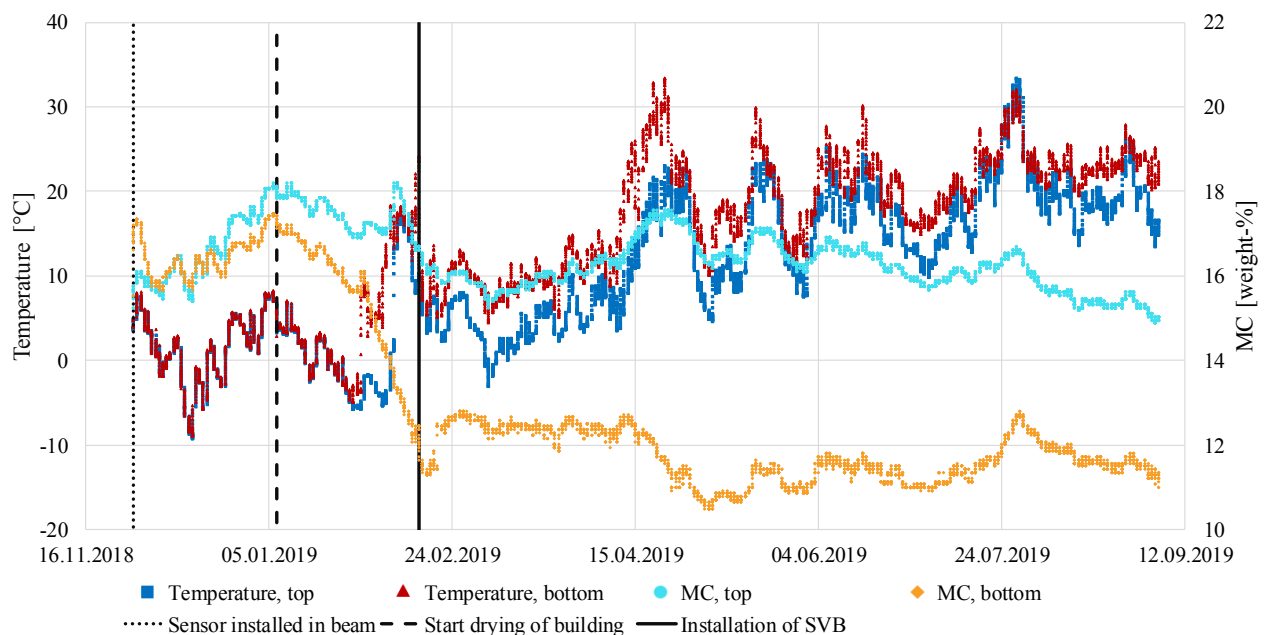
**Fig. 12.** Variation in temperature and MC in one of the wooden beams in roof D1 (Malvik). Measurements are conducted close to the roof underlay ("top") and close to the SVB ("bottom") in the roof above the living room.

Studying registrations from all the 14 sensors in the roof, the initial results show that the temperature in general is slightly higher close to the SVB than close to the roof underlay. This is also observed in the example in Fig. 12. As the building was not yet occupied in the period that is investigated, it is expected that the difference in temperature on the warm and cold face of the thermal insulation is small.

The results show that the MC in the wooden beams is high in some periods during the first nine months of measurements. At the date of installation of the SVB (continuous black line in Fig. 12) the MC was measured in the interval 12.1–23.6 weight-% in different positions in the roof (including both top and bottom of beams). Seven of the 14 sensors measured MC larger than 15 weight-% at this date. Nevertheless, the contractor chose to install the SVB due to issues related to the progress in the project. In the period after installation of the SVB (beyond the continuous black line in Fig. 12) the average MC was 14.6 weight-%. As the built-in moisture (MC at installation of the SVB) was measured up to 23.6 weight-%, the results indicate that there might be a risk of mould growth in roof D1.

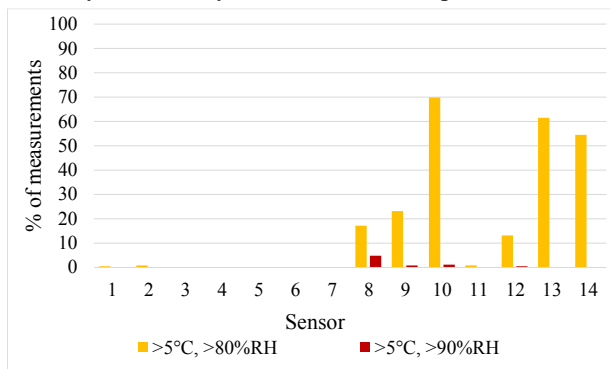
**Fig. 13.** Percentage of measurements with certain temperature and RH conditions in the roof. Sensors 1-7 and 8-14 are positioned in the lower and upper flange, respectively.

The results are presented in Fig. 13. Sensors 1–7 in the figure are positioned in the bottom of the wooden beams, while sensors 8–14 are positioned in the top of the wooden beams. The figure shows the percentage of measurements with the given temperature and RH conditions conducted in the period after the thermal insulation and SVB were installed.

At temperatures above 5°C, the RH in the bottom of the beams was lower than 80 % most of the time. This indicates that there is no substantial risk of mould growth in the bottom of the beams, as periods with RH below 80 % are not considered critical unless mould growth is already initiated. In the top of the beams the RH exceeded 80 % in up to 70 % of the measurements. Hence, there might be a risk of mould growth in the top of the beams. In addition, the temperatures measured in the roof are not large enough to kill mould in the roof. However, the investigations by [8] showed that a RH of 80 % had to be combined with a temperature of 20°C over five months to initiate mould growth. The duration of continuous periods with the given temperature and RH levels was not investigated in this study. In addition, the moisture and temperature conditions in the roof underlay, which is a critical point with regards to mould growth, was not investigated. Due to the higher MC levels in roof D1, the roof was opened for inspection 11.07.2019. No mould growth was registered at this time. In addition, two samples cut out of the roof underlay showed dry conditions in the top of the roof.
