Robust and reliable deep renovation by advanced prefabricated façade elements. Air-tightness performance and assessment of a demo case

This paper presents air-tightness results from a demo case study in Norway. In the demo case the airtightness as determined by blower-door tests quite unexpectedly deteriorated, while the design goal for the projects was a major improvement. Probable causes for the discrepancy are discussed, and include leakage from the ground, in element joints and in unplanned openings.

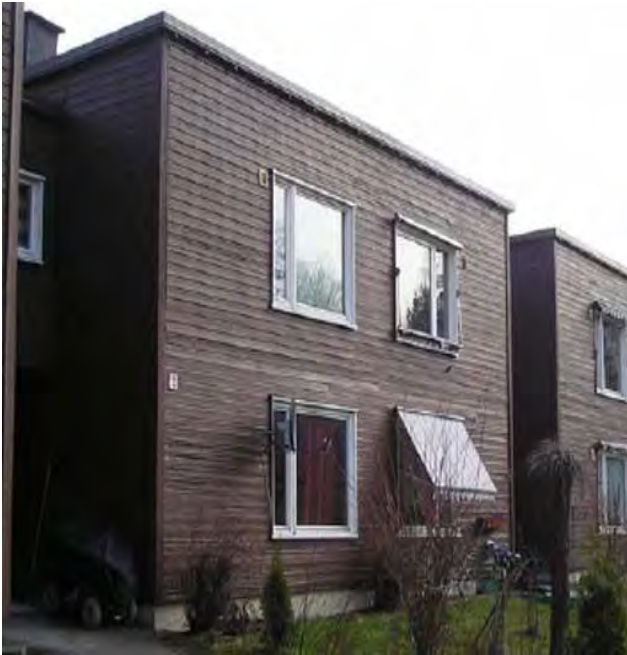
The building selected for deep renovation (Figure 1) is a two-storey timber-frame building from 1971, with only minor later upgrades, owned by Boligbygg Oslo KF. The building contains in total eight apartments, each with a floor area of approximately 42m², distributed around two staircases. The building is situated in a suburban area (Haugerud) in Oslo.

Figure 1 The demo building prior to refurbishment.

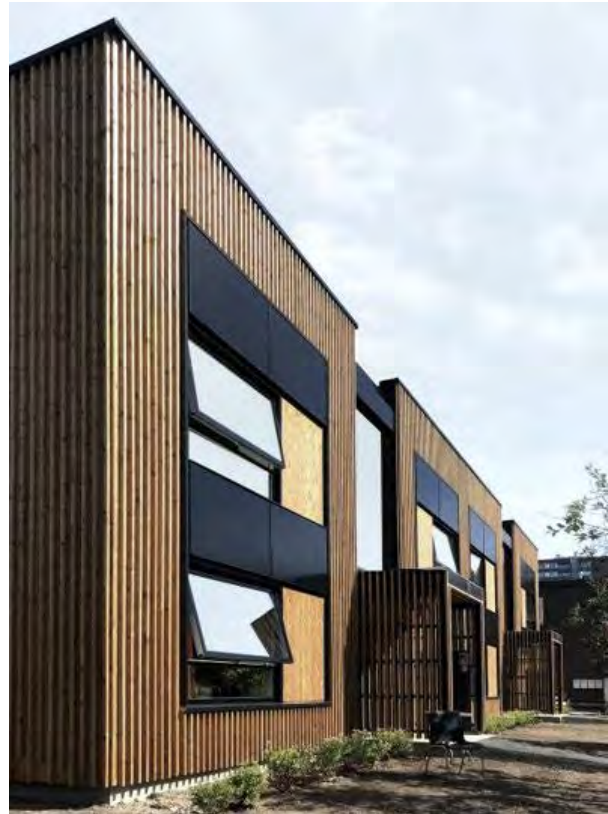
External, insulated woodframe elements with integrated supply air ducts (north façade), preinstalled windows, PV-panels (south façade) and external cladding were added to the existing external walls. During the condition assessment prior to refurbishment, it was determined that the load bearing capacity of the existing construction was insufficient for the added loads, and a new foundation for wall elements was prepared around the perimeter of the building.

Figure 2 The demo building after refurbishment.

entrance area was also built at site for each of the two staircases. The building after refurbishment is shown in figure 2.
