Xerophilic fungi in museum repositories challenge our perception of healthy buildings and the preservation of cultural heritage

ABSTRACT

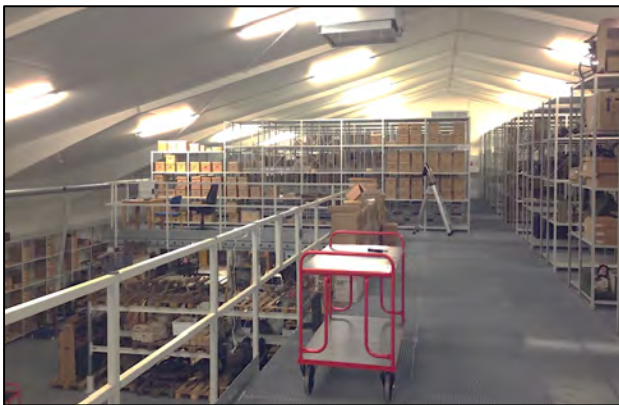
Fig 2. Repository 1 appeared in a good order

Outdoor and indoor building inspections showed no evidence of damages on the building envelope, causing propagating water. There was also no evidence of structural faults in the building constructions, causing elevated moisture in building structures.

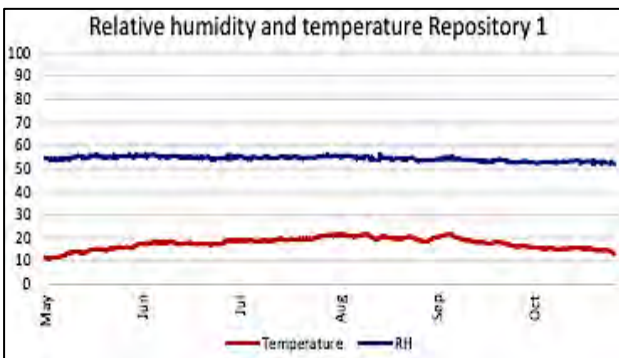
Fig 3. Six months variations of RH and T in repository 1

The data loggings of RH and T conducted as a part of the preventive conservation strategies at the museums showed that the dehumidifiers managed to keep RH slowly fluctuating between 52-63% RH during six months, while T fluctuated between 10°C and 23°C in the same period (fig. 3-5).

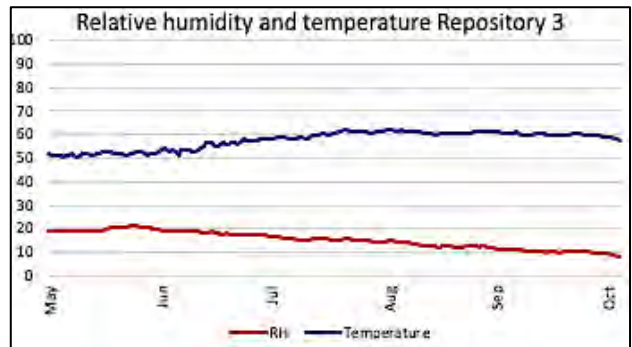
Fig 5. Six months variations of RH and T in repository 3

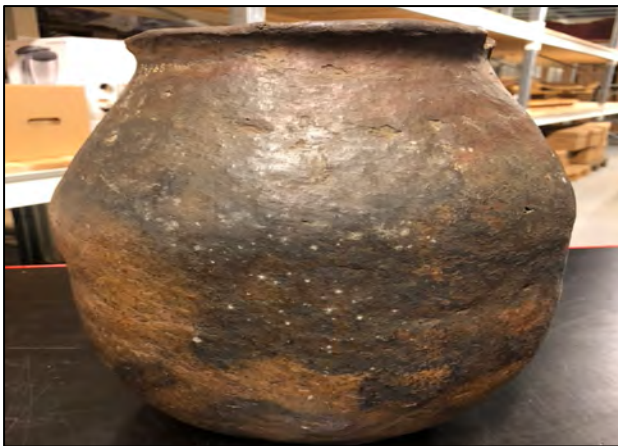
Inspection of the three museum repositories and their stored heritage collections showed no fungal growth concerning building structures and interiors. The fungal growth was solely associated with the stored heritage artefacts and appeared as distinct hyaline and white colonies on artefacts (fig. 6-8). It was not just artefacts made of organic materials such as wood, leather and textile that showed growth, but also artefacts made in inorganic material such as cast iron and ceramics (fig. 6). The growth was not widespread throughout the museum repositories; the growth was most sparse in repository 3, concentrated to few artefacts, while repository 1 and 2 showed heavier but still sporadic growth.

Fig 6. A prehistoric urn with fungal growth (repository 1)

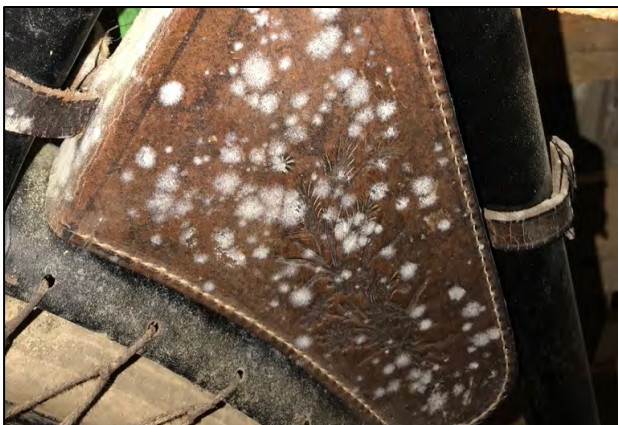
Fig 7. A bicycle leather case with fungal growth (repository 2)

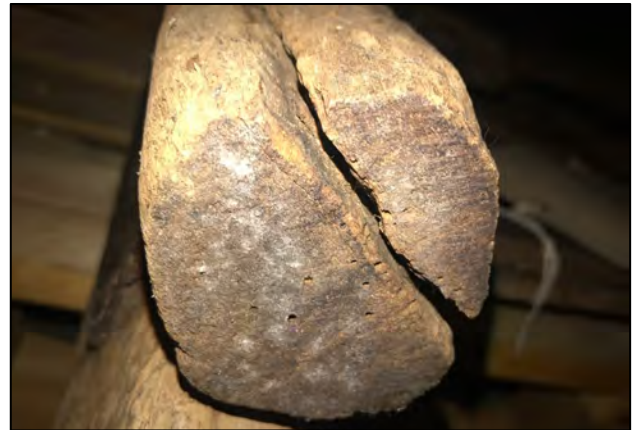
Fig 8. A wooden tool with fungal growth (repository 3)
