Development of smart control system for leakage warning in compact roofs

Silje Asphaug, Stig Geving and Roberta Moschetti

Department of Architecture, Materials and Structures, SINTEF Community, NO-7465, Trondheim, Norway

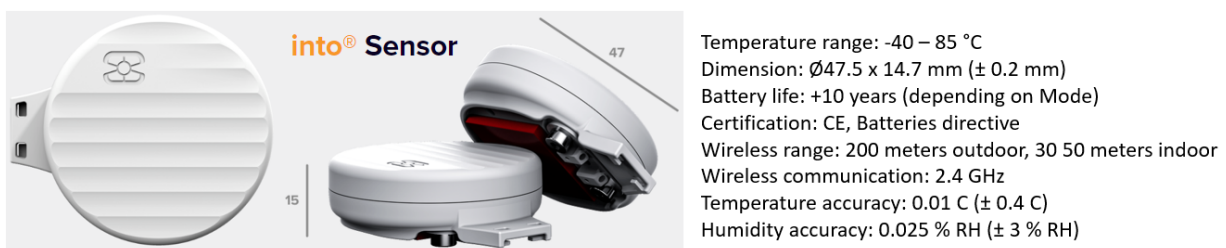
Figure 2. The into® Sensor are installed in building components such as a roof and measures the surrounding temperature, humidity, and water leaks [4].

The into® Sensor measures the surrounding temperature, humidity, and water through three different types of sensors and transmits the data wirelessly through a Gateway to a cloud application (iCS). In iCS the data is processed and if the system finds an abnormal moisture value or an immediate leakage it warns the involved users. The into® Sensor is configured as a data logger reading the measured values in specified intervals and transmits the reading in intervals depending on chosen mode. The logging interval can be configured from every 1 minute up to 15 minutes. The into® Sensor is depicted in figure 2.

The water sensor measures the electrical voltage between two electrodes located in the bottom of the sensor casing. The water sensor transmits a tensor of 3 volt and thus measure a voltage between 0 and 3 V. High values indicates that water is present between the two electrodes as a result from either a leak or condensation and results in a warning or alarm. When no water is present the voltage is low or zero.
