# SINTEF REPORT

**Tyre/road noise modelling:  
Measurements of passenger car tyres on an ISO track and  
frequency analysis of results.**

REPORT NO. SINTEF A14882	CLASSIFICATION Open	CLIENTS REF. Jannicke Sjøvold/Ingunn Milford/Jan Boe Kielland	
CLASS. THIS PAGE Open	ISBN 978-82-14-04474-4	PROJECT NO. 90E324/90E1031.34/90E266	NO. OF PAGES/APPENDICES 55
ELECTRONIC FILE CODE SINTEF14882.doc	PROJECT MANAGER (NAME, SIGN.) Truls Berge <i>Truls Berge</i>	CHECKED BY (NAME, SIGN.) Svein Å. Storeheier <i>Svein Å. Storeheier</i>	
FILE CODE	DATE 2010-2-15	APPROVED BY (NAME, POSITION, SIGN.) Odd Kr.Ø.Pettersen, Research Director <i>Odd Kr.Ø.Pettersen</i>

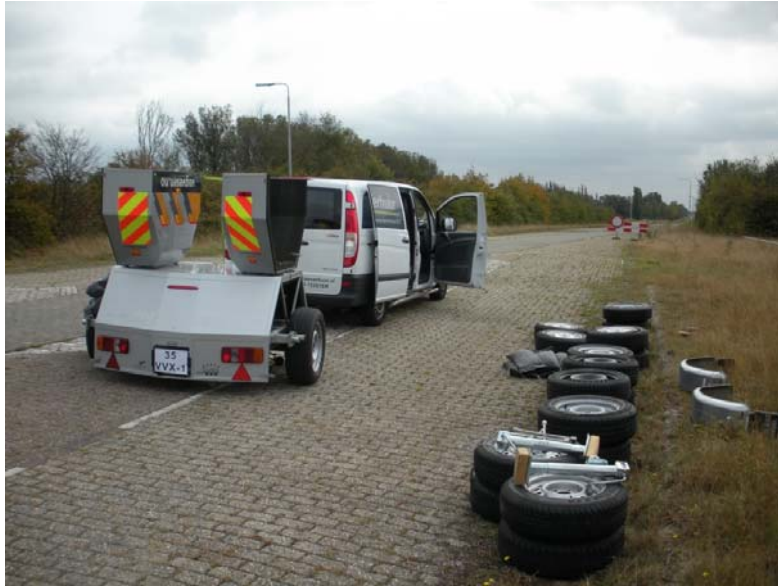
*Figure 1 CPX-trailer*

All measurements were done using the CPX-trailer of the Norwegian Public Roads Administration, as shown in figure 1.

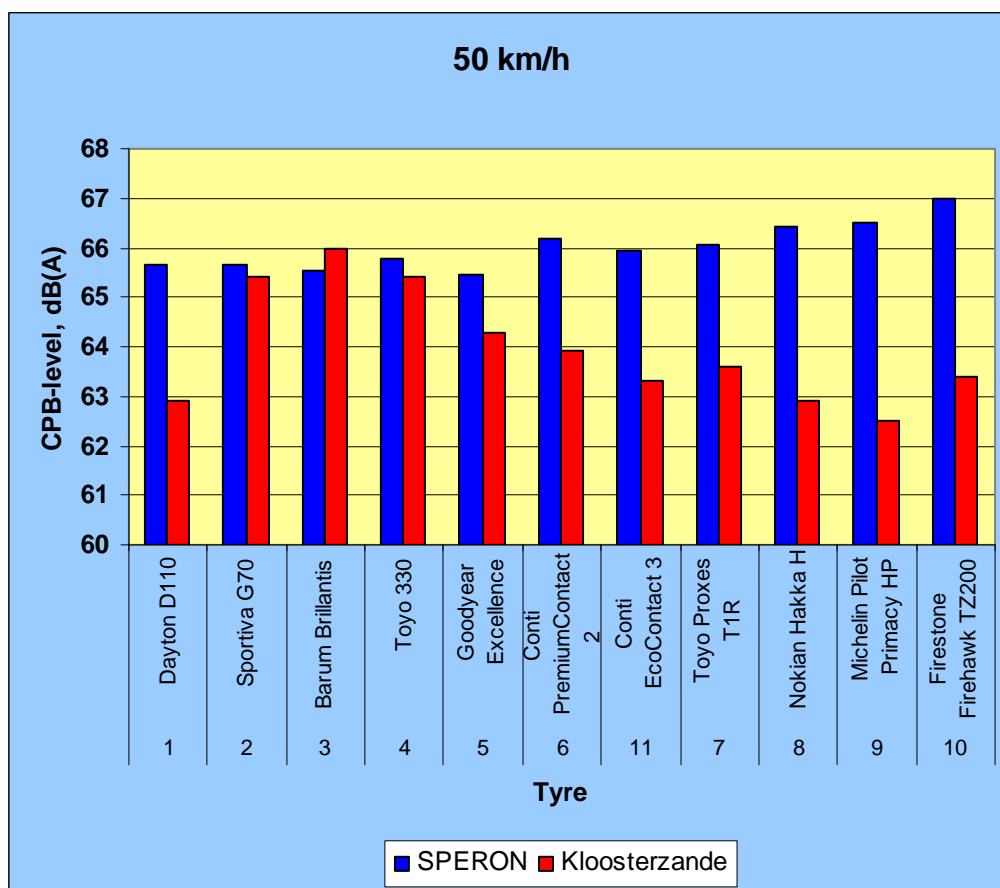
**Figure 25** SPERoN model (ISO) and Kloosterzande (ISO), 50 km/h

In table 5 and figures 25 and 26, the *SPERoN* modelling results are compared with the results from Kloosterzande. The *SPERoN* model gives results at a distance of 7.5 m. For comparison reasons, all the CPX-results at Kloosterzande have been recalculated to 7.5 m using an average difference of 22.5 dB(A) of the propagation filter between CPX and CPB, as found by Anfosso-Lédée<sup>6</sup> for dense surfaces. In the figures, the tyres are sorted according to tyre width.

From these figures, it is clear that there is no positive correlation between the ranking of the tyres using the Sperenberg ISO surface with the *SPERoN* model and the actual measurements on the ISO surface at Kloosterzande, based on overall A-weighted sound levels. Technically, there could be differences between these two ISO surfaces, but it is unlikely that this could explain this lack of correlation. A more detailed frequency analysis has been made on the datasets and is presented in Chapter 5.1.

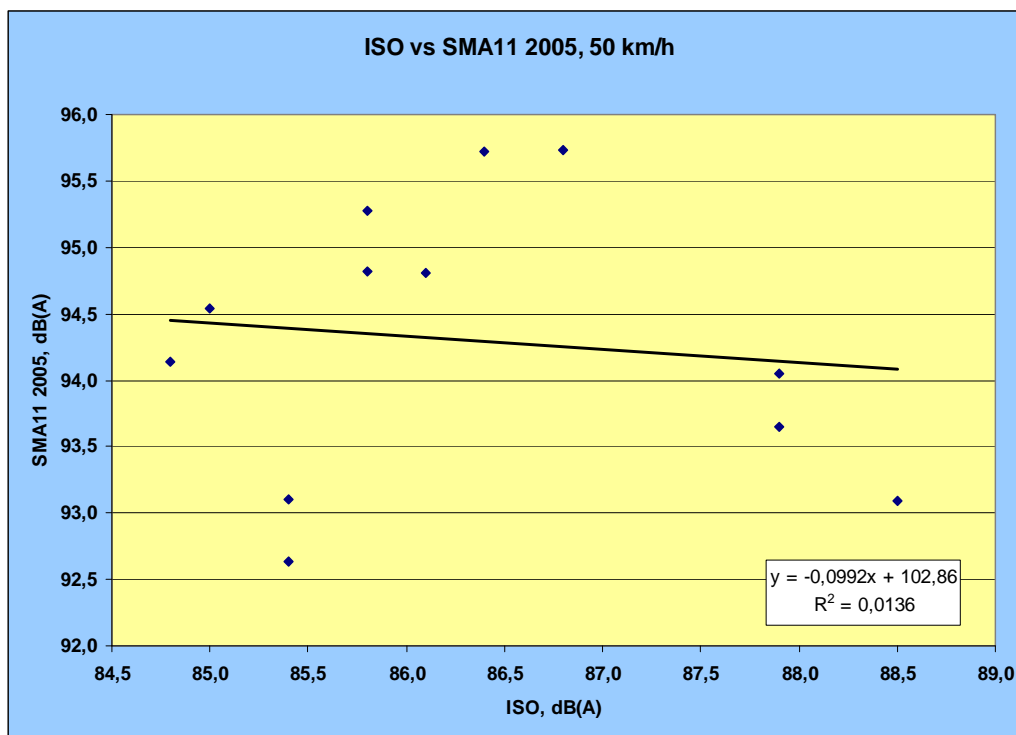
**Figure 29** Correlation between SMA11 2005 and ISO surface at Kloosterzande, CPX-levels at 50 km/h.

In figures 29 and 30, the correlation between the two tests is shown for each speed.

All measurements on typically existing road surfaces (SMA11) in Norway, exposed to winter conditions, show no correlation between the ranking of the tyres on the ISO surface and on the SMA surfaces.

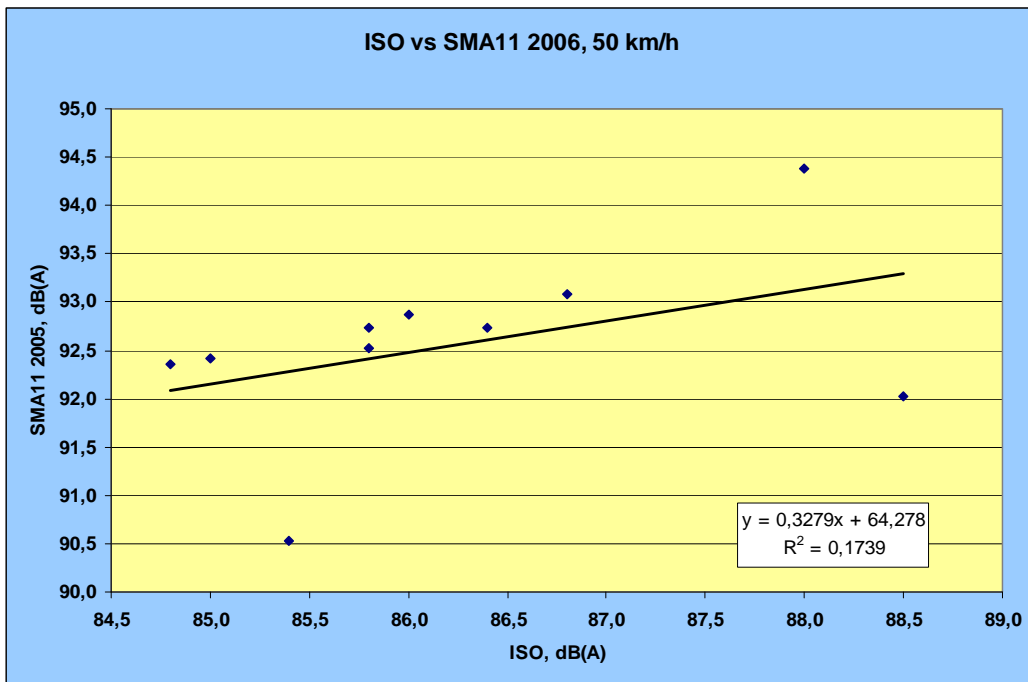
*Figure 33 Correlation between SMA11 2006 and ISO surface at Kloosterzande, CPX-levels at 50 km/h.*

In figures 33 and 34, the correlation is shown.

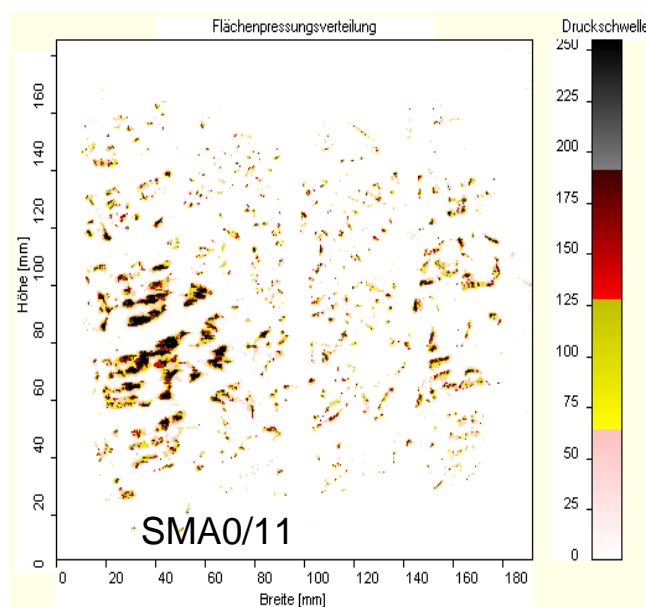
To be able to explain the reasons for such lack of correlation, one can look at a typical footprint (surface pressure distribution) of a smooth profiled (50 Sh) tyre on an SMA11 surface as measured by BAST<sup>7</sup>, with the same footprint on an ISO surface, see figures 35 and 36.

**Figure 35** Surface pressure distribution of a tyre on an SMA11 surface.

These figures show a dramatically less influence of the pattern on the SMA11 surface (which may even be smoother than the measured SMA11 surface in Norway), compared to the ISO surface.

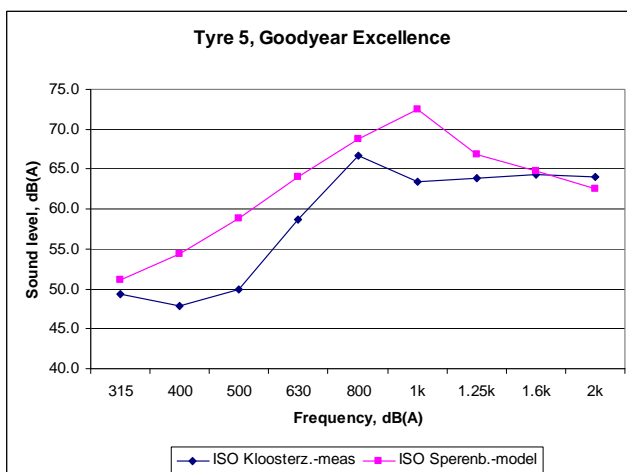
In figures 48-59, the frequency spectra for both surfaces are shown for the 11 tyres with available data for both cases. The chosen speed is 80 km/h.

In general, the model (pink colour) seems to overestimate the levels in the lower frequency range (below 800 Hz). However, one should be careful in the evaluation of these results, since the CPX-values has been recalculated to a coast-by situation (at 7.5 m) and the comparison is also done at two different ISO surfaces.
