Terrestrial processes affecting unlithified coastal erosion disparities in central fjords of Svalbard

RESEARCH/REVIEW ARTICLE

Terrestrial-sourced hazards; coastal erosion; coastal geomorphology; Digital Shoreline Analysis System; Svalbard.

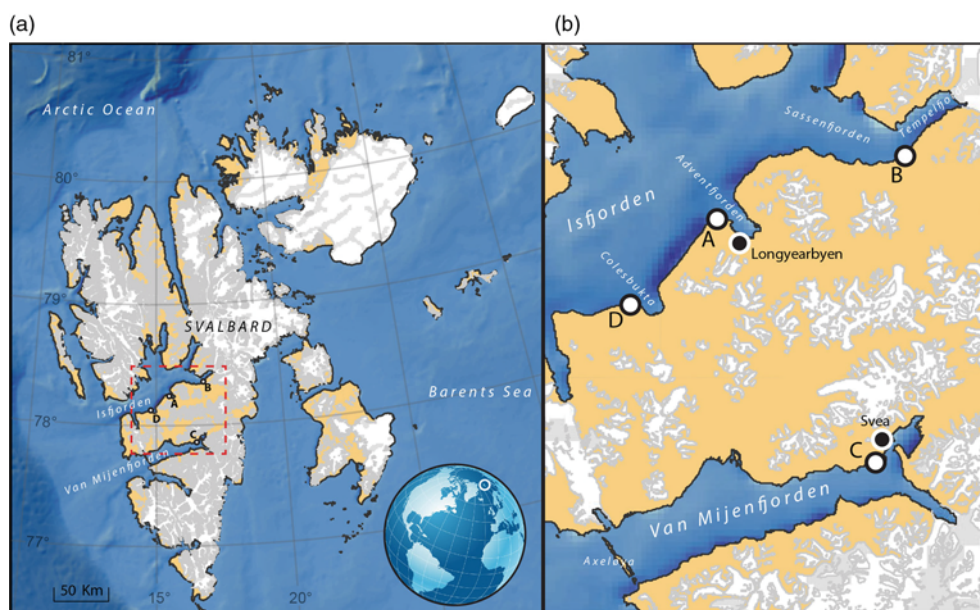
Fig. 1 (a) Svalbard; (b) the location of field sites: Vestpynten (A), Fredheim (B), Damesbukta (C) and Kapp Laila (D), with their associated fjords.

All field sites are located within the inner fjord regions of Svalbard (Fig. 1). As documented by Etzelmüller et al. (2003), the inner fjord areas of Svalbard are dominated by glacier fronts or glacier meltwater outlets, high abundance of beaches and many deltas. They are more prone to “rapid changes than anywhere else on Svalbard” (Etzelmüller et al. 2003: 38). Unlithified sediment cliffs consisting of Holocene beach, fluvial and glacial sediments that are susceptible to coastal erosion are commonly found in Van Mijenfjorden and are known to exist in much of the inner fjord regions (Mangerud et al. 1992; Johannessen 1997; Etzelmüller et al. 2003; Flyen 2009). All the field sites are located within non-glacierized zones, that is, all hydrological influence acting directly on the cliffs comes from precipitation runoff, snowmelt and groundwater flow. These are also locations where modern and historical infrastructure are present and in some cases in danger of being lost or damaged by

Vestpynten is situated 5 km west of Longyearbyen along Adventfjorden (Fig. 1). The bluff rises from one to approximately 6 m a.s.l. (Fig. 2a). The sediments are stratified, well-graded, beach sediments that range from silt to gravel fractions. Permafrost and an active layer of 150 cm thick are present. There are no indications of ice lenses. Pore water pressure at the base of the active layer is highest between May and July beginning rapidly and dropping relatively quickly as well, reflecting typical seasonal variations for spring/summer melt in the Arctic (Wold et al. 2012). A large snowdrift builds up along the bluff during winter and usually does not disappear until late June/early July (Fig. 2b). The bluff is actively undercut behind the snowdrift producing a cavity that measured up to 69 cm cutback in 2012 (Wold et al. 2012). Wind waves and ocean swell are commonly found breaking along the beach and can be up to 1 m in height for a one-year return period and up to 1.8 m for a 100-year return period (Lothe & Finseth 2012). Fast sea ice is not common at this site, however an ice foot, defined here as, a fringe of ice of varied width at the edge of the shores in cold regions which forms during the winter and either melts out in place or detaches as an ice floe in the spring/summer (Caline 2010; Strzelecki 2011a) is usually present. There is often drift ice that can become beached. There are no glaciers or rivers directly affecting runoff in the area, and the main source of water is spring and summer snowmelt.

Nøis rivers flow into the fjord (Figs. 1, 2c). This site is home to four cultural heritage buildings that are threatened by coastal erosion. The 190 m long and 3–6 m high section is made up of unlithified Holocene fluvial sediments that form an inactive, uplifted section of the Nøis River delta containing an active layer 90 cm thick (Sessford & Hormes 2013). The sediment distribution ranges from silt ($<8\%$) to boulders with the majority of sediment within the sand to gravel fractions (Sessford 2013). Uplifted marine terraces landward of the shore zone accumulate large snowdrifts during the winter. Two meltwater channels extend from above the terraces onto the relict fluvial plain that makes up the Fredheim site. Meltwater infiltration leads to active-layer interflow (Ballantyne 1978) via relict fluvial channels until it reaches the shoreline. The Nøis River flows from the Fimbulisen glacier catchment and is actively building up the Nøis River delta but not directly eroding the coast.

Kapp Laila is located on the southern shores of Isfjorden, the largest fjord in Svalbard (Fig. 1). It lies between the ghost town of Colesbukta and the active town of Barentsburg, both of which have been run by Russia for coal-mining purposes. There is no cultural heritage or infrastructure within 105 m of the cliff edge. The site is made up of two coastal cliff sections, where Cliff A (Fig. 2e) is approximately 6.5 m high and 70 m in length and, Cliff B is about 5 m high and 100 m in length (Fig. 2f). The raised beach sediments at Kapp Laila incorporate gravel, sand and silt. The majority of sediment is within the sand and gravel fraction. Vertically, both Cliffs A and B contain higher quantities of fine sands and silt in the lower regions of the cliff, than in the upper sections. Laterally, the bluff contains finer sediment towards the west and coarser materials—including boulders—to the east. There are no glaciers in the near vicinity; however, some small river channels (snow-patch and groundwater fed) flow between the cliff sections. Most of the cliff sections show evidence for solifluction and or slumping processes (Fig. 2f).

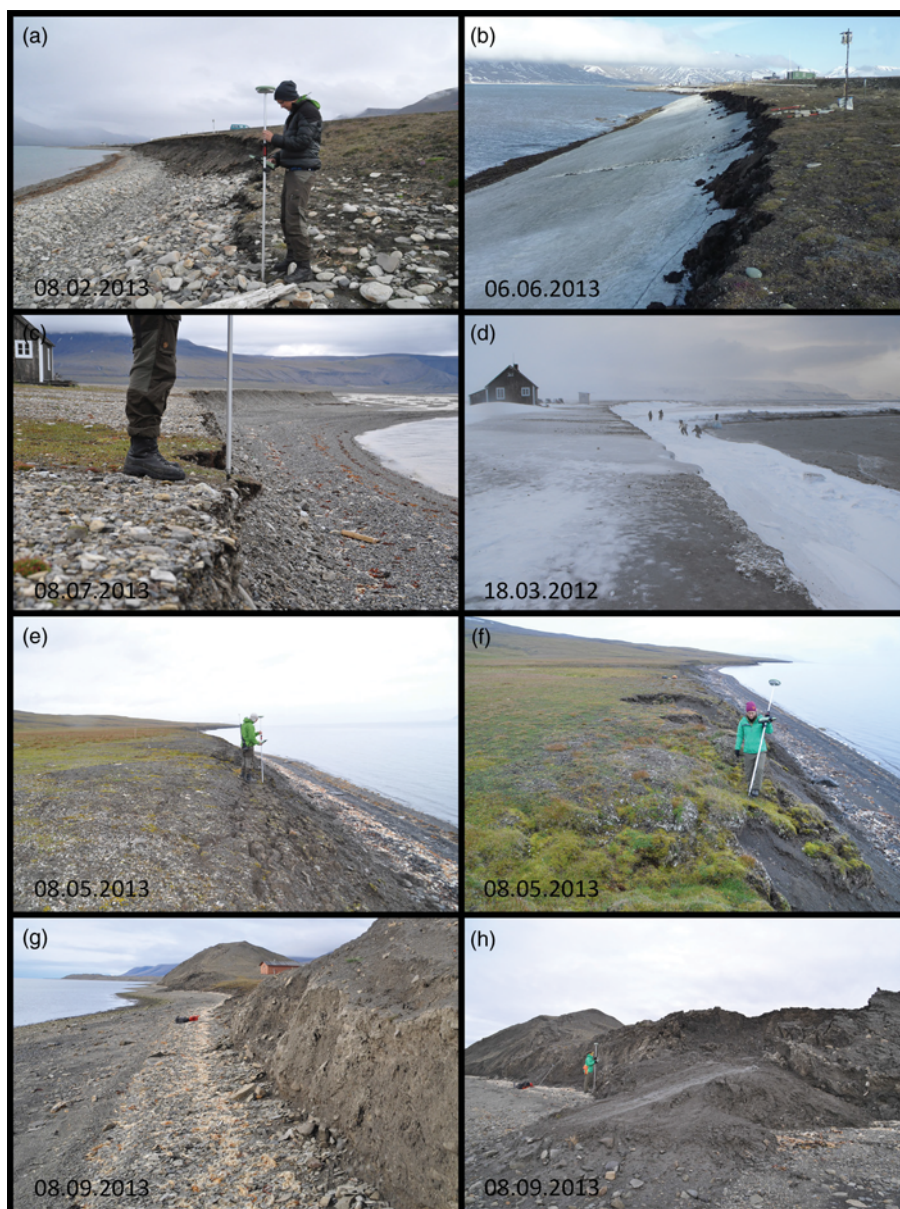
Fig. 2 Photographs from each field location showing (a, b) Vestpynten, (c, d) Fredheim, (e) Kapp Laila Cliff A, (f) Kapp Laila Cliff B and (g, h) Damesbukta. The left column of photographs shows the main cliff areas at each site and the right column of images indicates some of the terrestrial processes that affect each location: (b) large snow drifts, (d) ice foot build up and surface channel ice where active-layer interflow is present, (f) permafrost subsidence and (h) melt-out of dead ice.

The area is well protected from wave action due to the prograding Nøis River delta, leaving the longest wave fetch as 14 km from the north–east, a seldom-occurring wind direction (Eliassen 2013). Wave heights have not been measured or modelled at this site. In the winter of 2011/12, no fast ice was present at Fredheim. Recent years have shown that even if fast ice is not present in the fjord during winter months, there is still an ice foot attached to the shoreline, with snow drifts that build on top of it (Fig. 2d; Sessford et al. 2015).

water that is within the system at the end of the summer, when freezing begins. As most erosion likely takes place during melt in the spring, the water quantity of all sediments is quite possibly the same by fall. This goes for all sediments and processes similarly, except at Fredheim where erosion is thought to continue throughout the summer in those places where the relict fluvial channels are located as soil moisture at depth increases and follows these channels as active-layer interflow (Genxu et al. 2009). This may explain the cutback system seen where channels meet the erosional cliff (Figs. 2c, 4).

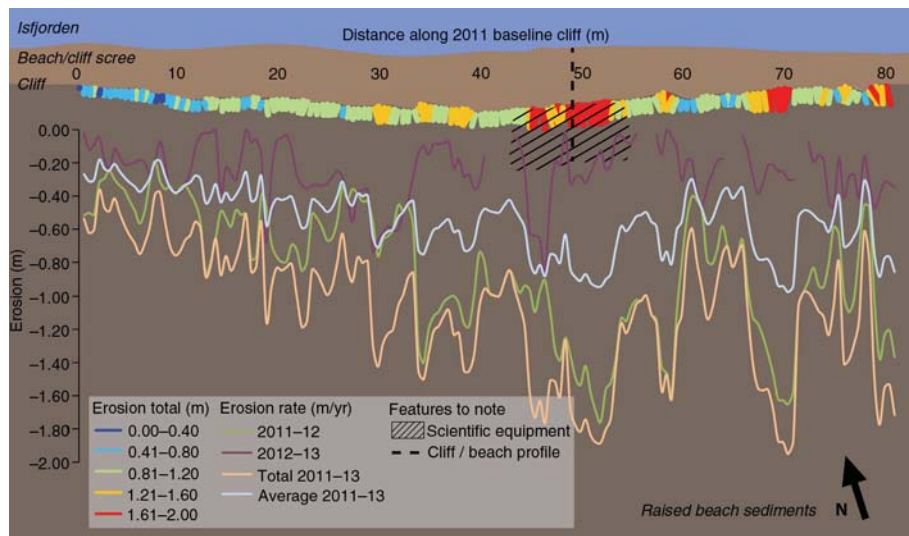
Fig. 3 Erosion measurements at Vestpynten overlying a schematic depiction of the site. The erosion total represents the real relative change on the horizontal shape of the cliff. The profile line is drawn in Fig. 8. Note that the highest rates of erosion are where scientific equipment has been installed for coastal technology research.

Infrastructure on permafrost coasts is usually considered to be the victim of coastal erosion, and not the culprit. However, construction activity itself may lead to permafrost damage and soil instability (Humlum et al. 2003). This effect may be observed at both Fredheim and Vestpynten, where human influence has drastically affected erosion rates (average of 0.58 m/yr). At Fredheim, the specific location is in reference to one of the cultural heritage buildings that used to be located nearer the coast. This building foundation was placed directly on the subsoil, allowing the building to transfer heat to the permafrost soil, and thus thawing it and changing its properties. This building has been moved back 6 m from the cliff in 2001 (Sessford 2013) because of its vulnerability to coastal erosion. The question arising is if the presence of the building itself, through thermal conduction of heat and/or disruption of hydrological cycles or the act of moving the building, affected erosion more? This cannot be answered here, but may be worth attention in future studies. At Vestpynten, there have been no buildings at the indicated location in Fig. 3; however,

drilling into the permafrost with air flushing was undertaken in April/May of 2012 at this site (Wold et al. 2012). The results, shown in Fig. 3, indicate high erosion (especially where drilling took place) for the August 2011–August 2012 year (up to -1.76 m) and relatively low erosion for the August 2012–August 2013 year. It seems likely that the drilling significantly impacted the stability of sediments; however, there is a general trend of greatly decreased rates in the 2012–13 year. Multiple studies support the warming of the ground thermal regime where drilling in permafrost takes place. Nonetheless, most suggest that it is using water to flush the hole that affects the thermal regime (Hanson & Hoelzle 2005; Ramos et al. 2009); however, these drillings were flushed with air. The impact of drilling on the surrounding sediments was not measured at the time, and external influences cannot be disregarded.

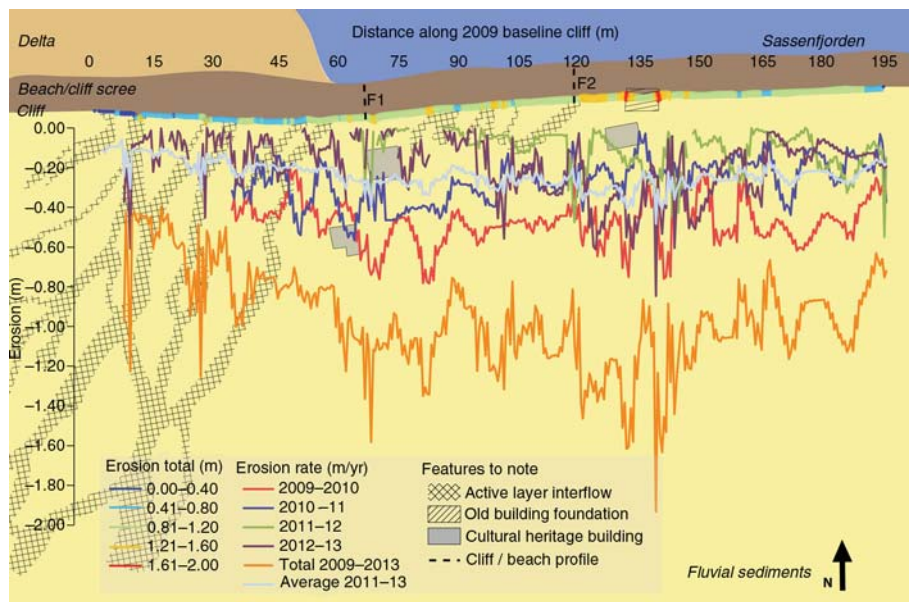
Fig. 4 Erosion measurements at Fredheim overlying a schematic depiction of the fluvial sediments and features of interest affecting erosion. Total erosion represents the actual horizontal cliff shape. Erosion rates indicate the differences between years. Note the location of the active-layer interflow via relict river channels and the old building foundation, where erosion rates appear higher. The profile lines can be viewed in Fig. 8.

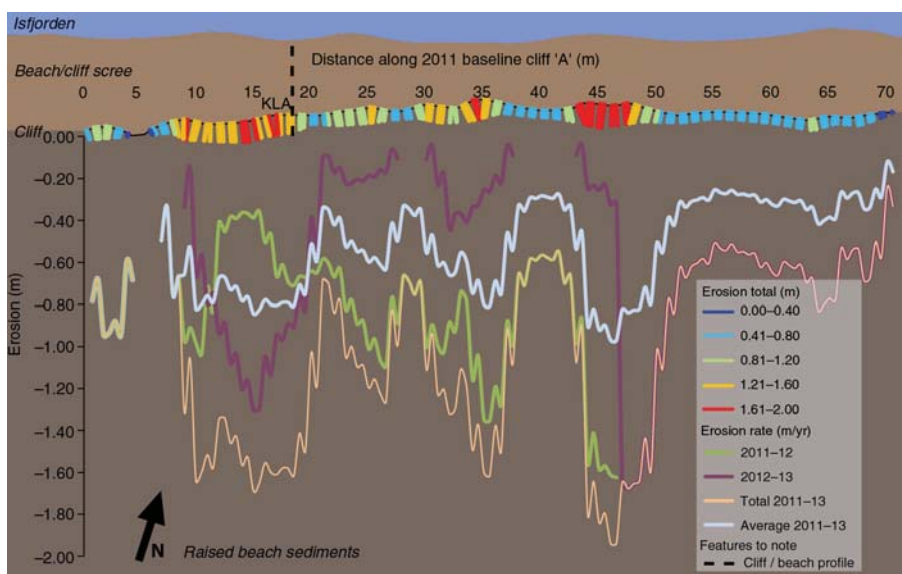
Fig. 5 Erosion measurements overlying a schematic depiction of Kapp Laila Cliff A within the raised beach sediments. The total erosion indicates the horizontal shape of the cliff retreat. The profiles can be viewed in Fig. 8.

Slumping (0.35 m/yr) was the main erosional agent at Kapp Laila Cliff B, yet it is no higher than erosion occurring just in the beach sediments in general (0.35 m/yr; Figs. 5, 6). This is likely because large slumping events which formed the back cut regions and small gullies took place before this study began (Figs. 2h, 6). However, there is slightly higher erosion at the edge of the back cut sections furthest away from the fjord (Fig. 6). There is little indication of larger ice bodies within the permafrost. It is thought that increased wind-blown snow entrainment

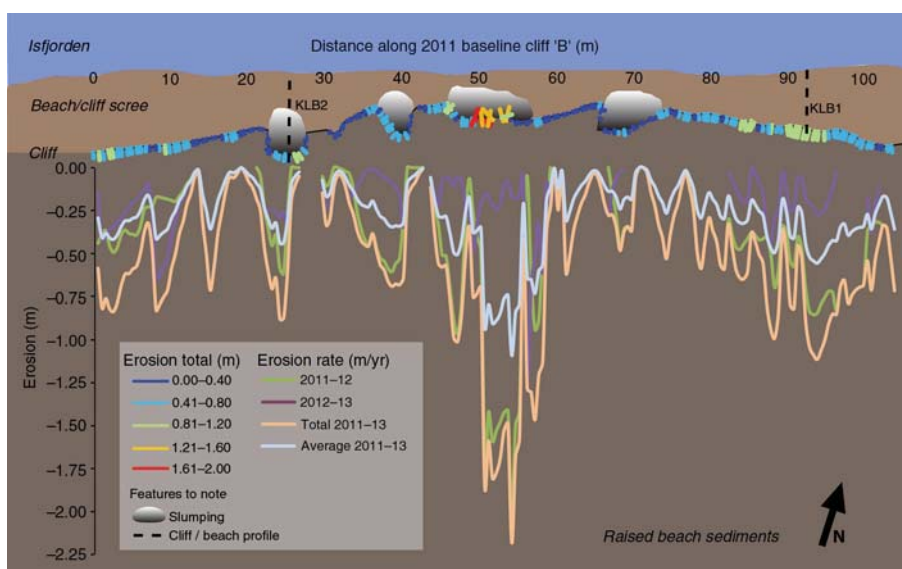
Fig. 6 Erosion measurements overlying a schematic depiction of Kapp Laila Cliff B, where the most dramatic loss in sediment occurs in conjunction with slumping. Total erosion shows the shape of the cliff horizontally. The profiles can be viewed in Fig. 8.

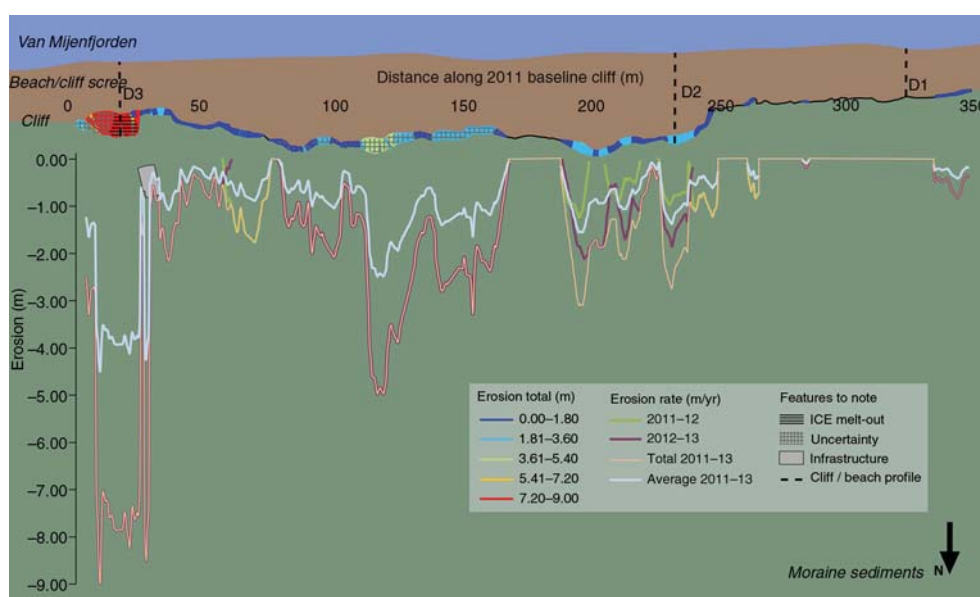
Fig. 7 Erosion measurements overlying a schematic depiction of Damesbukta in the moraine deposits, where total erosion shows the horizontal changes in cliff shape. Take note of the areas of uncertainty, where it is unknown where measurement placement followed the highest crack or most predominant cliff edge. Note the ice melt-out area, where in spring/summer of 2013 a large piece of dead ice melted out. The majority of the remaining sections are influenced by solifluction. The profiles can be viewed in Fig. 8.

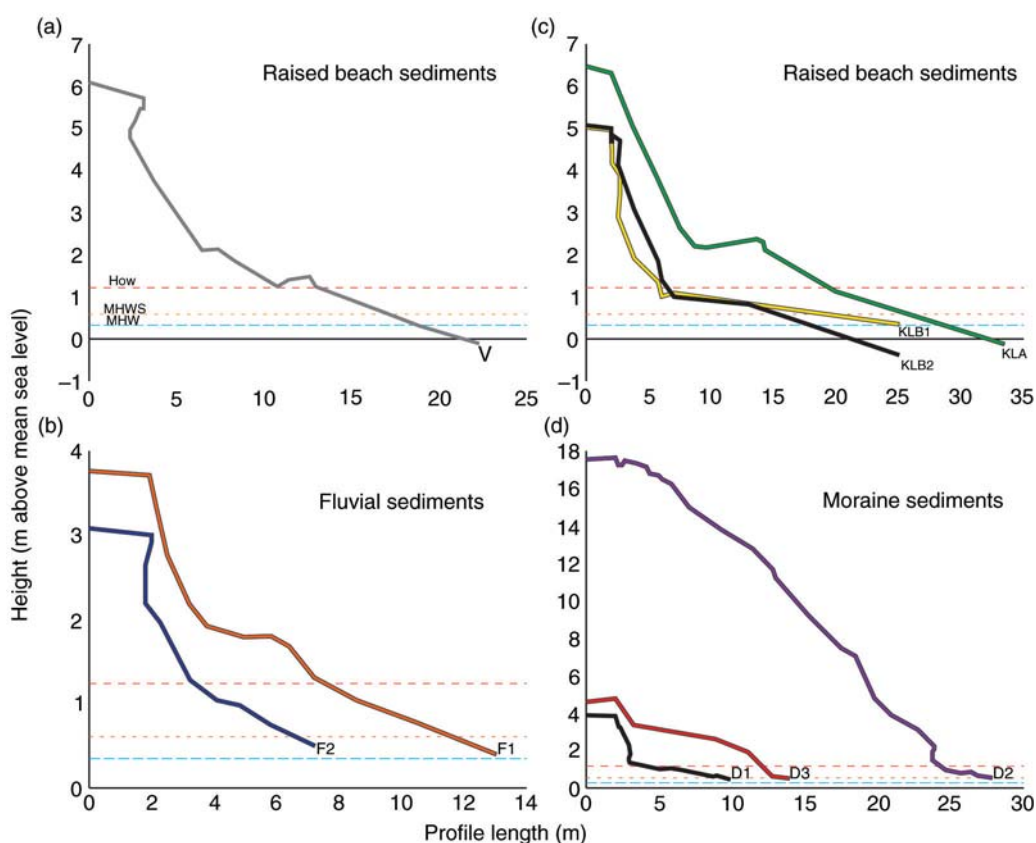
Fig. 8 Cliff/beach profiles at (a) Vestpynten, 17 August 2014, (b) Fredheim, 8 September 2014, (c) Kapp Laila, 15 September 2014 and (d) Damesbukta, 23 September 2014. The horizontal axis at zero indicates the mean sea level at Ny-Ålesund, which is 91 cm above the chart datum. Dashed lines indicate highest observed water level (HOW), mean high spring water level (MHWS) and mean high water line (MHW) at Ny-Ålesund.

Cliff and beach profiles were measured using the Emery Rod method. The time at which the waterline was measured was noted during fieldwork so as to calculate the correct elevations above mean sea level, as delineated by the Ny-Ålesund tidal charts (Norwegian Mapping Authority 2014). Ny-Ålesund was used as a reference for profiles as it is currently the only location on Svalbard that has a continuous record of tidal fluctuations. Ny-Ålesund has a mean water level of 91 cm, mean high water level of 137 cm and mean spring high tide of 154 cm above the chart datum. The highest observed tide
