# Non-destructive wafer-level bond defect identification by Scanning Acoustic Microscopy

S. Brand, S. Tismer, S.T. Moe, K. Schjøllberg-Henriksen

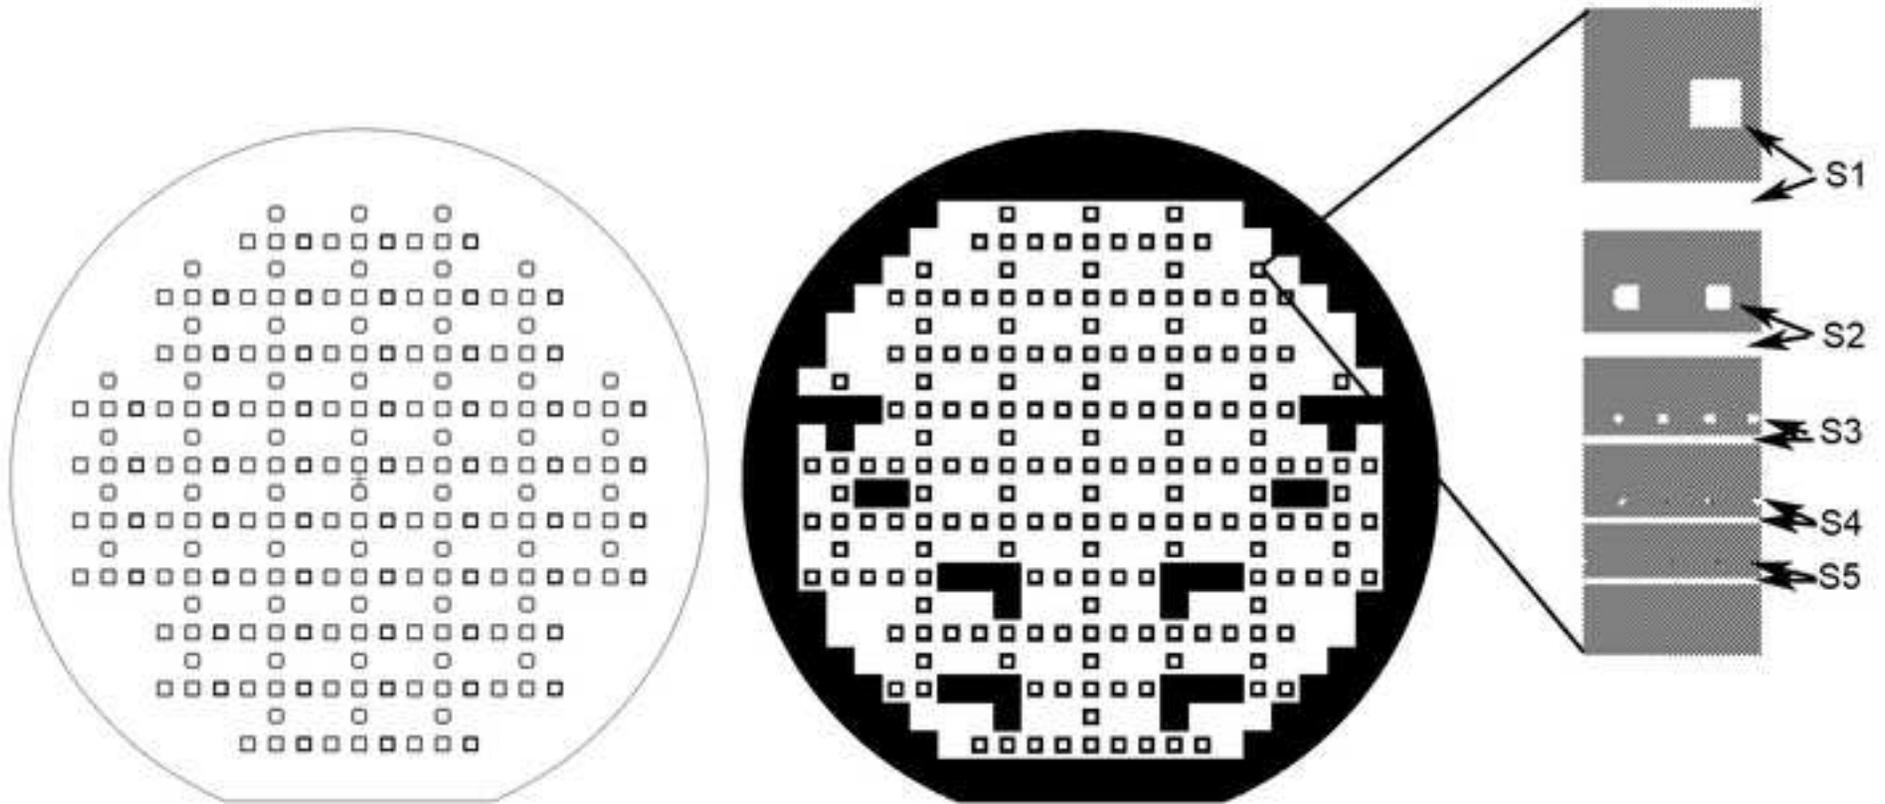
Figure 01  
[Click here to download high resolution image](#)

Figure 1: Top view of the protruding frames on the top wafer (left) and the bond metal pattern on the bottom wafer (right). The inset to the right shows the intentional metal defects in the bond metal. The wafers are bonded in areas where the protruding frames and the bond metal are both present.

After sputtering, the metal of the bottom wafer was patterned, defining bond areas with intentional line and point defects of five different defect sizes S1 – S5 ranging from 3.6 – 56.2 μm. Line defects and square point defects of all five sizes were made. The resulting sizes of the defects S1 – S5 on the Au and Al wafer were measured by scanning electron microscopy prior to bonding, and are listed in Table 2. Figure 1 shows the bond areas of the top and bottom wafers and the intentional defects. Figure 2 shows a schematic top view and cross-section of a bonded die with intentional defects.

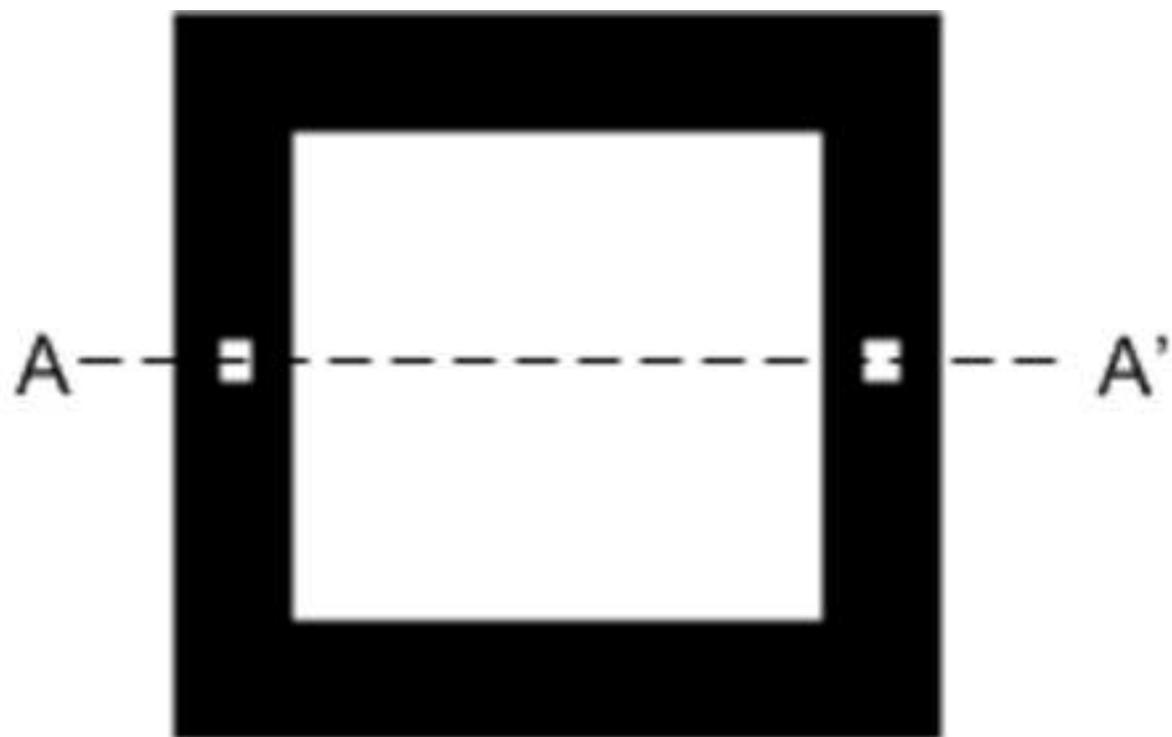
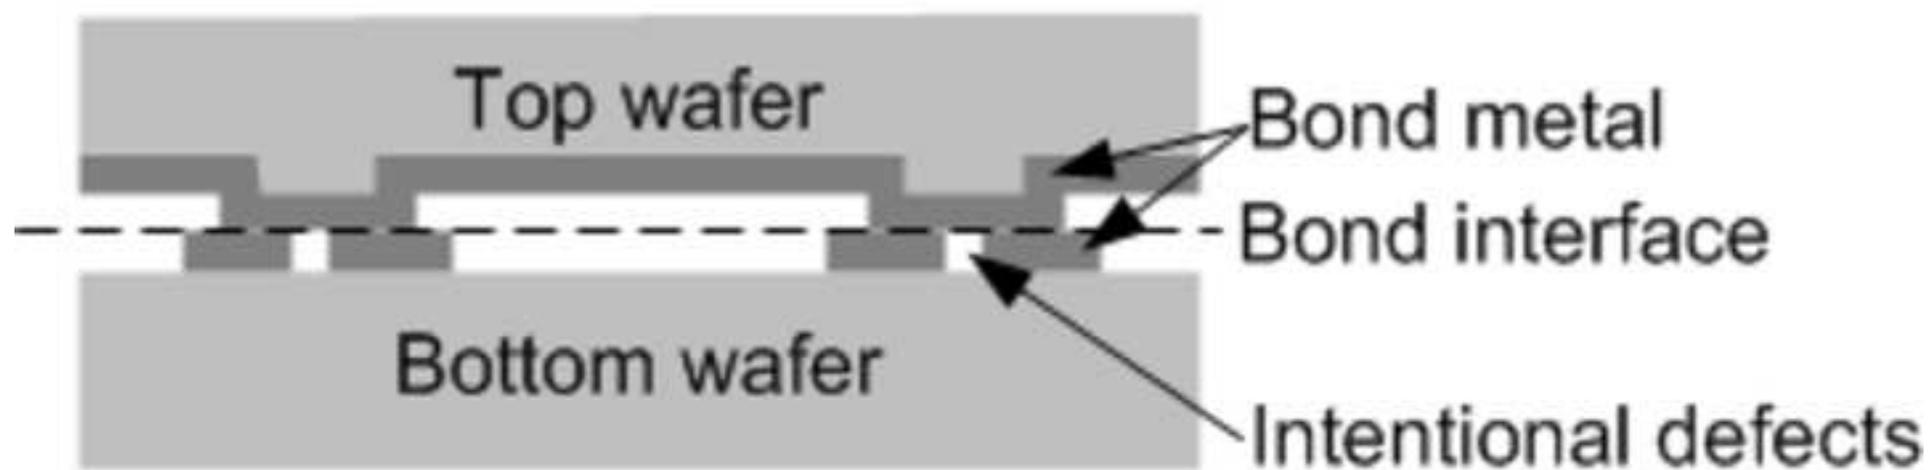
Figure 02

Figure 2: Schematic top view and cross-section along A-A' of a bonded frame die with intentional defects.

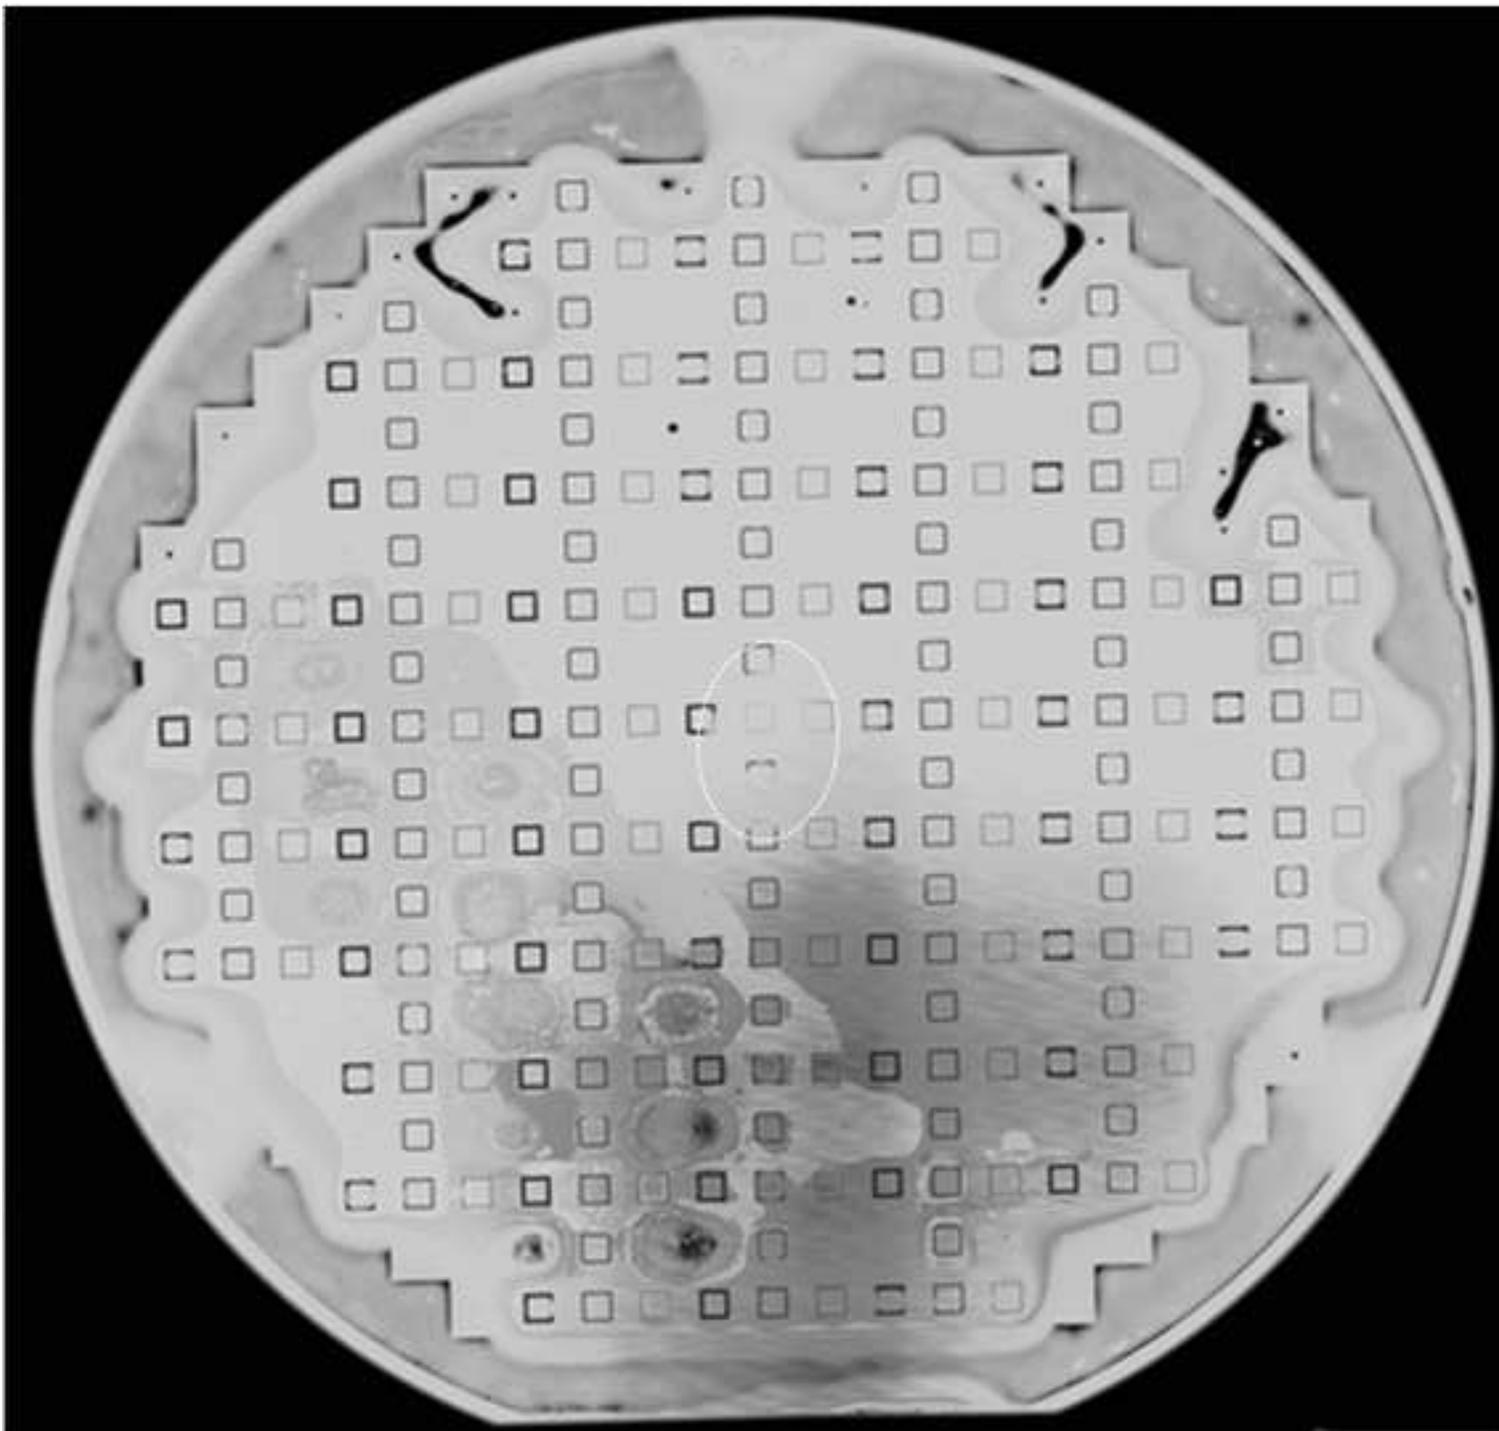
Figure 03  
[Click here to download high resolution image](#)

Figure 3: Acoustic micrograph of the entire Al-Al laminate, inspected at 175 MHz with a transducer with 8 mm focal length, applying 48 dB pre-amplification. The SAM was performed through 700  $\mu\text{m}$  thick silicon material. The white ellipse indicates an area of approximately 5 poorly bonded dies in the center of the laminate.

Figure 3 and Figure 4 show SAM overview images of the entire Al-Al laminate and the Au-Au laminate. The imaging contrast was higher for the Al-Al laminate (Figure 3) than for the Au-Au laminate (Figure 4). The internal pre-amplification was reduced from 48 dB for the Al-Al laminate to 42 dB for the Au-Au laminate in order to improve the visibility of the smaller delamination defects. The acoustic micrographs of the entire laminates identified areas with potentially poorly bonded areas in the center of the Al-Al laminate, as shown in Figure 3.

The acoustical overview image shown in Figure 3 enabled the detection of approximately 5 chips with poor metal thermocompression bonding in the center of the laminate. The poorly bonded area in the center of the Al-Al laminate was discernible by SAM prior to device dicing, when the poorly bonded chips delaminated. No such areas of poor metal bonding were seen in the acoustic micrograph the Au-Au laminate (Figure 4), and no large areas with delaminated chips occurred during dicing, suggesting that thermocompression bonds that were too weak to withstand dicing could be identified by SAM.

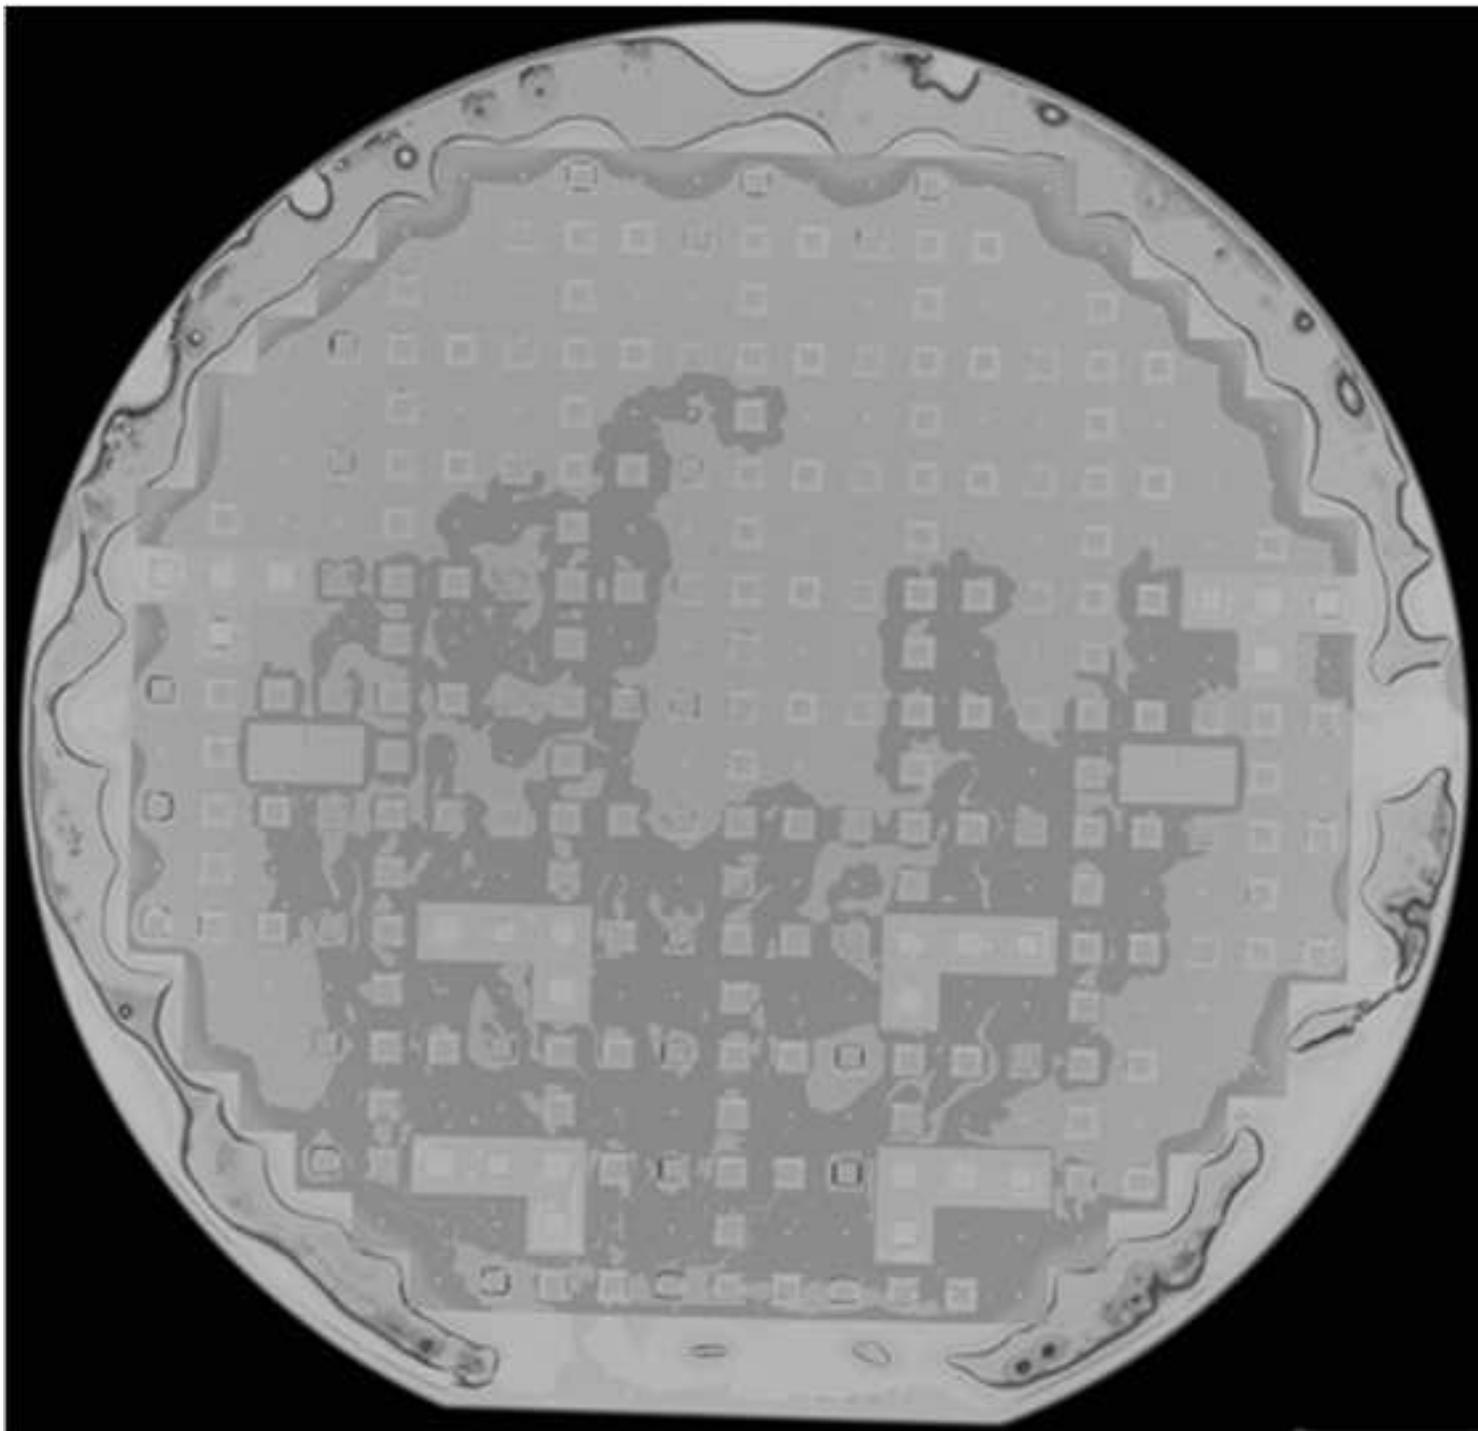
Figure 04  
[Click here to download high resolution image](#)

Figure 4: Acoustic micrograph of the entire Au-Au laminate, inspected at 175 MHz with a transducer with 8 mm focal length, applying 42 dB pre-amplification. The SAM was performed through 700  $\mu\text{m}$  thick silicon material.

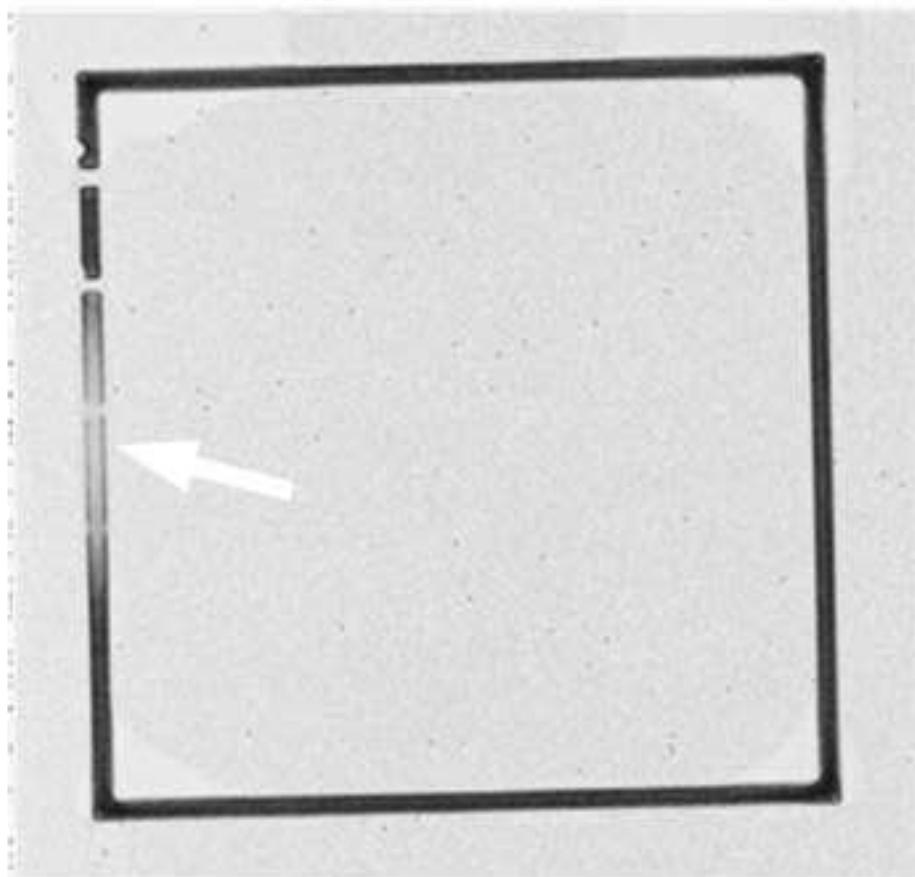
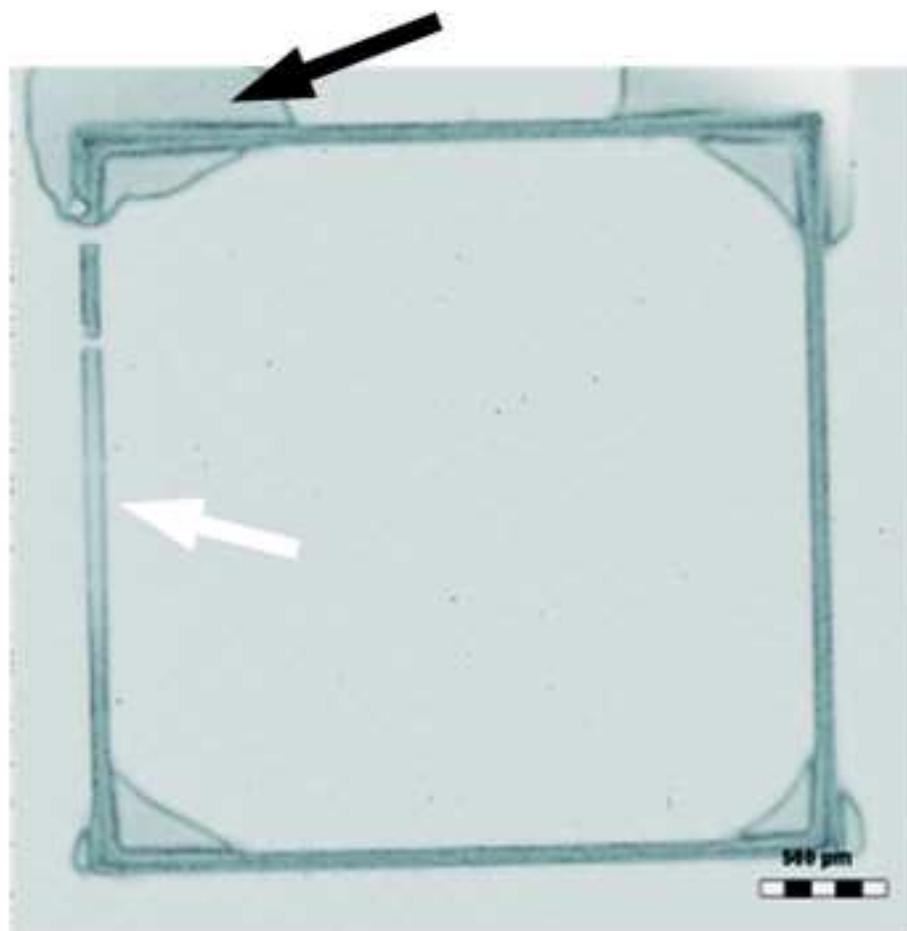
Figure 05  
[Click here to download high resolution image](#)

Figure 5: Acoustic micrographs of chip No 17 of type F100 from the Al-Al laminate, inspected at 175 MHz frequency applying 8 mm focal length, 48 dB pre-amplification and 7.4  $\mu\text{m}$  scan increment. Left: conventional SAM imaging. Right: after transferring the time-domain signals into the spectral domain. The white arrows indicate poor bonding and possible leak in an area of the bonded frame. The black arrow indicates possible trapped air.

Figures 5 – 8 show acoustic detail micrographs of chips from the Al-Al laminate. Figure 5 indicates the improved imaging resolution achieved by the split-spectrum analysis. Figure 6 also shows the results of the narrow-band spectral imaging and allows the identification of the intentionally introduced bonding line defects of 3.6  $\mu\text{m}$  width. The line defects of widths 4.5, 7.2, 22.4, and 52.3  $\mu\text{m}$  can also clearly be seen, as well as the point defects of 22.4  $\mu\text{m}$  and 52.3  $\mu\text{m}$ . In Figures 7 and 8, a varying imaging contrast can be identified in the bond frames, indicating a change in acoustic reflectivity which is likely to be related to the condition of the bond seal. Figures 9 – 10 contain acoustic detail micrographs of two selected chips from the Au-Au laminate sample. While Figure 9 shows a chip with a well bonded frame, Figure 10 displays a chip with several poorly bonded areas in the bond frame.

The acoustic micrographs in Figure 5 – Figure 10 show that line defects as narrow as 3.6  $\mu\text{m}$  could be detected by SAM supplemented by appropriate signal processing, and that point

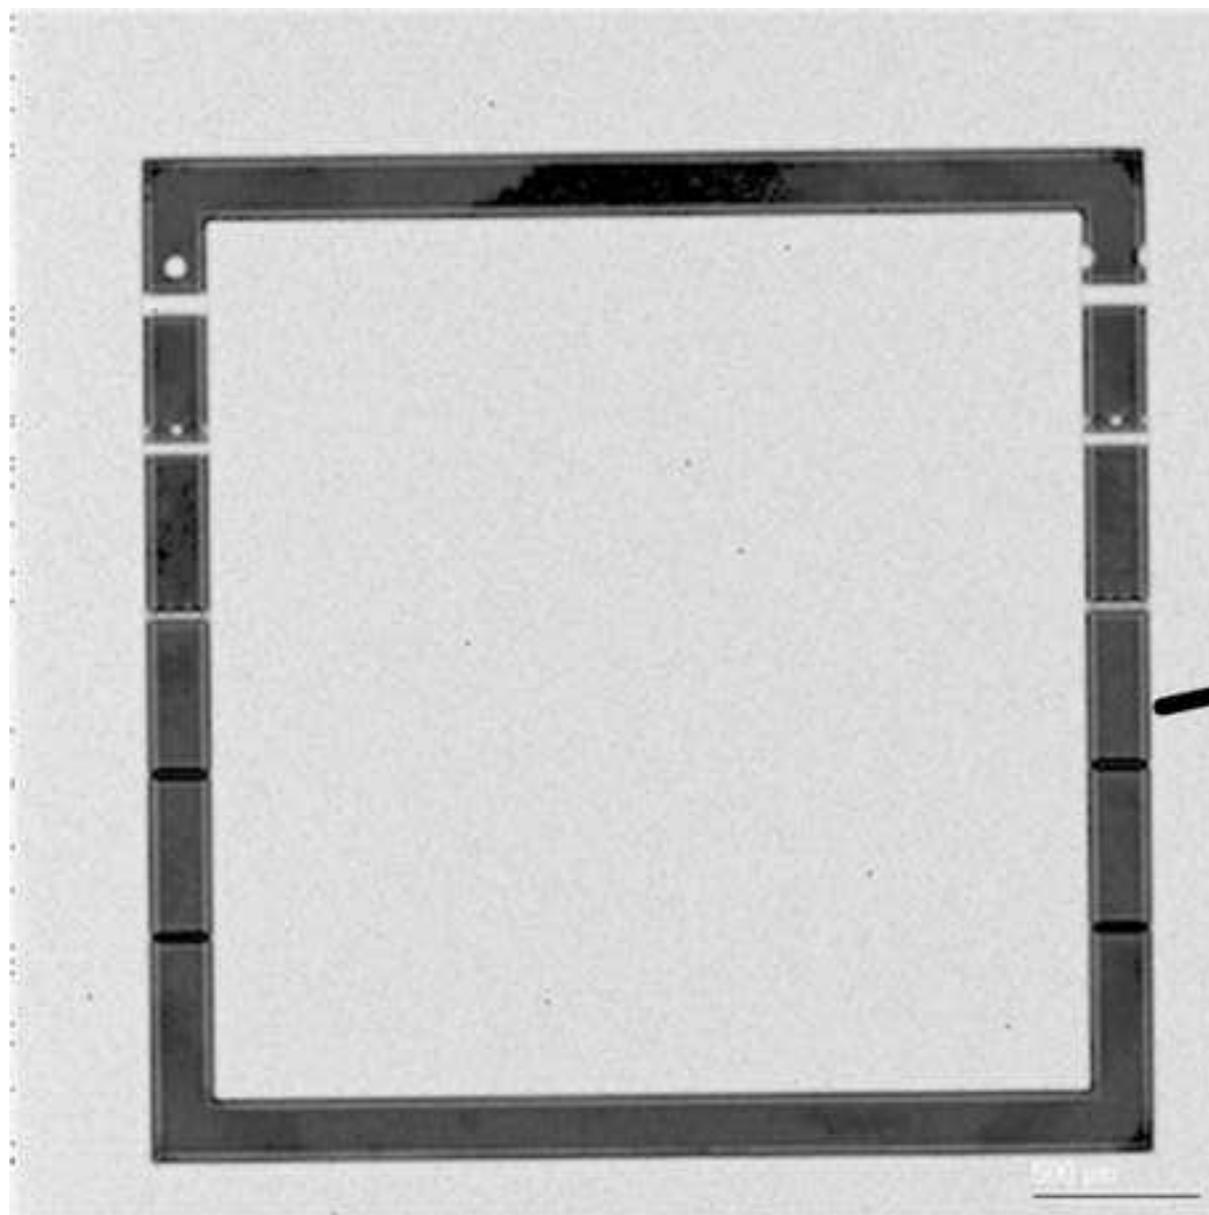
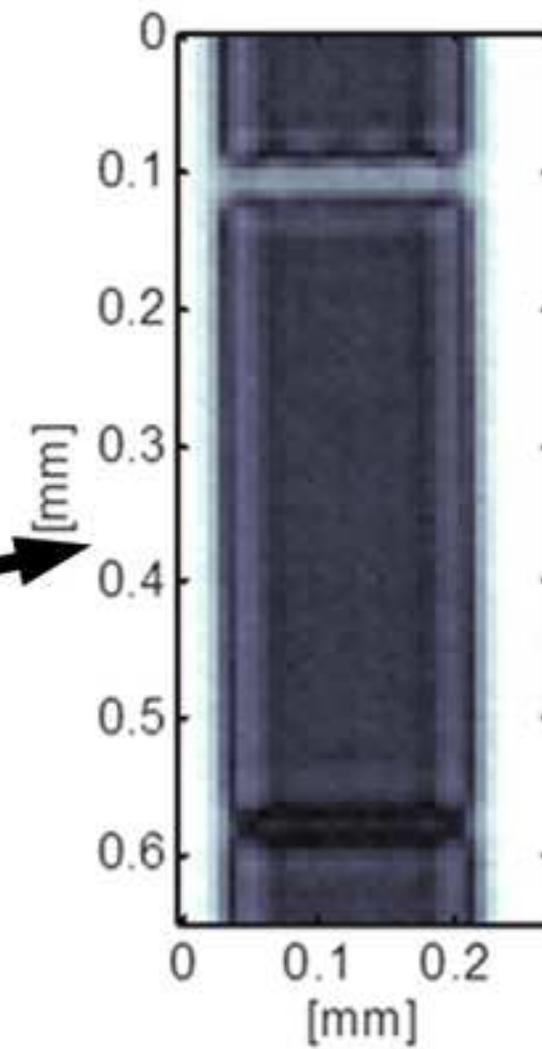
Figure 06  
[Click here to download high resolution image](#)

Figure 6: Acoustic micrograph of chip of type F200 from the Al-Al laminate, inspected through 400  $\mu\text{m}$  thick silicon material at 175 MHz frequency applying 4 mm focal length, 33 dB pre-amplification and 7.2  $\mu\text{m}$  scan increment. All line defects, including those of width 3.6  $\mu\text{m}$  are seen, in addition to individual point defects of side edge 22.4 and 52.3  $\mu\text{m}$ .

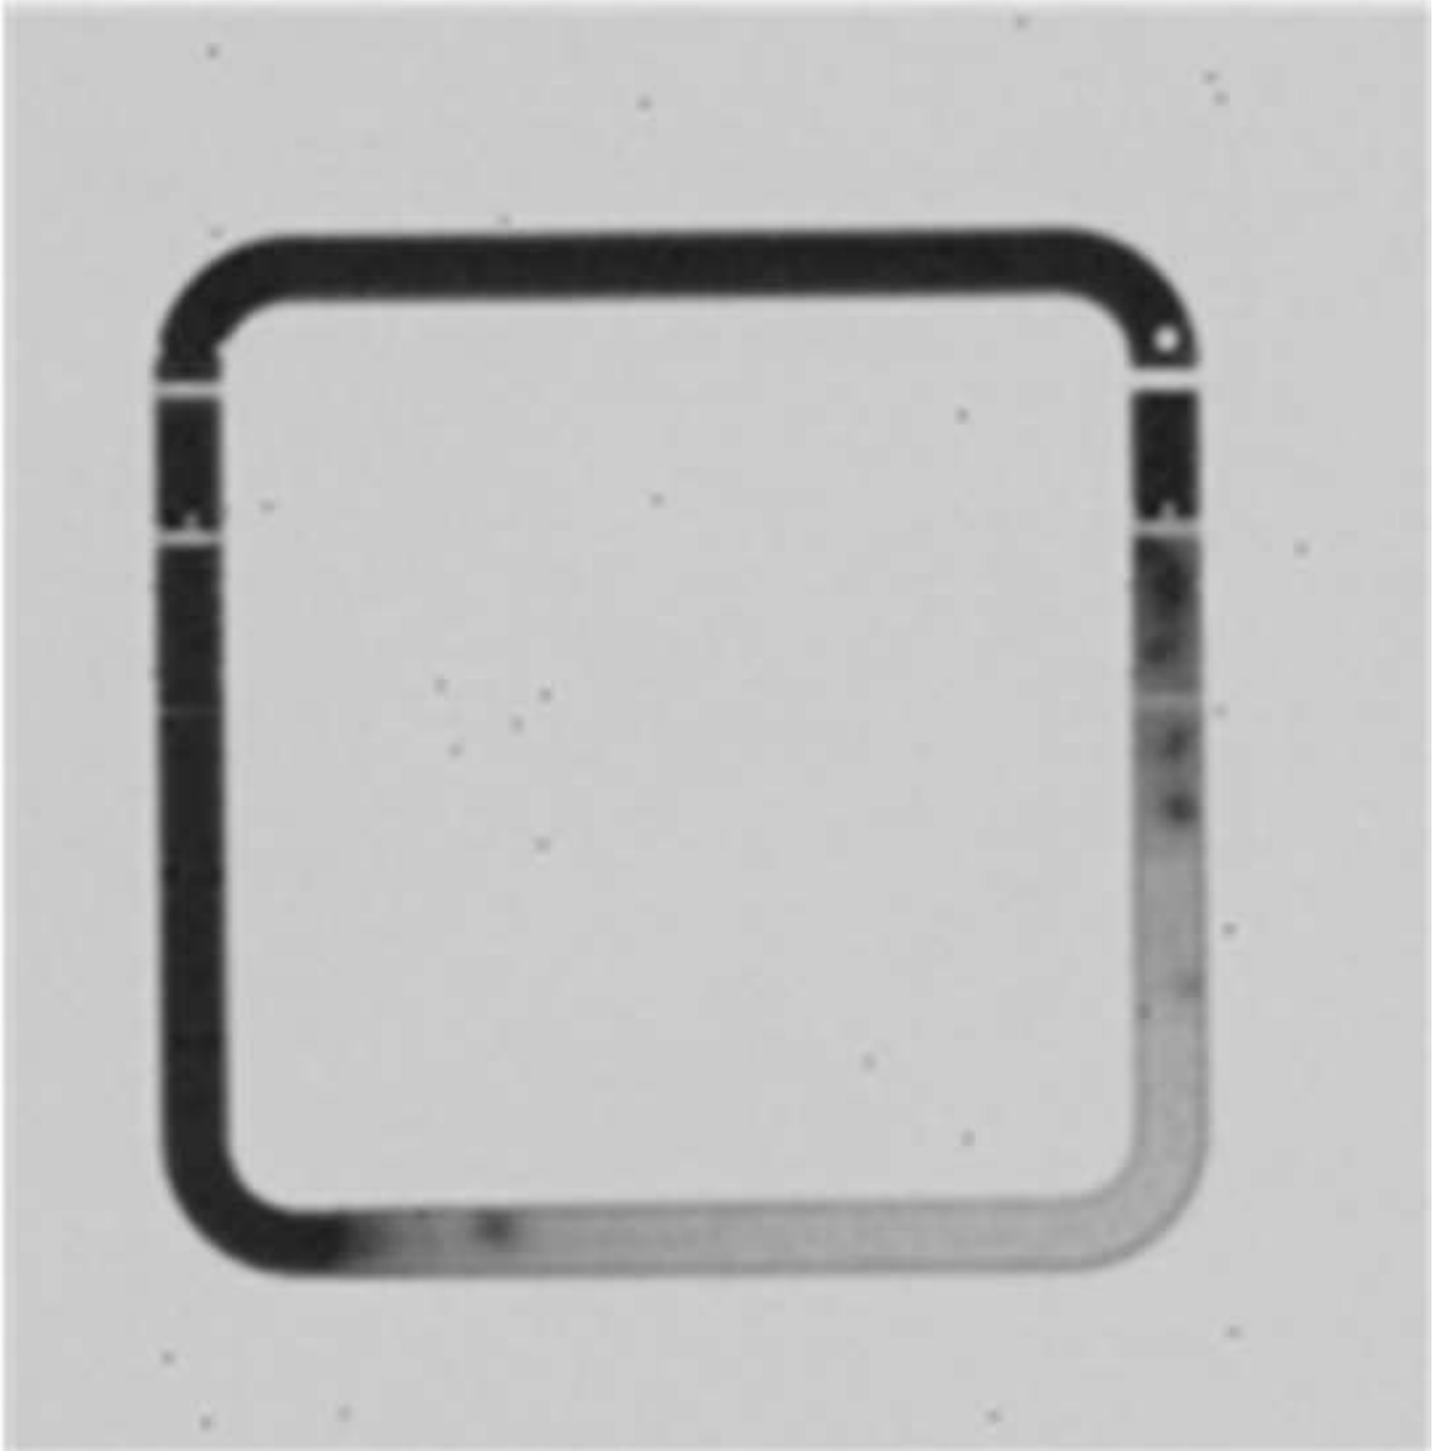
Figure 07

Figure 7: Acoustic micrograph of chip No 146 of type F200R from the Al-Al laminate, showing that approximately 40% of the frame was poorly bonded.

2012; Malik *et al.* 2013). The large standard deviations of the fracture force distributions imply that no clear conclusion can be made regarding which of the two investigated bonding metals that resulted in the highest strength. However, a high bond strength value does not necessarily mean that a tight seal has been formed along the length of the entire bond frame. For instance chip No 17 in Figure 4 clearly showed areas that were not bonded at all, but still had a fracture force of 39.3 N (33.9 MPa).

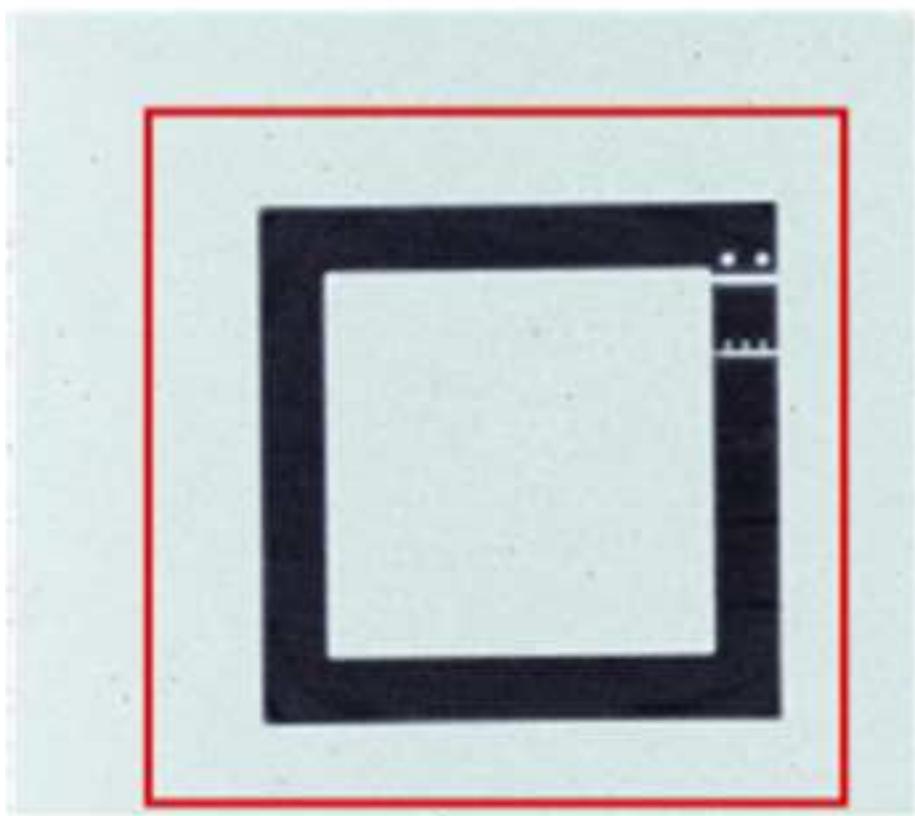
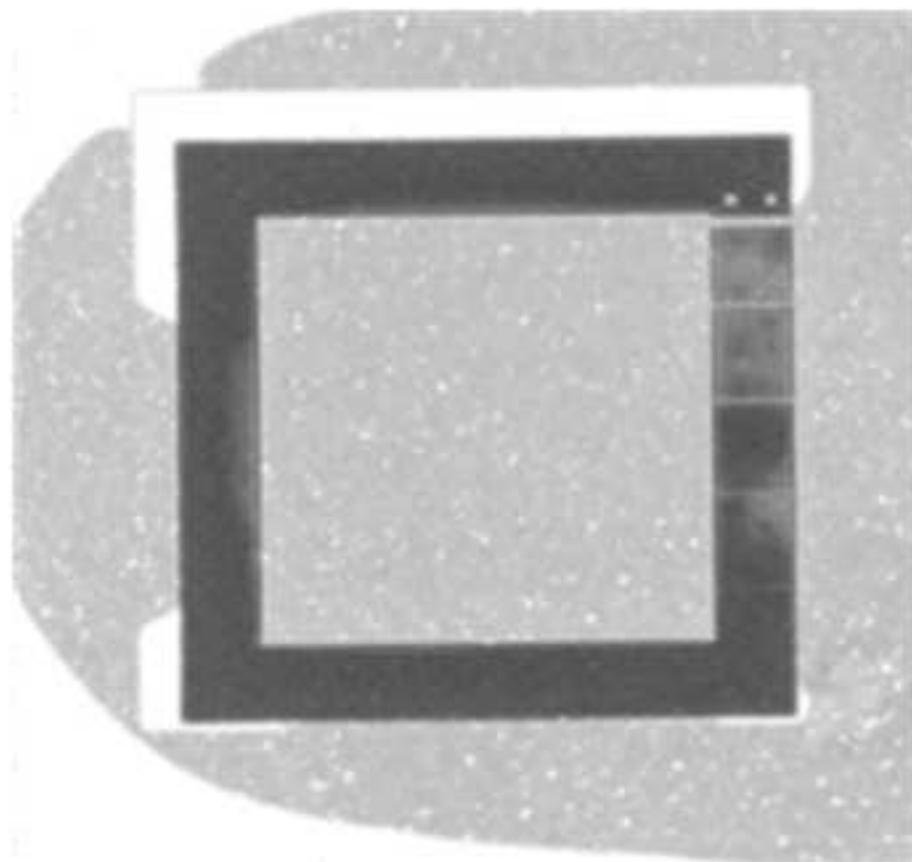
Figure 08  
[Click here to download high resolution image](#)

Figure 8: Acoustic micrographs acquired through 700  $\mu\text{m}$  silicon material at 175 MHz with 8 mm focal length. Left image: Acoustic micrographs of chip No 54 of type F400 from the Al-Al laminate. Line and point defects of size 22.4 and 52.3  $\mu\text{m}$  are clearly seen. There is no indication of poorly bonded areas. Right image: Acoustic micrograph of chip No 21 of type F400 from the Al-Al laminate. All line defects are seen, as well as point defects of size 52.3

$\mu\text{m}$ . There may be some indication of poorly bonded areas between defects S3 – S5 and around defects of size S2.

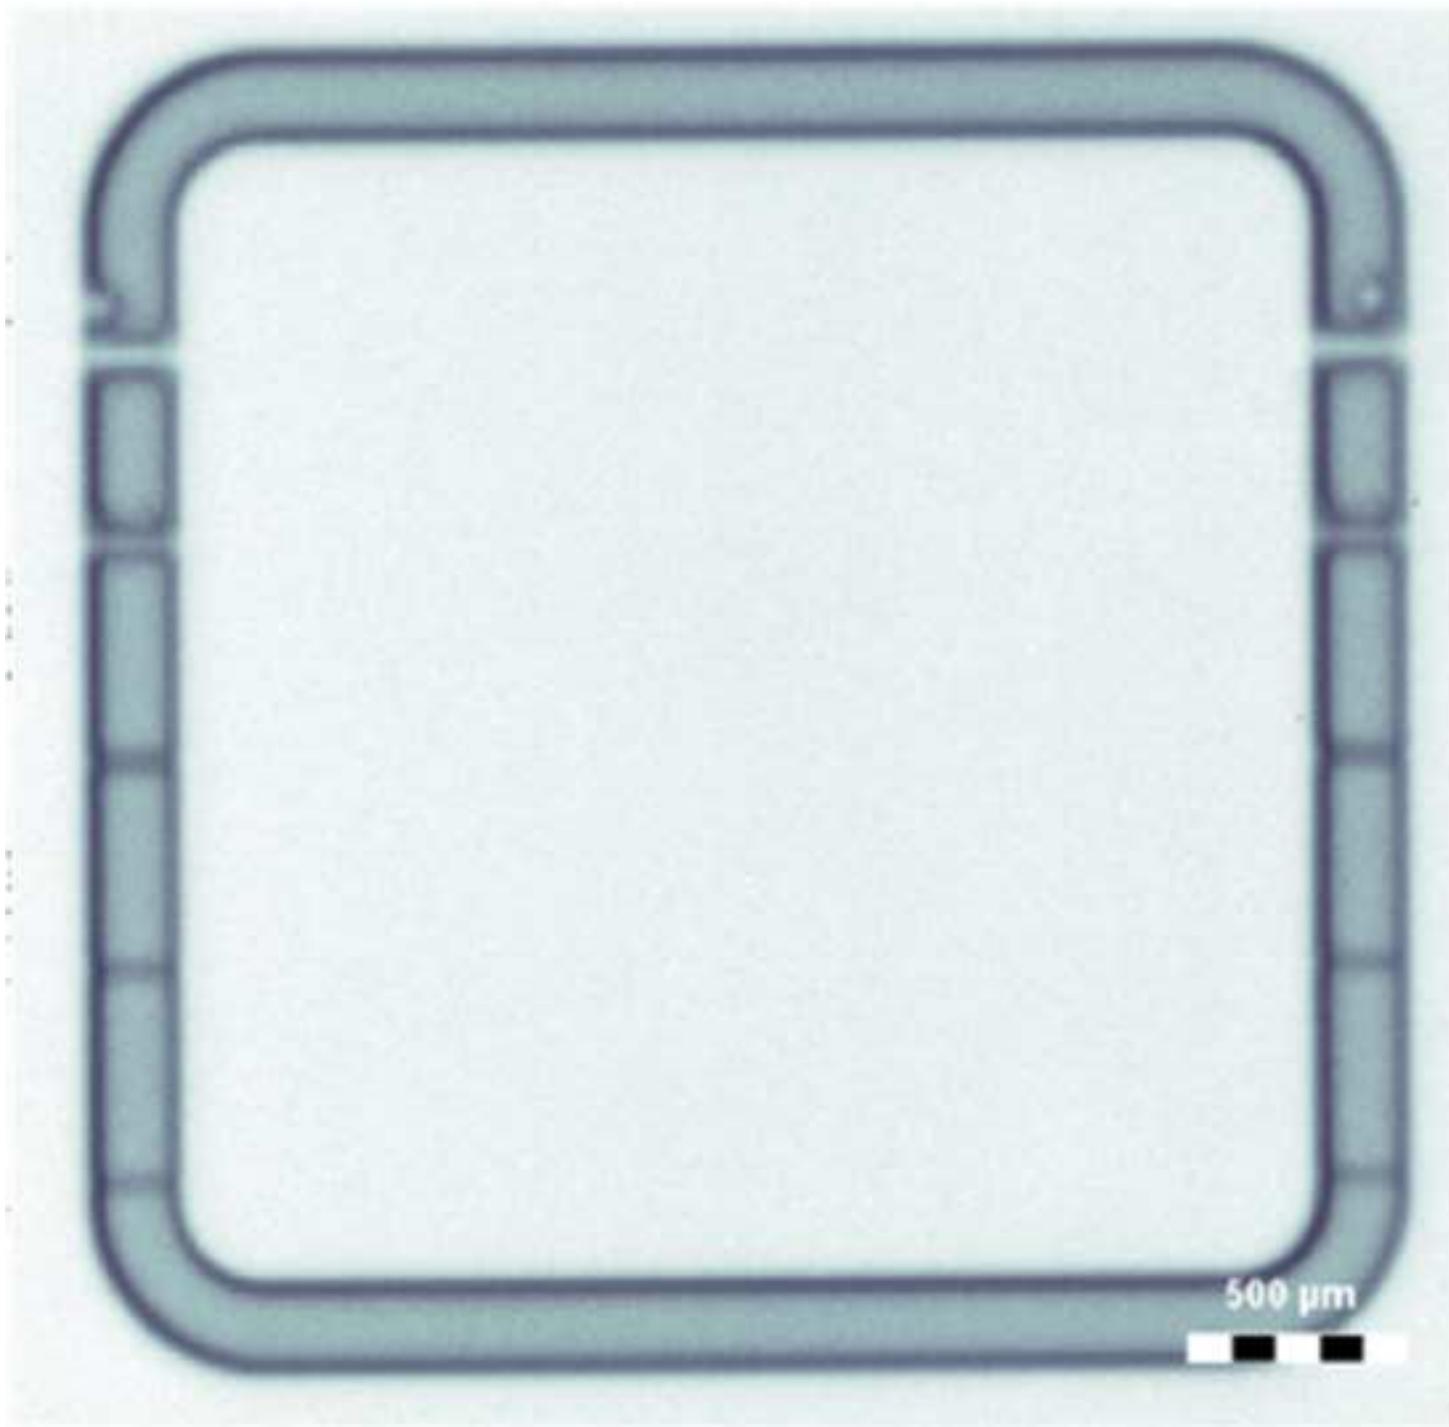
Figure 09

Figure 9: Acoustic micrograph of chip No 31 of type F200R from the Au-Au laminate obtained through 700  $\mu\text{m}$  silicon material at 175 MHz with 8 mm focal length. All line defects and point defects of size 56.2  $\mu\text{m}$  can be seen. There is no indication of poorly bonded areas.

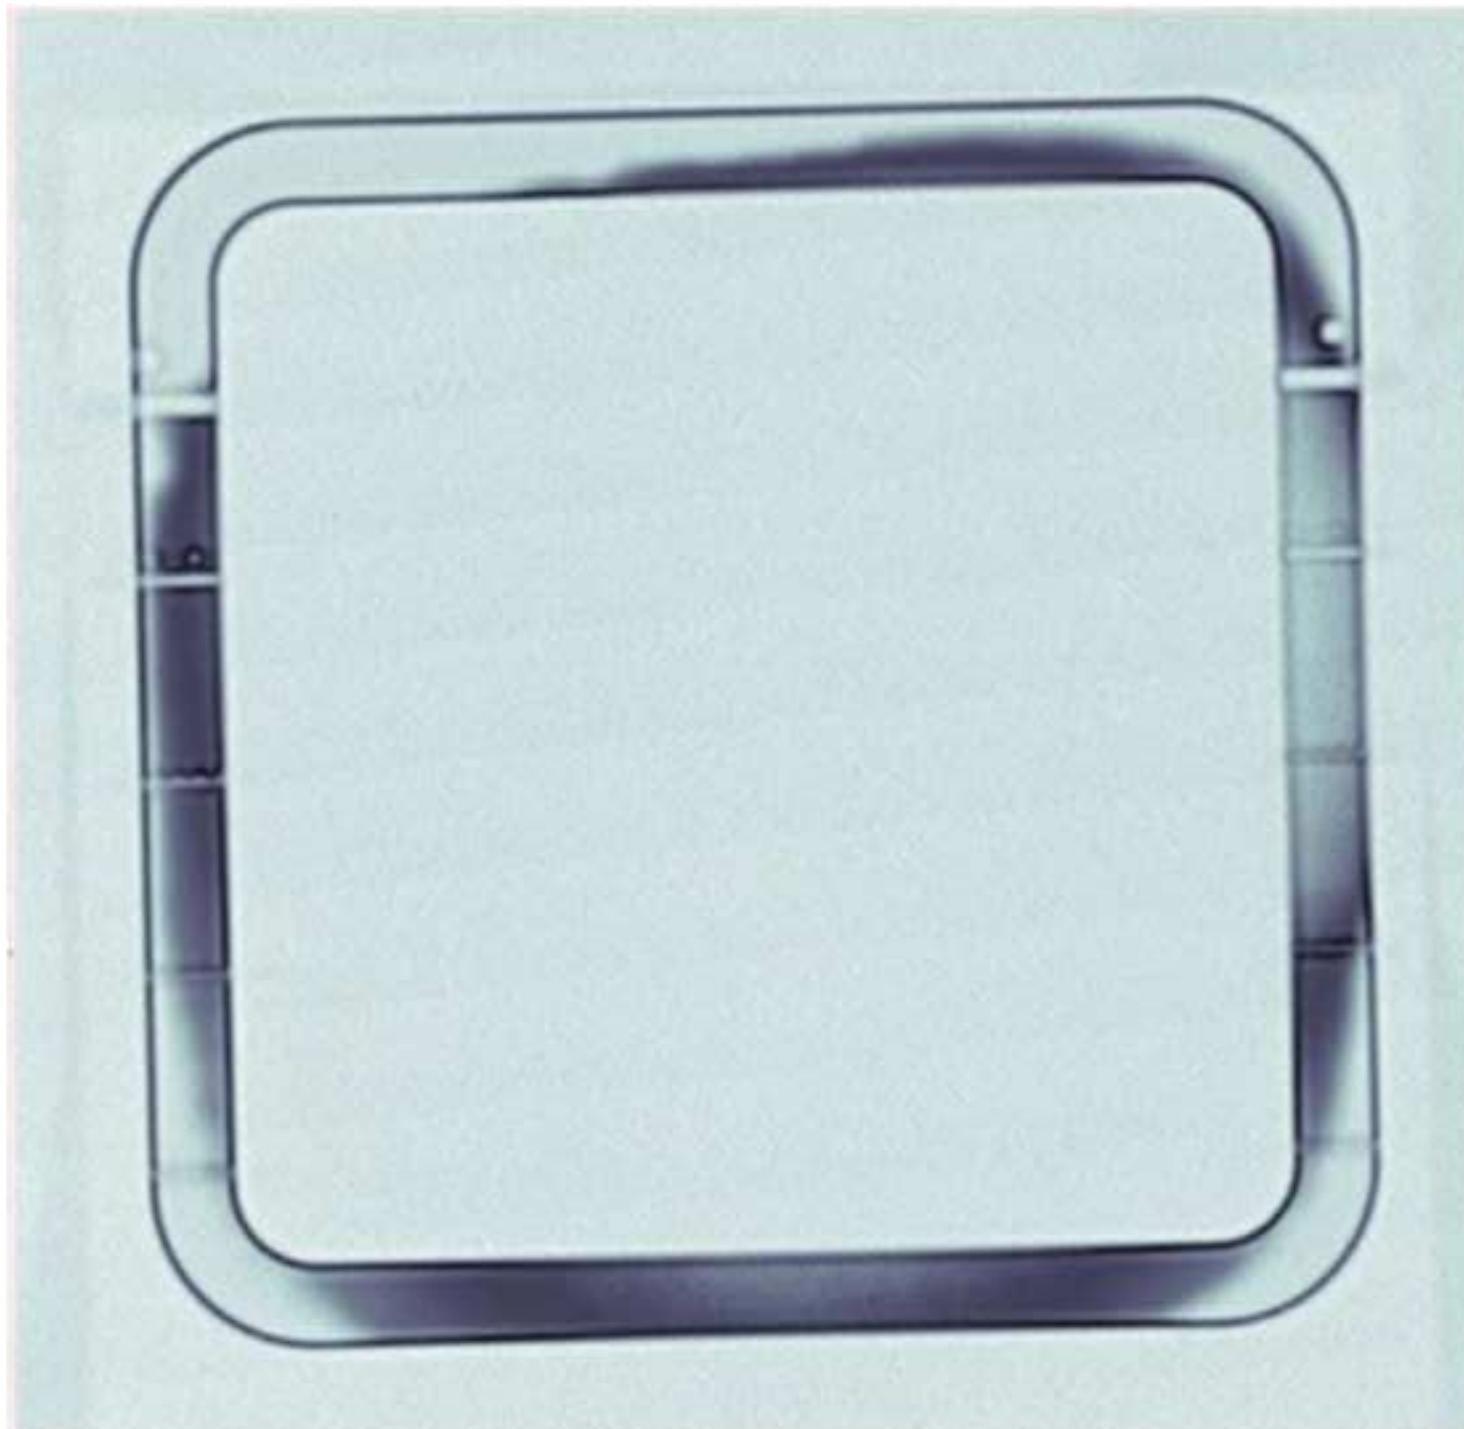
Figure 10

Figure 10: Acoustic micrograph of chip 6 of type F200R from the Au-Au laminate scanned through 400  $\mu\text{m}$  silicon material. All line defect sizes and point defects of sizes 25.3 and 56.2  $\mu\text{m}$  can be seen. The chip seems to have poorly bonded areas on each of the four edges.
