# Non-destructive wafer-level bond defect identification by Scanning Acoustic Microscopy

S. Brand, S. Tismer, S.T. Moe, K. Schjøllberg-Henriksen

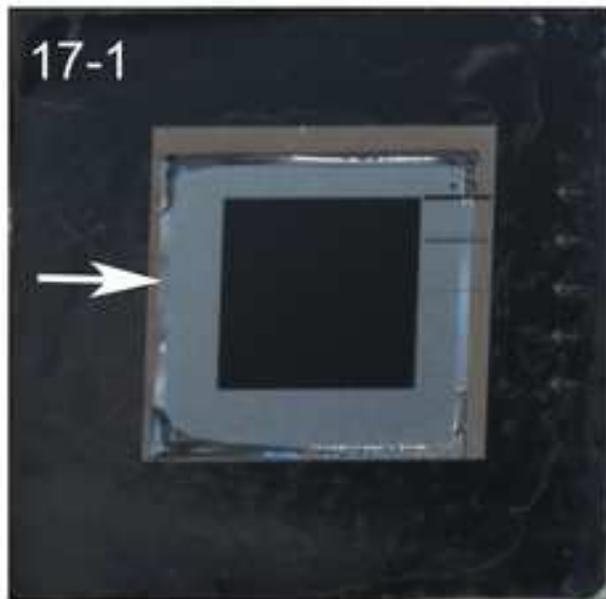
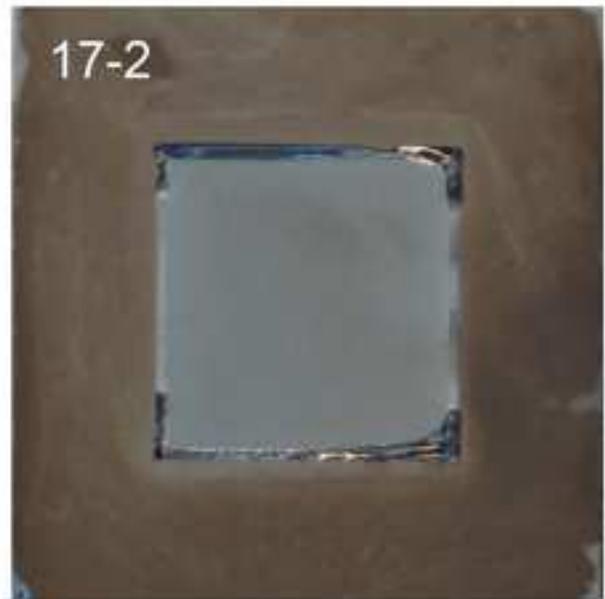
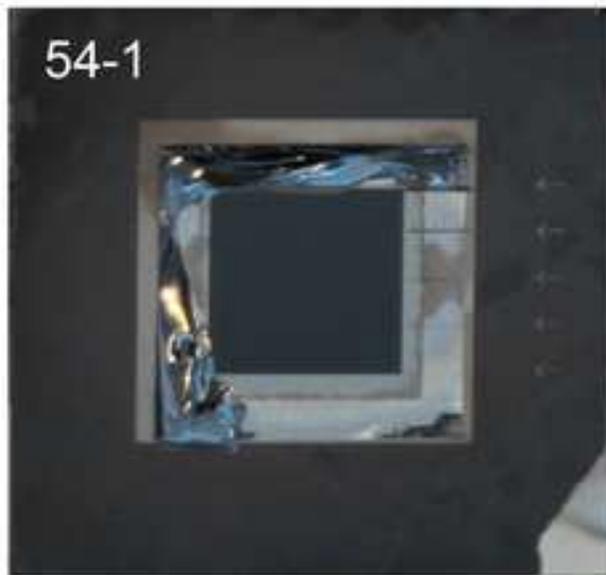
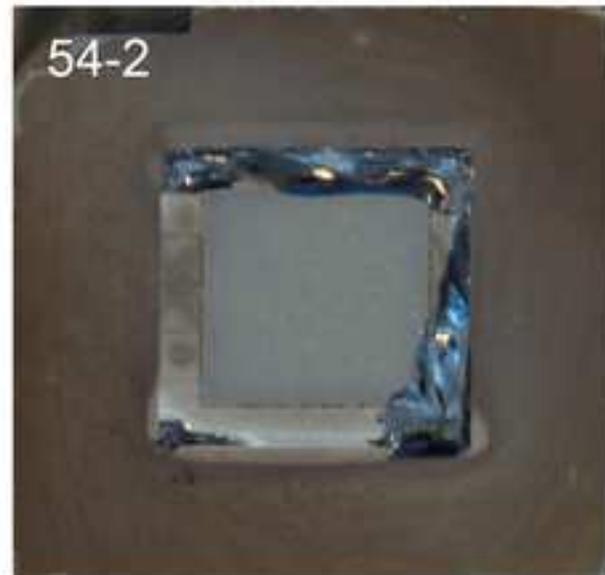
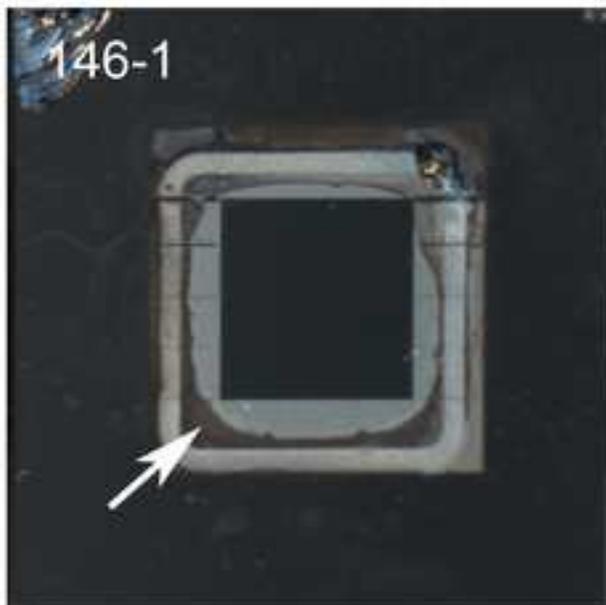
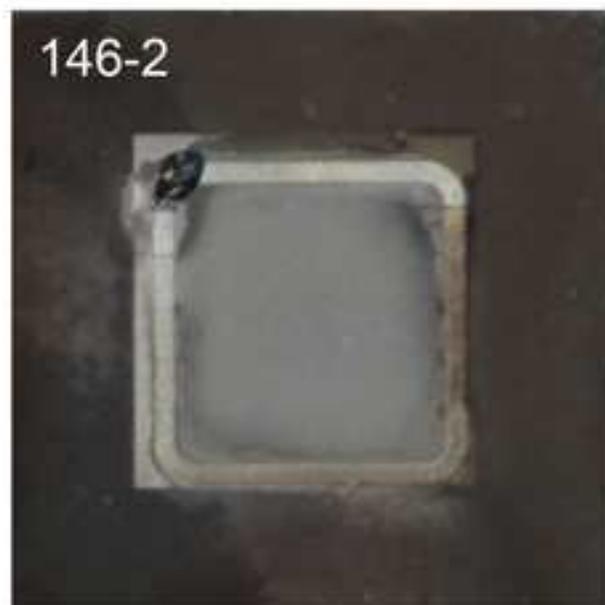
Figure 11  
[Click here to download high resolution image](#)

Figure 11: Fracture surfaces of chips 17 (type F100), 54 (type F400), and 146 (type F200R) from the Al-Al laminate. Both fracture surfaces are shown. The arrow in chip No 17-1 points to an area where the Al bond frame had a deviating color. The arrow in chip No 146-1 indicates an area where the enclosed silicon surface had a deviating color.

Inspection of the fracture surfaces after pull testing of chips bonded by Al-Al thermocompression bonding showed that all chips except chip 208 had cohesive fracture in both the silicon and the aluminum seal. Chip 208, of design F100, showed cohesive fracture in the aluminum only. For the other chips, the amount of cohesive silicon fracture ranged from less than 2% to 80%. The three chips with a fracture force below 5 N all had less than 2% cohesive silicon fracture. Figure 11 shows optical micrographs of fracture surfaces of chips from the Al-Al laminate. The chips in Figure 11 are the same chips as in the acoustic micrographs in Figures 5, 7, and 8.

In some of the fractured samples, the bonding Al had a deviating color in a part of the bonded frame. Chip 17 in Figure 11 is one example. The areas of the bonding Al with deviating color are thought to mark drying stains in areas of the bond frames, i.e. indications of water leaking across the bond frame, and hence, a poor seal. This assumption is supported by the acoustic micrograph of the same chip (Figure 5), which does indicate a poor bond in that particular area. In other samples, like chip 146 (Figure 11), a deviating color was observed on the silicon surface near the corners of the bond frame. The scanning acoustic micrographs (see Figure 5) also showed that the area near the corners of the bond frame seem to be different. It is assumed that during SAM, the areas near the corners of the bond frames were showed air bubbles caused by incomplete filling of coupling medium in the volumes enclosed by the frames. These areas are thought to be visible in the fracture surfaces due to drying stains.

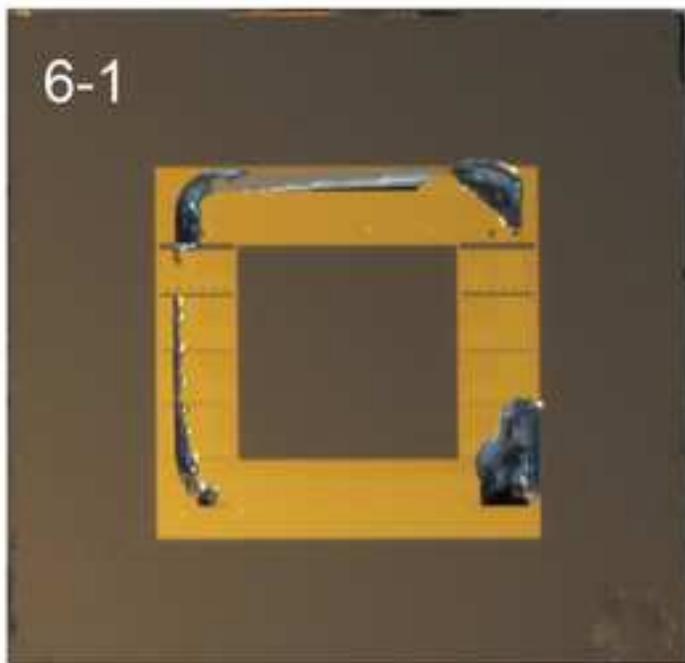
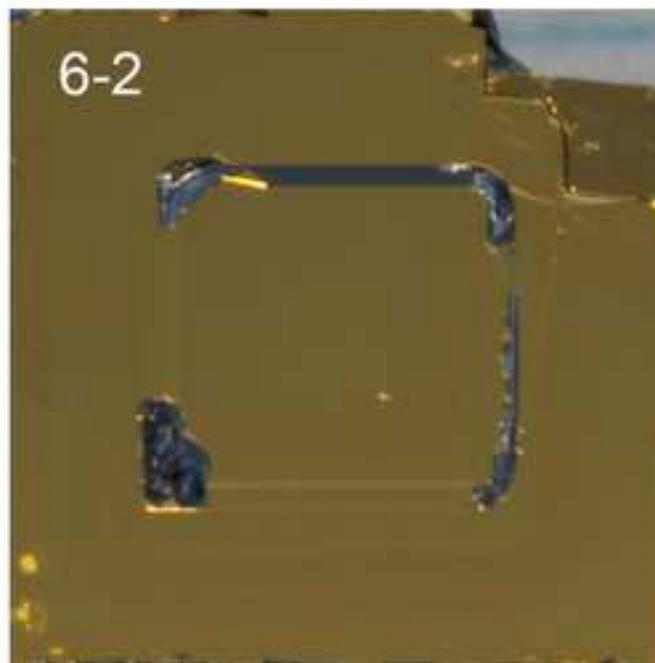
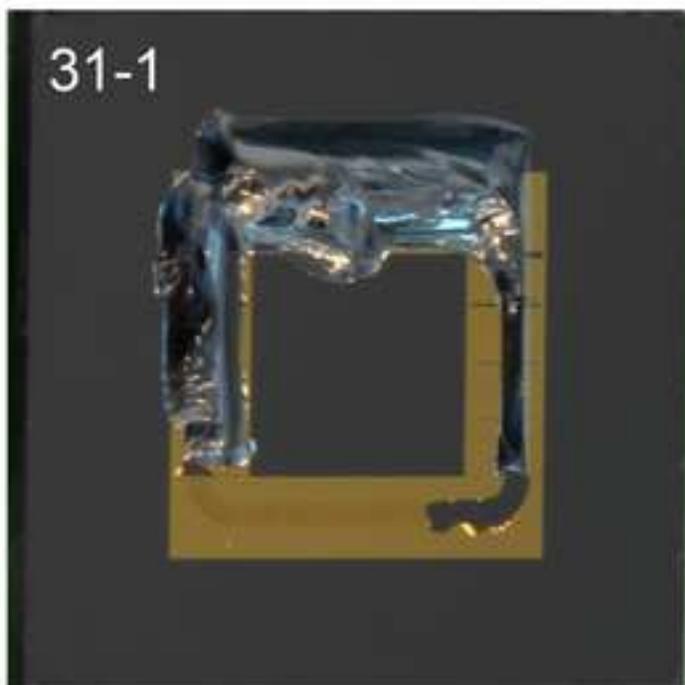
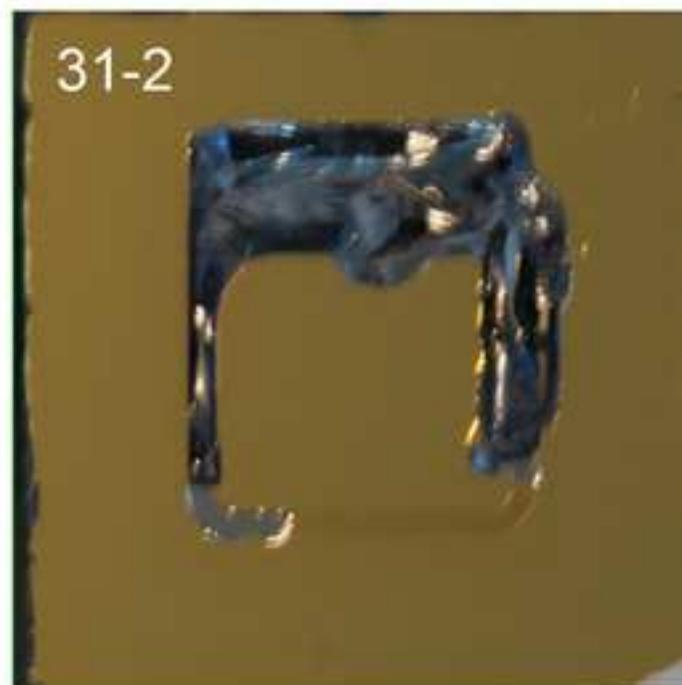
Figure 12

Figure 12: Fracture surfaces of chips No 6 and 31 of type F200R from the Au-Au laminate.

The chips bonded by Au-Au thermocompression bonding all exposed three types of fracture simultaneously: cohesive silicon fracture, cohesive gold fracture, and adhesive fracture at

the interface between TiW and Si. Optical micrographs of the fracture surfaces of the chips from Figures 9 – 10 are displayed in Figure 12.

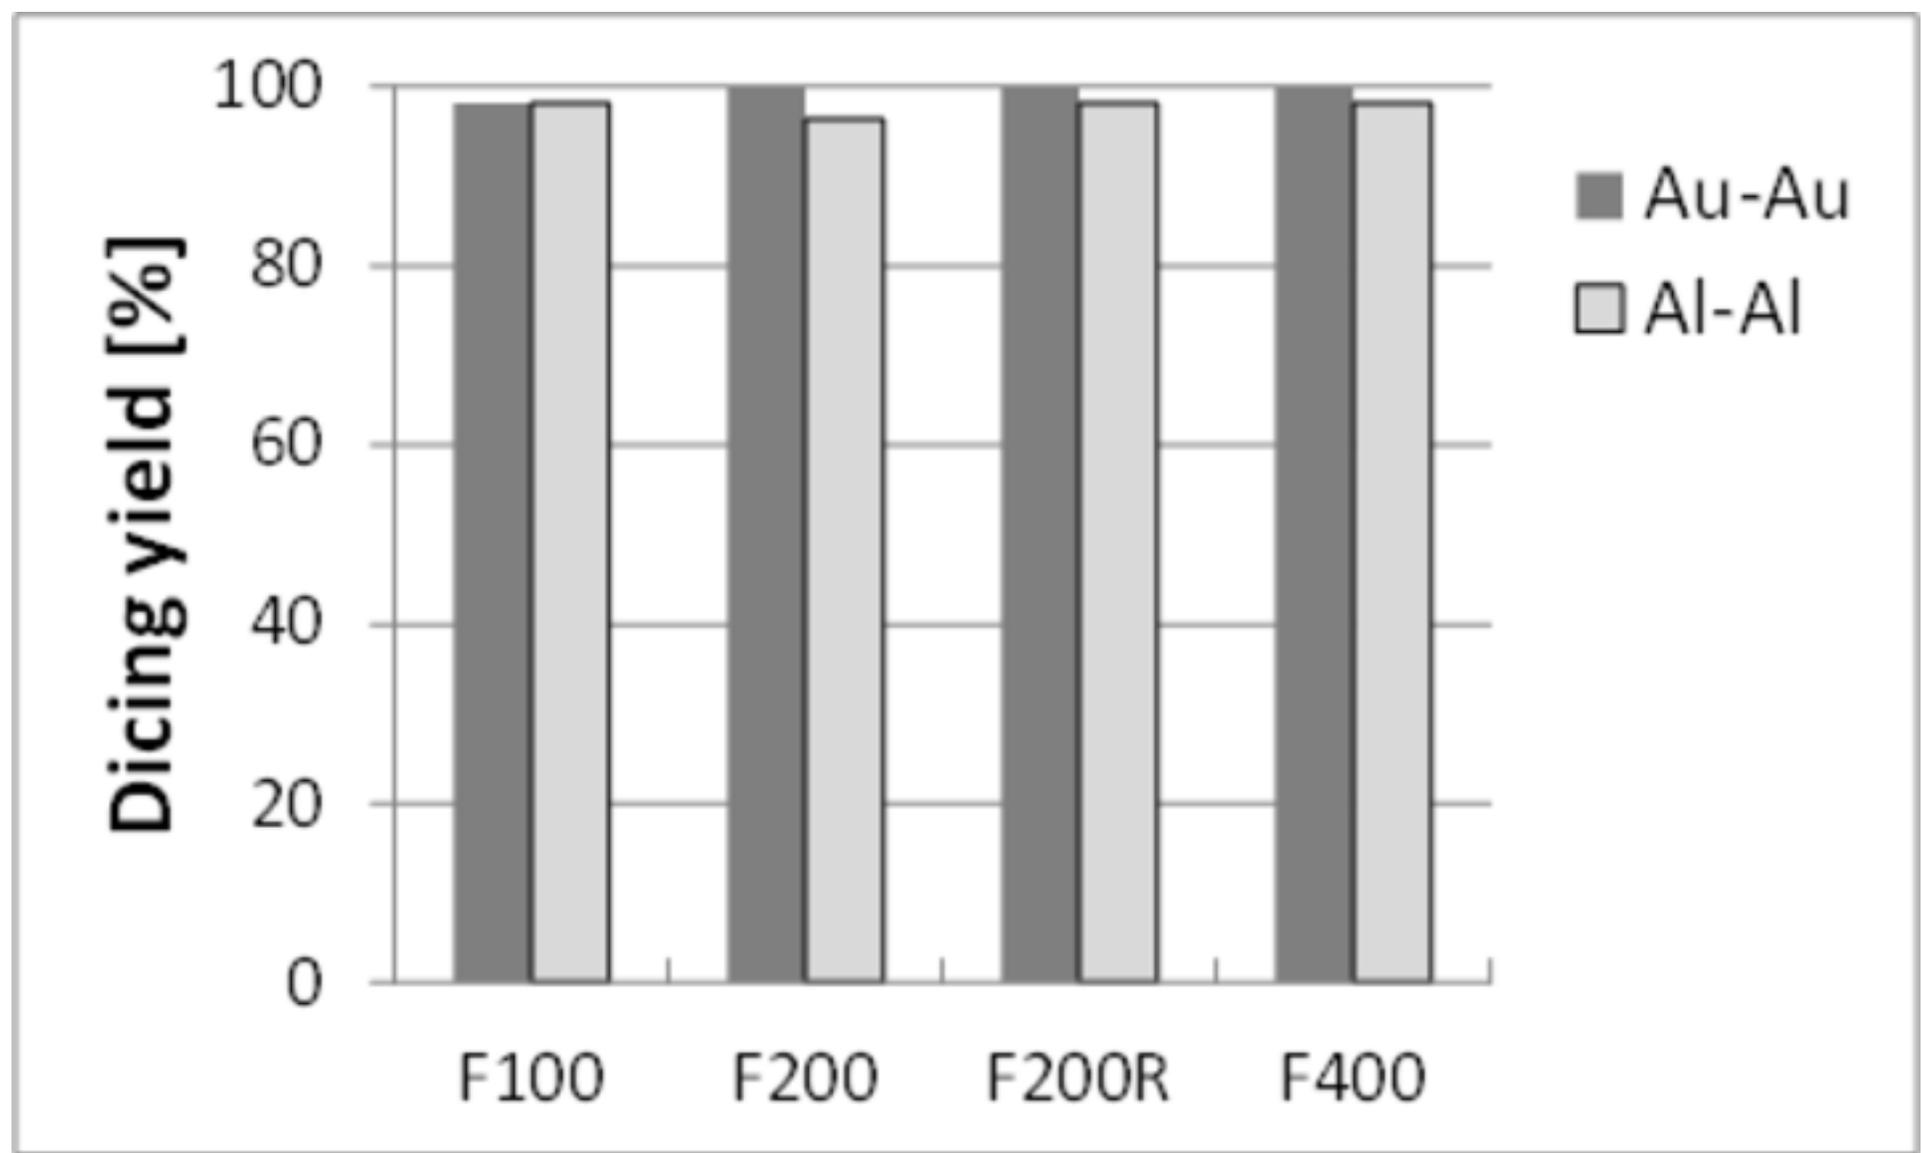
Figure 13  
[Click here to download high resolution image](#)

Figure 13: The dicing yield of the four bond frame types for the two bonded laminates.

The dicing yield for each frame design is plotted in Figure 13. A dicing yield above 96% was obtained for all chip types, regardless of frame width. There was no significant difference between Au-Au and Al-Al bonding with respect to dicing yield. The average values and standard deviations for the fracture forces and bond strengths calculated from eight measured chips are listed in Table 3. The average fracture forces were 79.9 N for Au-Au bonds and 67.4 N for Al-Al bonds. However, student t-testing showed that the bond strengths were not significantly different, even at only 90% confidence level.
