Role of Pitting in the Formation of Potholes in Carbon Cathodes - A Review

Samuel Senanu¹, Tor Grande², Arne Petter Ratvik³

Department of Material Science and Engineering, Norwegian University of Science and Technology, Trondheim, Norway

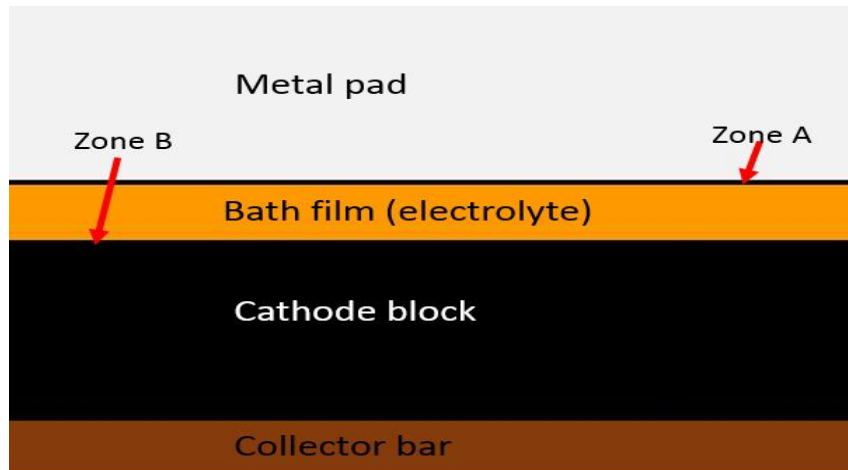
Figure 2.2. Sketch of the interfaces and zones at the carbon cathode from [2].

It is proposed that Reaction 4 relies on a constant supply of Al^{3+} ions, which is formed by the anodic dissolution of molten aluminium at the metal/electrolyte interface (zone A). Increasing the current within the system will increase the driving force for the anodic dissolution of Al^{3+} and will increase the driving force for the transport of Al^{3+} ions to and into the cathode material (zone B), thus increasing the chance of aluminium carbide formation [2, 12]. Figure 2.2 is a sketch showing the interfaces and zones as explained by Rafiei et al. [2].

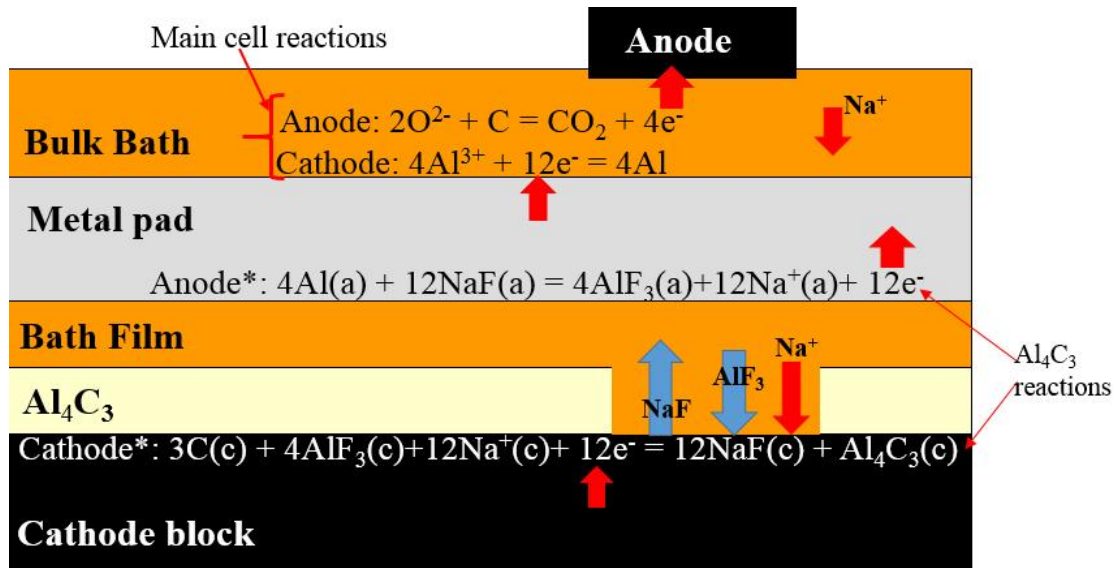
Figure 2.3. Model for the electrochemical formation of aluminium carbide from [13].

According to Keller et al. [12], when bath penetrates into a cathode block, it will have to equilibrate with the more negative potentials that exist in the carbon due to an ohmic voltage drop. This will cause electrochemical reactions similar to Reaction 4 to occur leading to the formation of aluminium carbide within the cathode block. According to the authors, these electrochemical reactions will proceed until a higher bath ratio and accordingly a more negative potential corresponding to the one in the cathode is reached [12]. Figure 2.3 illustrates an electrochemical wear model developed by Li et al. [13]. The model is based on the concept of a “carbon pump” proposed earlier by Solheim and Tschöpe [14]. Solheim and Tschöpe proposed that the aluminium carbide layer formed on the carbon cathode is porous and filled with electrolyte. The pores filled with electrolyte can be considered as a small electrolysis cell where porous aluminium carbide is formed at the bottom of the pores (cathode side of cell) while the aluminium carbide is oxidized at the top of the pore (anode side of cell). This forms a “pump” where carbon is transported from the carbon cathode [14]. Sodium ions (Na^+) are assumed to be the sole carrier of current within the cell.

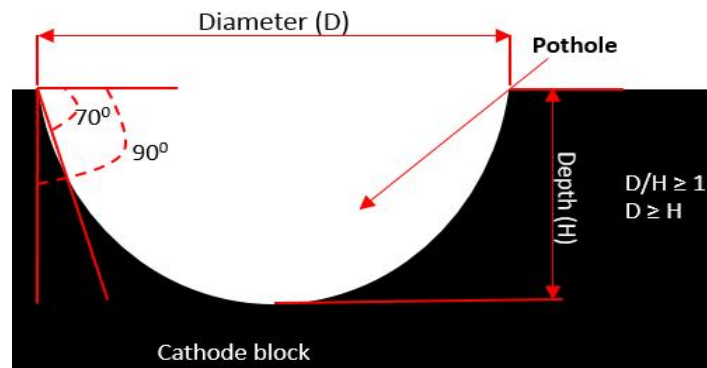
Figure 2.5. Schematic diagram of a pothole. Redrawn from [26]

In their paper on the fundamentals of potholes formation, Siew et al. [26], described potholes as eroded holes in the carbon cathode that are roughly hemispherical in the base and can range in size from golf balls to basketballs. They went on to propose that potholes generally have steep sides that form angles of 70 - 90° with the cathode surface and have an aspect ratio of equal or slightly greater than one as shown in Figure 2.5.

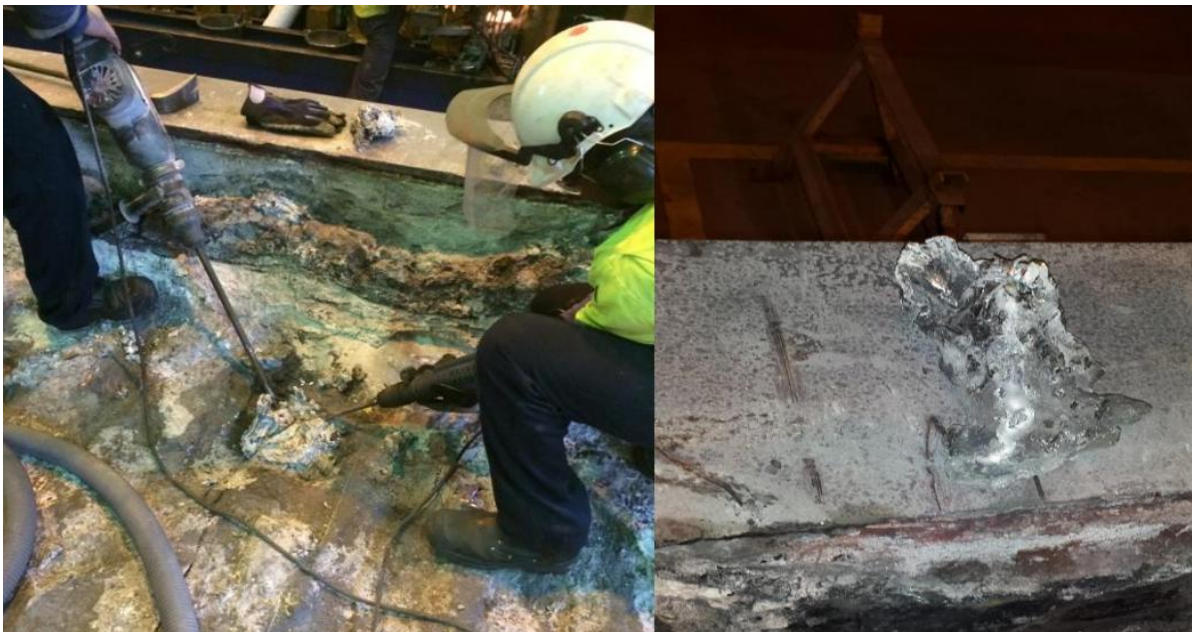
Figure 2.6. A pothole filled with aluminium metal (the metal removed is shown on the right).

Industrial observations from autopsies show that pothole formation occurs at locations with very high current densities such as the ends of the cathode blocks as well as locations with weaknesses in the pot linings such as cracks, gaps, narrow joints, veins etc. [1, 25, 26]. Figure 2.6 shows a picture of a pothole observed during an autopsy, the pothole was filled with aluminium metal. The presence of aluminium in such a pothole is likely to speed up the formation process, as the current density will be higher at this location. According to Sørli and Øye [1], the concentration of current density along metal-filled surface cracks in the cathode may generate pothole-like cavities that erodes to veritable ditches across the carbon pane, sometimes several meters long [1]. Autopsied cathodes examined by Sørli and Øye [1] may suggest that some cracks or veins of aluminium in the carbon may be wholly or partially converted into aluminium carbide, while in other veins the metal appears to have smoothed and enlarged the crack [1].

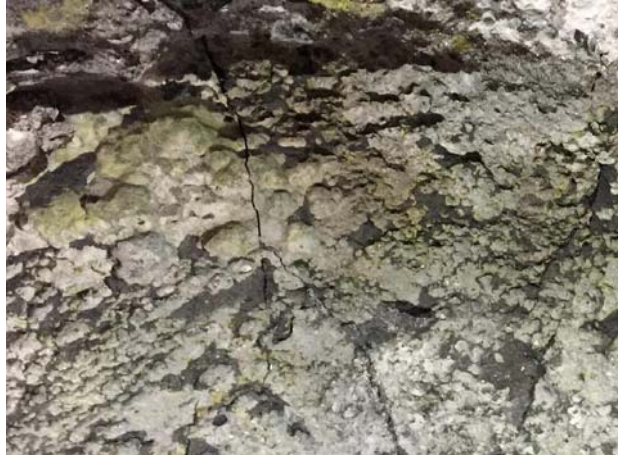
Figure 2.7. Pitting on the carbon cathode surface.

Pitting is a terminology used mainly under the subject of corrosion where it represents a highly localized form of corrosion that produces sharply defined cavities [28]. Its usage in connection with cathode erosion is therefore reasonable since the cathode erosion is mainly a chemical or electrochemical corrosion of the carbon cathode involving the formation and dissolution of aluminium carbide [1]. Pitting is observed on the carbon cathode surface at locations with the highest current densities [5]. Figure 2.7 is a picture showing pitting on a cathode surface.
