AC Corrosion Tests on Materials for Electrically Heated Flowlines

ABSTRACT

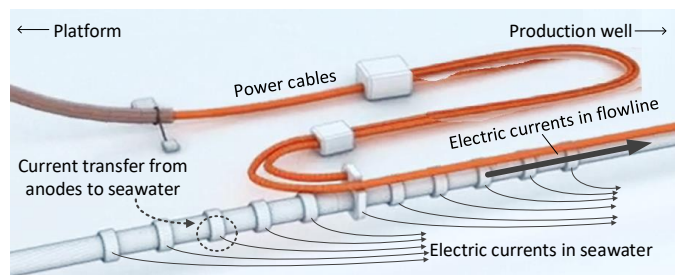
Fig. 1: Principle sketch of Direct Electrical Heating. Electrical currents are transferred from anodes on the flowline to surrounding seawater.

In a DEH-system, the flowline steel conducts electrical alternating current (AC) to generate heat in the flowline. For safety and reliability reasons, the heating system is electrically connected ("earthed") to surrounding seawater through several sacrificial anodes. Typically, 40 % of the current is conducted by seawater, while the flowline steel conducts the remaining 60 %, (Nysveen et al., 2007). The electric current is transferred from the flowline steel to surrounding seawater via anodes connected to the flowline. This is indicated in Fig. 1.

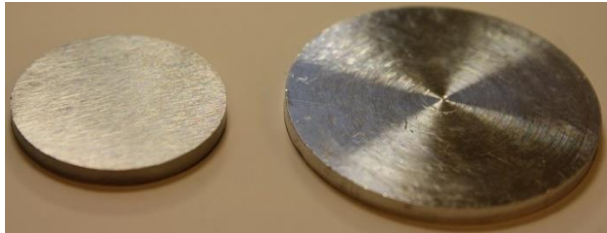
Fig. 2: Polished specimens of steel (left) and aluminum (right)

The specimens were coin shaped with a thickness of 2 mm, see Fig. 2. Exposed areas were 0.79 cm² and 3.84 cm². For bare steel, AC corrosion acceptance limits are typically referred to coating defect sizes of 1 cm², like in British Standard 15280. Thus, a steel specimen size close to 1 cm² is preferred and has been used in the tests.

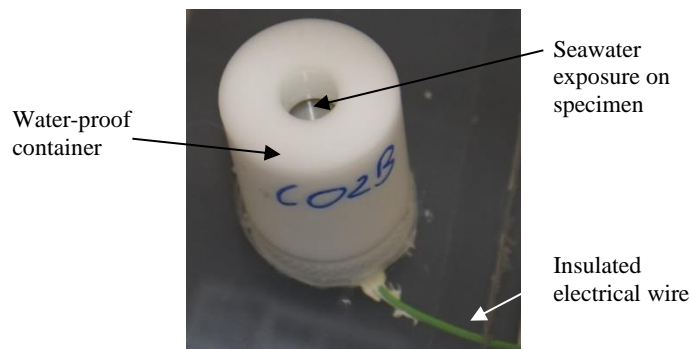
Fig. 3: Watertight container for steel specimen.

The specimens were placed in special-built containers, where only one side was exposed to seawater. See Fig. 3. An insulated electrical wire was terminated to the reverse side of the specimens.

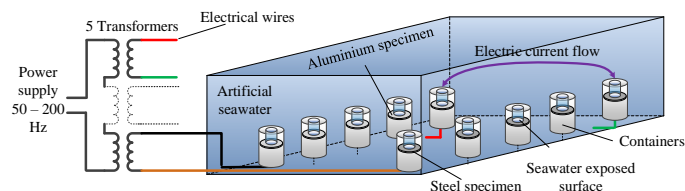
Fig. 4: AC corrosion test set-up. An AC current is forced between a steel and aluminum specimen.

Each test consisted of five pairs of specimens located in storage boxes, filled with approximately 20 L of artificial seawater. The seawater mixture was in accordance to ASTM D1141. An AC current from a contant voltage source was forced between pairs of specimens; one steel and one aluminum. A safety transformer ensured equal amount of current flowing in all specimen pairs. Fig. 4 shows a sketch of the test set-up. The water was not stirred during the test period, only replenished as water vaporized. Ambient temperature was approx. 20°C. The pH level was measured to 8 in all test set-ups prior to and during the test periods.

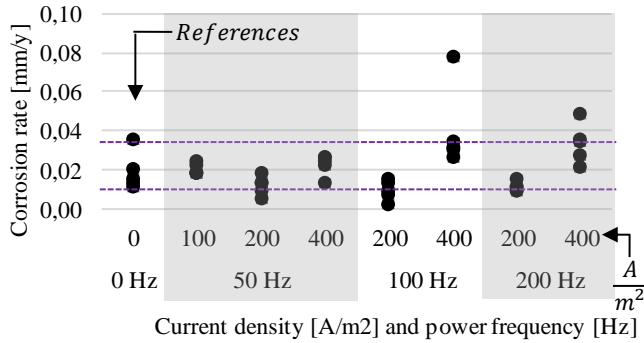
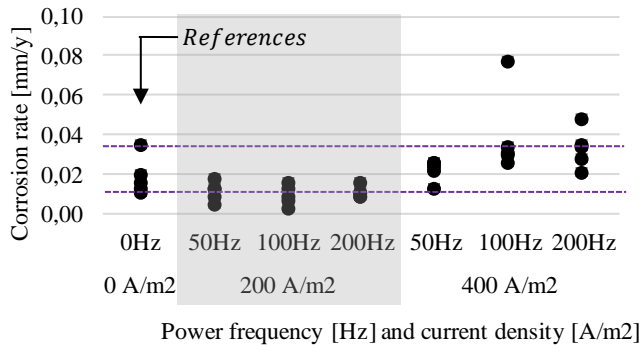
Fig. 5: AC corrosion rate of steel specimens. The leftmost results are reference measurements with no AC current applied. The horizontal lines indicate span in corrosion rate for the reference specimens.

Fig. 6: AC corrosion rate of steel specimens. The leftmost results are reference measurements with no AC current applied. The horizontal lines indicate span in corrosion rate for the reference specimens.

The corrosion rates on the steel specimens varied from 0.002 to 0.08 mm/year, as seen in Figs. 5 and 6. The leftmost data points are the reference specimens, with no applied AC current. There is no clear indication that the corrosion rate is dependent on TCD or power frequency. For most of the data points with applied AC current, the corrosion rate is within the span of the reference specimens (horizontal dashed lines). Visual inspection of the samples did not reveal any localized or uniform corrosion attacks.

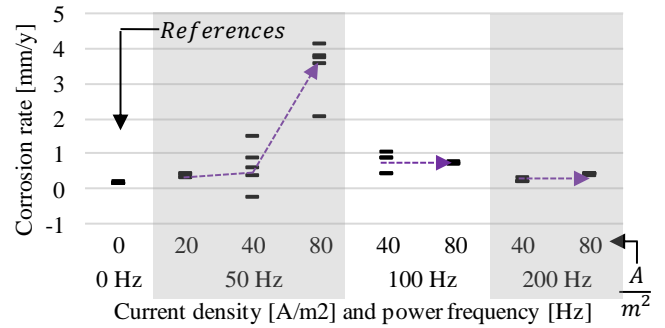
Fig. 7: AC corrosion rate of aluminum specimens. The leftmost results are reference measurements with no AC current applied.

The AC corrosion rate of aluminum specimens varied between 0.1 and 4.1 mm/year, as shown in Fig. 7. This corresponds to a material loss from 8 to 315 mg, excluding the single negative corrosion value. The dashed lines indicate the trend of the data. At 50 Hz, there is a clear trend that the corrosion rate increases at increased TCD. A corrosion rate rise by a factor 10 is seen when increasing from a TCD level of 20 to 80 A/m². For 100 Hz and 200 Hz, the corrosion rate is fairly unaffected by TCD increase within the tested range.

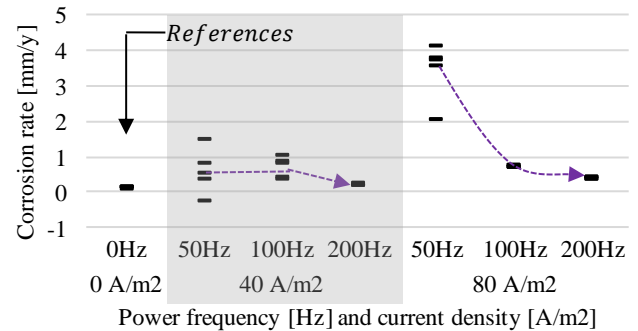
Fig. 8: AC corrosion rate of aluminum specimens. The leftmost results are reference measurements with no AC current applied.

For TCD of 40 A/m², the average corrosion rate is similar for 50 and 100 Hz, see Fig. 8. At 200 Hz, the rate is reduced by a factor 2-3. At a TCD of 80 A/m², the corrosion rate is reduced to 1/5th at 100 Hz compared to what is observed at 50 Hz. At 200 Hz, the corrosion rate is half what is observed at 100 Hz. This is seen in the rightmost section of Fig. 8.

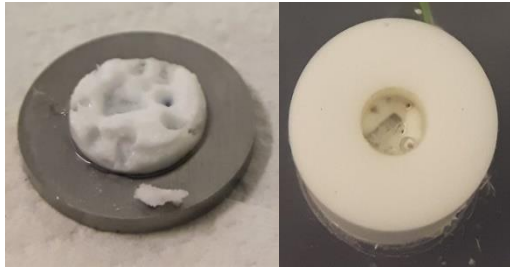
Fig. 9: Deposits on steel specimen at TCD of 200 A/m² at 50 Hz.

On the steel specimens, a white and hard deposit attached, as seen in Fig. 9. This is believed to be calcareous deposits formed because of cathodic protection. A softer deposit was seen on the aluminum specimens (aluminum oxide), as seen in Fig. 10. It is a trend that the thickness of the deposit increases for higher TCD and decreases at higher power frequencies. This is expected since formation rate of the deposit is analogue to corrosion rate of aluminum the specimens. Deposits were observed for the reference specimen, but less than for the other specimens.

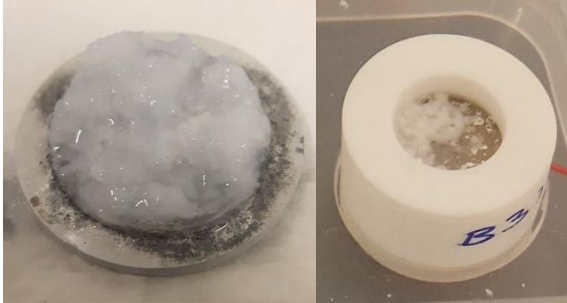
Fig. 10: Deposits on aluminum specimen at TCD of 80 A/mm² at 50 Hz (left) and TCD of 40 A/mm² at 200 Hz (right).

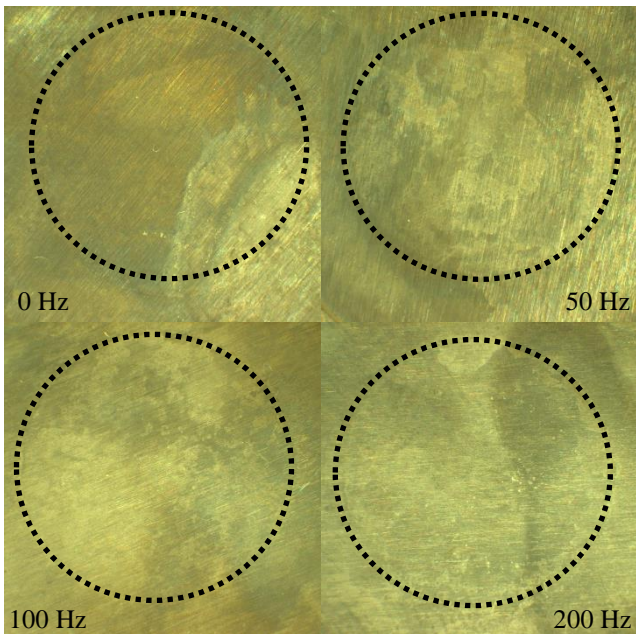
Fig. 11: Corrosion on steel specimens at 0-200 Hz. TCD was 400 A/m² on the 50, 100 and 200 Hz specimens. The exposed surfaces are indicated by black markers.

Visual inspection did not identify any corrosion or dissimilarity between the steel specimens, only some discoloration. In microscopy, the reference specimen topography was even on the entire object. On the surface of the 400 A/mm² specimens at 50, 100 and 200 Hz, some unevenness was vaguely seen. However, the difference between the three frequencies were unnoticeable. See Fig. 11.

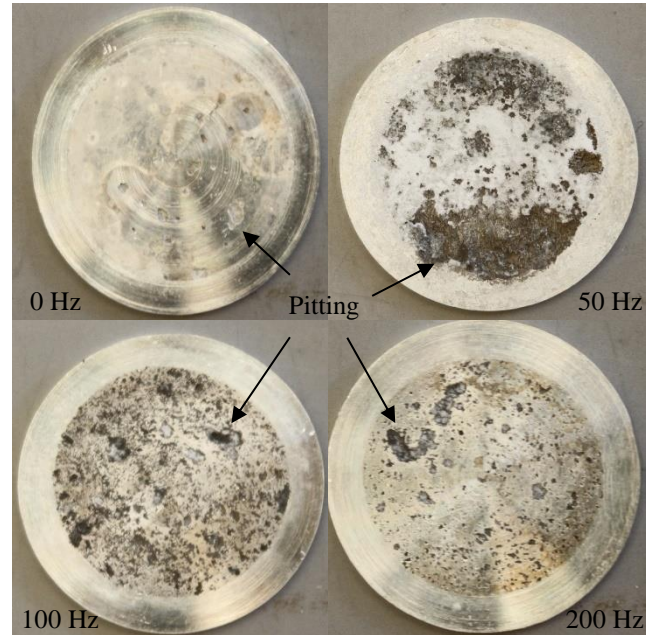
Fig. 12: Corrosion on aluminum specimens at 0-200 Hz. TCD was 80 A/m² on 50, 100 and 200 Hz specimens. This greatly exceeds design limits at 50 Hz. Thus, such corrosion rates are not relevant for DEH installations at 50 Hz.

the average calculated by the weight loss method. This is normally not a problem for anodes, but may increase the probability for non-faradic material loss, i.e. material pieces that detach from the anodes. Fig. 12 shows images of aluminum specimens after the corrosion tests and cleaning process. The figure includes a reference specimen (no AC current applied), together with specimens at 50, 100 and 200 Hz at 80 A/m². The white substance on the 50 Hz specimen could not be removed even by extended cleaning, and is therefore believed to be porous aluminum. Minor areas of white substance can also be observed on the 100 and 200 Hz specimens. Note that a TCD of 80 A/m² greatly exceeds the current design limit at 50 Hz, meaning that such corrosion rates are not relevant for DEH installations at 50 Hz.
