Influence of Local Weather Conditions on Ventilation of a Pitched Wooden Roof

Abstract: This paper investigates the influence of temperature and wind conditions on ventilation of the air cavity beneath the roofing in a full-scale pitched wooden roof construction. The potential for condensation in the air cavity is studied. The relevant roof construction is equipped with 81 thermocouples and four air velocity measurement devices. A weather station at the site records outdoor temperature and wind conditions. Five periods between 2016 and 2018 are investigated. The findings show distinct periods of below-ambient temperature and positive condensation potential in the ventilated air cavity of the roof. A relation between low wind speed and positive condensation potential is shown. Difference in size of periods with below-ambient temperature and periods with positive condensation potential in the roof regulate the humidity in the air cavity. Large negative peaks in the condensation potential indicate dry-out of the construction.

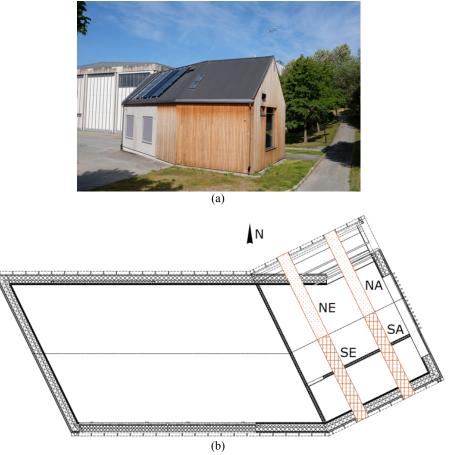
Fig. 1 (a) The ZEB Test Cell Laboratory; (b) position of the air cavities included in the study. Source: the figure is based on a plan drawing created by Luca Finocchiaro.

The study was carried out on a full-scale experimental laboratory building, ZEB Test Cell Laboratory, situated in Trondheim, Norway (see Fig. 1). The building has a wooden roof construction with a roof angle of 40°. The roof has eaves-to-eaves ventilated air cavities below the roofing, with 48 mm wide inlets and outlets along the eaves. The air cavities are 10.8 m long, 552 mm wide and 48 mm high. The lower surface of the cavities consists of a flexible roof underlay mounted on an oriented strand board (OSB). The upper surface is an OSB covered by a bitumen-based roofing membrane on the weather exposed side (see Fig. 2).

Four of the cavities on the roof were studied, described in the plan drawing in Fig. 1, showing the building from above. Two cavities on the southern side of the roof, denoted as SA and SE, and two cavities on the northern side of the roof, denoted as NA and NE, were included in the study.

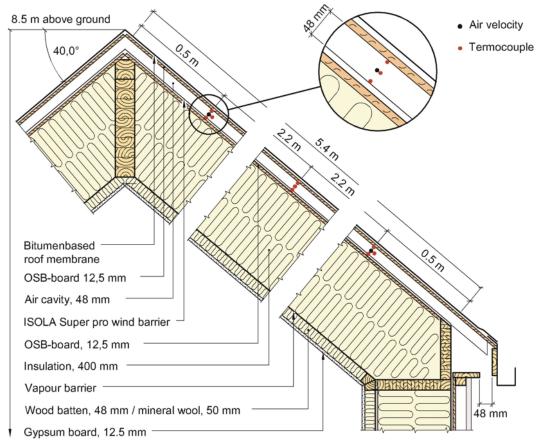
Fig. 2 ZEB Test Cell Laboratory roof structure.

The air cavities of the roof are equipped with instrumentation for temperature and air velocity measurements (Fig. 2). Eighty-one (81) thermocouples are shared evenly on nine parallel cavities. In each cavity, three thermocouples are located 0.5 m above the eaves, three are found between the eaves and ridge, and three are located 0.5 m below the ridge. In each triplet, one sensor is installed on the roof underlay, one is installed in the middle of the air cavity, and one is mounted on the rear surface of the roofing. In two of the air cavities, two air velocity measurement probes are installed. The accuracy and range of the sensors are ± 0.10 °C and -20 °C-60 °C for the thermocouples, and 0.05 m/s and 0.05-5 m/s for the air velocity probes.

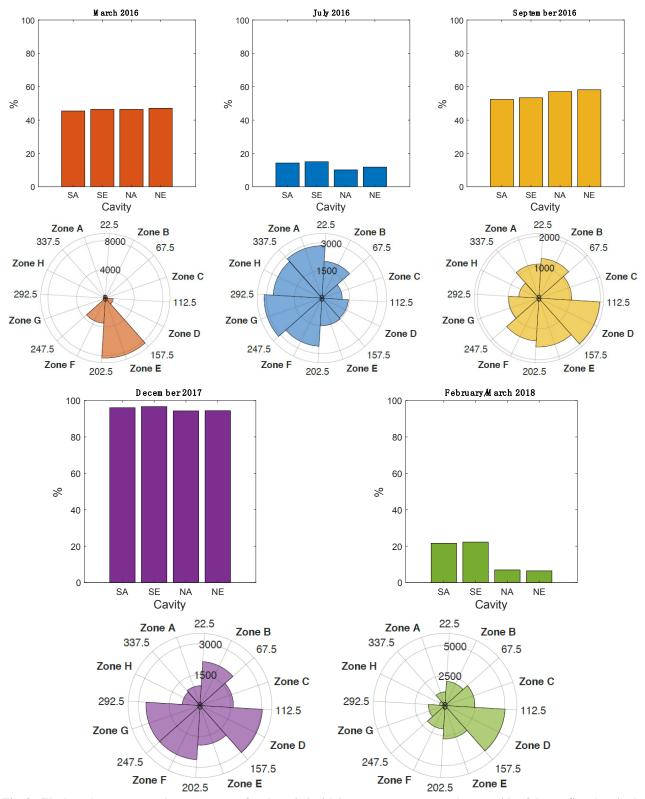
Fig. 3 The bar charts present the percentage of each period with lower temperature on the rear side of the roofing than in the outdoor air. The polar charts show the occurrence of wind from different directions towards the house. The radial axes in the polar charts represent the number of measurements within a zone. Note that the scale of the radial axes varies between the different periods.

In this paper, the temperature and condensation conditions in the ventilated air cavity of a full-scale pitched wooden roof have been investigated. Five periods between 2016 and 2018 were included in the study. How the temperature in the air cavity depends on the outdoor temperature and wind is presented in Fig. 3. The subsequent CP_i in periods with below-ambient temperature in the air cavity is examined in Figs. 4 and 5.

The measurements from the roof at ZEB Test Cell Laboratory demonstrated of long periods below-ambient temperature in the ventilated air cavity beneath the roofing. During the spring and autumn periods, the measurements at the rear side of the roofing showed temperatures below the ambient temperature for approximately 50% of the time. This is in line with the results found by Gullbrekken et al. [10]. In the December period, below-ambient temperature was measured close to 100% of the time. There was no snow on the roof in this period. Low outdoor temperatures and periods with clear sky may have contributed to large cooling of the roof and the subsequent low temperatures at the rear side of the roofing. During the second winter period, in February/March 2018, comparatively small intervals with below-ambient temperature were measured. Snow,

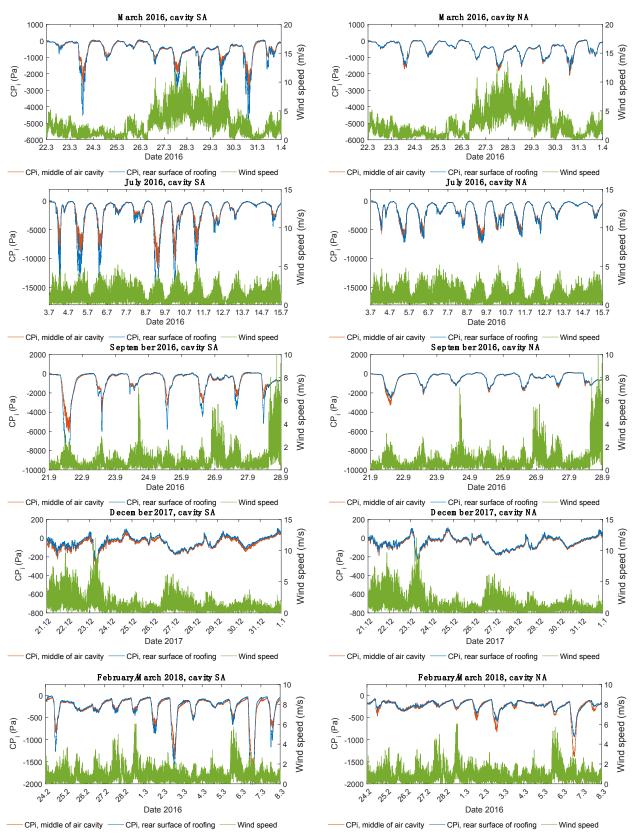
Fig. 4 Variation in CP_i and wind speed in the five periods. Results for cavities SA (left) and NA (right) are presented. Note different axes scales.

180°, 225°, 270°, 315° \pm 22.5°. The angle of 0° corresponds to wind approaching perpendicular to the wall on the northern side of the building (zone A). Fig. 4 shows CP_i in the air cavity and wind speed as a function of time. Fig. 5 compares the risk of condensation in the different periods. In Fig. 5 results are not given for February/March 2018, as no positive CP_i was found in this period.

As recorded in Fig. 4, differences in CP_i were found when comparing the southern and the northern side of the roof. Due to heating by the sun, the negative peaks in CP_i were much larger on the southern side. The large negative peaks in CP_i correspond to the points of time with high temperatures in the air cavity found by Gullbrekken et al. [10]. The periods of positive CP_i were larger on the northern side of the roof. Together with the smaller size of negative peaks, this implies that the risk of condensation is higher at the northern side. A larger CP_i was also observed for the rear side of the roofing than for the middle of the air cavity. However, the rear side of the roofing also had a larger dry-out potential because of greater heating of the roofing during the day. This decreases the risk of long-term moisture deposit on the OSB. Both during the spring and autumn periods, the local climate gave high temperatures during the day and shifts to low temperature during the night. The high temperatures give the large negative CP_i during daytime, while the shifts to low temperatures during night contribute to the positive CP_i. The winter period in 2017 gave positive CP_i in up to 33% of the time as a result of the long periods of undercooling. The summer period in 2016 and the winter period in 2018 showed very little and no positive CP_i, respectively. This agrees with the smaller periods of below-ambient temperature on the rear side of the roofing found in these periods.

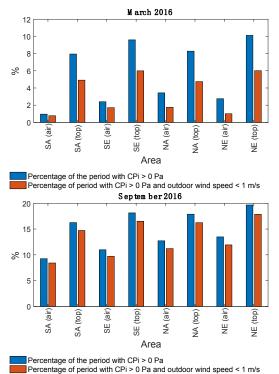
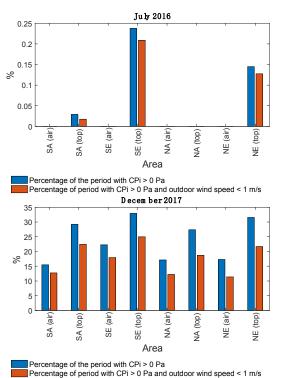
Fig. 5 Percentage of each period with positive CP_i , and percentage of each period with positive CP_i at the same time as the wind speed is < 1 m/s. Note different axes scales.
