Hygrothermal conditions in Cross Laminated Timber (CLT) dwellings

Abstract. The use of CLT has been increasing the last decade, and a subsequently focus on documentation of the accompanying indoor climate and exposed wooden surfaces on human well-being. This study presents the results of a measurement campaign conducted over one year of a CLT apartment building in Grimstad, Norway. The apartment building consists of three floors with 35 apartments and comply with the Norwegian passive house standard and energy grade A. Measurements of the relative humidity (RH), indoor air temperature and wood moisture content (MC) were performed in the exposed CLT spruce panels in three apartments in two different floors. The results from the three apartments show a relatively small variation in the MC values regardless the residents behavior measured as RH variation through a complete year. Selected periods from a cold period (winter) and a warm period (summer) show the variation in relative humidity (RH) and moisture content in the CLT element. However, results from control measurements showed higher MC values. The gap between the measurements and methods are discussed.

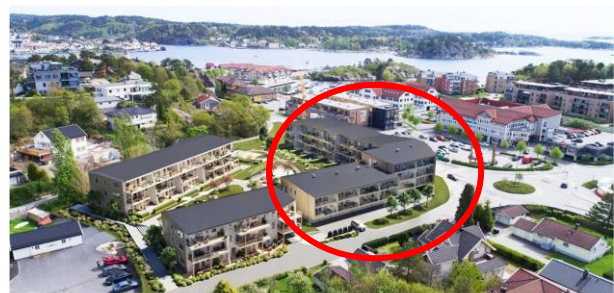
Fig. 1. Illustration of Skonnertveien hageby [7]. The highlighted area shows where the three CLT apartments are situated.

The measurements were conducted in three apartments in a CLT apartment building in Grimstad, Norway. The apartments have occupants from the age of 25 to 70, with different behavior patterns measured as RH variation. The three apartments are a part of Skonnertveien hageby that were completed in 2017 and consist of 35 low- energy apartments. The main building structure is cross laminated timber elements (CLT) with exposed CLT in interior surfaces. All surfaces are treated with water- based stain. The building comply with the Norwegian passive house standard NS3700 [6] and energy grade A. Figure 1 shows an illustration of Skonnertveien hageby.

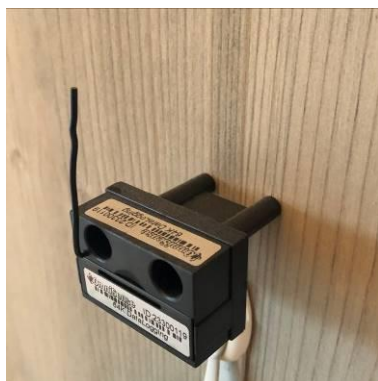
Fig. 3. Position of measurement point in AP.1

The indoor climate parameters in kitchen/ living rooms in AP. 1, AP. 2 and BR2 in AP.3, the room air temperature (T), the relative humidity (RH) and the wood moisture content (MC) were measured using wireless sensors (Protimeter HygroTrac S-16)[9]. The sensors were calibrated for Douglas fir, and the MC has not been adjusted for European Spruce which have been used in the CLT element in Skonnertveien hageby. Estimated difference between Douglas Fir and European Spruce is approximately 0.2%MC in the actual measurement range. The sensors were mounted on the walls in three different heights (0,10 m from the floor, 1- 2 m from the floor and 0,10 m from the ceiling). The sensors were attached with two stainless steel screws into the CLT exposed wall panels (indoor), acting as electrodes to measure the MC. The screws penetrate the wooden surface to a dept of 10 mm and measure the electric resistance. The RH and T sensors is inside the plastic casing at a distance of 30 mm from the wooden surface, see Fig. 3. The values were recorded with 5 minute intervals.

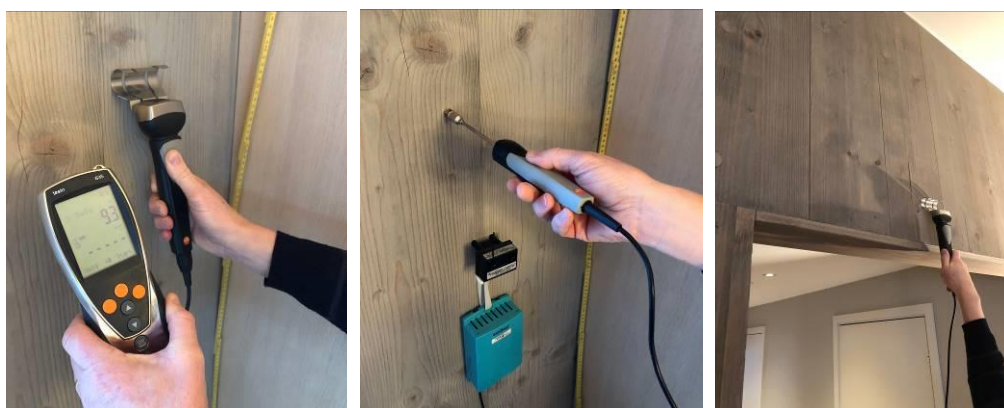
Fig. 4. Left: The non- destructive moisture meter on the inner surface of the exterior CLT wall element. Middle: The surface thermocouple on the inner surface of the exterior CLT wall element. Right: The non- destructive moisture meter on the surface of the interior CLT wall element.

Control measurements were performed of the temperature of the exposed CLT surface and wood moisture content in apartment 1. The measurement were performed using Testo 6160 non-destructive moisture meter and Testo Surface thermocouple, see Fig. 4. An overview of the used measurement equipment and their features and accuracy is given in Table 3. The electromagnetic field penetrates the material via the

contact plates and creates a measuring field with a depth of approx. 50 mm. Both the surface temperature and the moisture content were measured every 50 cm, from 50-250 cm, on the left and right side of the vertical line with the wireless sensors. This were performed four times (test1- test4). In addition, horizontally measurements of an interior CLT wall element were conducted to see if there were any variations between an exterior and an interior wall element with an expected more even MC (test5-test8), see Fig. 4.

Figure 9 shows the moisture content of the interior CLT wall element that were measured above the entrance to the KL+LI, see Fig. 4.

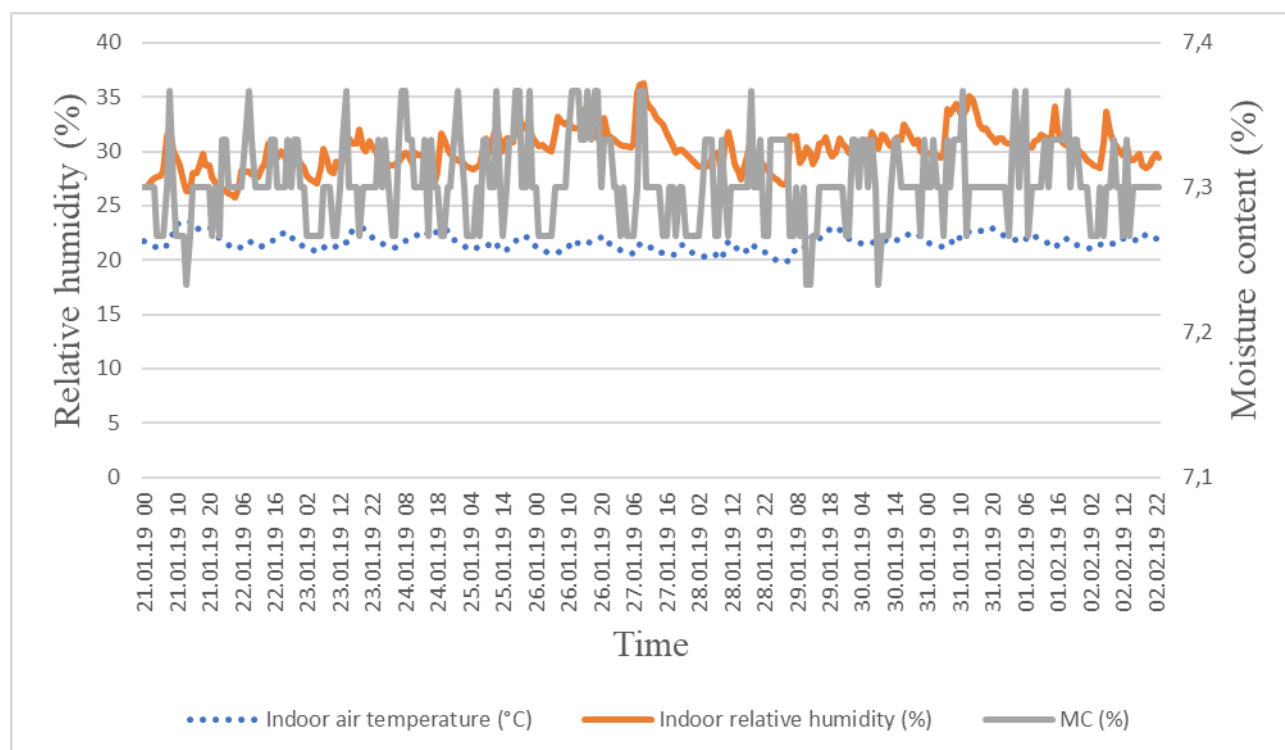
included in this paper. Figure 5 shows the indoor relative humidity, the indoor air temperature and moisture content of the CLT wall element facing northwest in a cold period in winter. Outdoor climate is reported as observation approximately 4 km away from the apartment building (Landvik weather station). In the cold period in winter, outdoor temperature has a range from -17 to 3 °C. In the warm period in summer outdoor temperature have a range from 12 to 28 °C. The outdoor relative humidity had a rather stable range of 65 to 95 %RH in the cold period in winter.

Fig. 5. Hourly mean indoor relative humidity, indoor air temperature and wood moisture content in Ap.1 from January 21st to February 3rd.

The measured MC values presented in Figure 5 and 6 are relatively low. Especially in the warm period in summer the MC values are significantly low compared to a normal spruce sorption curve shown in [10]. Further investigation was therefore conducted with control measurements of the MC% and surface temperature in the CLT wall element as described in 2.3.

The measured results presented in Figure 5 and 6 are results from the sensors mounted on the inner surface of the exterior CLT wall element in the combined kitchen and living room in Ap.1. The measuring periods were chosen to represent a cold period in winter with a range in the outdoor temperatures from -17 to 3 °C with a relative low RH around 25- 35 %, and a warm period in summer with outdoor temperatures from 12 to 28 °C with a relative high RH of around 60-70 %. However, the summer period also shows relatively low levels of indoor RH of 40 %. The results in Figure 5 and 6 show a small variation in the moisture content, regardless the season and the residents' behavior, measured as RH. The sensors were mounted on two different wooden planks in the CLT wall element, see Fig. 3 and 4. The HygroTrac s-16 sensor use electrodes to measure the resistance between the two stainless steel screws. Since the resistance over two different wooden plank is different than if the sensor was mounted on one wooden plank only, this may be some of the explanation to why the measured MC values in Figure 5 and 6 are low compared to the control measurements presented in Figure 7 and 9 and Hygrotrac emc curve for generic wood [11]. When the control measurements were conducted the RH in apartment 1 were around 30 % and the MC values

showed results around 10%, compared to the field measurements in Figure 5 and 6 that showed MC values around 7 % when the RH were 30%. The spruce sorption curve [10] shows that with a RH level of 60% the MC value should be around 11%, compared to the results in Figure 5 and 6 that shows MC values just above 7% when the RH is 60%. The HygroTrac s- 16 sensor should be mounted on one wooden plank to avoid misleading values caused by glue and larger cracks in the CLT element that will affect the resistance. The measured surface temperatures in Figure 8 and moisture content in Figure 7 and 9 are results from the control measurements on the inner surface of the exterior CLT wall element in the combined kitchen and living room in Ap.1. The results presented in the control measurements show a significant higher moisture content of 8.0- 10.5 MC% compared to the long-term measurements presented in Figure 5 and 6 of 7.2- 7.6 MC% for summer and winter. The HygroTrac s-16 sensor have an accuracy of $\pm 1\%$ MC in wood, and it is difficult to argue an exact MC value because of this uncertainty factor. The measurement equipment that were used in the control measurement (Testo 6160) have an accuracy of $\pm 3\%$ in wood, and have a higher uncertainty factor than the long-term measurements. The high uncertainty factor in the measurement equipment makes it difficult to argue why the MC values represented in the control measurements are higher than the MC values presented in the long- term measurements. However, we can argue that the position of the HygroTrac s-16 sensors affect the resistance, and therefore the MC are most likely uncertain.

The measured RF results presented in Figure 5 and 6 shows that the relative humidity have a moderate development, similar to other studies [1, 3].

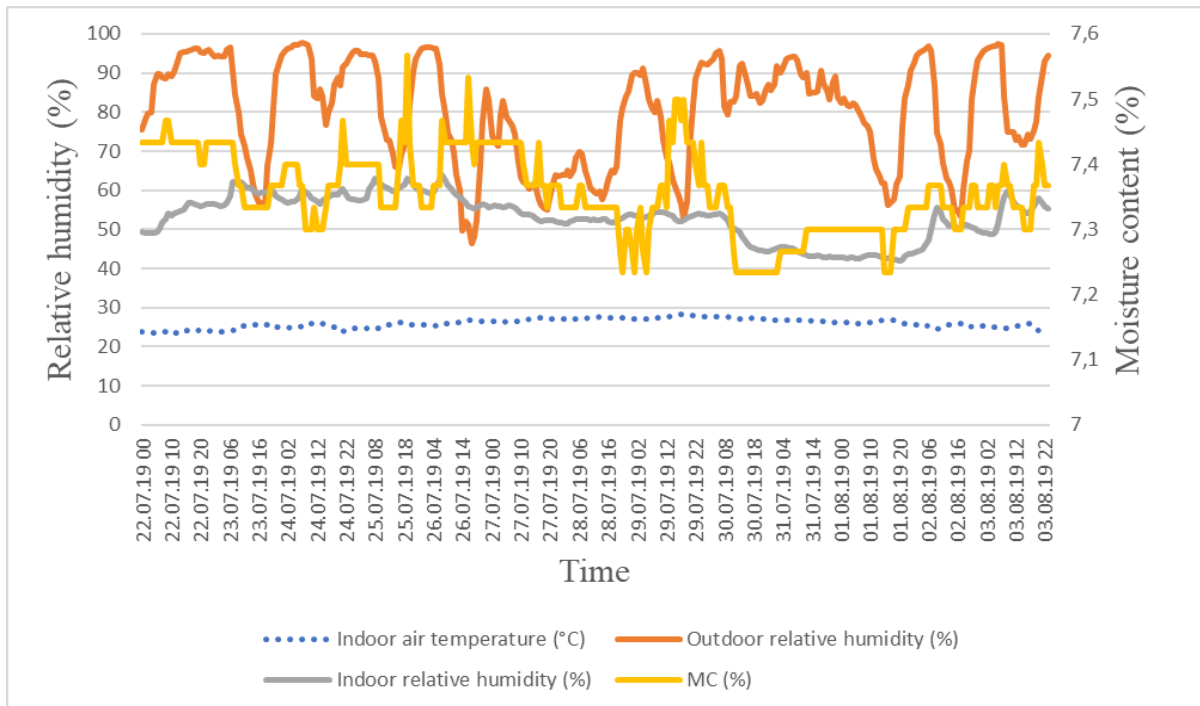
Figure 6 shows the indoor and ambient relative humidity, the indoor air temperature and moisture content of the same CLT wall element facing northwest in a warm period in summer.

Fig. 6. Hourly mean outdoor and indoor relative humidity, indoor air temperature and moisture content in Ap.1 from July 22nd to August 4th. Same CLT element and sensors as in Figure 5.

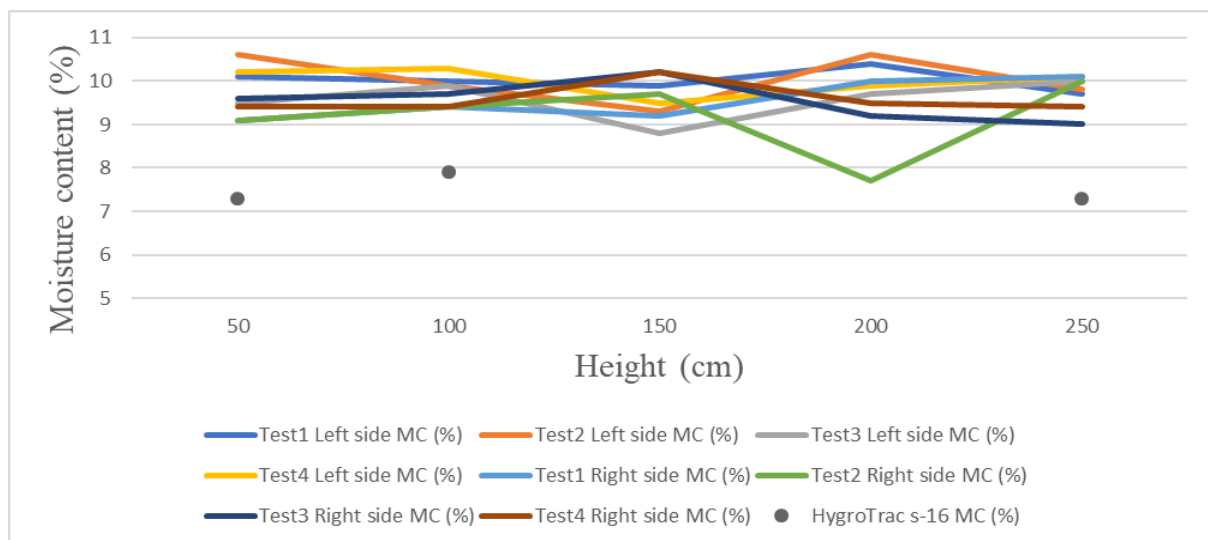
and showed 21,5 °C the first two tests and 22,8 °C the second two tests. The RH value in apartment 1 were around 30 % during the experiment. Figure 7 shows the moisture contents of the four repeated tests at the right and left side of the wireless sensors and the sensors value at the time where the measurements were conducted. Figure 8 shows the surface temperatures of the four tests.

Fig. 7. Moisture content of test1-test4 at the right and left side of the wireless sensor (HygroTrac s-16) in Ap.1 January 8th, 2020.

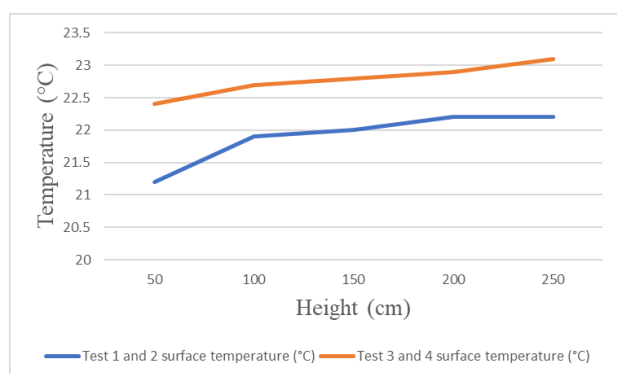
Fig. 8. Surface temperatures of test1-test4 at the right side of the wireless sensor (HygroTrac s-16) in Ap.1 January 8th, 2020
