OUTWARD DRYING OF BASEMENT WALLS

Documentation of a laboratory experiment

Silje Asphaug and Ingrid Hjermann

Klima 2050 Note No 136

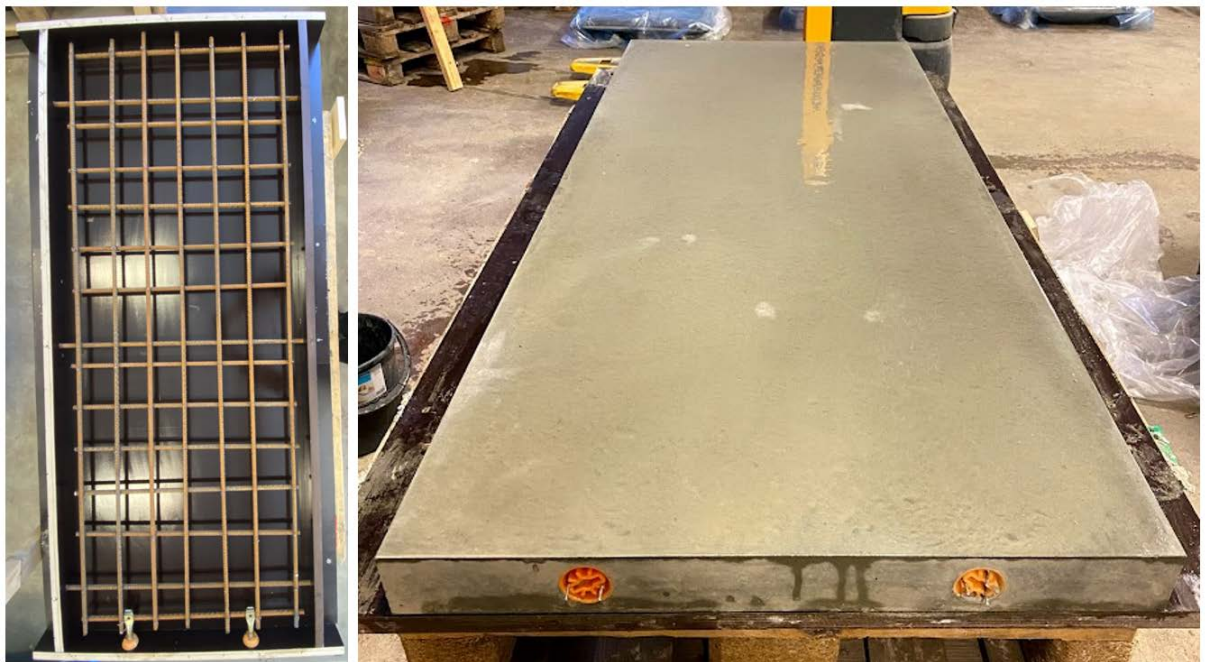
Figure 5.1: Formwork, reinforcement, and Vemo sleeves (left), a concrete segment straight after removing the formwork with the drying surface facing upwards (right).

The formworks of the concrete segments were constructed using water-resistant plywood boards with internal measurements corresponding to the dimensions of the concrete segments ($60 \times 600 \times 1500$ mm). Three $\text{Ø}10$ reinforcement bars were placed through drilled holes on the long side of the formwork (centred in the middle of the cross-section). The remaining bars were attached using steel wires. Horizontal and vertical reinforcement bars were placed with centre distances of approximately 100 mm and 83 mm, respectively, and a surface cover of 50 mm, as shown in Figure 5.1. The concrete was produced by Unicon and transported from the concrete plant to the laboratory premises by a concrete mixer truck. The concrete segments were horizontally cast in the formwork. A vibrating poker was gently used during casting to release the air pockets and level the surface. The concrete surface was brushed a few hours after casting to ensure that the drying surface was even. The concrete segments were covered with wet towels and sealed in plastic during the first three days, after which they were placed in a water bath for 25 days (28 days of curing in total). The formwork was removed one day after casting. Two Vemo sleeves per concrete segment were embedded into the top of the concrete during casting, centred in the middle of the cross-section 300 mm apart. The Vemo sleeves constituted the attachments for the suspension of the concrete segments. Bolts were temporarily screwed into the Vemo sleeves to prevent corrosion of the sleeves.

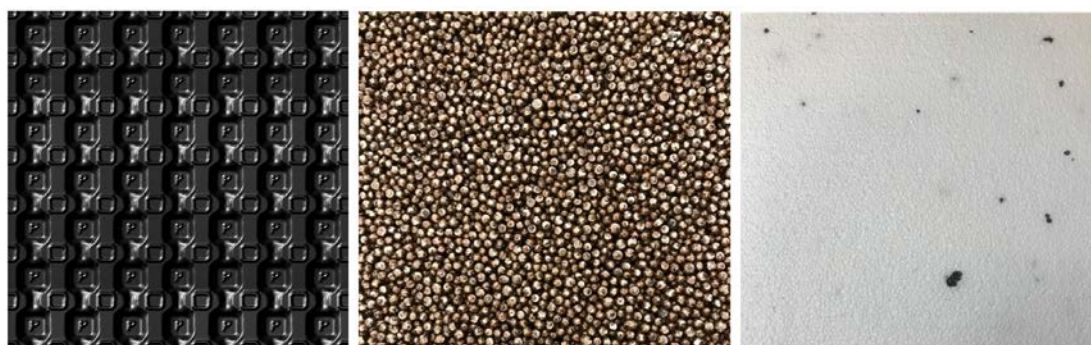
Figure 5.3: Dimpled membrane (left), permeable insulation (middle), and semi-permeable insulation (right).

The thermal insulation and dimpled membrane were stored in the laboratory premises and exposed to climatic conditions of approximately $20\text{ }^{\circ}\text{C}$ and 20 % RH. This period amounted to three days for the permeable thermal insulation and approximately two weeks for the dimpled membrane and semi-permeable thermal insulation. The thermal insulation was cut using a band saw, and the dimpled membrane was cut using scissors. As the permeable thermal insulation is produced with dimensions of 750×1000 mm, two boards were joined with two adjacent cut surfaces 900 mm above the bottom of the wall segment. The height of the dimpled membrane was 1000 mm, and two dimpled membranes were glued together with two overlapping knobs, 1000 mm above the bottom of the wall segments. The two types of thermal insulation and the dimpled membrane are depicted in Figure 5.3.

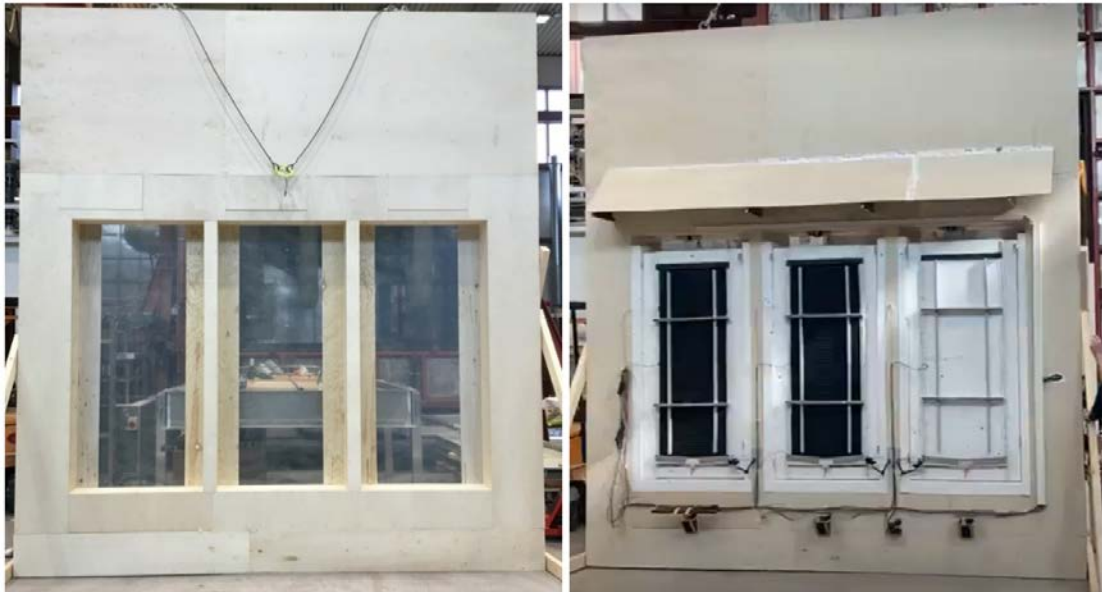
Figure 5.4: Wooden frame (left) and roof overhang (right)

The wooden frame was constructed as shown in Figure D4, with dimensions of $3830 \times 3800 \times 206$ mm. Construction timber with dimensions of 48×198 mm was used for the studs and support beam in the wooden frame. Double studs and beams were glued and screwed together to avoid creep deformation during weighing of the weighed wall segments. Heat transfer between the exterior and interior climatic chambers was prevented by insulating the wooden frame with 200 mm mineral wool. The air conditioning system in the exterior and interior climatic chambers was equipped with fans to create powerful air flows to ensure a well-mixed atmosphere. Therefore, a vapour-barrier covering the entire interior side of the wooden frame was sealed to the edges of the frame using vapour-barrier tape to avoid air penetration or air washing of the wall segments and grease-filled gap. Plywood sheets were mounted on the exterior and interior sides of the wooden frame to ensure lateral bracing, leaving recesses for mounting, instrumentation, and inspection of the weighed wall segments. In the recesses, the joints between the vapour barrier and construction timber were sealed with vapour barrier tape. The initial test series of climatic exposure in the exterior climatic chamber revealed condensation and water dripping from the roof. Therefore, a roof overhang was mounted on the wooden frame, providing cover and rainproofing of the weighed wall segments, as depicted in Figure 5.4. Finally, the joints in the plywood sheets were sealed with a wind barrier tape on the exterior side of the wooden frame.

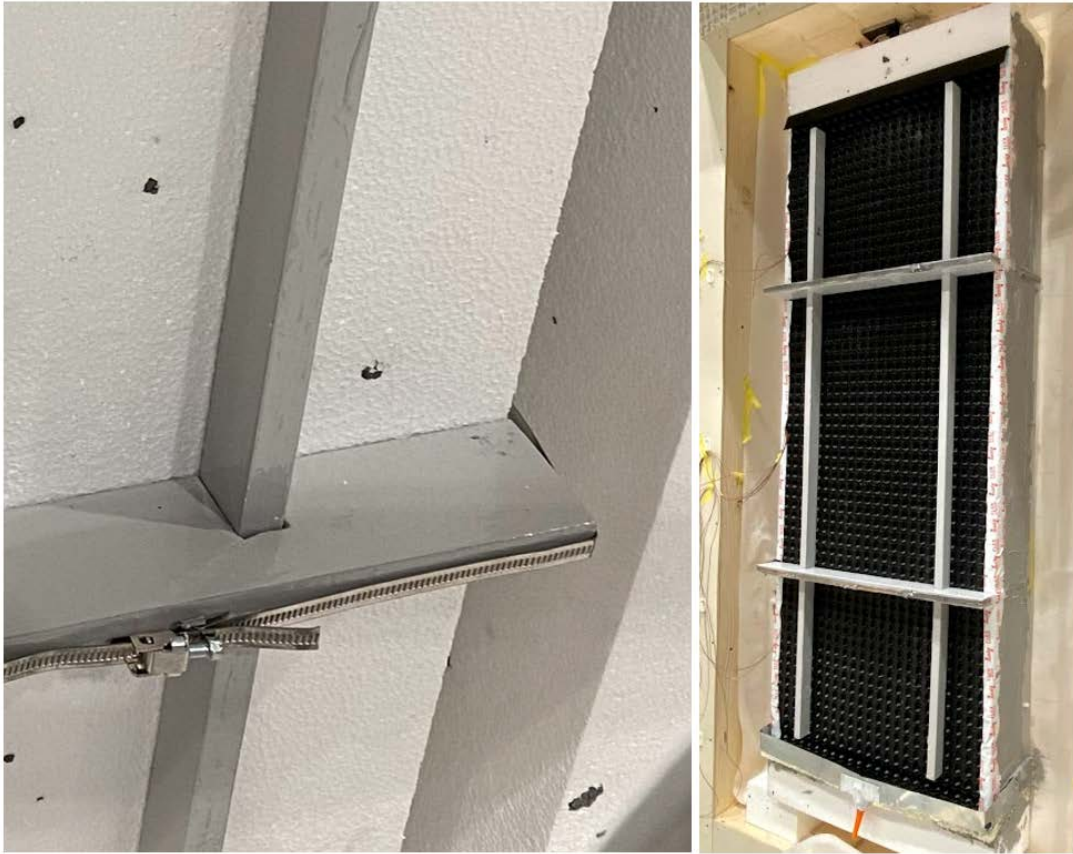
Figure 5.6: Thermal insulation and dimpled membrane gently pressed against the concrete segments and held in place by means of frames and band-hose clamps.

To avoid screws penetrating the wall segments, the thermal insulation and dimpled membranes were gently pressed against the concrete segments and held in place by means of frames and band-hose clamps, as shown in Figure 5.6. The frames were composed of water-resistant plywood boards, brushed with sandpaper, and sealed with two coats of epoxy to limit moisture uptake in the wood fibres. The vapour barrier in the wall recesses was temporarily covered with a wind barrier on the exterior side during assembly to reduce the risk of puncturing the vapour barrier. The drying surface of the concrete segments was temporarily covered with a vapour barrier to reduce surface evaporation during the wall assembly.

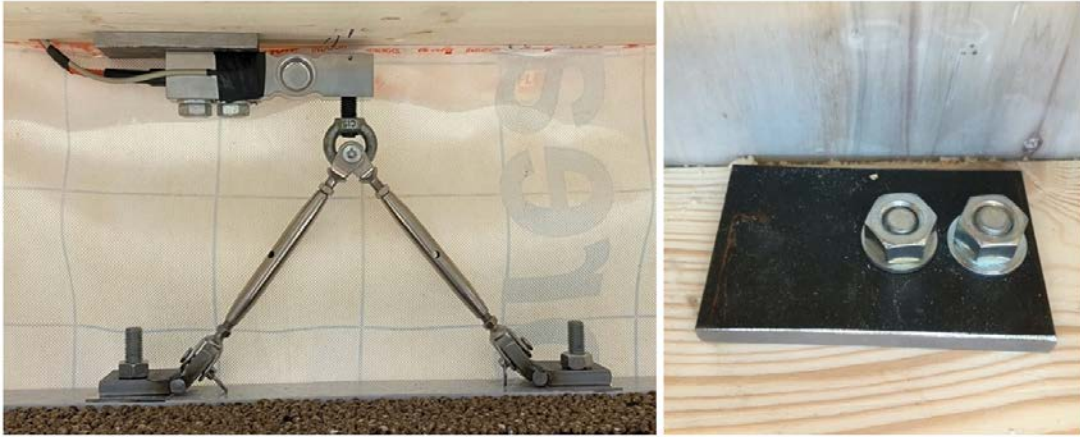
Figure 5.8: Suspended load cell and attachment details (left), and steel plate mounted above and below the attachment of the load cells (right).

To hang the weighed wall segments in the suspended load cells, bolts were screwed into the Vemo sleeves embedded into the concrete during casting. Steel plates, steel angles, and nuts were attached to the bolts. The steel angles were tailor-made with oblong slots horizontally to allow for adjustments of the centre of gravity of the weighed wall segments. Jaw-to-jaw rigging screws were used between the steel angles and the suspended load cells to allow for sideways adjustments of the wall segments. The suspended load cells were mounted by means of dowels inserted through oblong slots in the support beam, permitting adjustments of the load cells so that the weighed wall segments could hang flush with the vapour barrier on the interior side of the wooden frame. Small steel plates were mounted above and below the attachment of the load cells in the support beam to distribute the pressure on the timber. The suspended load cell and attachment details are shown in Figure 5.8.

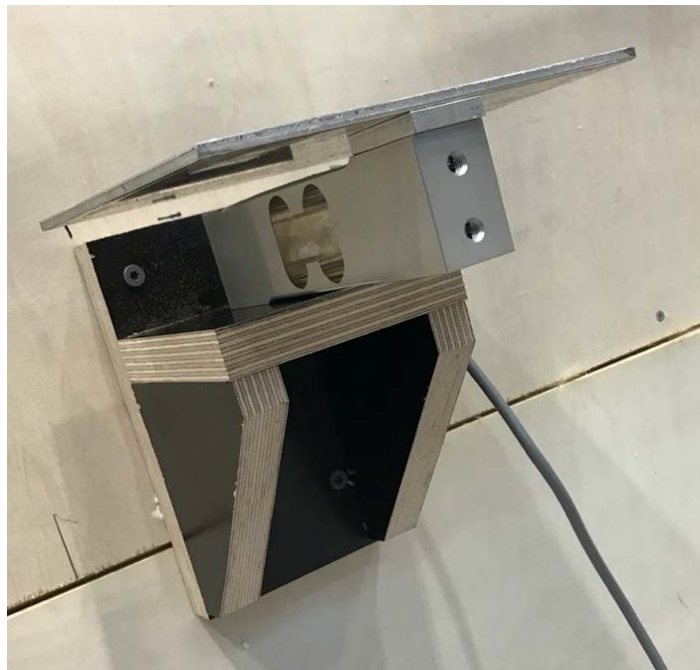
Figure 5.9: The load cells weighing the condensed water were screwed onto brackets made of plywood.

Standing-load cells were mounted beneath each wall segment at the exterior side of the wooden frame as follows: the load cells were screwed onto brackets made of plywood, and thin steel plates constituting the foundations for the water tanks were mounted on top of the cells (see Figure 5.9). As the load cells worked as cantilever beams, small steel spacers were mounted between the standing-load cells and steel foundations for the water tanks.

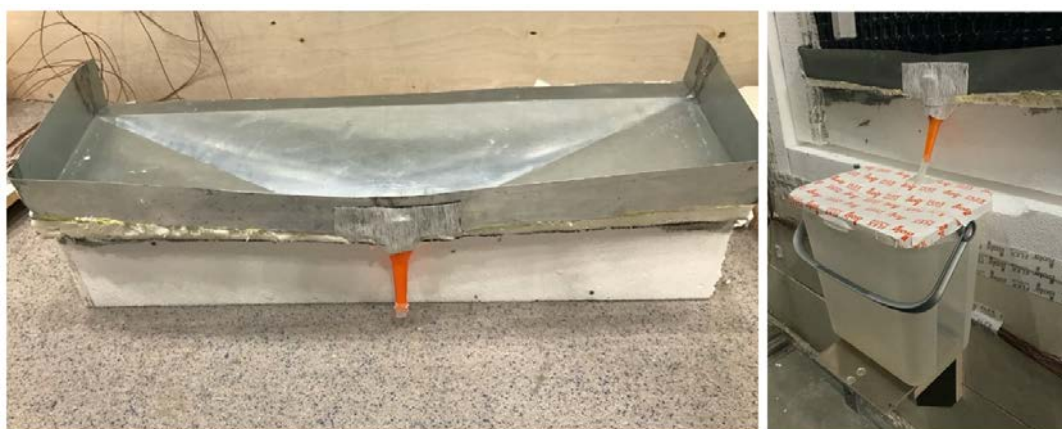
Figure 5.10: Metal fittings and water tanks mounted underneath the wall segments.

To transfer condensed water from the wall segments to the water tanks, metal fittings with plastic funnels and plastic tubes were mounted underneath the wall segments (see Figure 5.10). The funnels were hand-cut and glued to the metal fittings using butyl tape. The metal fittings were degreased, and a hydrophobic coating was applied to the upper surface to ease the runoff of water. To seal the airgaps underneath the metal fittings, polyurethane foam was applied to the bottom side and glued to the EPS. Eventually, the metal fittings were glued to the bottom of the concrete. The water tanks were glued to the steel plates at the standing-load cells. Then, the water tanks were filled with sunflower oil, and the metal fittings and water tanks were covered with vapour-barrier tape to reduce the evaporation of moisture. A small gap between the tape and wall segments allowed for some air exchange to the exterior air.
