Use of EPS formwork blocks in 4-storey apartment buildings

Risk- and vulnerability analysis

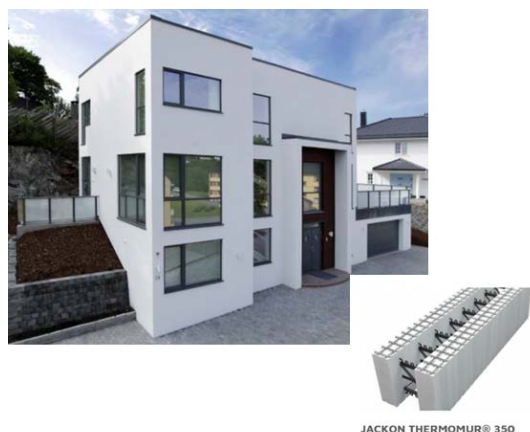
Figure 1. *Thermomur Building System.*

Thermomur is formwork blocks of *Jackopor*, which is made of expanded polystyrene (EPS), together with binders of high density polyethylene (HDPE) and polypropylene (PP). The *Thermomur*-elements are piled on top of each other and filled with a core of concrete which is reinforced. The building system is used for outer- and inner walls.

Thermomur is formwork blocks of *Jackopor*, which is made of expanded polystyrene (EPS), together with binders of high density polyethylene (HDPE) and polypropylene (PP). The *Thermomur*-elements are piled on top of each other and filled with a core of concrete which is reinforced. The building system is used for outer- and inner walls.

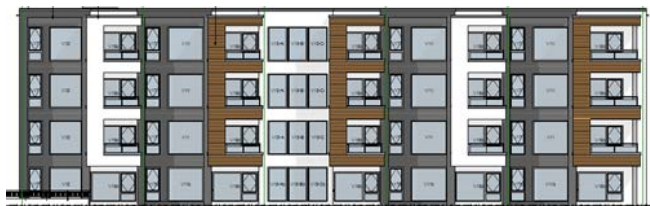
Figure 3 Facade, Losjevegen 3A-3B

A 4-storey apartment building in Losjevegen 3A-3B in Melhus, Norway is used as a case building for the project, see Figure 3 and 4. The case building has 5 apartments per floor, and parking/storage in the basement. The case building is used to find relevant fire safety requirements for 4-storey apartment buildings in VTEK, to calculate the specific fire energy and to determine the available safe egress time.

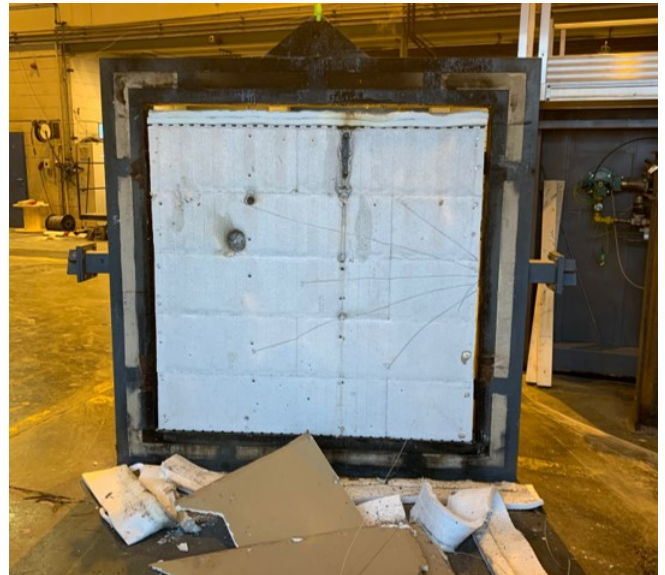
Figure 5 Result after small-scale test with inlaid mistakes and damages (12, 5 mm gypsum plate type A, 10 minutes)

- Thermomur covered with 12,5 mm gypsum board type A, fastened with 30 mm screws
- Test duration 10 minutes
- Poor execution, where the tape was left out from the joint and no filler was used
- Inserted gypsum plug
- Inserted gypsum anchor
- Hole after a gypsum plug is removed
- A larger hole with diameter 28 mm, simulating a damage after e.g. a bookshelf has been torn down and a larger bit of the gypsum has been removed

The visual results are shown in Figure 5.

- Melting from poor execution in joint is hardly visible
- Melting from inserted gypsum plug or anchor is hardly visible
- Hole after gypsum plug causes local melting and shrinking with a diameter of 30 mm
- Larger hole with diameter 28 mm causes local melting and shrinking with a diameter of 90 mm and a depth of 70 mm

The results showed that the building system is not vulnerable to damages in the cladding and poor execution, it only leads to local melting and shrinking. But the screws fastening the gypsum board easily loosened from the binders after the test, because of the heat. The minimum screw length of 30 mm is thus critical.
