WIRELESS MONITORING FOR ASSESSMENT OF CONCRETE RAILWAY BRIDGES – EXPERIENCES FROM FIELD TESTS

This paper focus on assessment on a prestressed three span concrete box bridge by the use of a wireless monitoring system in combination with visual inspection. The bridge is located in the very north of Sweden, in Abisko. A visual inspection of the bridge carried out the 18th of August in 2016 several crack patterns were mapped on the inside of the box girder bridge located near supports in the spans on both sides of the bridge. The cause of the cracks are not completely clear. To reveal the reason for cracking a long term project has been initiated by Trafikverket. Here a new developed wireless system has been used. Investigating change in crack widths by the use of LVDTs and strain gauges. Also accelerations are monitored together with the temperatures. In addition also fibre optic systems and non-destructive tests were carried out (not reported here). The results/conclusions presented in the paper are preliminary and final results will be presented 2021.

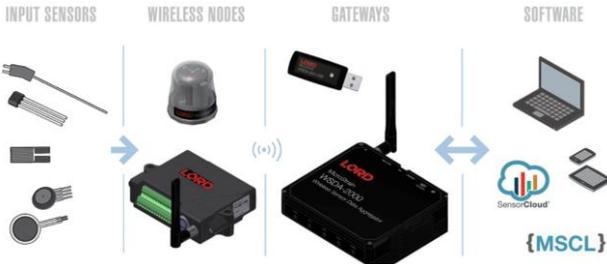
Figure 2 – Wireless monitoring system – in general.

In Figure 2 the principle for the system is shown. To a node a sensor is connected, from the nodes the data are then transferred wirelessly to a base station and from the base station the real-time data are downloaded to the cloud. The system installed on the bridge is shown in Table 1, where also an explanation to the different devices are presented, together with the placement in the first section of the bridge, se also figure 3. In Figure 4 the fiber optic system used is presented. The FOS is used only to monitor a pre-set intervals.

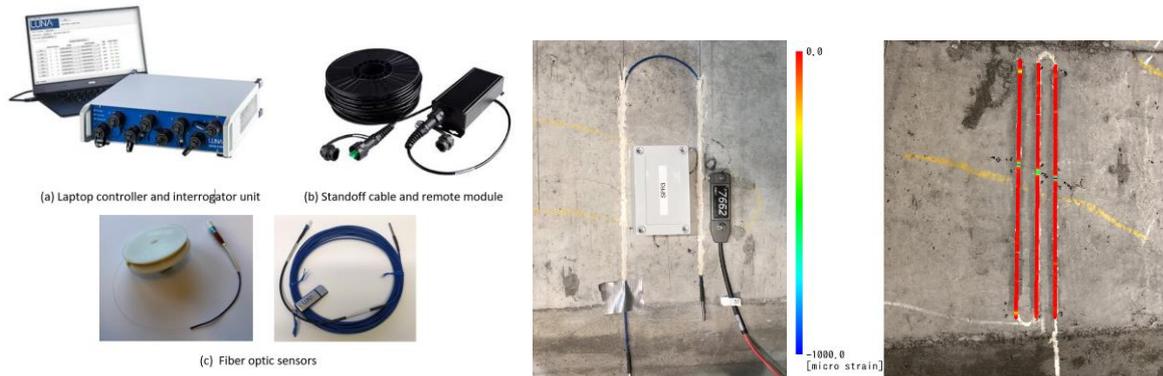
Figure 4 – a) Fibre Optic System. This platform is configured to measure standard “Rayleigh” High-Definition Fiber Optic Sensors (HD-FOS). HD-FOS operation is based on the measurement of the Rayleigh backscatter in optical fiber and delivers maximum spatial resolution for static and quasi-static applications. b) Installation of fibre optics in section where we also have a crack (LVDT) and a strain gage. c) Optical results from the FOS monitoring
