Fire spread in a large compartment with exposed cross-laminated timber and open ventilation conditions: #FRIC-02 - Exposed wall and ceiling

ABSTRACT

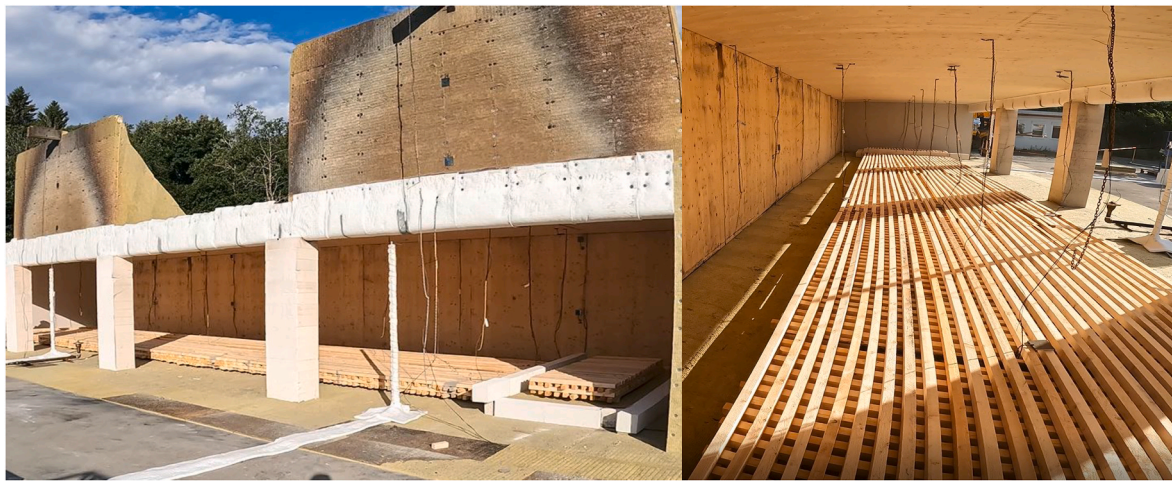
Fig. 1. Experimental setup from the outside and inside of the compartment. The small wood crib on the scale is on the right side of the left image.

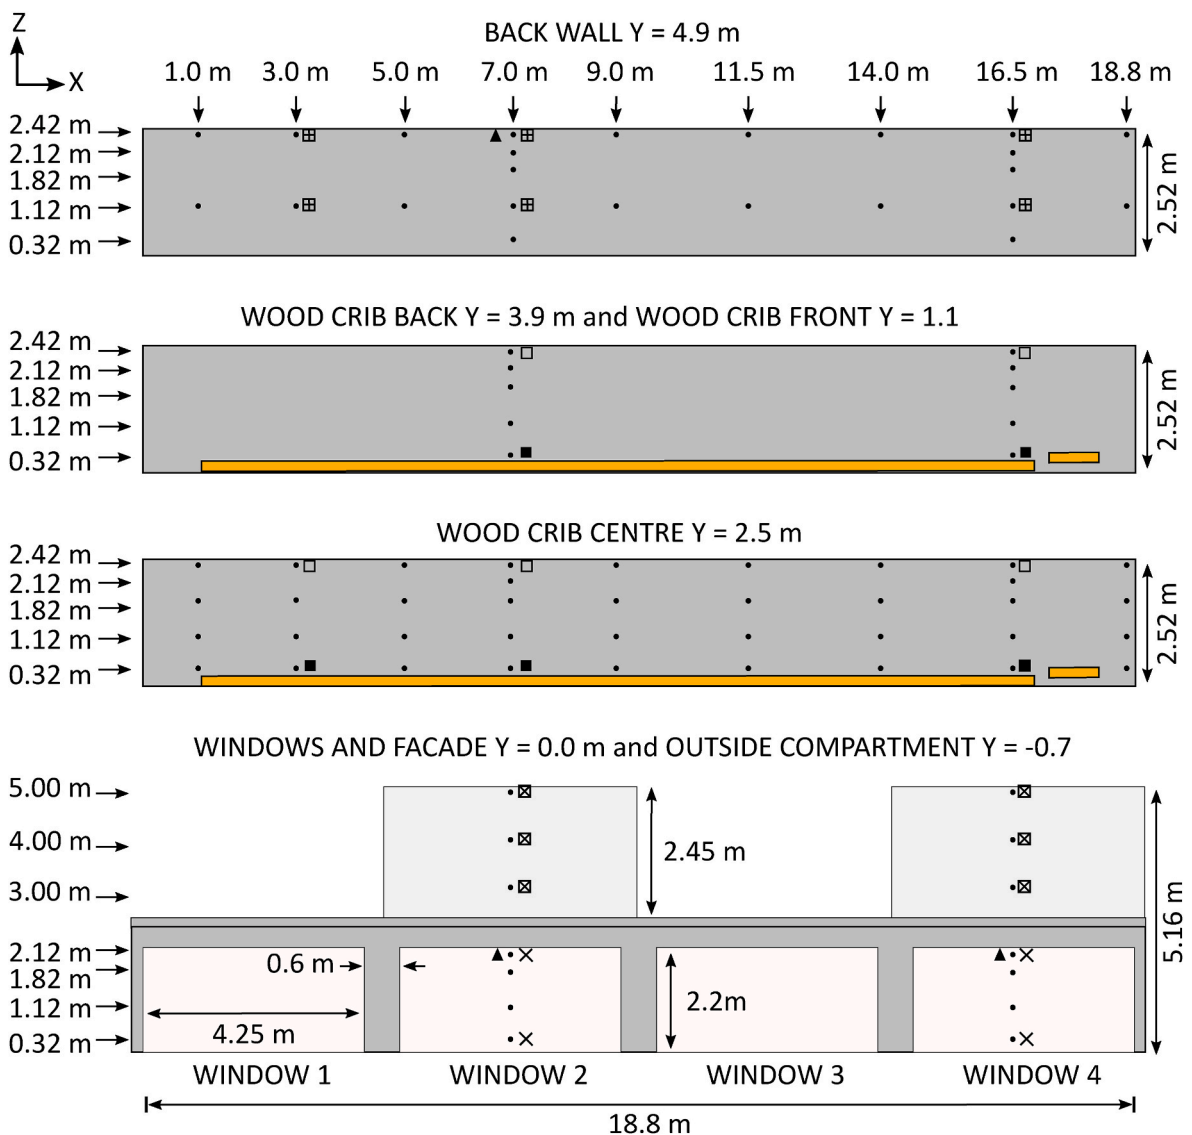
Fig. 5. Instrumentation in XZ-plane. For Y = -0.7 m, only TCs are used, not gas sensors or bidirectional probes. For symbols, see Fig. 3. Figure from #FRIC-01.

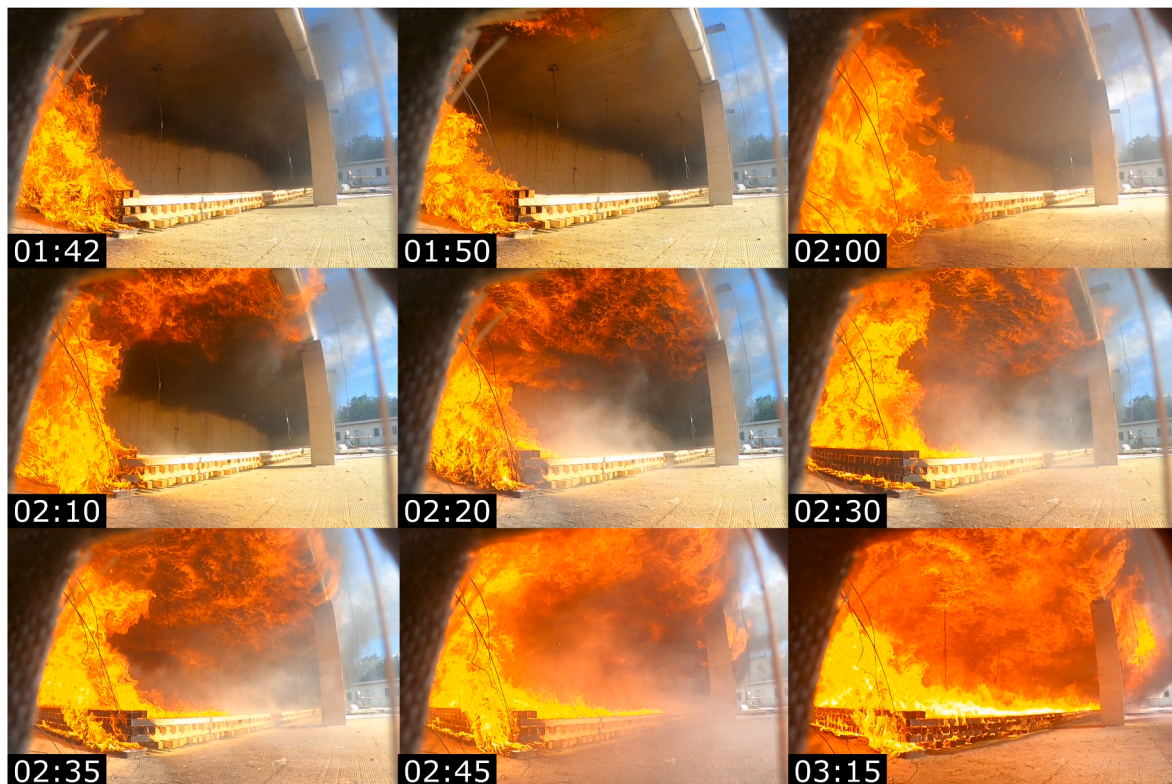
Fig. 6. Flame spread below the ceiling after ignition of CLT seen from the left side of the compartment. Time (mm:ss).

ceiling ignited, while the ceiling fire now covered approx. One-third (~6 m) of the ceiling area. The unignited wood crib was, at this point, strongly preheated by the burning ceiling, which is seen by the cloud of evaporated moisture in Fig. 6.

Fig. 6 gives a unique insight into the mechanisms of the fast fire spread. Shortly after ignition of the ceiling, a thick smoke layer formed below the ceiling. This smoke layer contained a large fraction of combustible gases (recognised by the black colour) and is a key factor for the flame spread below the ceiling, as discussed in #FRIC-01 [9]. The radiation from the burning ceiling preheated the CLT wall and the wood crib, which is seen by the cloud of evaporated moisture at 02:20 in Fig. 6. Shortly after, the wood crib fire started to spread rapidly.

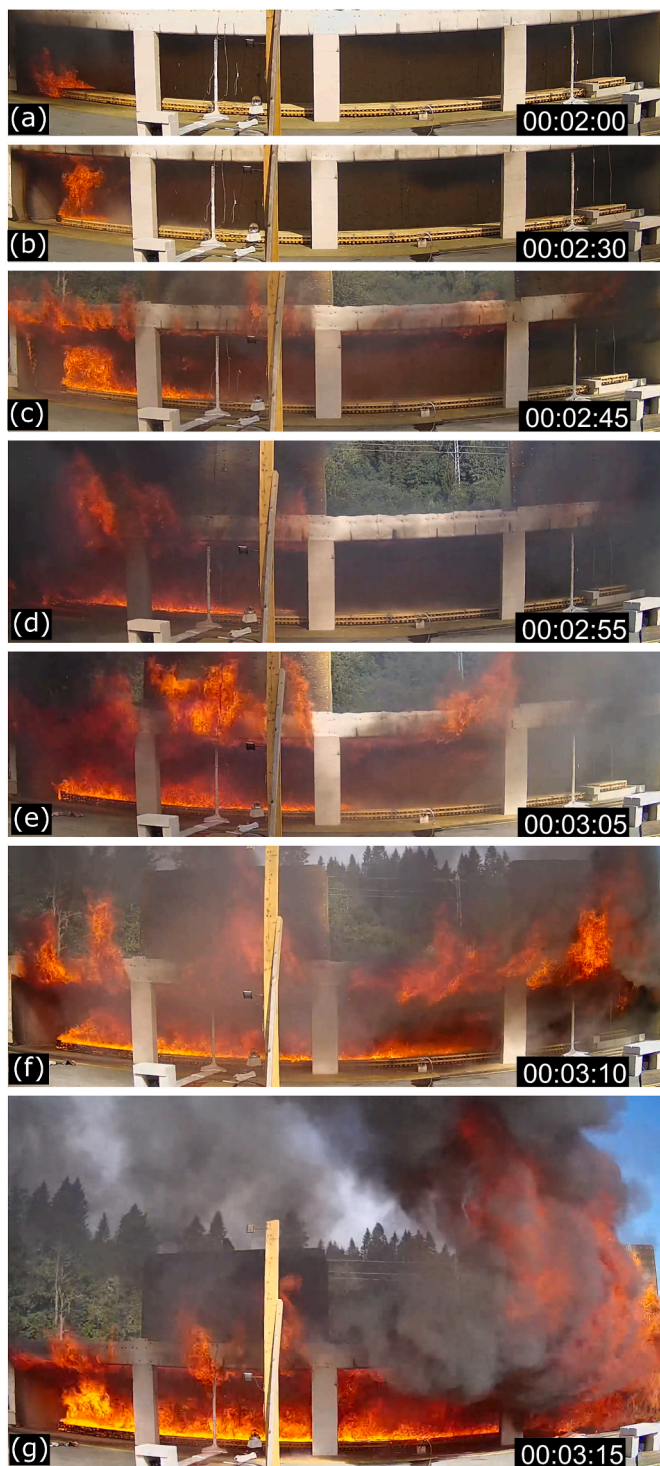
Fig. 7. (a)–(g) Fire spread across the compartment. Time (hh:mm:ss).

The first observation of the wall burning was at 02:00. At 02:30, a few meters of the upper third of the wall was burning at the left side of the compartment. From this point on, the fire spread rapidly, see Fig. 7. At 03:05, the fire had spread to about half the wood crib and three-fourths of the ceiling. At 03:10, large external flames emerged out of Window 4, and the entire length of the wood crib ignited at 03:13. This time is here defined as flashover as it was the first occurrence of all materials simultaneously burning. After the flashover, external flames appeared from all window openings, with the largest flames out of Window 4, farthest away from the ignition point.

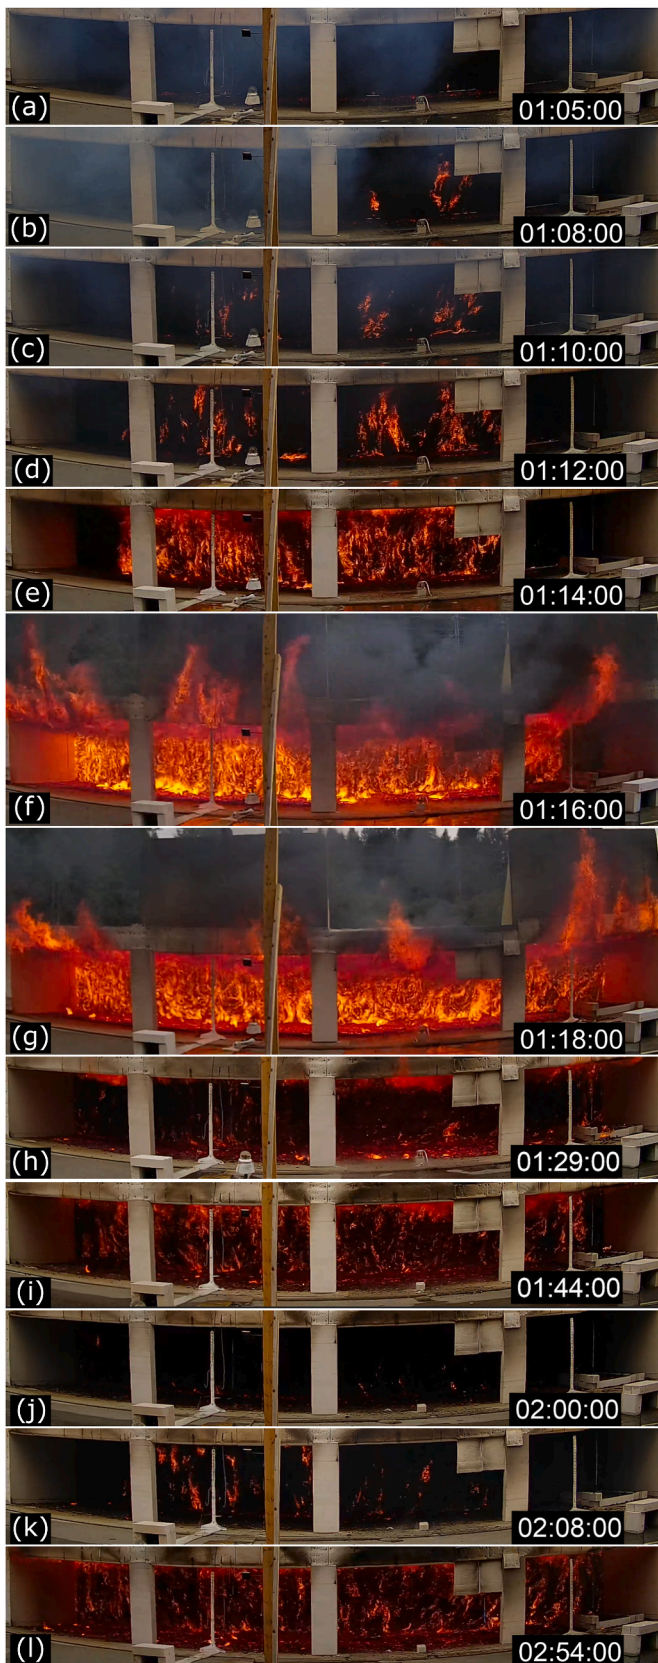
Fig. 9. (a)–(l) Development of the second flashover. (j) Fire intensity at its minimum. (k) Fire intensity at minimum compartment temperature. Time (hh:mm:ss).

Furthermore, the development of the flames in the transition to the second flashover matches well with the char depth pattern shown in Figs. 28–30. This is apparent in Figs. 10(a) and Fig. 11, where the first flames leading to the second flashover appeared at the lower height of the wall and the innermost part of the ceiling. It was also clear that the wall had been more charred than the ceiling at this point, as most of the wall was burning, while just part of the ceiling had visible flames on the surface. In addition, the right end of the back wall and ceiling ignited last, as seen in Fig. 9 (e). Consequently, it appears that the non-uniform

After the second flashover, the intensity and temperatures of the fire varied strongly, as seen in Figs. 9 and 12–14. The varying intensity and the compartment still burning after 175 min can be explained by three coinciding factors. 1) The burning of wood follows a natural variation in burning intensity. 2) The intermediate CLT elements were thin, only 20

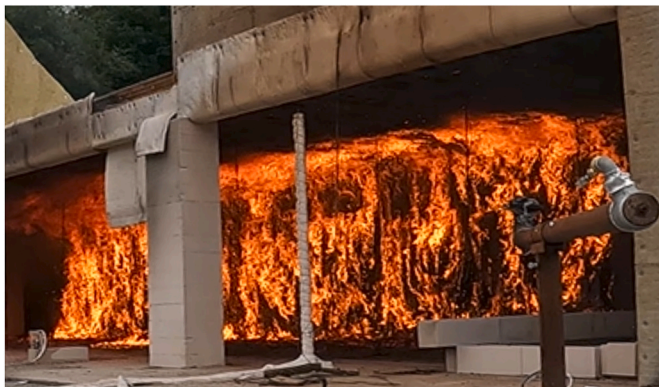
Fig. 11. In the transition to the second flashover, the full height of the back wall was burning before half of the ceiling width had been included in the fire. Photo from 74 min.

The small flames that appeared from 66 to 70 min (Fig. 10) rapidly grew in size, and at 74 min, most of the wall and half of the ceiling were burning, see Fig. 11. A distinct change in the burning behaviour occurred between 74 and 76 min, see Fig. 9. At 74 min, the flames were mainly originating from the burning of the fresh wood of the second layer. However, at 76 min, the intensity of the flames had increased significantly, and from the images, it is evident that also the first layer was burning again. The incident heat flux towards the wall increased in this period from approx. 40 kW/m² to 104 kW/m². At this point, external flames emerged from all window openings. At 78 min, the right end of the compartment was also included in the fire.

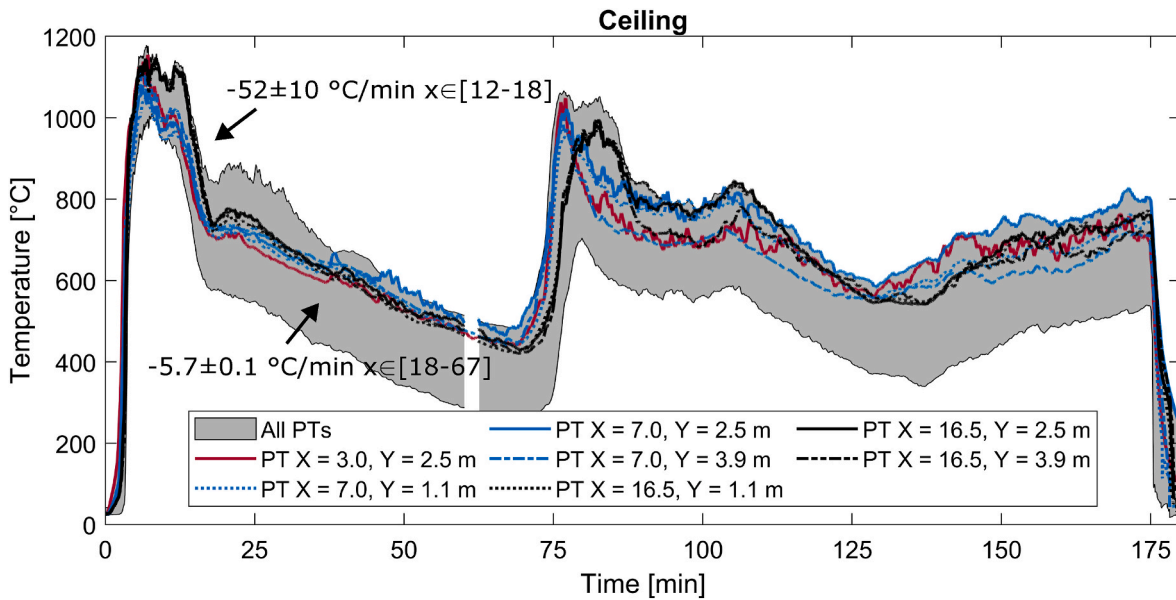
Fig. 12. Temperatures 100 mm below the ceiling measured by PTs facing downwards. The grey area covers all measurements by PTs in the compartment. X and Y represent the position of the PTs.

From 18 min, a temperature increase was measured by all PTs in the ceiling and some of the PTs on the back wall and the wood crib, see Figs. 12–14. This increase lasted for about 5–8 min, and the peak values were reached at 22 min. This increase is also seen in Figs. 15–17. Except for this short-lived increase, the temperatures in the whole compartment decayed after the extinguishment of flames at the CLT. The temperatures next to the ceiling and the wall decreased almost linearly, with an average rate of 5.7 ± 0.1 °C/min over the next 50 min. The ceiling temperatures in the decay phase were uniform, with just minor differences along the Y-axis. In contrast, significant differences were seen for the wood crib temperatures, with lower temperatures at the window side.

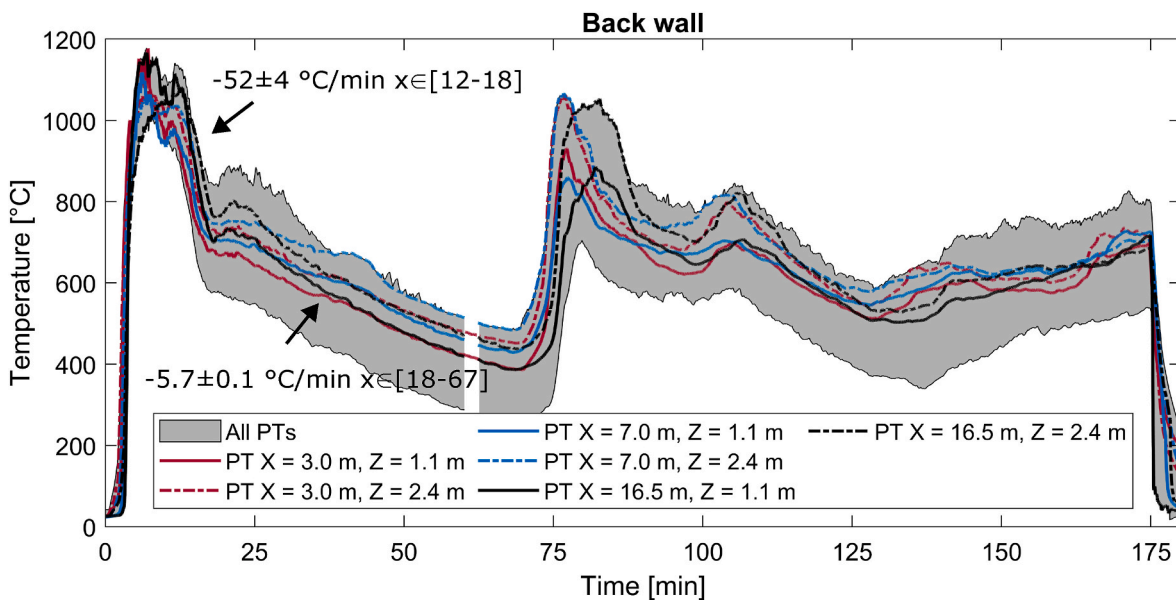
Fig. 13. Temperatures 100 mm in front of the back wall measured by PTs facing away from the wall. The grey area covers all measurements by PTs in the compartment. X and Z represent the position of the PTs.

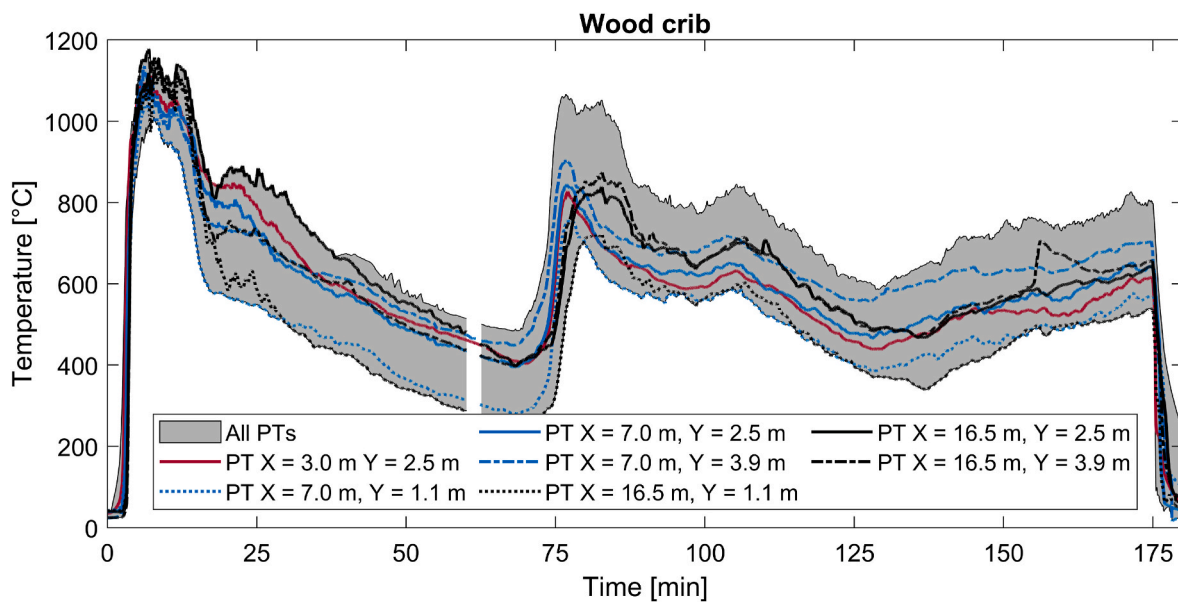
Fig. 14. Temperatures on top of the wood crib measured by PTs facing upwards. The grey area covers all measurements by PTs in the compartment. X and Y represent the position of the PTs.

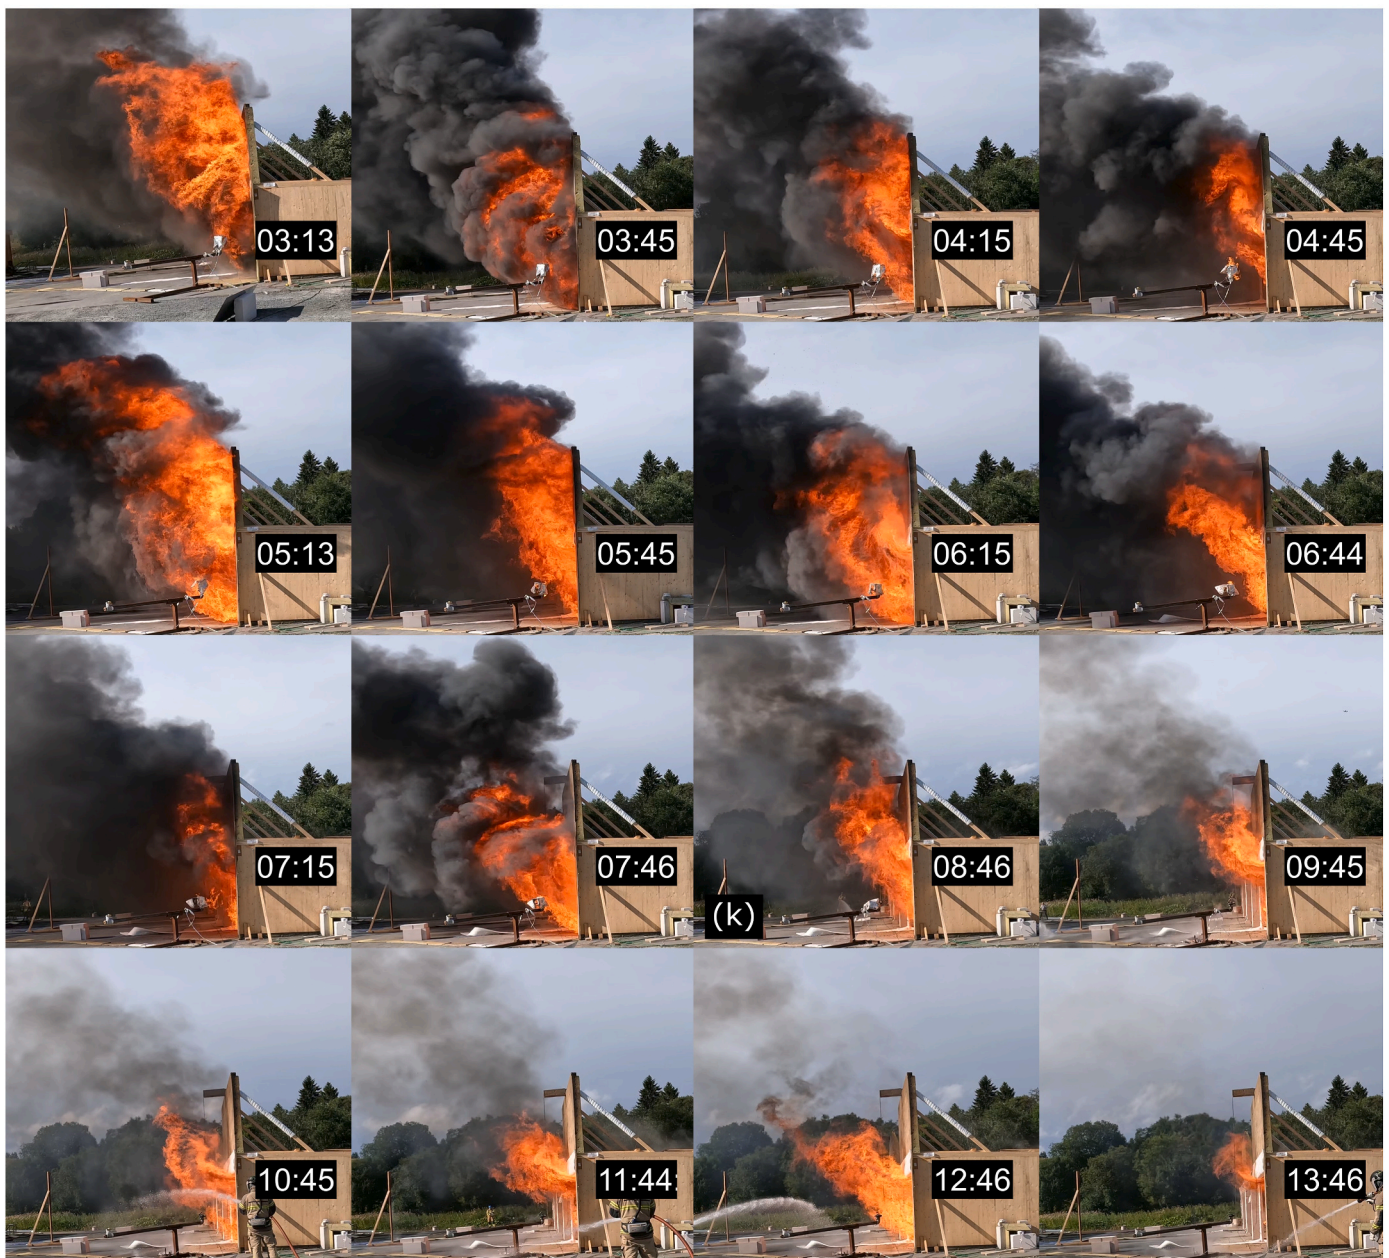
Fig. 18. Side view of external flame emerging from Window 4. Time (mm:ss) after ignition. The given times might deviate slightly (± 1 s) from the exact times as the start of ignition was not recorded.

Another characteristic of the flame from Window 4 was that it filled almost the entire window height for a part of the window in the most intense burning phase. Hence, the neutral plane was here almost at floor level. This can be observed several times in Fig. 18 and shown over time in Fig. 19.

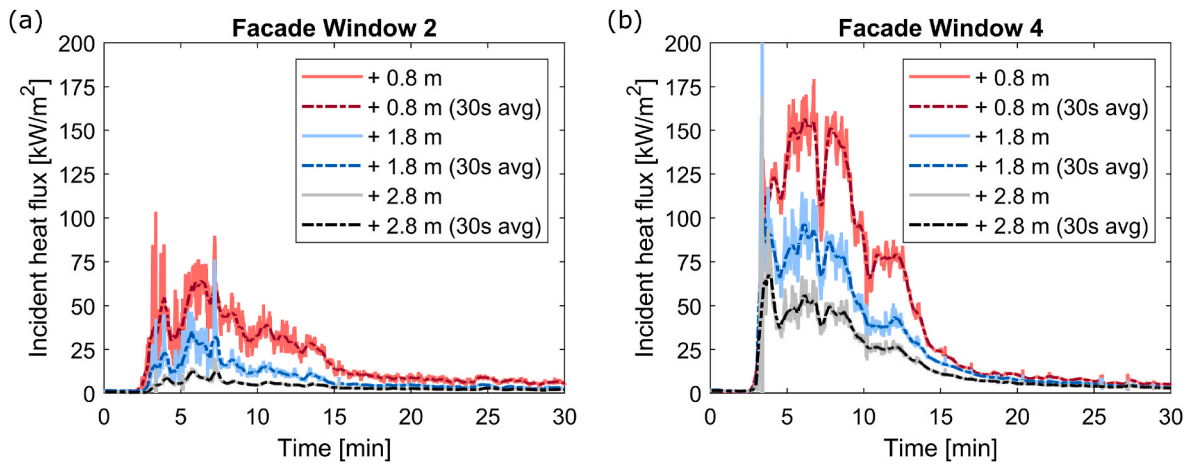
Fig. 22. Incident heat flux at the facade above Window 2 (a) and Window 4 (b). +0.8, 1.8, 2.8 m are heights above the window soffit.

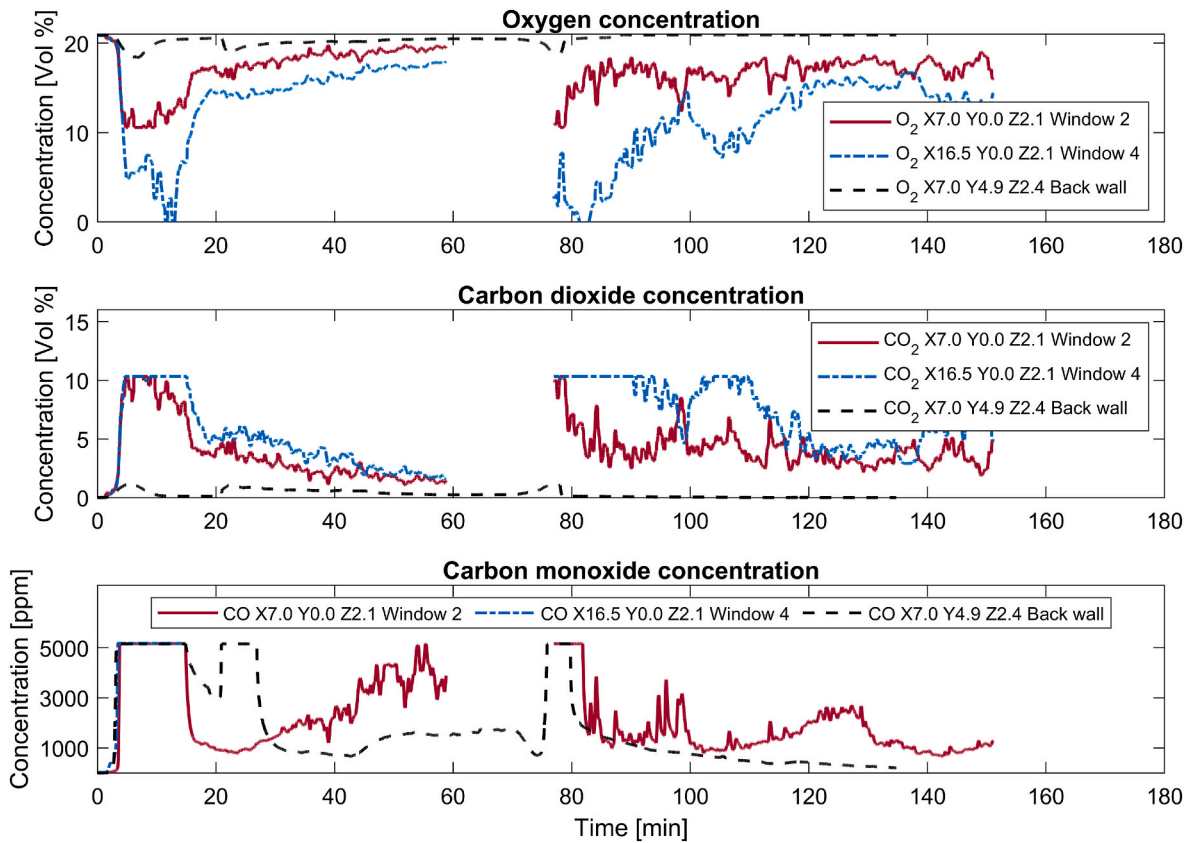
Fig. 27. O₂, CO₂ and CO concentrations of the compartment.

Oxygen (O_2), carbon dioxide (CO_2), and carbon monoxide (CO) concentrations were measured at three different locations, as described in Section 2.3, and the results are given in Fig. 27. The O_2 concentration measured in Window 2 was not recorded due to a fault. The O_2 concentration shown is, therefore, calculated backwards from the CO and CO_2 concentrations. For short periods, both the CO and CO_2 reached the limits of the sensor, and the actual O_2 concentration will therefore be lower than what is shown in the figure. Measurements for Windows 2 and 4 are missing from 60 to 80 min and after 150 min.

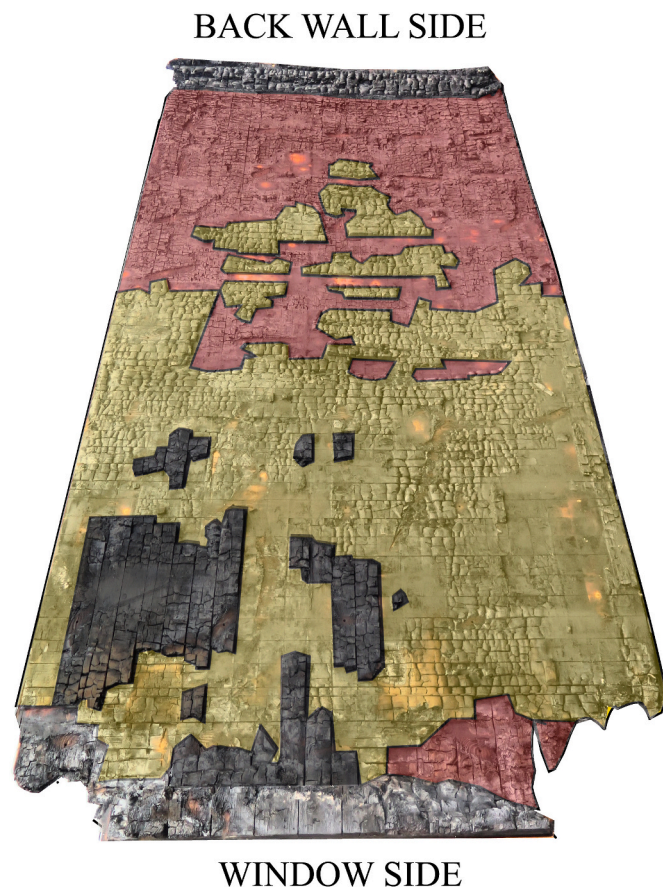
Fig. 30. Visualization of non-uniform charring for one CLT ceiling element based on a photo. Black is the 3rd layer, yellow is the 4th, and red is the 5th layer. The holes at the right and left lower corners of the window side were caused by smouldering and reignition after the end of the experiment, as this part was hard to reach with water due to safety precautions. (For interpretation of the references to colour in this figure legend, the reader is referred to the Web version of this article.)

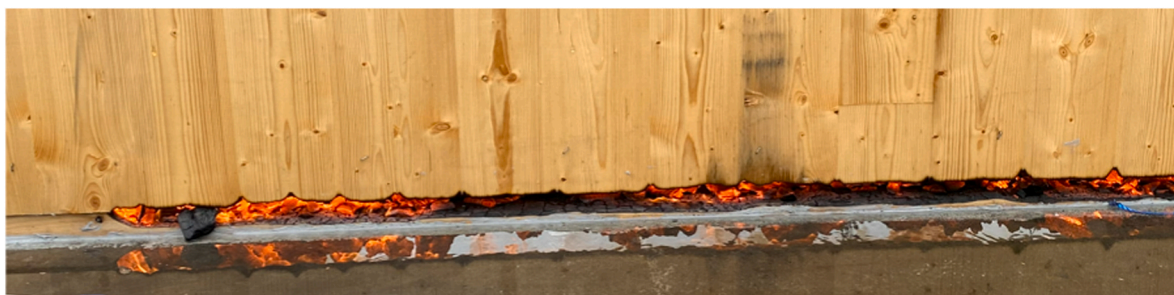
Fig. 31. The fire burned through the intersection between the back wall and the bottom plank at approximately 60 min. The image is taken at a later point when the gap had become larger. The lack of a fire sealant between the bottom plank and the CLT wall enabled this and highlights that connection details are crucial to fire safety.

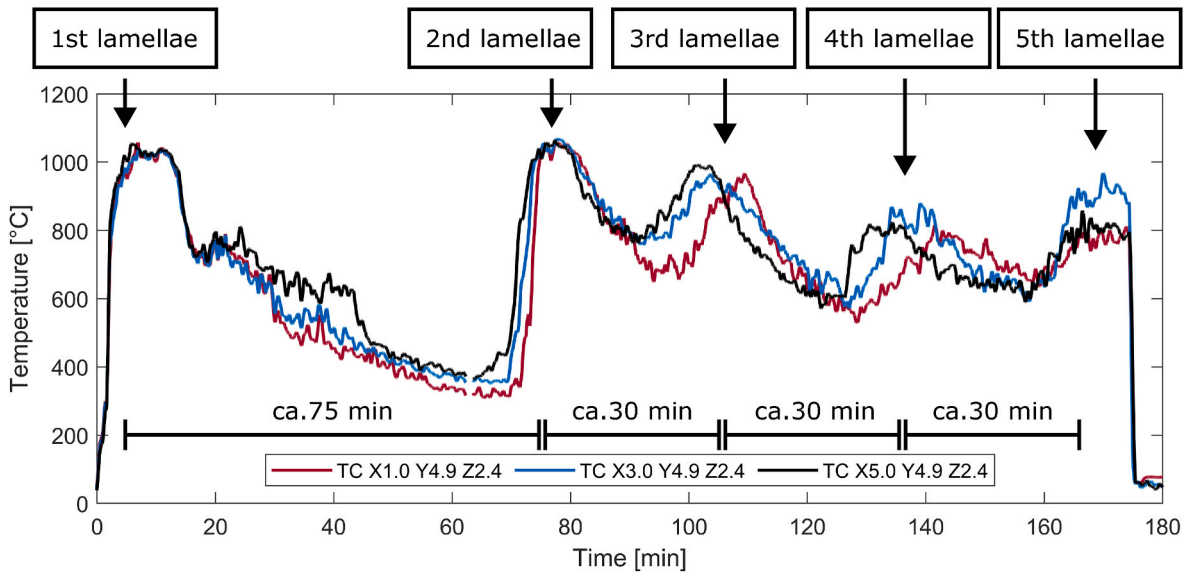
Fig. 32. Temperature of three TCs located next to the back wall. The peaks correspond to the burning of the different layers in the CLT wall.

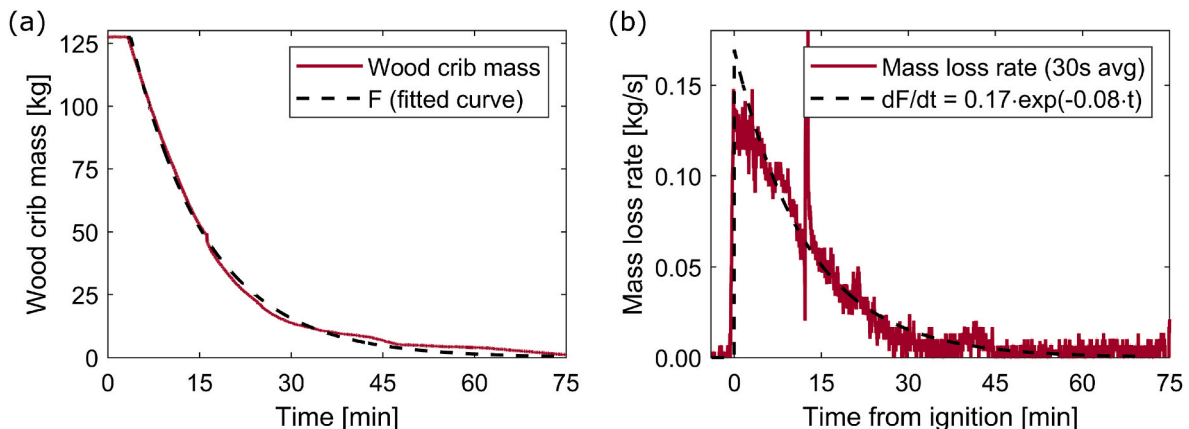
Fig. 33. (a) Mass loss of the small wood crib (1.0 m × 2.8 m) put on a scale. (b) Mass loss rate of the small wood crib.

The mass loss rate of the wood crib was determined as described in Section 2.3. An exponentially decaying function was fitted to the measured mass loss of the crib on the scale and then derived to get the MLR, see Fig. 33. Compared to the real MLR averaged over 30 s, the estimated MLR based on the fitted curve gave a good match.

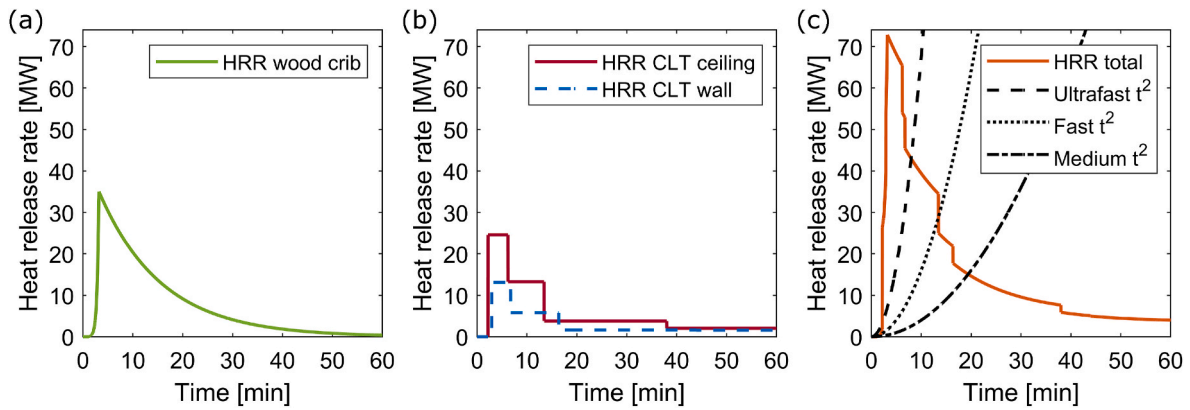
Fig. 34. Heat release rate of the wood crib (a), CLT (b) and total (c). The total HRR of the experiment is compared against the medium, fast and ultrafast fire growth rates [6].

The estimated HRR for the maximum external flames from Window 4 was 66 ± 20 MW, which does not align with a total HRR of 73 MW, see Fig. 34, as this would mean that two-thirds or more of the combustible gases were burnt outside. It is acknowledged that the estimation of the external flame involved significant uncertainties, both through the determination of the flame volume and by the conversion from volume to HRR. In addition, the method to determine the heat release of external combustion was developed based on smaller flames. Still, the estimated HRR of the external flame indicates that the total HRR is estimated too low, at least for some period. A factor that significantly influences the HRR is the combustion efficiency. This was set to 0.8, but given the high temperatures in the compartment and the strong re-radiation between the crib, the wall and the ceiling, it is not unlikely that the combustion efficiency could be higher than 0.8. Given that the combustion efficiency is correct, the HRR from the wood crib is considered to be quite accurate. However, the HRR from the CLT wall and ceiling is based on only three measurements each, where the average value of those is used to estimate the HRR from the CLT. Since there was quite a large difference between the minimum (1.90 mm/min) and maximum (3.28 mm/min) charring rate, it is not unlikely that the calculated average value is lower than the actual average value. Assuming a combustion efficiency of 0.9 instead of 0.8 and an average charring rate of 3 mm/min instead of 2.64 and 2.71 mm/min, the estimated total HRR ends up being 92.5 MW, almost 20
