Operation track record and repair of direct electrical heating system

ABSTRACT

Direct electrical heating is a flow assurance method for subsea flowlines. This article considers direct electrically heated flowlines that were installed at an offshore facility in 2004. In 2022, one of the piggyback cables was successfully repaired. The root cause for failure was dielectric breakdown of the transition joint between the feeder cable and the piggyback cable because of high accidental axial compression forces. The accumulated operation time from 2004 to 2022 was 450 days. Fingerprints from commissioning were essential in fault location, and the fault was pin pointed with an accuracy of a few meters. Investigations of the XLPE insulation material showed that the cable was in a generally good condition.

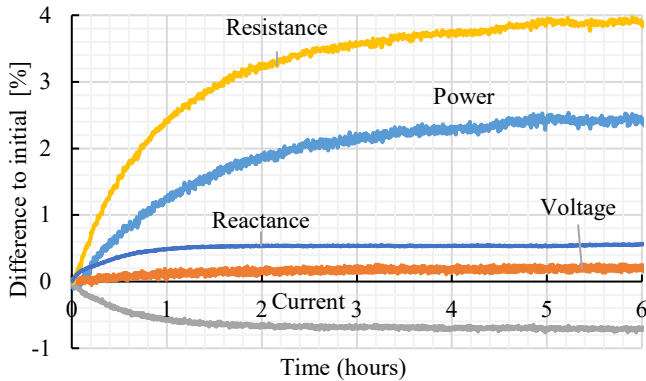
During design and operation, it is worth noticing that the DEH load resistance and reactance are temperature dependent. The temperature coefficient to electrical resistivity is 0.001 1/K for 13Cr, 0.003 1/K for X65 and 0.004 1/K for copper. For DEH1, stationary conditions are reached after about 6 hours, see Figure 6. The resistance increases by about 4%, power by 2.5%, reactance by 0.6% and current by -0.7%.

Figure 6: Record of topside parameters of DEH1 during start-up.

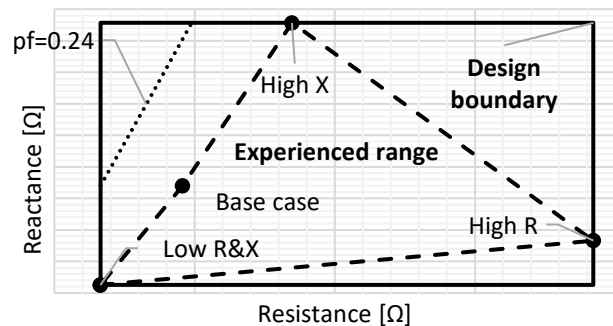
Based on magnetic steel properties proposed in Table 2, a range in the DEH impedance (resistance and reactance) is found, see Figure 7. The triangle in the center (dashed lines) represents the boundaries of experienced variation in resistance and reactance. However, design often considers all combinations of resistance and reactance, and is referred to as RX-window (resistance-reactance-window) indicated by solid lines. Impedances resulting in a lower power factor than 0.25, or 0.24 to include some margin, are not relevant for supply current greater than about 1000 A. Resistance and reactance corresponding to power factor of 0.24 is indicated by a dotted line. Power factor (pf) is defined as resistance divided by impedance.

Figure 7: Generic resistance-reactance (RX)-diagram based on material data from Table 2. Power factor (pf) of 0.24 indicated by dotted lines.

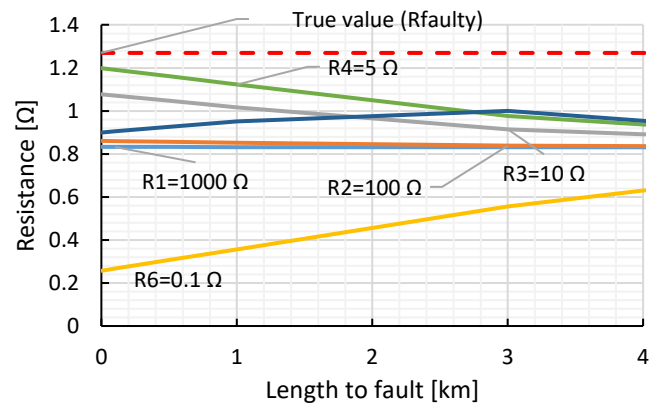
Fault location is performed by considering various fault locations and fault sizes, see Figure 9 and Figure 10. In the figures, the dashed lines represent the true resistance and reactance as measured from the topside power cabinet at low voltage at the fault event. The correct size and location of the fault is found when any of the solid lines crosses the dashed lines, for both resistive and reactive terms. For DEH1, this was at $X=0$ km for a 5Ω fault (25 cm^2). $X=0$ means at the start of piggyback cable, or upstream of this location, i.e. on feeder or riser cable.

Figure 9: Topside resistance as function of length to fault for various fault types. Dashed line represents true resistance.

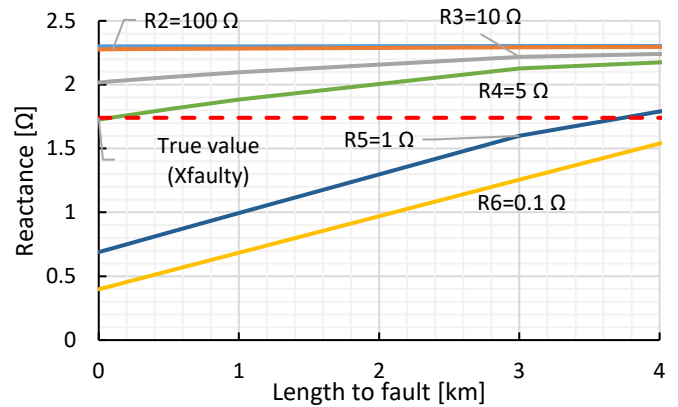
Figure 10: Topside reactance as function of length to fault for various fault types. Dashed line represents true resistance.

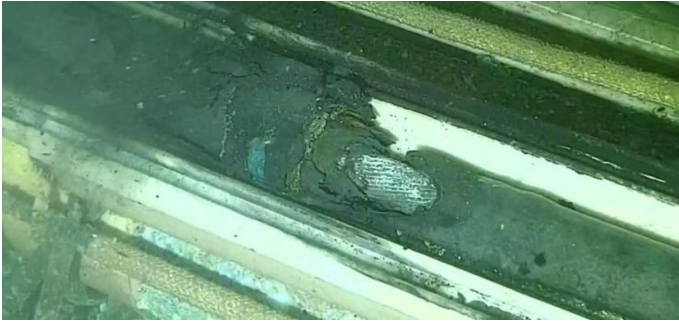
The fault location was visually confirmed by ROV operation to be on the piggyback cable close to the joint between the feeder and piggyback cable, see Figure 12.

Figure 12: Fault located on piggyback cable.

During repair, some length to each side of the fault was removed and a spare piggyback cable of 800 m was spliced in in both directions: for the section where there was a piggyback cable and as a replacement of armored feeder cable since the fault was at the intersection between these. As the piggyback cable has no metallic armor, two 800 m 240 mm² ground cables were installed as continuation from the feeder cable armor to the grounding point at the pipe near end. The two main implications of the repair were an adjusted impedance and possible local reduced heating efficiency.

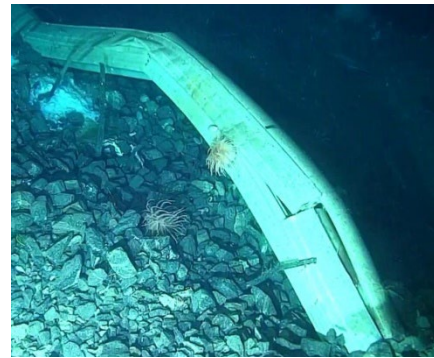
Some meters from the fault location, the steel bands holding the piggyback cable protection system to the flowline had snapped, see Figure 15. This may be a combination of thermal stresses from intermittent operation, unfortunate back-tension of piggyback cable during installation (too much cable in the protection) and other factors.

Figure 15: Piggyback cable protection snapped from flowline.

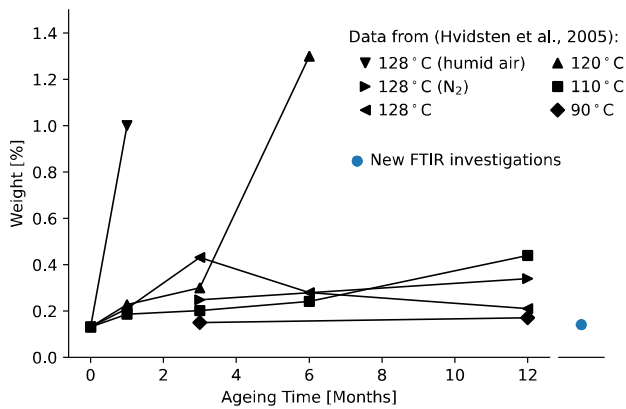
Oxidation of the XLPE insulation material was checked by FTIR (Fourier Transformed Infrared) spectroscopy, based on the same method as (Hvidsten et al., 2005). These results, see Figure 17, show that the oxidation of this cable was low compared to (Hvidsten et al., 2005), meaning that the XLPE insulation in general was in good condition when the fault occurred.

Figure 17: Carbonyl content calculated from the FTIR compared to measurements in (Hvidsten et al., 2005).
