Prevention of ASR by use of low alkali OPC and silica fume. Field and lab studies from the Maridal culvert and the Storo bridge in Oslo, incl. assessment of residual expansion

Bård M. Pedersen
Eva Rodum
Marit Haugen
Jan Lindgård

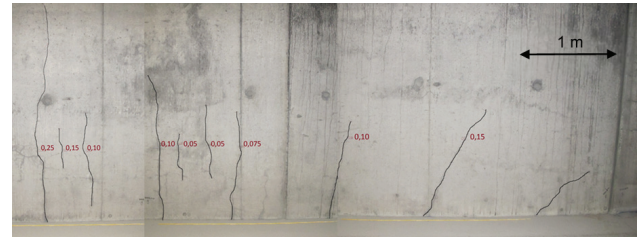
In June 2017, the Maridal culvert was visited and surveyed, and six cores were drilled from four different sections of the culvert. Typical crack patterns caused by early age hydration heat effects in a wall-on-slab structure are shown in Figures 3 and 4. Vertical cracks in the wall are caused by external restraint from the slab during the cooling phase of the wall. Cracks with crazing pattern (Figure 4) are caused by temperature gradients over the cross section of the (warm) wall shortly after demolding. Drying shrinkage may also produce (or further develop) the crazing, as can ASR if present. The crack widths varied from very fine cracks 0.03 mm up to 0.45 mm. These examples are typical for the initial state of cracking of a new structure, just a week or two after casting. The origin is cement hydration and subsequent heat generation.

Figure 3   Visual assessment of wall in the Maridal culvert, right half of section 42. Main cracks intensified on the photo, crack widths (in mm) are drawn on the photo [11]

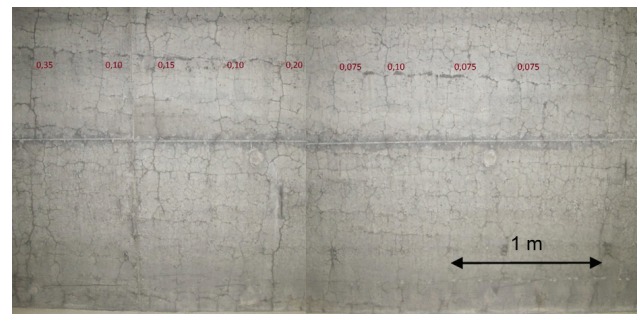
Figure 4   Visual assessment of wall in the Maridal culvert, part of section 38. Crack widths (in mm) are drawn on the photo [11]

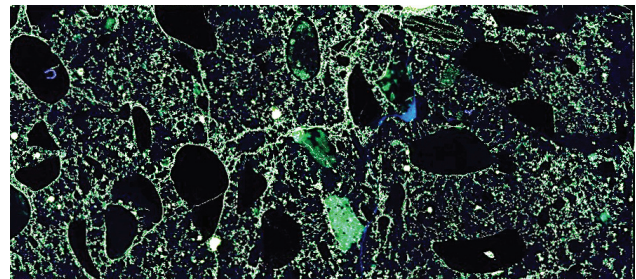
- Plane polished section (Figure 5): Some cracks in the cement paste, a few cracks in aggregates and very few cracks running from aggregates into the cement paste. No appreciable signs of ASR.

Figure 5   Plane polished section from wall section 42, in ordinary and UV-light. The length of the section is 200 mm, surface to the right. Comment: The core was drilled through a crack starting at the surface (crack width 0.25 mm), then turning parallel to the surface in a depth of about 80 mm. Due to this cracking, the outer part of the core was broken during the drilling process. The core was thus glued before preparing the polished section, with a non-fluorescence epoxy. These cracks can therefore only be observed in the left picture (but not in the right picture). [10]

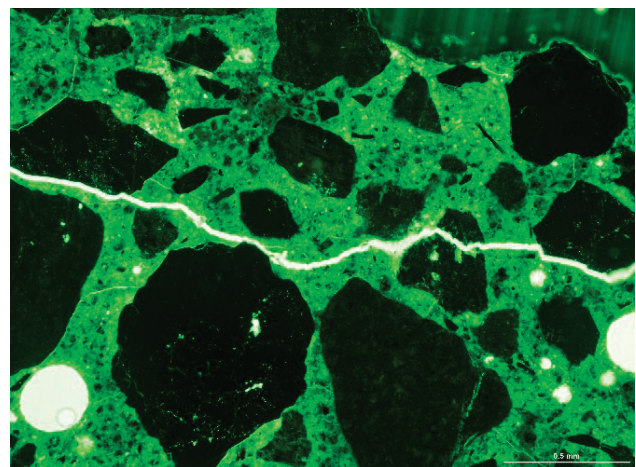
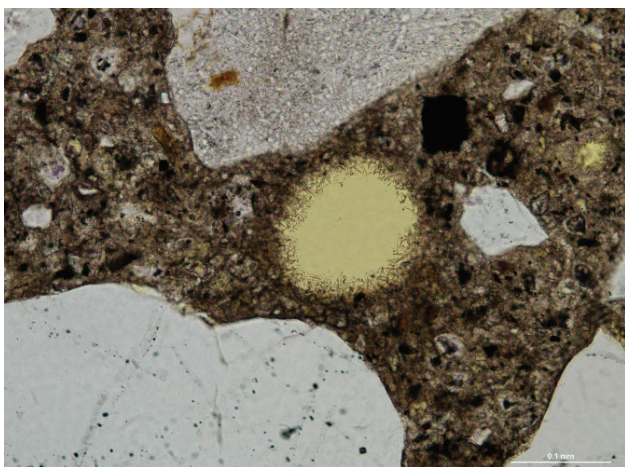
Figure 6   Thin section details. No signs of ASR were observed. Left: Ettringite in a small air void. Right: Crack in the cement paste. [10]

- Thin section (Figure 6): Some micro-cracking, no coarse cracks. Some ettringite and a few particles of undispersed silica fume were observed. No signs of ASR.

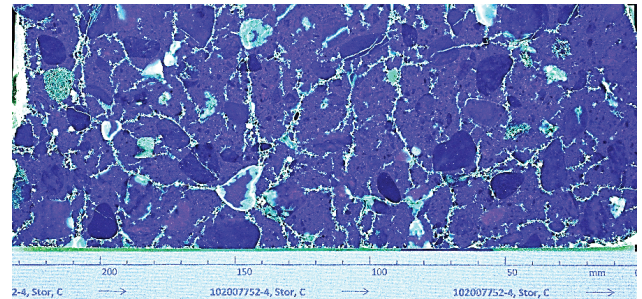
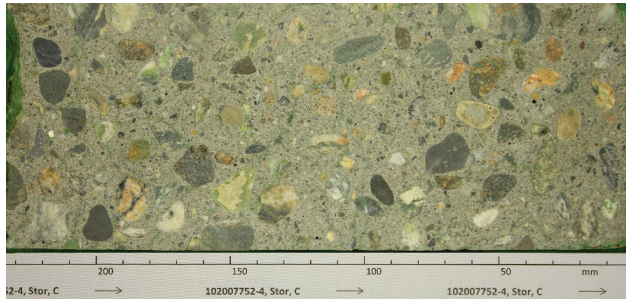
- Plane polished section (Figure 8): Cracks in some aggregate particles, some cracks running from the aggregate into the cement paste. A white precipitation product found in some air pores.

Figure 8   Plane polished section from Storo bridge, in ordinary and UV-light. The length of the section is 230 mm, surface to the right [10]

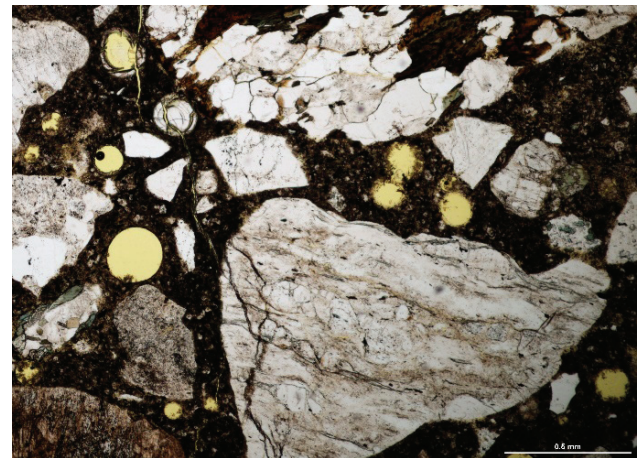
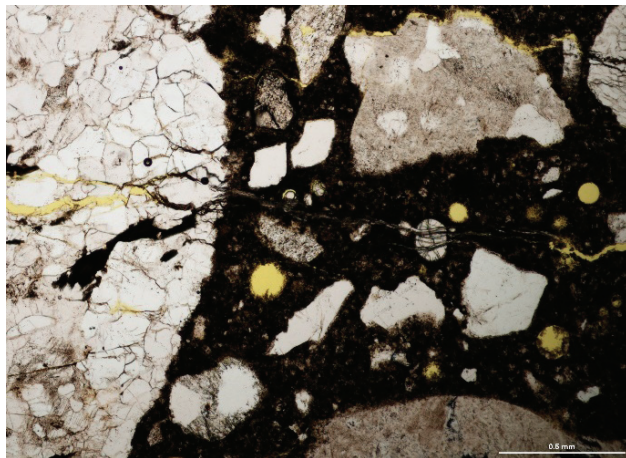
- Thin section (Figure 9): Many micro-cracks and fine cracks. Alkali-silica gel observed in several air pores and in cracks, both in the aggregate particles and in the cement paste. ASR has led to internal cracking of the concrete.

Figure 9   Thin section details. Left: Alkali-silica-gel in a crack running from a quartz-rich rock. Air void in crack filled with alkali-silica gel. Right: Alkali-silica gel in a crack running from a mylonite rock. Air void in crack filled with alkali-silica gel [10]

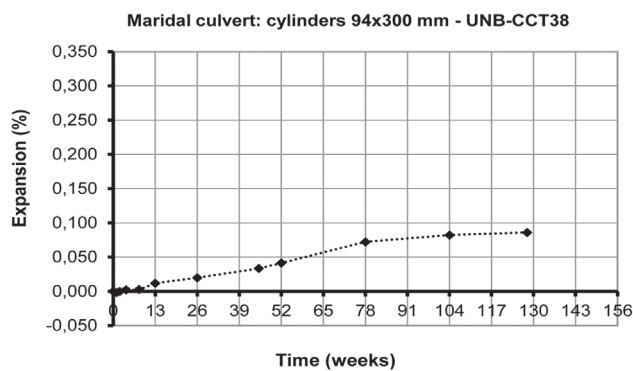
Expansion results up to 128 weeks of exposure are shown in Figure 10. As can be seen in the Figure, the specimens are expanding slowly at 38 °C before levelling off after two years of exposure.

Figure 10 Residual expansion testing by the Canadian UNB-CCT test method. Mean values of three samples [12]

So, what can we learn from this plot? Should we expect that the concrete would react and expand in the long run or not? When exposed to 38 °C and 100% RH there is obviously some potential for reaction. The expansion level at 52 weeks is above the border of the 0.030% limit given by the Norwegian regulations when running performance testing by use of the concrete prism test method [8]. However, the residual expansion test method is "more aggressive" than the CPT-method since there is no leaching of alkalis (or more likely a slight ingress of alkalis from the solution surrounding the sample). The results shown in Figure 10 have been compared with residual expansion results from another bridge with a more reactive concrete composition, see Section 4.2.

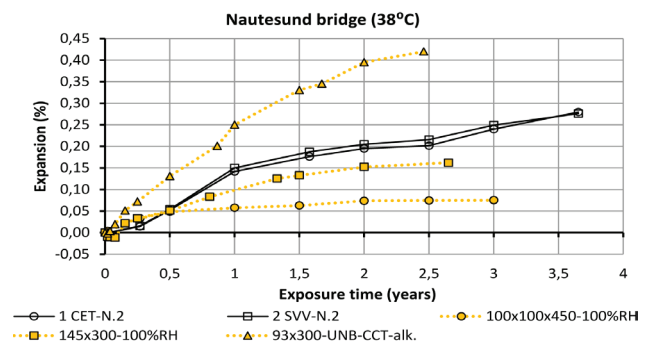
Figure 11 Test results from the Nautesund bridge, all samples exposed to 38 °C. Black lines show results from accelerated testing of freshly cast reconstructed concretes, yellow dotted lines show results from residual expansion testing [12]

As seen from Figure 11, the accelerated residual expansion of the Canadian "UNB-CCT" cylinders (labelled "93 × 300-UNB-CCT-alk.") is 0.25% at 1 year and still increasing. Accelerated residual expansion of sawn 100 mm prisms (labelled "100 × 100 × 450-100%RH") and ø145 mm drilled cylinders (labelled "145 × 300-100%RH"), tested according to the Norwegian CPT-method, show significantly lower expansion levels at all ages. The sawn prisms (with highest area/volume-ratio) is levelling off after six months of exposure at a relatively low expansion level, most likely due to lack of alkalis caused by leaching combined with further consumption of alkalis by the ASR-gel developed during the testing. The expansion potential for the freshly cast reconstructed concrete (100 mm prisms labelled "Mix 1" and "Mix2") is significantly higher than the residual expansion of sawn prisms of original concrete (of same prism size), but much lower than the results of the "UNB-CCT" residual method with possibility of external alkali supply. The ø145 mm drilled cylinders are still expanding after two years of exposure but are tending to level off after 1-1.5 years of exposure.

It is interesting to note that the freshly cast reconstructed concretes and the two residual expansion test series, all exposed to 100% RH, obtain equal expansion (0.05%) after six months of exposure. After this point in time, the access to alkalis in the concrete pore water is controlling the further ASR expansion. Since the field concrete already (during 50 years of service) had developed ASR at the time of drilling, the "starting" alkali level in the pore water is lower (due to consumption of alkalis by the ASR-gel) compared with the freshly cast concrete. This is assumed to be the main cause for the earlier levelling off for the field concrete samples.
