## MonArc Project Report 2019

Monitoring of Arctic Infrastructure  
(MonArc – project duration 2017-2019)

**KEYWORDS:**Infrastructure,  
permafrost,  
foundations,  
monitoring, climate  
change, Svalbard,  
Arctic.**VERSION**

2019:01231

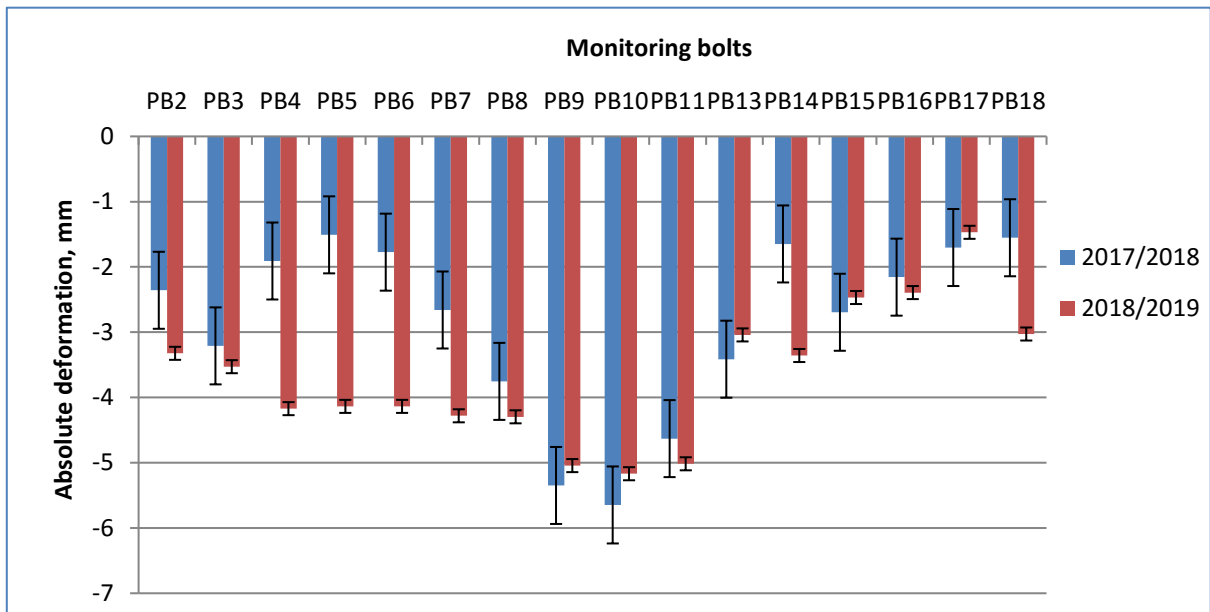
Absolute displacement and errors of measurements of the monitoring points under the multi-purpose garage are in the range 1-2,5 mm/year, with decrease in magnitude for 2018–2019 in comparison to 2017–2018. The latter is opposite to the situation at the outer walls. Settlements under the central part of the garage are smaller than at the outer walls. One may suggest that permafrost conditions are colder (and hence the settlements of piles are smaller) under the building compare to the outer walls due to drier conditions and better surface conditions (absence of snow in the wintertime).

Figure 6. Absolute displacements of monitoring points (and errors of measurements) on the outer walls at the multi-purpose garage in Pyramiden in 2017-2018 and 2018-2019.

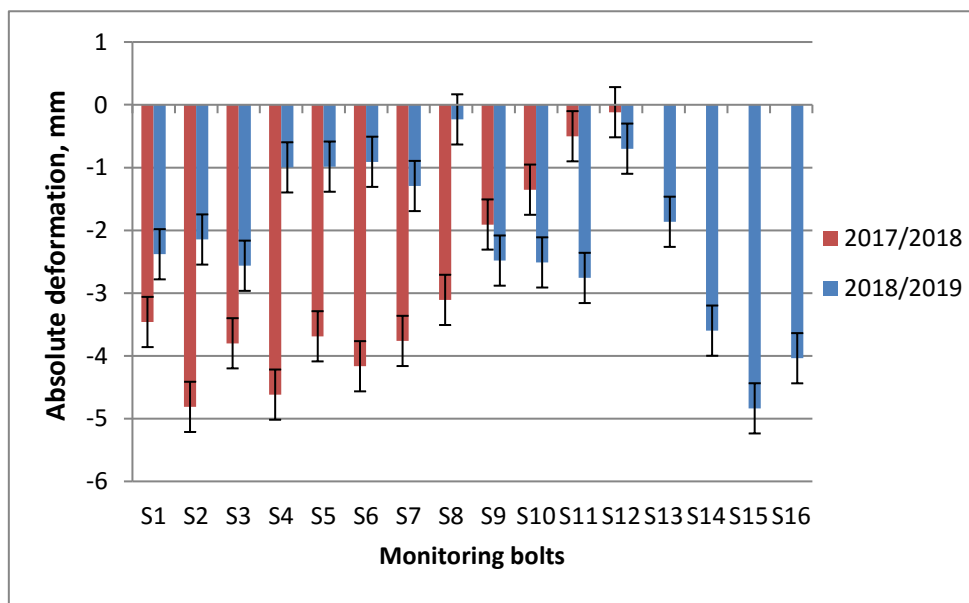
**Figure 9. Absolute displacements (and errors of measurements) at the barack "Låven" in 2017–2018 and 2018–2019.**

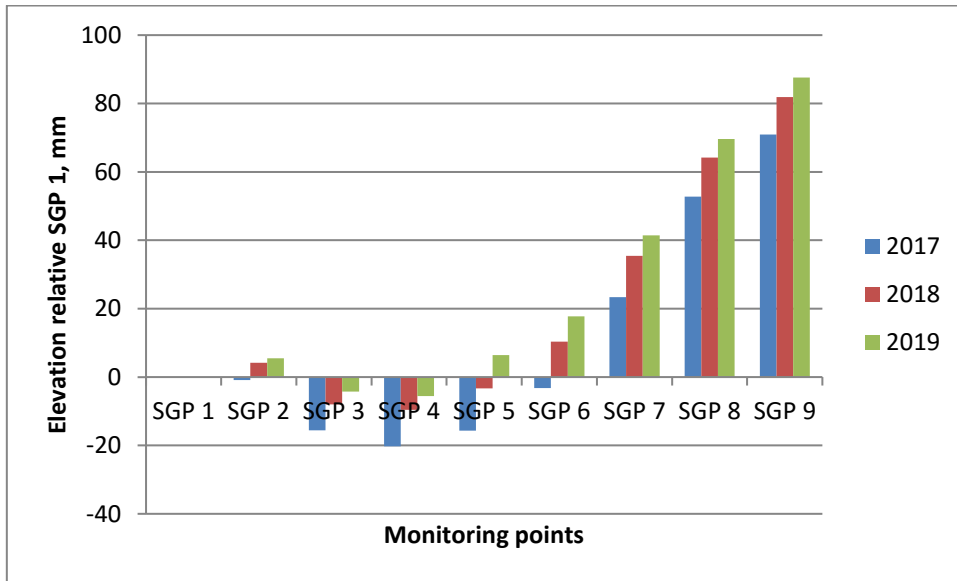
For the "Magnetittlageret" garage, elevations of measured points (for the right-hand side – SGP2–SGP9; for the left-hand side – SGL2–SGL9) were measured in relation to the first channel on each side (for the right-hand side – SGP1; for the left-hand side – SGL1) for 2017–2019 and are presented in Figure 10–Figure 11.

Absolute displacements on both sides of the garage (relative to the first points on each side) are presented in Figure 12–Figure 13. One can see significant differential (1–14 mm) vertical displacements on both sides of the garage in 2017–2018 and 2018–2019. Displacements were higher in 2017–2018. Largest displacements are noted on the right-hand side when one facing entrance of the garage (the entrance towards the airport).

Figure 10. Elevations of points SGP2–SGP9 relative to SGP1 on the right-hand side on the "Magnetittlageret" garage.

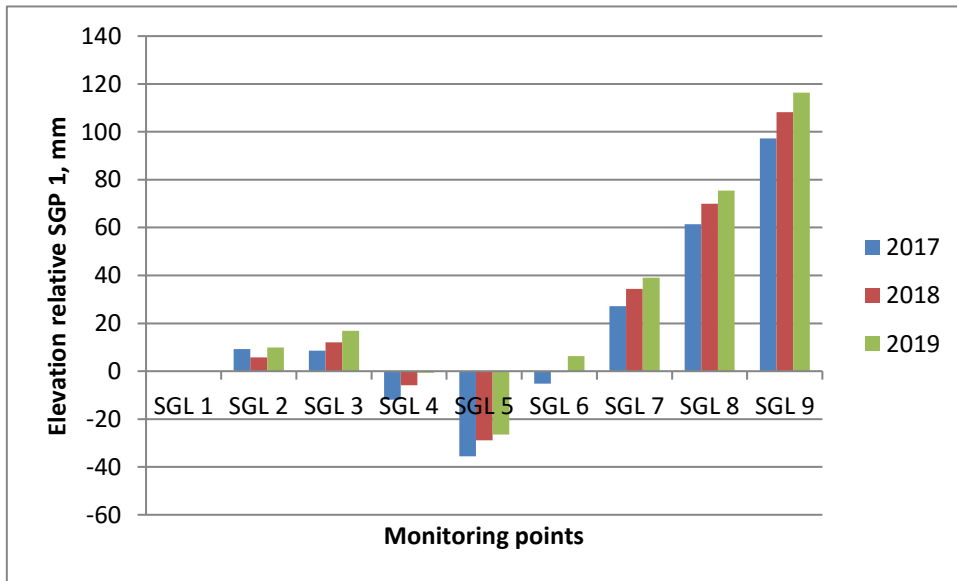
Figure 11. Elevations of points SGL2–SGL9 relative to SGL1 on the left-hand side on the "Magnetittlageret" garage.
