# Experiences with Thermal Spray Zinc Duplex Coatings on Road Bridges

Ole Øystein Knudsen <sup>1,\*</sup>

**Abstract:** Road bridges are typically designed with a 100-year lifetime, so protective coatings with very long durability are desired. Thermal spray zinc (TSZ) duplex coatings have proven to be very durable. The Norwegian Public Roads Administration (NPRA) has specified TSZ duplex coatings for protection of steel bridges since 1965. In this study, the performance of TSZ duplex coatings on 61 steel bridges has been analyzed. Based on corrosivity measurements on five bridges, a corrosivity category was estimated for each bridge in the study. Coating performance was evaluated from pictures taken by the NPRA during routine inspections of the bridges. The results show that very long lifetimes can be achieved with TSZ duplex coatings. There are examples of 50-year old bridges with duplex coatings in good condition. Even in very corrosive environments, more than 40-year old coatings are still in good condition. While there are a few bridges in this study where the coating failed after only about 20 years, the typical coating failures are due to application errors, low paint film

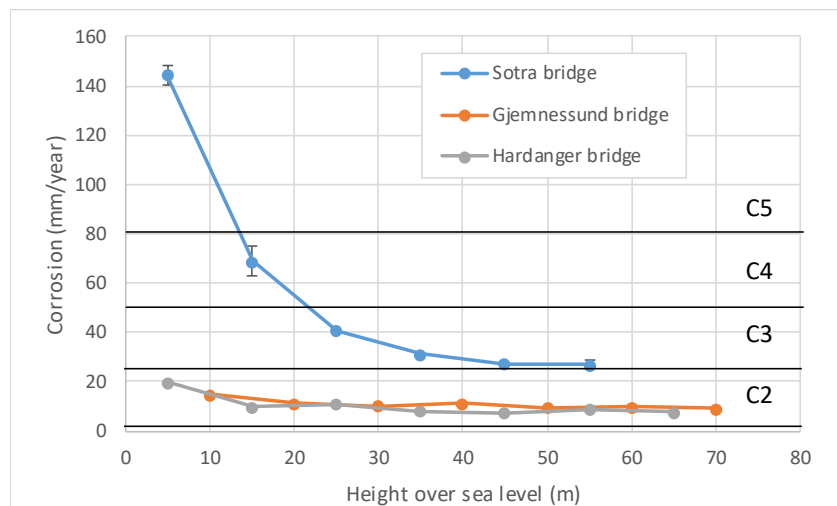
**Figure 2.** Corrosivity on three bridges as a function of height over sea level.

As Table 3 shows, the corrosivities measured at the level of the bridgeway are all within categories C2 and C3. On Nessundet bridge, the west side is more corrosive, probably because western winds are dominating. Under the bridgeway, the samples were shielded from rain, which resulted in a much lower corrosion rate than on the sides. Tjeldsund bridge is going east-west, so the difference between the directions are smaller, but the north side is slightly more exposed. On Gjemnessund, the corrosivity was highest under the bridgeway, where the samples were mounted on a vortex shedding blade. This is probably explained by the deposition of sea salt and shielding from rain that would wash the salt off the surface. The sailing clearance is 43 m, but salt deposits are nevertheless found under the bridgeway. In general, coastal bridges are more susceptible to coating degradation and corrosion on the underside of the bridgeway due to this effect. On Sotra bridge, C3 corrosivity was found on the pylon at the level of the bridgeway. No measurements were performed on the bridgeway, which may have shown higher corrosivity, as found on Gjemnessund. Hardanger bridge, which is the most shielded of the five bridges showed low corrosivity. As for Gjemnessund, the corrosivity may have been somewhat higher on the bridgeway, but due to the high sailing clearance and wind shielding, the corrosivity is assumed to be low even here. Figure 2 shows corrosivity as a function of the height along one pylon on three of the bridges, measured from 5 m above the sea level. On Gjemnessund and Hardanger, the corrosivity was generally low all the way. For both bridges, this was somewhat surprising since the pylons are located near the sea. Airflow patterns around the massive concrete pylons may partly explain the difference, but the lower annual precipitation at these two sites may also have contributed, decreasing the time of wetness on the samples. For the Sotra bridge, it is interesting to see how the corrosivity decreases as a function of height. Up to about 12 m, the corrosivity was category C5. Further up the corrosivity gradually decreased and reached almost category C2 from 45 m.

From the corrosivity measurements, it is evident that the height above sea level has a large influence on corrosivity. Annual precipitation also seems to be an important parameter. Wind conditions are expected to contribute, but wind measurements on the investigated bridges have not been performed and cannot be discussed in this study.

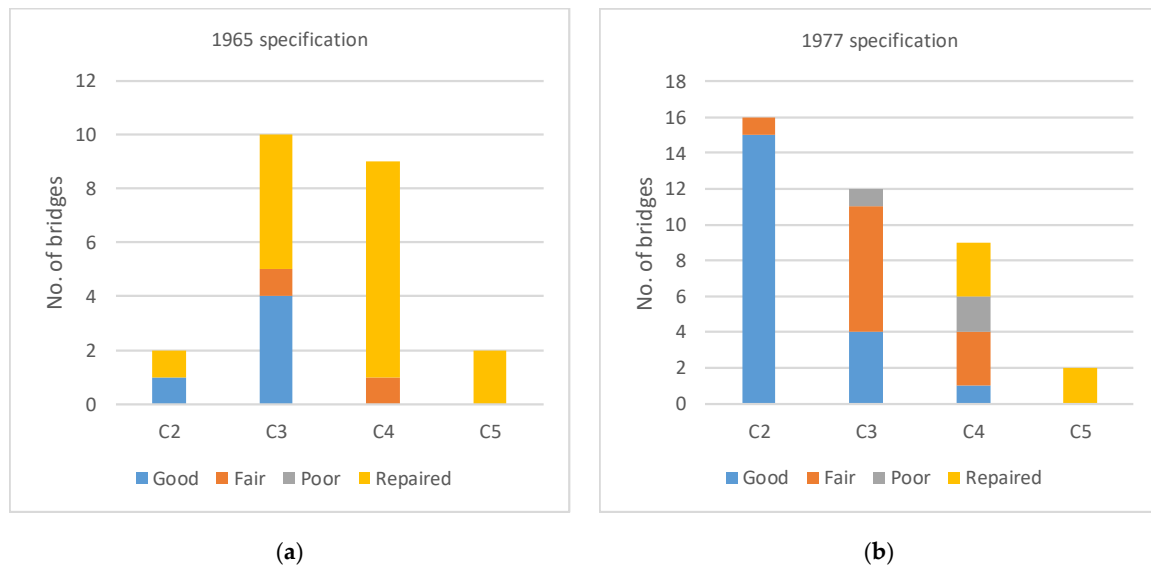
**Figure 3.** The summary of coating condition for the two specifications as a function of corrosivity: (a) 1965 specification; (b) 1977 specification.

A graphical summary of the coating performance on the bridges in Table 4 is given in Figure 3a. Of the 23 bridges, 16 have received coating maintenance, i.e., about 70%. Of these, eight are in C4 environments, five in C3 environments and one in a C2 environment. The repair of the C2 bridge was preventive maintenance due to topcoat flaking and not corrosion. Both the two bridges in the C5 environment have received maintenance. Of the remaining bridges, two are in a fair condition and five are in good condition.

The coating performance of bridges in Table 5 is shown graphically in Figure 3b for the 38 bridges built between 1978 and 1995. Of the 38 bridges, only five have received coating maintenance so far, i.e., about 13%. These five bridges are all exposed in C4 or C5 environments. Not surprising, the duplex coatings are performing very well in C2 environments. Contrary to Figure 3a, Figure 3b does show a correlation between corrosivity and coating performance.

The performance of the coatings in the C5 environment is similar for bridges coated with the 1965 specification and with the 1977 specification. The Madsøybrua and Erikstadstrøm bridges listed in Table 4 were repaired after 25 and 42 years, respectively. The Bergsøysundbrua and Nordhordlandsbrua bridges listed in Table 5 were repaired after only 19 and 23 years. A close inspection of the coatings reveals that application errors led to the failures on Bergsøysundbrua and Nordhordlandsbrua. Both bridges are floating bridges and may be regarded as mainly exposed in the marine splash zone. In the offshore industry, the corrosion rate in the marine splash zone is assumed to be 400  $\mu\text{m}/\text{y}$ , i.e., corrosivity category CX [9]. Hence, to classify these bridges as category C5 may be too low.

The coatings were mainly degraded on the underside of the bridgeway, where marine salt deposits will never be washed off by rain. Hence, a concentrated and very aggressive brine is formed on the coating surface. For Bergsøysundbrua, the maintenance started too early. Even though the organic coating had partly failed, the zinc coating was still protecting the steel. For Nordhordlandsbrua, the degradation was more severe and the steel had started to corrode in some areas.

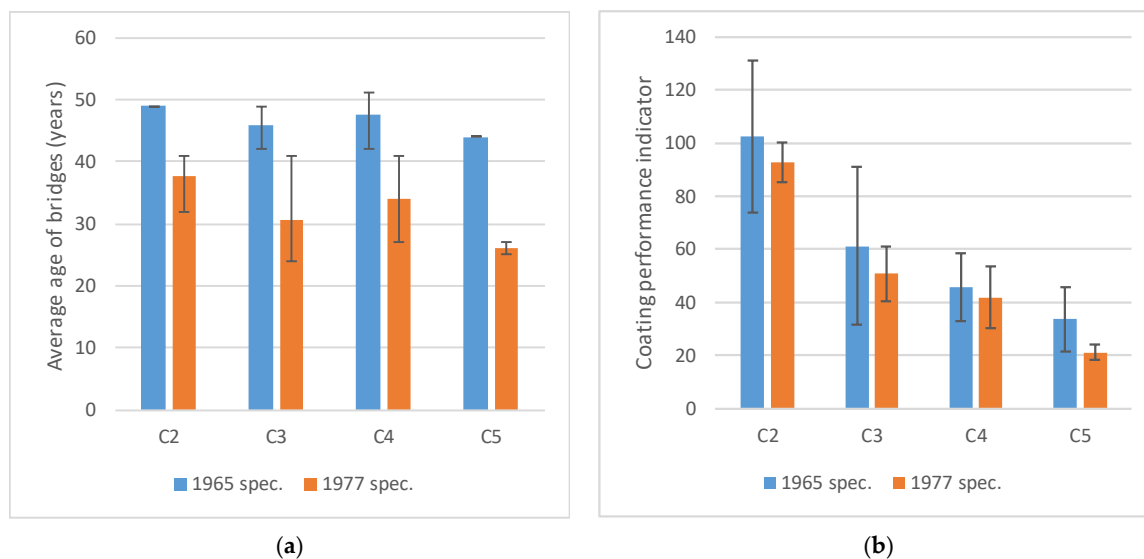
**Figure 4.** The coating age and performance: (a) Average age of the bridges. The bars show the highest and lowest age within each category of corrosivity; (b) Coating performance indicator as a function of corrosivity. The bars indicate standard deviation.

Figure 4a shows the average age and age span of the bridges in the study, illustrating the difference in exposure time for the two coating specifications. Since only 21 of the 61 bridges has received coating maintenance so far, the average coating lifetimes as defined by time to first major coating maintenance (ISO 12944-1 [11]) cannot be calculated. Only the result for the C5 exposures represents actual lifetime since all bridges have had coating maintenance. In order to enable a quantitative comparison of coating performance, the coating performance indicator (CPI) was defined, as described above. The average CPI as a function of corrosivity is shown in Figure 4b, while the CPI for each bridge is given in Tables 4 and 5. The error bars show the standard deviation. Figure 4b shows that the coating performance increases with decreasing corrosivity for both coating specifications, as expected. There are only two bridges in both the C2 and C5 environments for the 1965 specification though, which gives a rather weak statistical base for making conclusions. Additionally, the standard deviation is rather high for several of the categories, but the trend in the results is evident.
