TECHNICAL REPORT

Extreme Overheating in Self-regulating Heating Cables

Tranberg AS

TR NO. TR A5943	DATE 2004-03-04	CLIENT'S REF. Dag Kjosavik	PROJECT NO. 14X20601
ELECTRONIC FILE CODE 040227bm83735		RESPONSIBLE (NAME, SIGN.) Hallvard Faremo <i>HF</i>	CLASSIFICATION Unrestricted
ISBN NO. 82-594-2629-3	REPORT TYPE	RESEARCH DIRECTOR (NAME, SIGN.) Hallvard Faremo <i>HF</i>	COPIES 6
			PAGES 31
DIVISION Electric Power Technology	LOCATION Sem Sælunds v. 11	LOCAL FAX +47 73 59 72 50

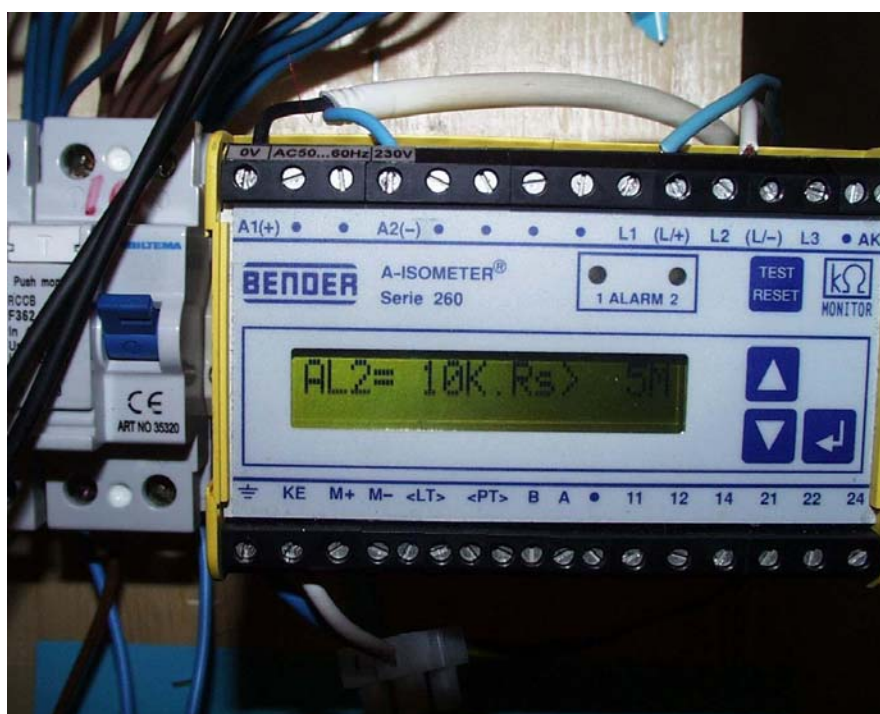
Figure 26: Bender insulating monitoring device installed in test set-up.

Together with the “Bender” were installed to new cables having supply of saline water. Nothing happened during the first three weeks (500 hours). Then alarm was triggered for phase 2. The calculated insulation resistance indicated 7,1 - 9,6 k Ω . The error message was located to one of the newly installed cables. The earth leakage measurements of the circuit showed 8 – 10 mA. (The earth leakage circuit breaker in the system shall not disconnect before at 30 mA.) In the following week (170 hours) we had alarm every time we filled the bottle with saline water. (The water evaporates, therefore refilling is necessary.) The insulation resistance in this period alternated between 4,5 and 6 k Ω . The earth leakage current in the same period was measured to 10 – 17 mA. The earth leakage circuit breaker then disconnected the voltage.

Briefly summarized the insulating monitoring device produced alarm for a whole week before the earth leakage circuit breaker disconnected the voltage.
