Norwegian Pitched Roof Defects

Abstract: The building constructions investigated in this work are pitched wooden roofs with exterior vertical drainpipes and wooden load-bearing system. The aim of this research is to further investigate the building defects of pitched wooden roofs and obtain an overview of typical roof defects. The work involves an analysis of the building defect archive from the research institute SINTEF Building and Infrastructure. The findings from the SINTEF archive show that moisture is a dominant exposure factor, especially in roof constructions. In pitched wooden roofs, more than half of the defects are caused by deficiencies in design, materials, or workmanship, where these deficiencies allow moisture from precipitation or indoor moisture into the structure. Hence, it is important to increase the focus on robust and durable solutions to avoid defects both from exterior and interior moisture sources in pitched wooden roofs. Proper design of interior ventilation and vapour retarders seem to be the main ways to control entry from interior moisture sources into attic and roof spaces.

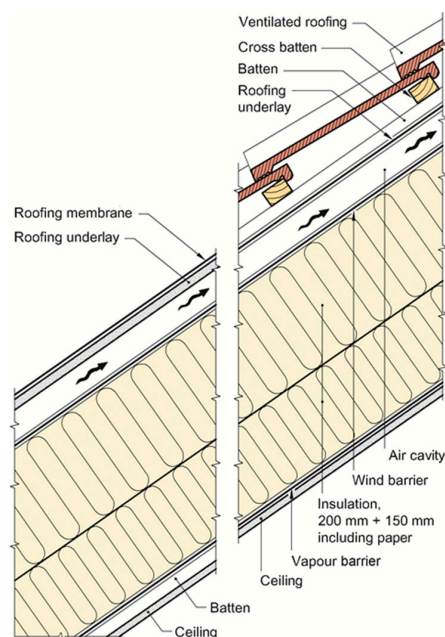
- raintight roofing;
- drainage and ventilation cavity;
- vapour-tight underlayer roof;
- ventilation cavity; and
- vapour open wind barrier.

Figure 1. Roof Type A, which separates the rain and wind barrier [13]. Here shown with two common types of roofing.

Roof construction Type A is a typical roof built before the year 2000 (see Figure 1). The outer part of the roof consists of:

Type A separates the rain and wind barrier with roofing directly on wooden sheets or with the roofing and underlayer above a separate wind barrier. The roof is ventilated both between the wind barrier and rain barrier and between the rain barrier and the roofing. The rain barrier can be vapour tight. This detail results in additional materials and often higher labour costs compared with the more developed and modern construction of Type B (see Figure 2).

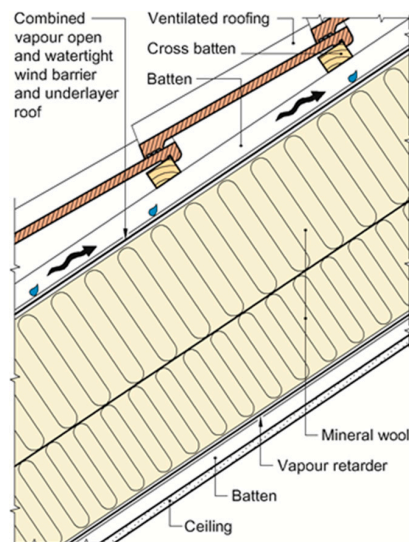
- raintight roofing;
- drainage and ventilation cavity; and
- combined vapour open and watertight wind barrier and underlayer roof.

Figure 2. Roof Type B, which is an insulated pitched wooden roof with vapour open combined wind barrier and underlayer roof. All ventilation of the roof takes place in the air cavity below the roofing [13].

Type B is a development of Type A and an improved roof design (see Figure 2). The outer part of the roof construction consists of:

The main difference between Type A and B is that the drainage and ventilation of Type B is performed directly under the roofing. Both roof types are thermally insulated between the wood rafters. However, the thermal insulation in roof Type B can be placed directly under the underlayer roof because the underlayer roof is a sufficiently vapour open and watertight wind barrier. A study done by [14] involved laboratory measurements of the performance of a combined wind barrier and underroof in driving rain. The measurements concluded that holes in the battens caused by fixing screws or nails are possible leakage locations in such roofs. The problem can be limited by use of special gaskets between the underlayer roofing and the batten [14].

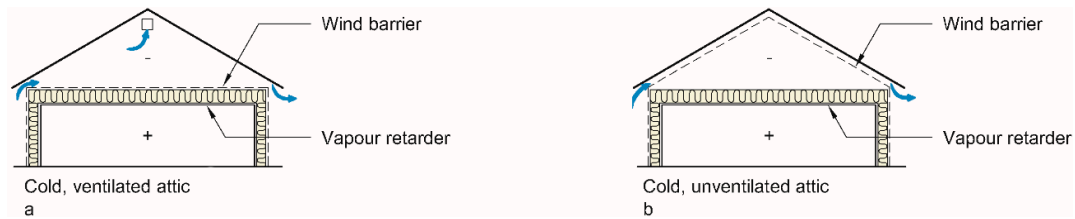
- (b) Cold, unventilated attic space with all ventilation between the underlayer roof and roof covering. The construction is a further development of a) and an improved roof design. The underlayer roof is a vapour open and watertight wind barrier. Both the wind barrier and vapour retarder should be used continuously, thus making it easier to ensure airtightness of the building.

Figure 3. Roof Type C with cold attic. (a) Cold, ventilated attic space with air stream flowing through the attic itself. (b) Cold, unventilated attic space with all ventilation between the underlayer roof and the roof covering. Image further developed from [16].

Type C consists of roofs with an air volume (attic) between the insulation and the roofing. During most of the year, the air temperature in the attic will be close to the ambient temperature, but during sunny summer days, the temperatures in the attic can be higher than the ambient temperature. The roof with cold attics can be built up in two different ways (see Figure 3):

designed in order to avoid penetration of snow and rain into the attic. Only the vapour retarder contributes to the airtightness of the building (ceiling), making the solution vulnerable to holes and imperfections in the vapour retarder, which again can cause condensation because of air (containing moisture) leakages through the construction. Hagentoft *et al.* [15] found that the moisture level of cold ventilated lofts is improved if the attic floor is airtight, has low built-in moisture content, and has well-ventilated indoor air.

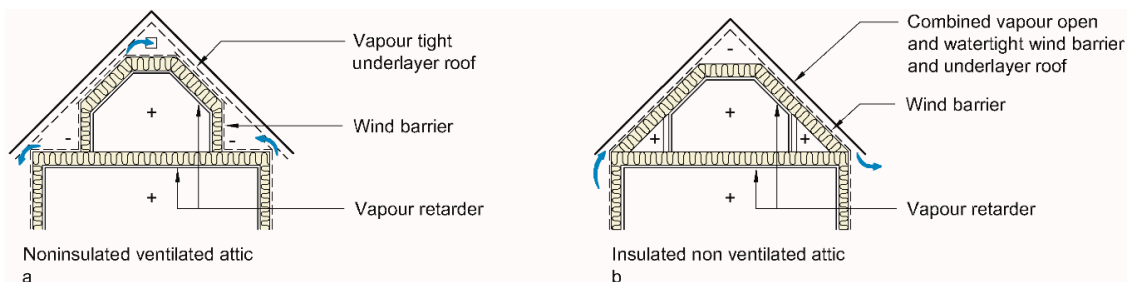
- (a) Thermally non-insulated ventilated attic. The underlayer roofing can be vapour tight. There are ventilation openings in the ridge and between the underlayer roof and the thermal insulation along the purlin of the building. Ventilation openings have to be designed in order to avoid penetration of snow and rain into the attic. The vapour retarder and wind barrier are not continuous through the floor construction and the roof is therefore particularly vulnerable to moisture damage due to air leakages.
- (b) Thermally insulated non-ventilated attic. The underlayer roof has to be vapour open. The construction is a further development of a) and an improved solution. It is possible to make a continuous and airtight joint between the wind barrier on the wall and the underlayer roof, thus making the construction more resistant to moisture compared to a).

Figure 4. Roof Type D with heated rooms in part of the attic. Thermally insulated non-ventilated attic rooms (a) and thermally non-insulated, ventilated (from outside) attic rooms (b). Further developed from [13].

Type D consists of roofs with heated rooms in part of the attic and is thoroughly described by [13]. This type of construction is, according to Uvsløkk, particularly vulnerable to moisture damage and heat loss from air leakages because the vapour retarder is not continuous through the floor construction. The construction type can be built up in two different ways, or a combination of these:

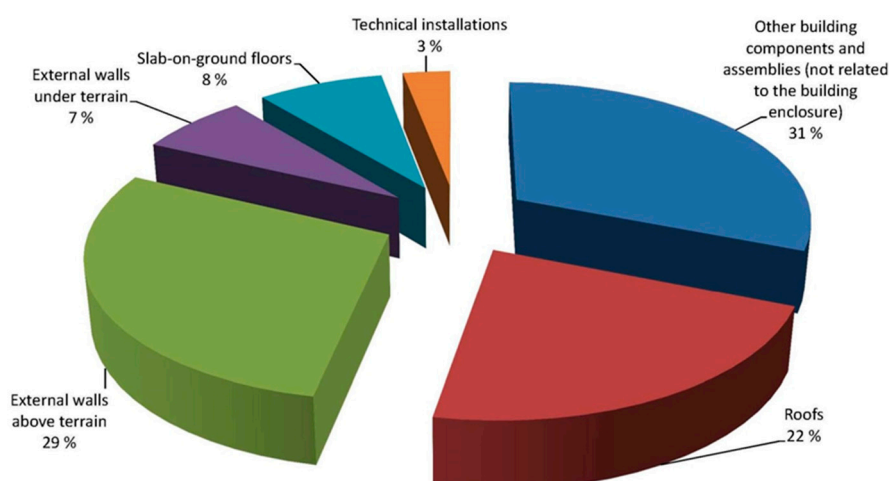
Figure 5. Process-induced building defect cases for the 10-year period from 1993–2002 (a total of 2423 building defect cases), distributed by localization of defects [12].

As Figure 5 shows, 22% of the registered building defects are localized in roofs. Furthermore, 24% of the total building defects are caused by precipitation (see Table 1). It is worth noting that 75% of all defects are caused by moisture alone or as a consequence of moisture.
