MMWood – System for Maintenance Management of Historic (Wooden) Buildings

Project report 367
Svein Haagenrud and Guri Krigsvoll
**MMWood – System for Maintenance Management
of Historic (Wooden) Buildings**

Part I MMWood Deliverable

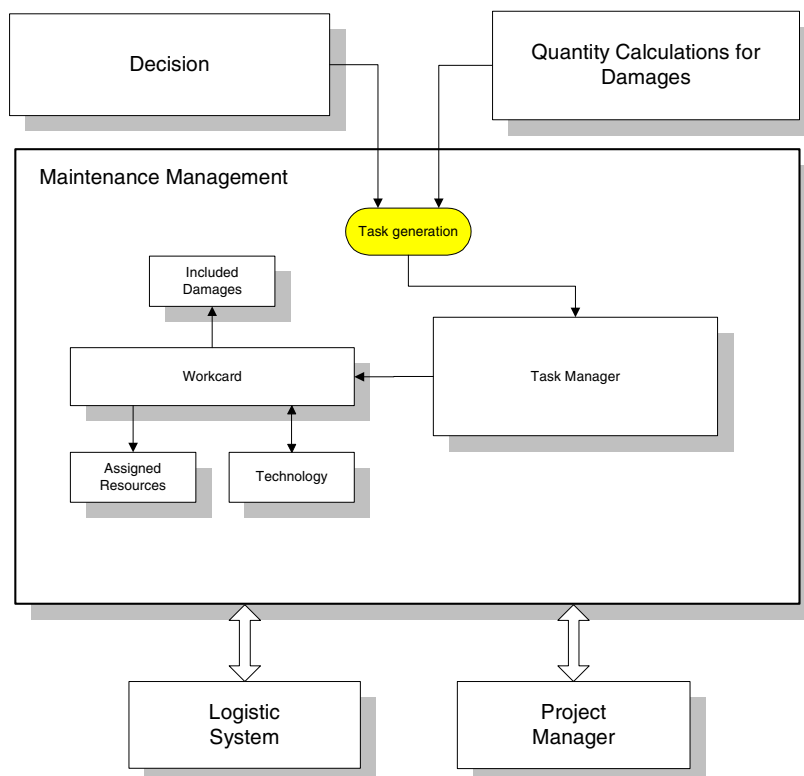
Figure 3: Description of Maintenance Management module

The MM-module is responsible for turning the user decisions regarding the damages/states of the objects into tasks for further processing. This can consist of the systems own module for making work cards, or export to an external project management application. Figure 3 sows a description of the module.

Figure 1 describes the main parts of the MMS. Not all the modules are implemented in MMS. The Condition Assessment module is described in Figure 2, the Maintenance Management module in Figure 3, while the Decision module is described in Figure 4.

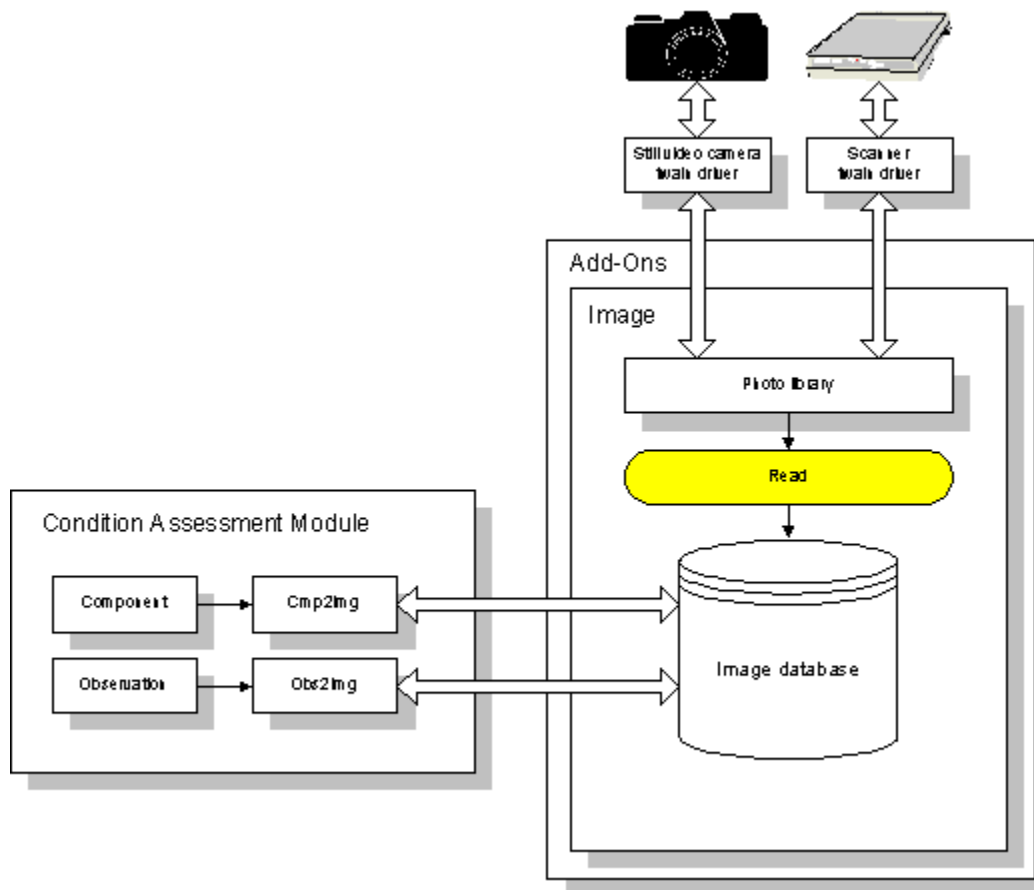
Figure 5: The photo database, including the import functionalities, is an example of Add-Ons.

Add-Ons are modules that are not required to run the application, but which enhance the usability of the system. Examples of Add-Ons are Photo database (Figure 5) and Maps and GIS-functionalities.

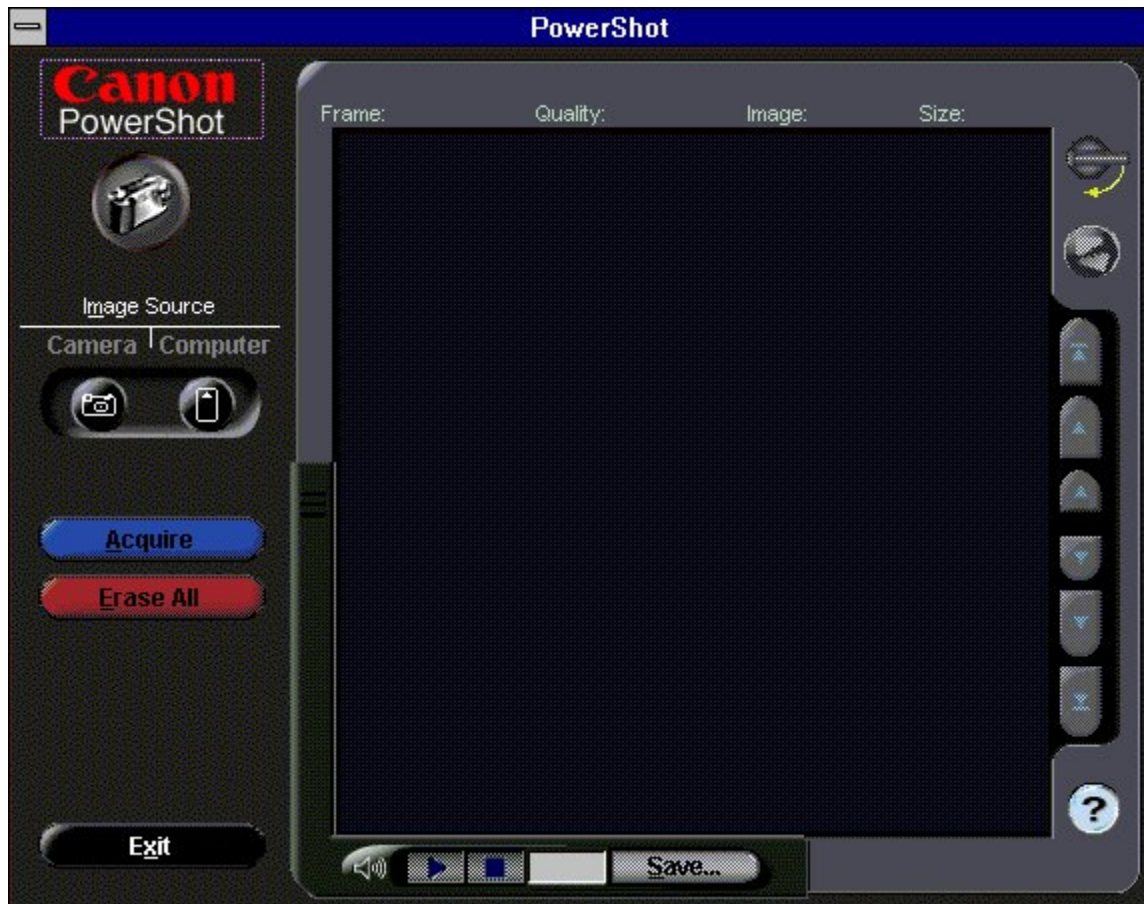
When choosing Read Images the user will open a new form where he can choose which images should be transferred to the application (the layout of this form will vary depending on which digital camera is connected):

If the camera and its driver supports image numbering the Track-field will contain the numbers, otherwise the user has to enter those manually in order to link the images to the correct damage. When the images are automatically linked, Reference will be marked - otherwise the user has to mark this manually in order to save the images. When the user has chosen the images he wants to save, he presses Save.

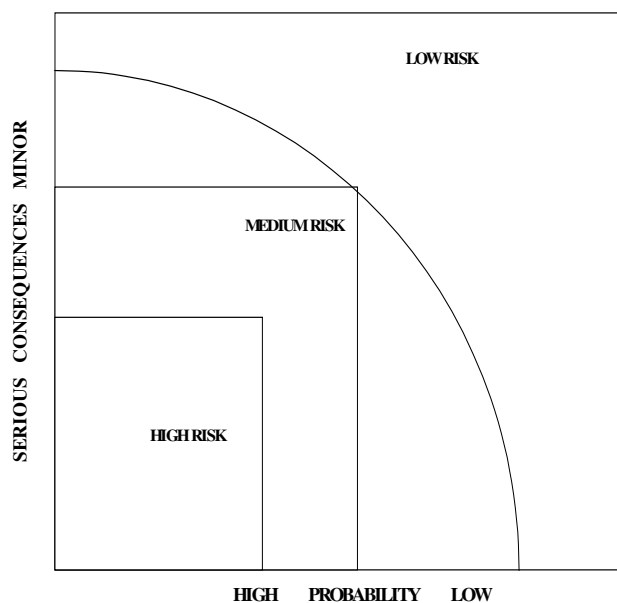
Figure 8: Relations between Consequences, Probability, and Risk.

Risk is determined by the combination of probability and consequences. This is shown in Figure 8. Low probability combined with serious consequences give the same risk as high probability combined with minor consequences. In connection with the assessment of risk it is important both to evaluate the technical risk for the item as such and the risk for the user or third part. This is related to the consequences on which the assessment is based. It shall be specified which consequences that have been used as a basis for the specification of risk.

- Low
- Medium
- High

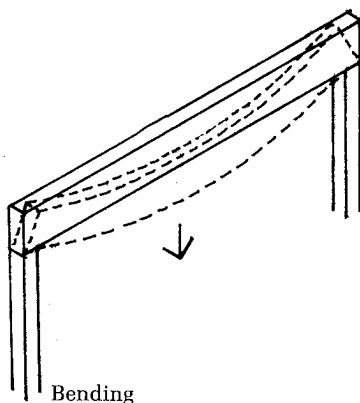
Downward deformation of horizontal load-bearing construction members of wood, with direction either into the centre of the field (following the static moments line) or towards one of the points of support.

Deflection or bending, Example drawing:

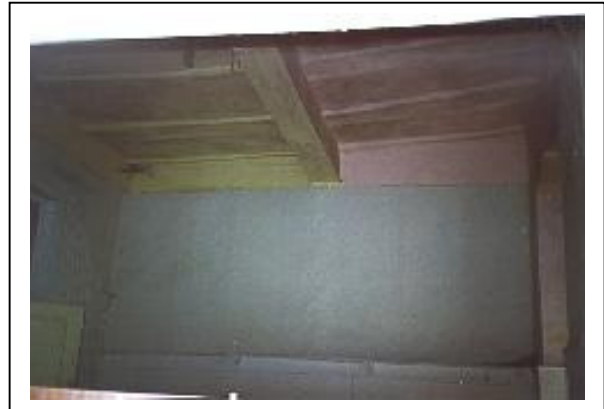
Slight symptoms.

Deflected ceiling; the top perimeter line of the white wall painting is horizontal.

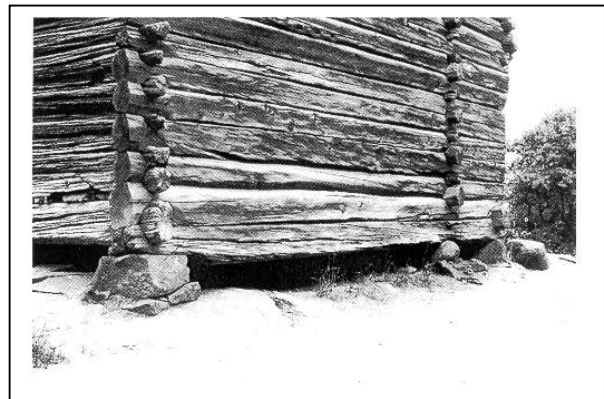
Medium-strong symptoms.

Log construction with deflecting sill. The tensile load at the corner points is increased strongly and leads to open joints in the wall and to damages at the wood joints. The floor inside is also deflecting.

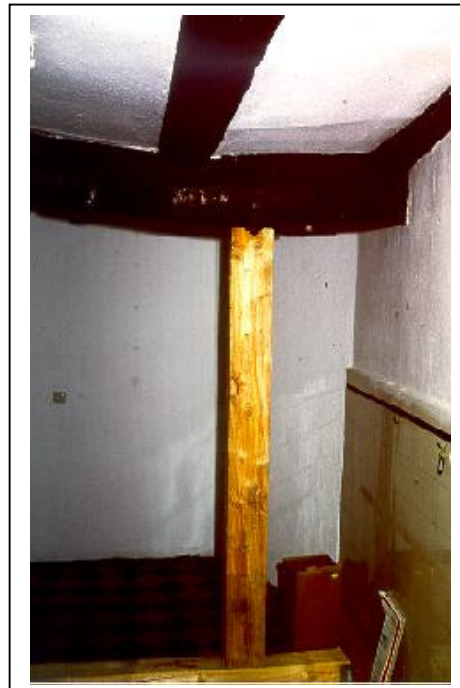
Downstand beam deflected to destruction, post as temporary precaution.

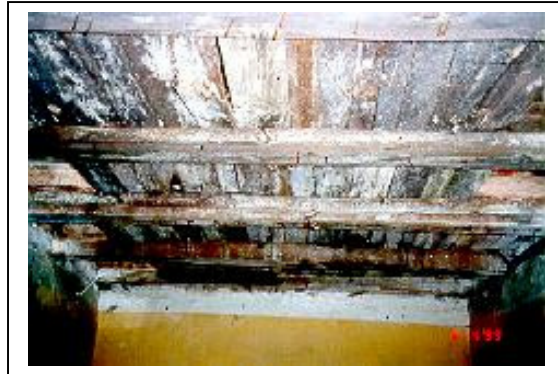
Rathenow, Zietenkasernen. Caused by fungal infection one piece of the floor is broken

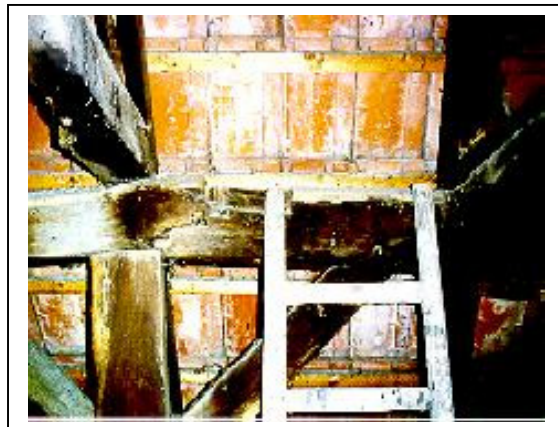
Cracked purlin in the roof.

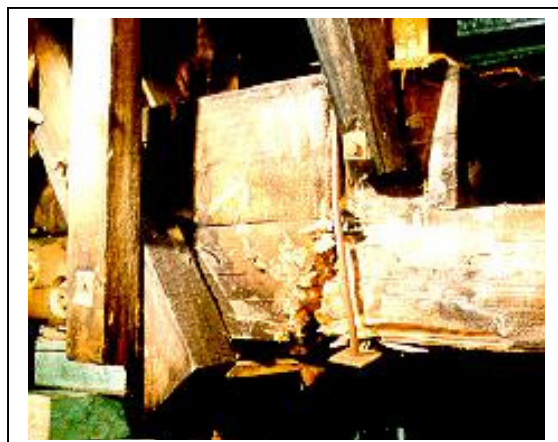
Pieces of roof trusses are broken because of forcing.

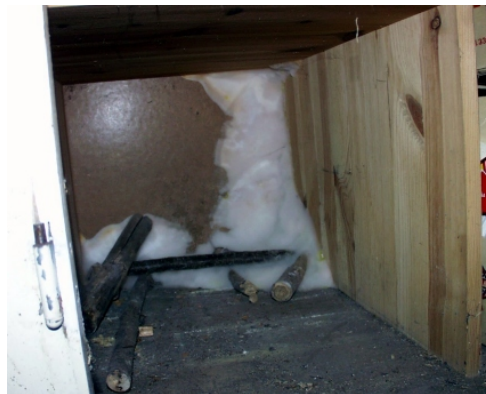
Growth of the fungus mainly on the surface, no or very little softening of the wood.

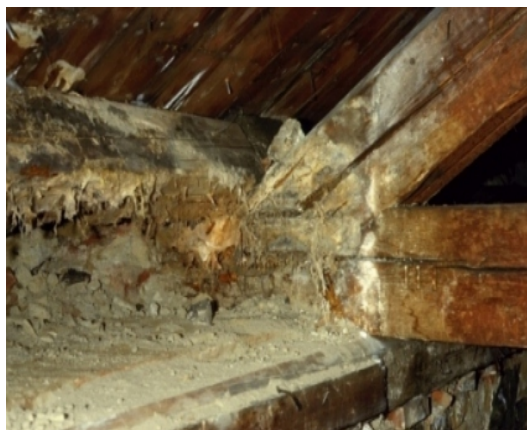
Severe decay of the wood. The wooden construction has less than 25 % of its original strength. Often extensive growth of fungal mycelium.

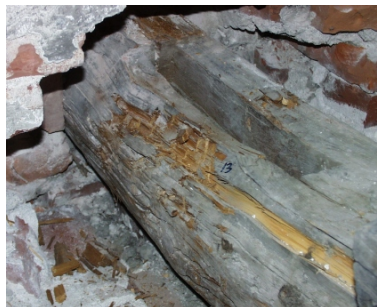
Softening or cracking of the wooden surface. Growth of the fungus may be seen on the surface, but is not always present.

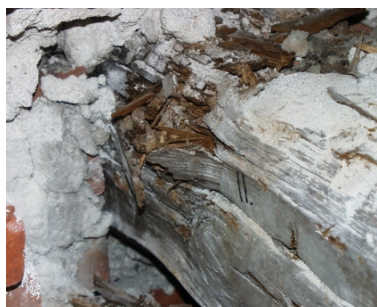
Some decay of the wood is observed. The wooden construction still has more than 50 % of its original strength. Growth of the fungus may be seen on the surface, but is not always present.

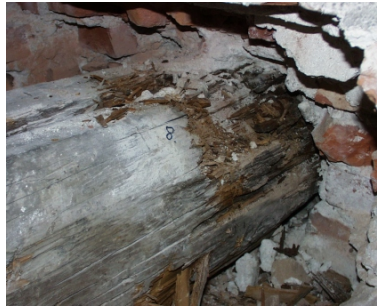
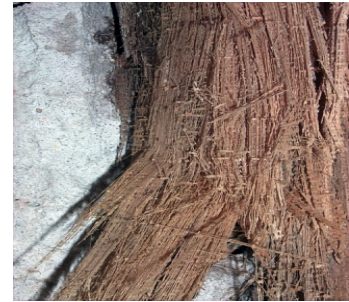
Severe decay of the wood. The wooden construction has less than 25 % of its original strength. Growth of the fungus may be seen on the surface, but is not always present.

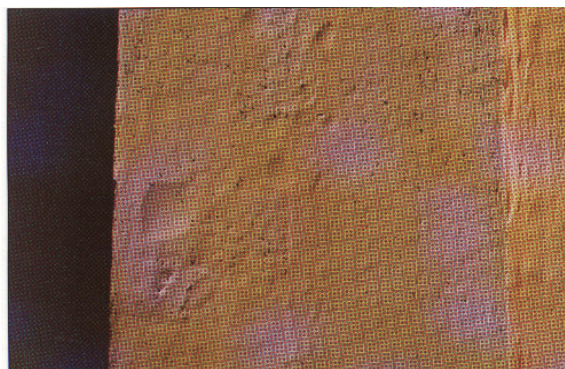
Few and small blisters. Limited damage.

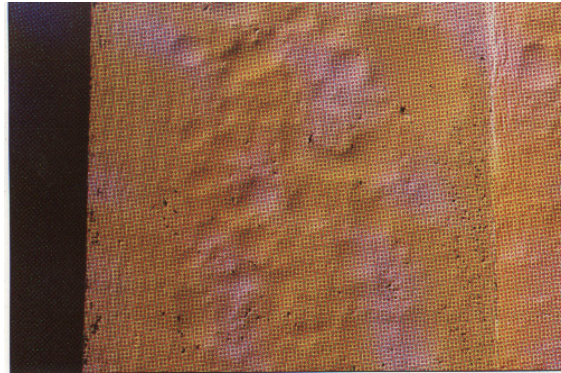
More and larger blisters. The extension of the damage is increasing.

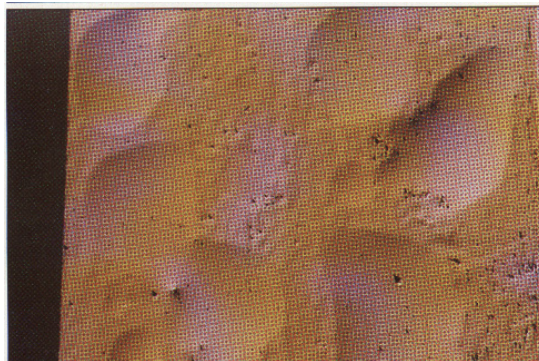
Blisters cover large areas and are of bigger size.

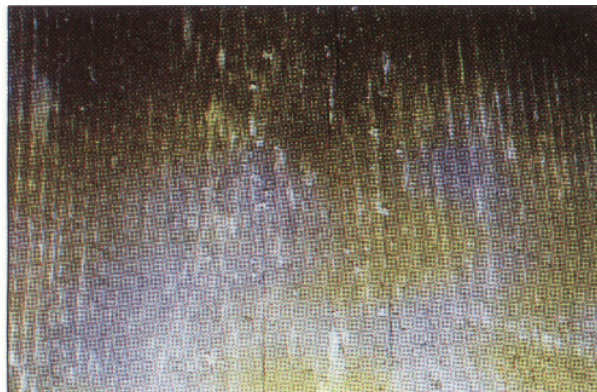
Small signs of growth, a more thorough investigation may be necessary to detect the difference between for instance algae and dirt.

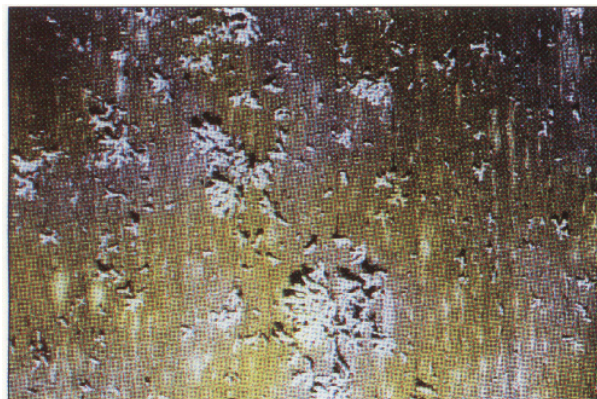
Significant growth on the surface leading to the disappearance of part of the paint film.

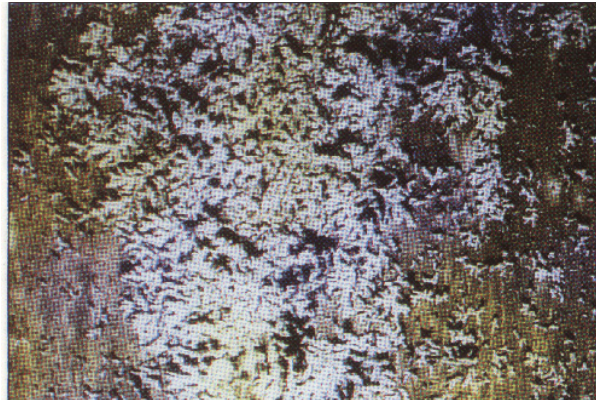
Areas of the paint film are covered, could be more severe damages underneath.

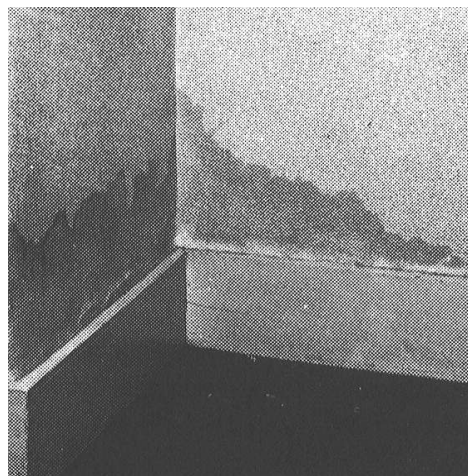
Rising water sign on the wall slightly visible. Readability of the different level reached by the water after recurring wet-dry cycles. No efflorescence.

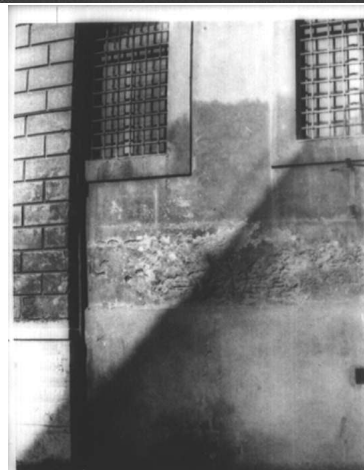
Clearly visible stains of medium intensity; possible efflorescence presence; slight cracking and overgrowth of finishing layers.

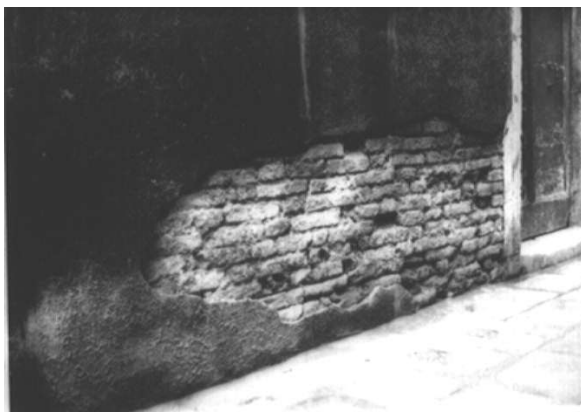
Dark continuous stains; marked efflorescence; persisting organic growth; wide cracking and detaching of finishing layers.

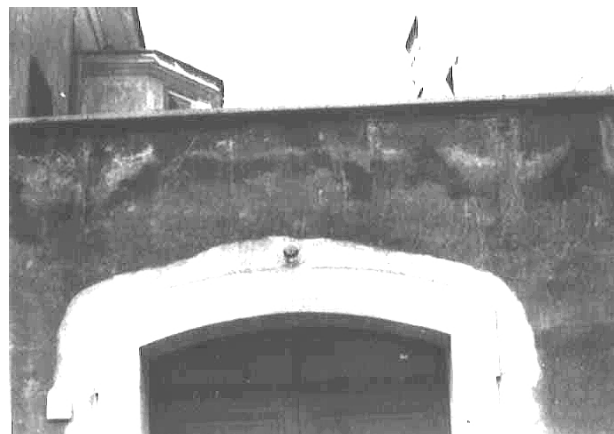
Slightly visible stains and efflorescence.

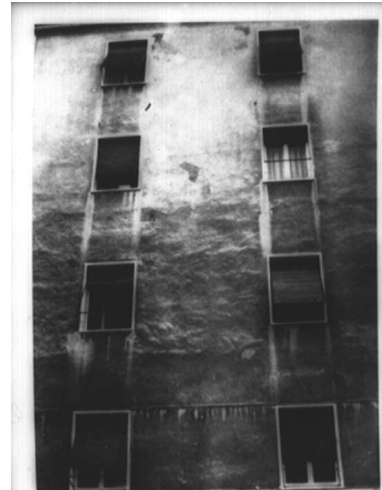
Clearly visible stains of medium intensity, accentuated stains after rains and or concentrated in cold areas; possible efflorescence presence; slight cracking and overgrowth of finishing layers.

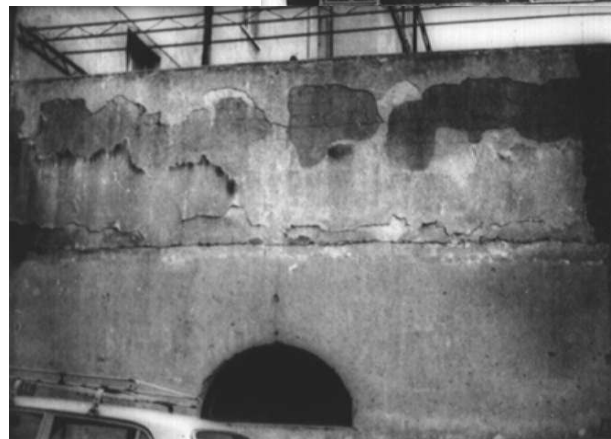
Dark continuous stains; marked efflorescence; persisting organic growth; wide cracking and detaching of finishing layers.

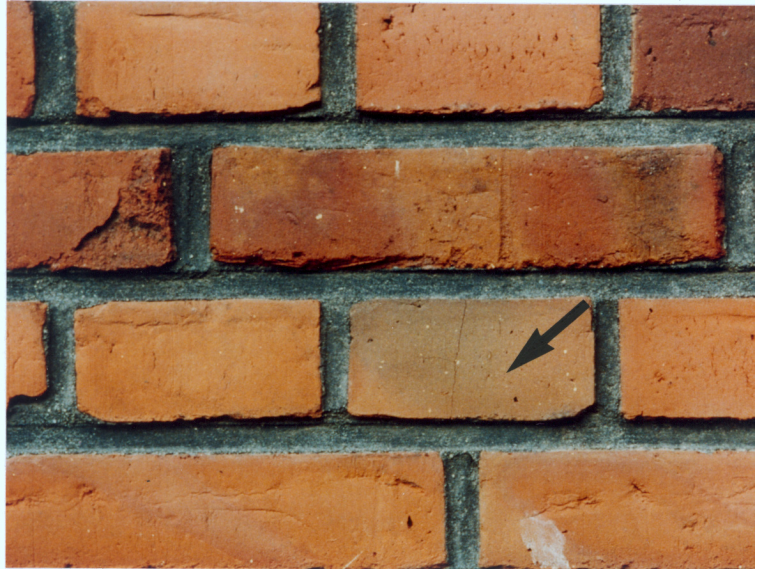
Vertical crack $b \leq 0.1$ mm

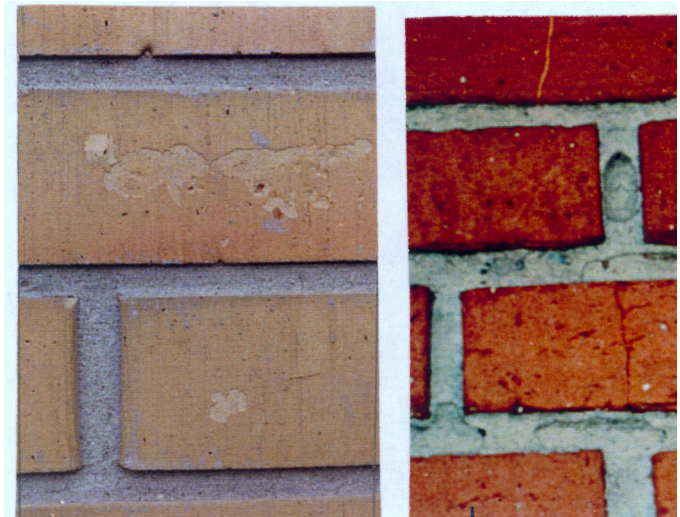
Craters or flakes with $t < 1.0\text{mm}$ in the
unit or mortar joints

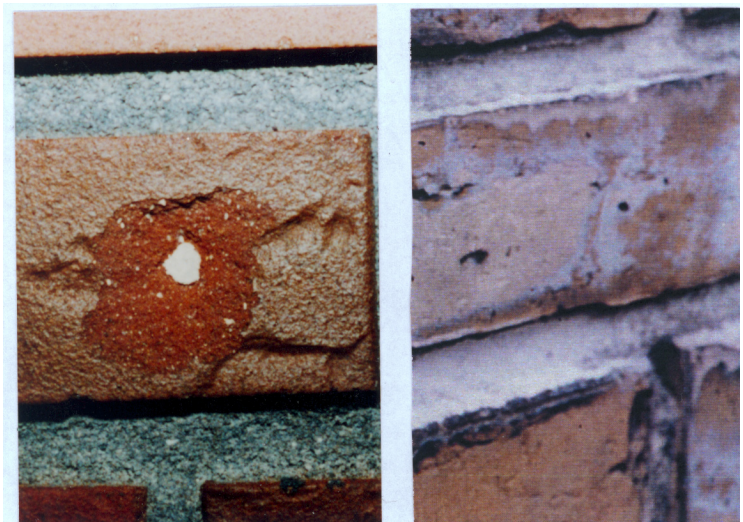
Scales with $t > 3-4\text{ mm}$ in unit or
mortar joints.

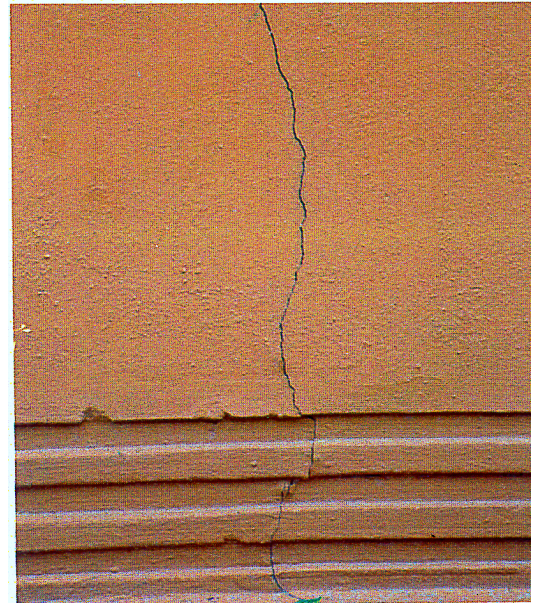
Width of crack $b < 0.5$ mm

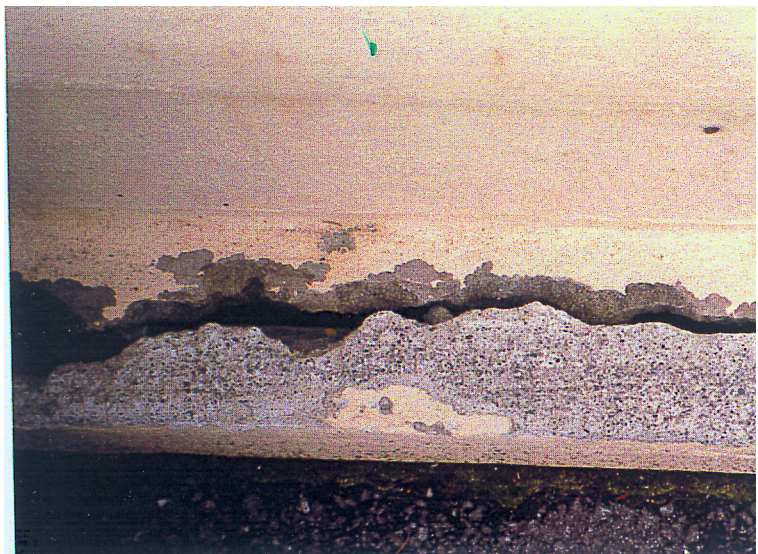
Width of crack $b > 3.0$ mm

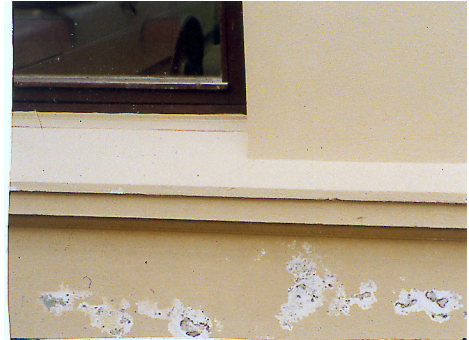
Depth of sores < 1.0 mm

A few particles can be rubbed off with a brush

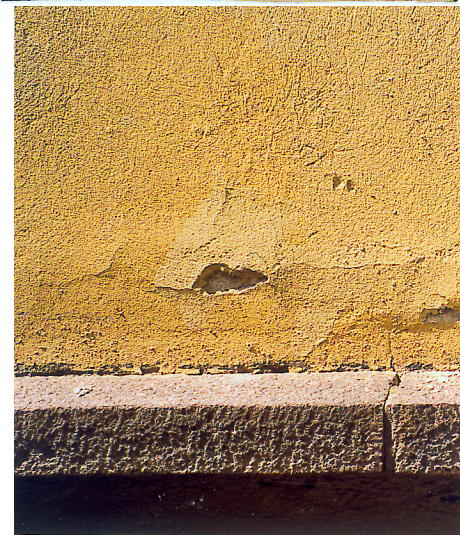
Depth of sores 1.0 mm < t < 3.0 mm

Local disintegration.

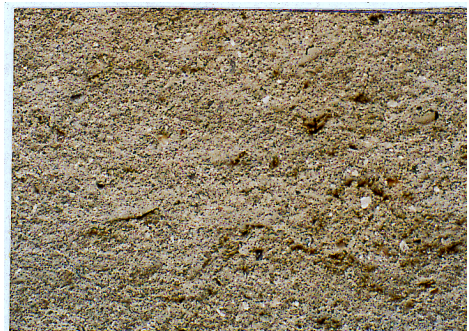
Sores and disintegrated materials deeper than 3.0 mm into the surface in more than 25 % of the area of a wall

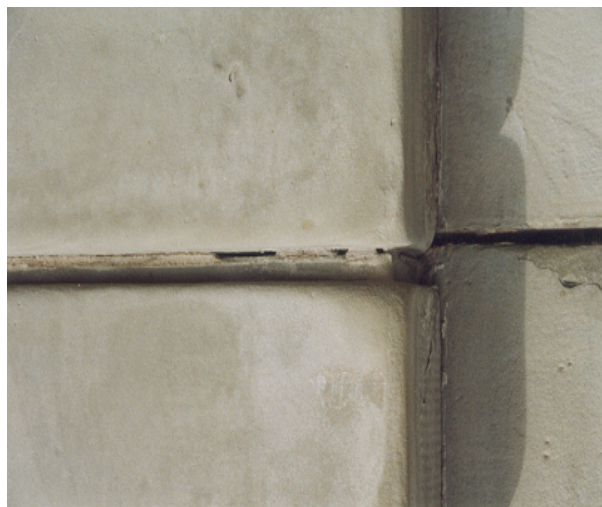
Smooth powdering of surface layer when brushed by hand.

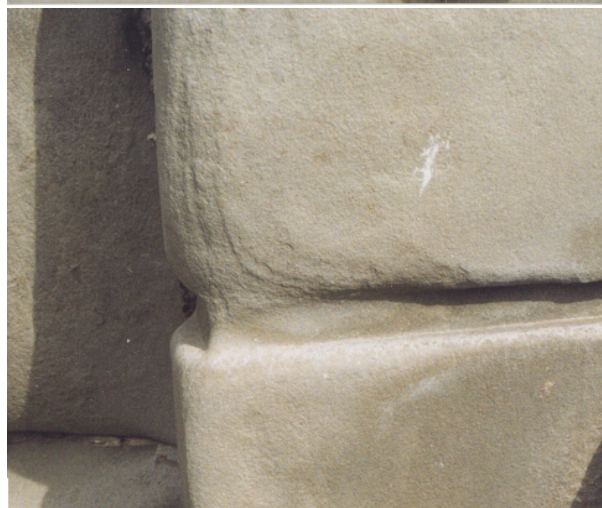
Coarse surface. Heavy sanding when brushed by hand.

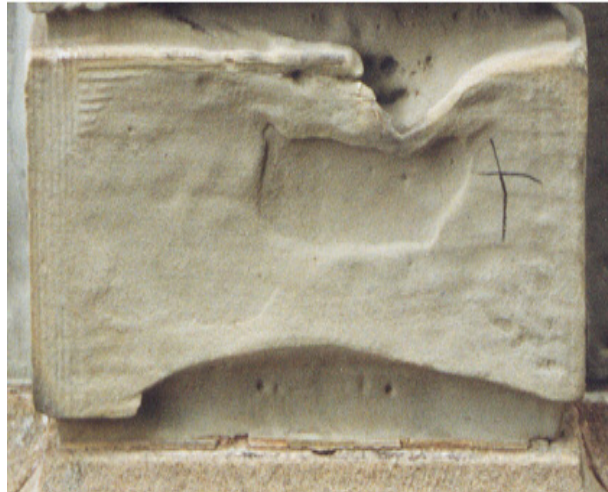
Total collapse of stone when brushed by hand.

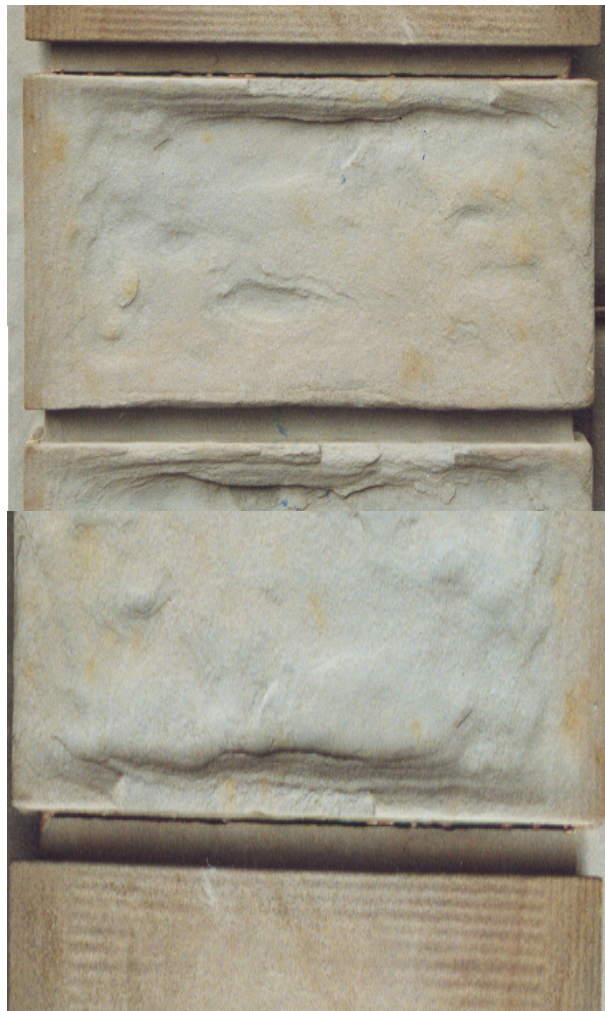
First step of craters/holes, which
is more than 10 mm of depth.

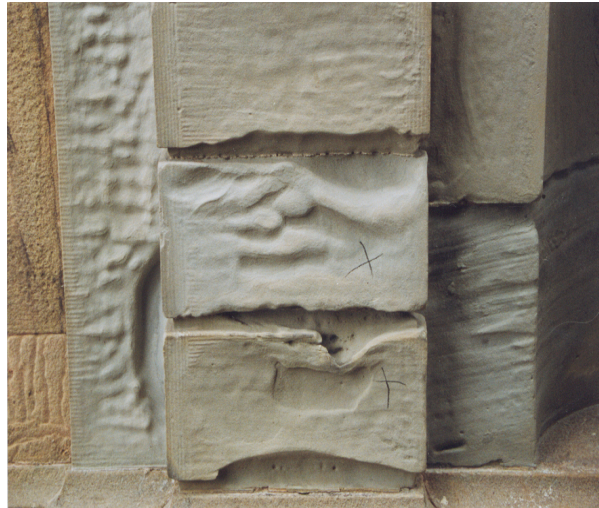
Big alveoli or “waves” in the surface. Total change of the surface appearance.

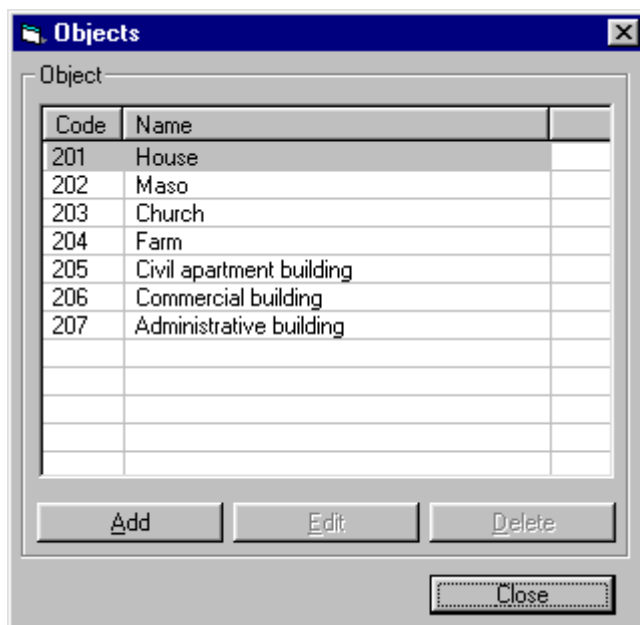
Figure 9: Object types defined by the Italian partner.

The system manager is free to define the different types of object depending of the use of the system. A building manager has other needs than a construction consultant. Object types may be different types of buildings, either different building functions or different building techniques. Object types may also be different construction typologies as building, bridge, and other forms for infrastructure. Figure 9 shows an example for defining Object types.

Since all partner have been working with buildings, all have chosen different building types as types of object. Norwegian standard for building categories (NS3457, 1995) is used as a suggestion for building types, while the partners can use their own system or national standards. Eventually a European standard would fit. Figure 9 shows the system used by the Italian partner.

The chosen building types is: House, Maso, Church, Farm, Civil apartment building, Commercial building, and Administrative building. See Figure 9. The Italian object refers to the category “Maso”.

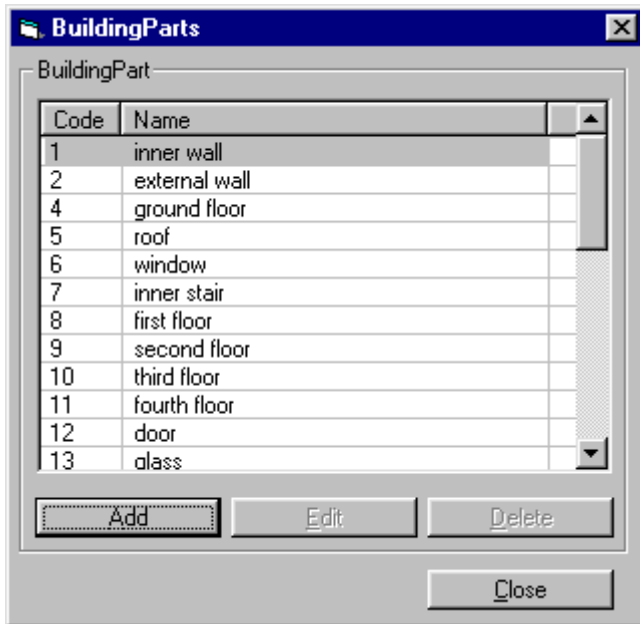
Figure 10: Chosen building parts by the Italian partner.

The system has been configured with a definition of all the building part useful to define the chosen object and the existing damages. The system manager is free to define the building parts. The Building parts may be defined with codes in increasing order, Figure 10, or with

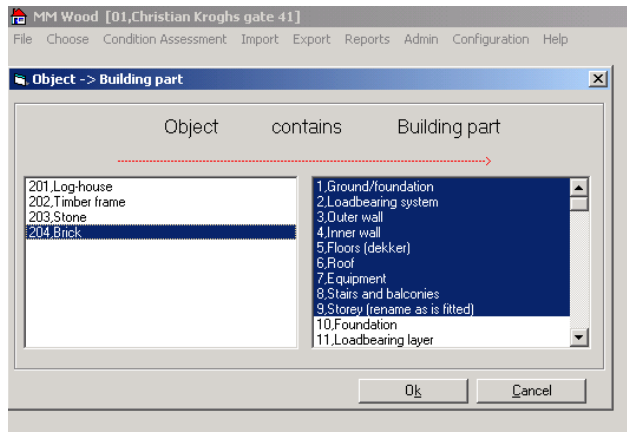
Figure 11: The relation between Object and Building.

The MMS-configuration also demand a relation between Object type and Building parts, and further between Parent building parts and Child building parts in several levels. Examples showing how to make the relations are shown in Figure 11 and Figure 12.

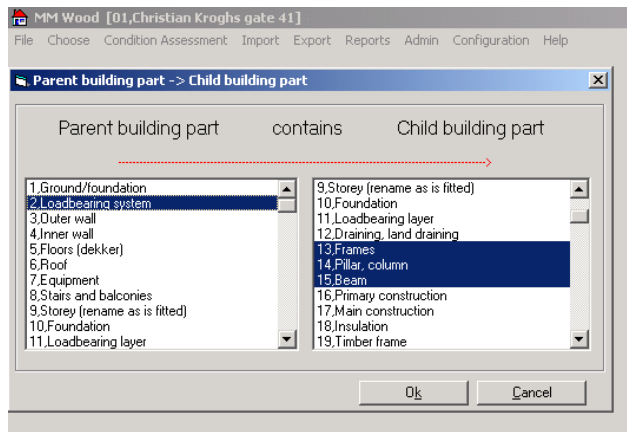
Figure 12: The relation between building parts on different levels.

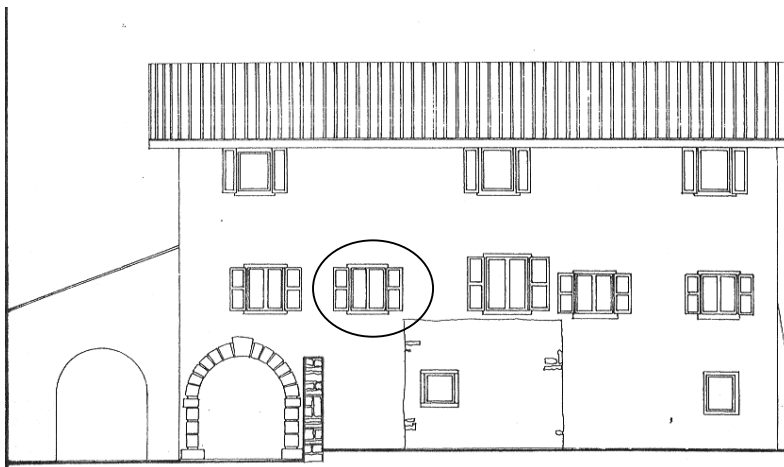
An orientation system has been chosen to identify the different building parts. The facades of the building have been divided into axis (x and y) depending on the number of floor (x) and

on the number of windows (y). So, for example, Window S-2-4 means the window on the south facade, at the second floor in the fourth position (Figure 14):

Figure 14: The position of the window S-2-4 by use of the orientation system.

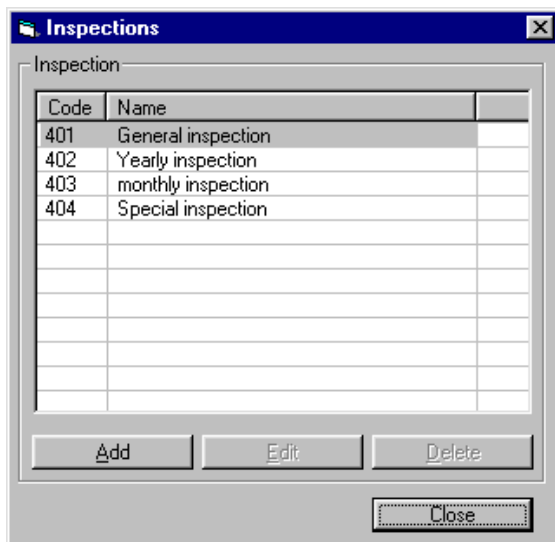
Figure 15: Defining different types of inspections.

The system manager is responsible for defining the types of inspections. Inspection types may be types already defined by the user or firm. Four different kinds of inspection types have been used in the MMWood project: General Inspection, Yearly inspection, Monthly inspection, and Special inspection, Figure 15.

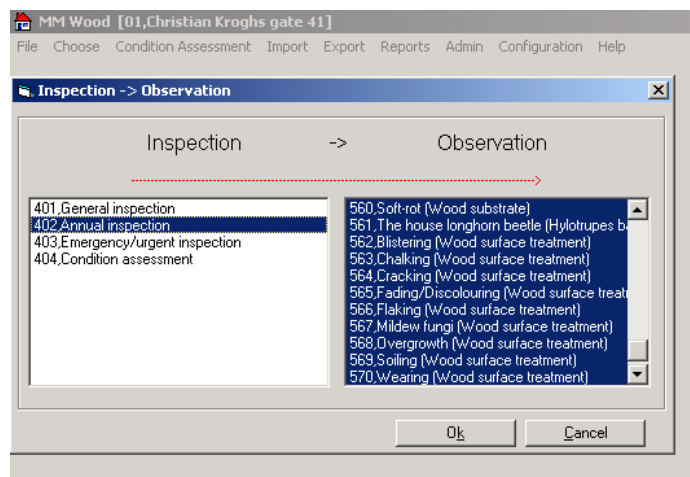
Figure 16: Relations between the annual inspection and the possible observations that can be made during that particular type of inspection.

Figure 16 shows examples of relations between the annual inspection and the different observations that can be made during that particular inspection type.

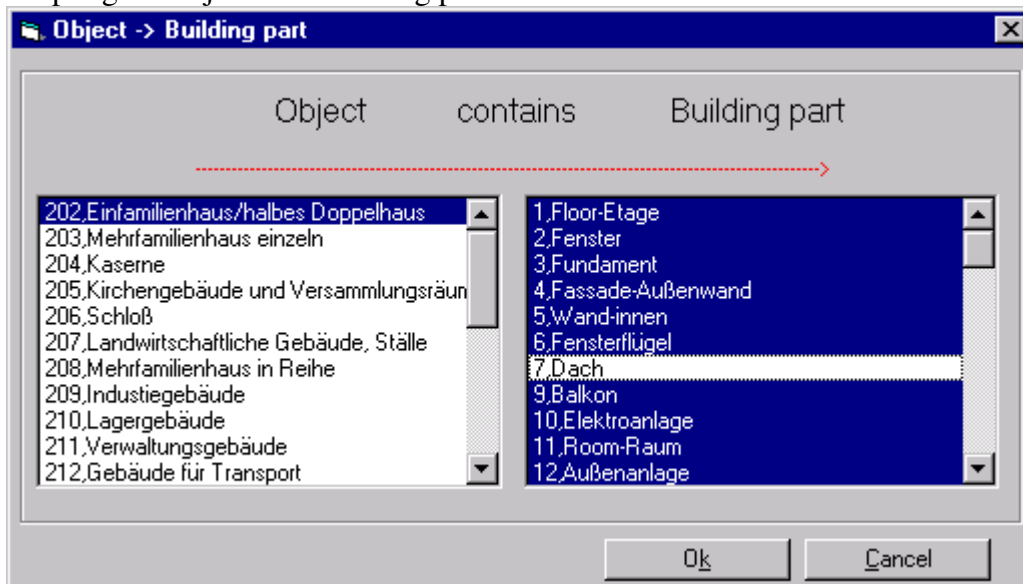
Figure 19: Relation between Object and Building part in the German configuration.

The predefinition of objects and building parts follows mainly the Norwegian standard NS3451 (NS3451, 1988) and NS3457 (NS3457, 1995). Figure 19 shows one example for coupling the object with building parts.

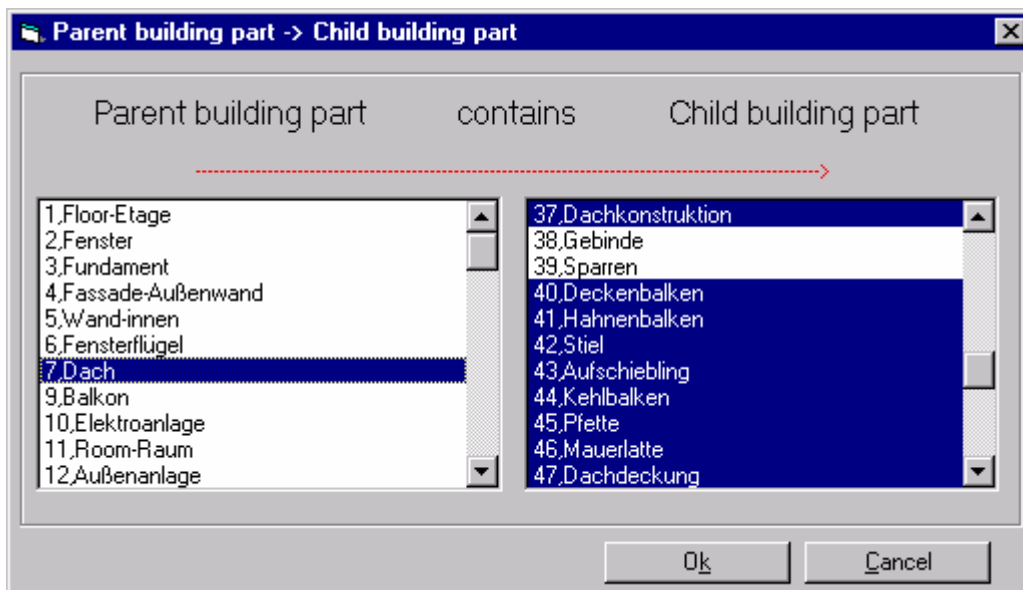
Figure 20: Relations between Parent building part and Child building part in the German configuration.

Nearly every building part has to be coupled with groups of building parts, which lies in the next layer: For example Wall-Window-Window frame/Window glass/Window board. Figure 20 shows one example of the coupling between parents building part and child building parts:

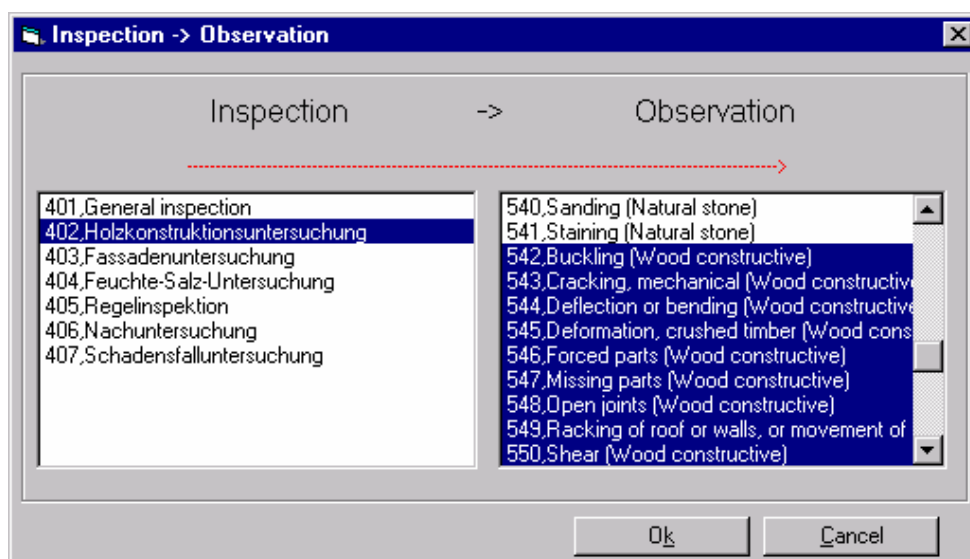
Figure 22: Inspection types and relations between Wood constructive inspection and the belonging observations in the German configuration.

The MMS system is built up in a very general way and that also includes the inspection types. In our system we have defined the following inspection types: General inspection, Wood constructive inspection, Moisture and salt inspection, Annual inspection, Follow up inspection, and Emergency inspection. Figure 22 shows the Wood constructive inspection. The system has predefined different observations all based on the damage atlas developed in WP2. After defining an inspection this have to be related to one or several observations, Figure 22.

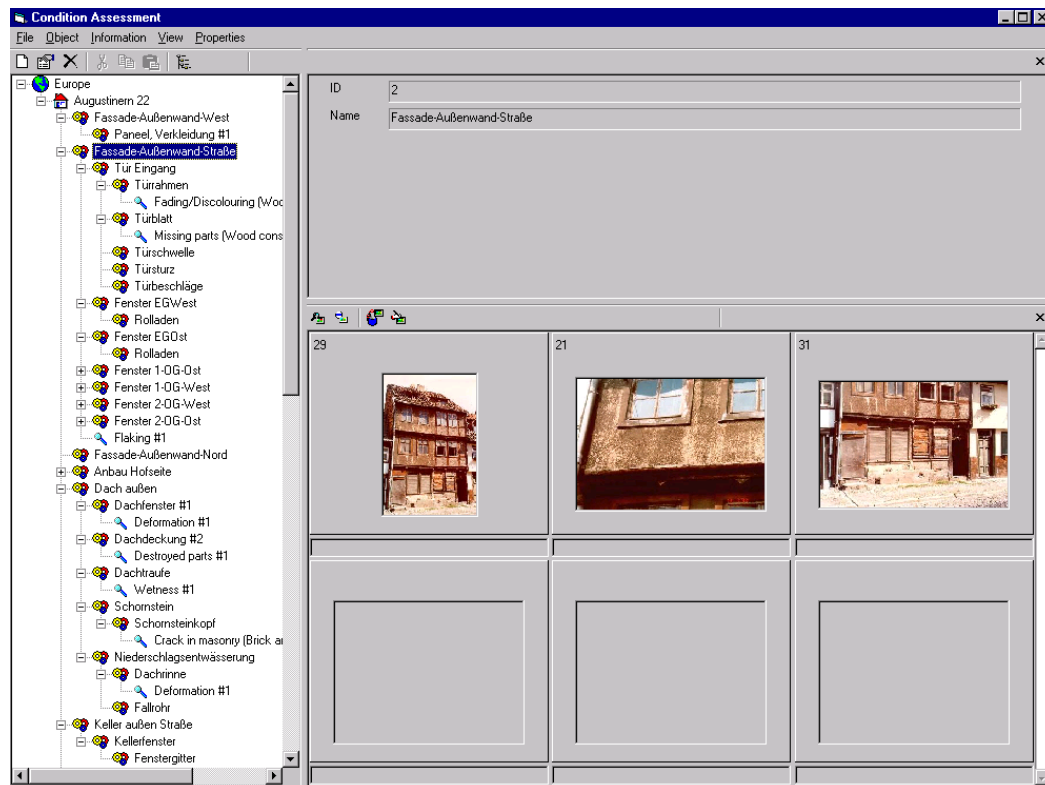
Figure 27: Detail of building part tree of the chosen object with observations during the General inspection.

The condition assessment of the object Augustinern 22 in Quedlinburg was performed in Summer 2000 as test and finally in December 20001. The Germany partner ZHD with project-team Potsdam carried out the condition assessment. Some parts of information for the object were former project (archive, measurement). The inspection type used was a General inspection. Figure 23 and Figure 24 show the facade of the chosen object, while Figure 25 and Figure 26 give the section and plan drawings. In Figure 27 part of the inspection tree is given for the object chosen.

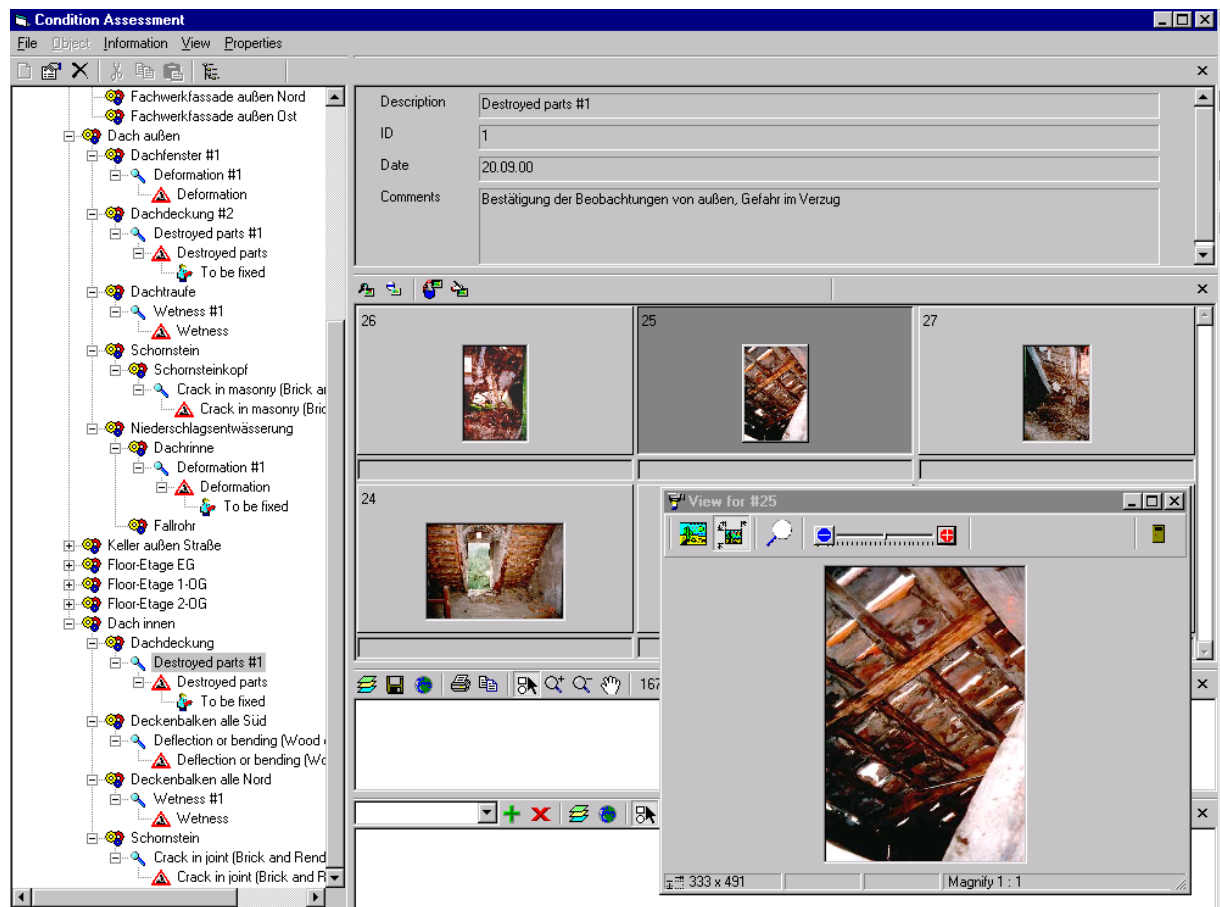
Figure 28: Detail of the Condition Assessment regarding to the roof.

Figure 28 will illustrate the next step (partly at object, partly at office) for estimation the damage and the decision. In General inspection we used images to show the actual/acutely situation too. Figure 29 shows the properties of door regarding to the wood treatment

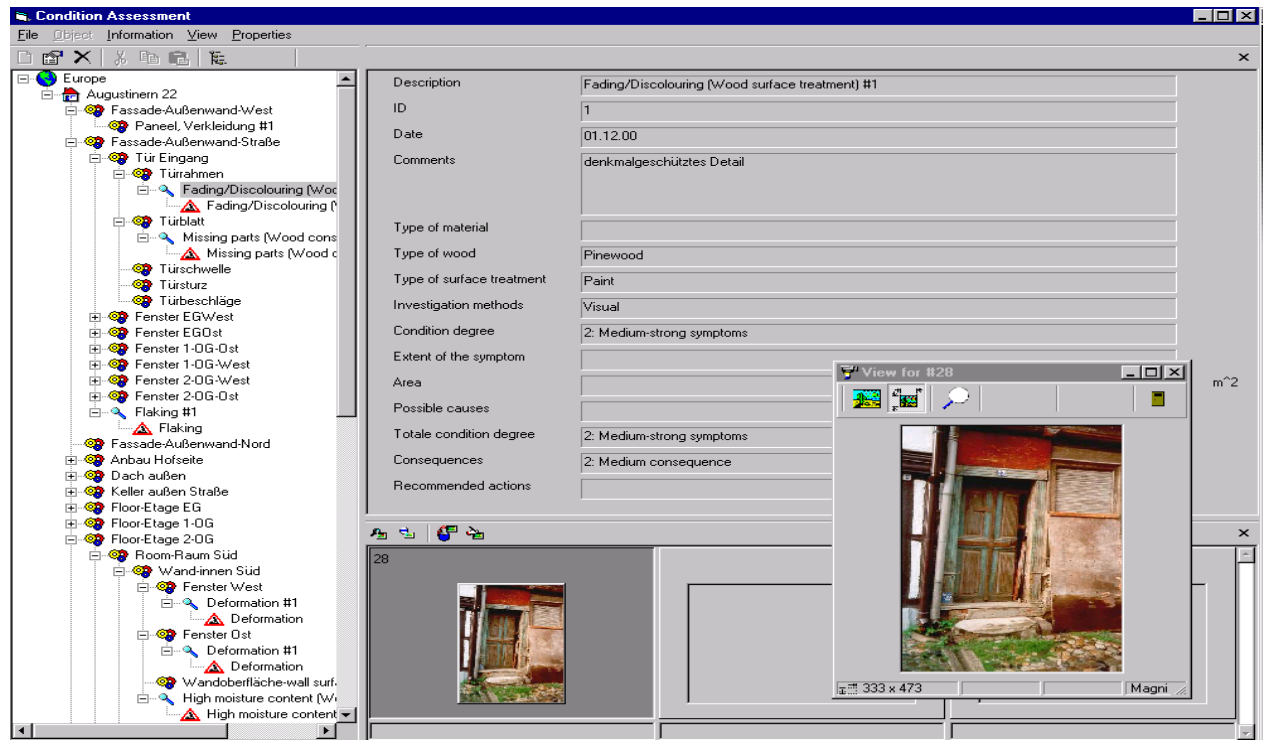
Figure 29: The properties of door regarding to the wood treatment:
