MMWood – System for Maintenance Management of Historic (Wooden) Buildings

Project report 367
Svein Haagenrud and Guri Krigsvoll
**MMWood – System for Maintenance Management
of Historic (Wooden) Buildings**

Part I MMWood Deliverable

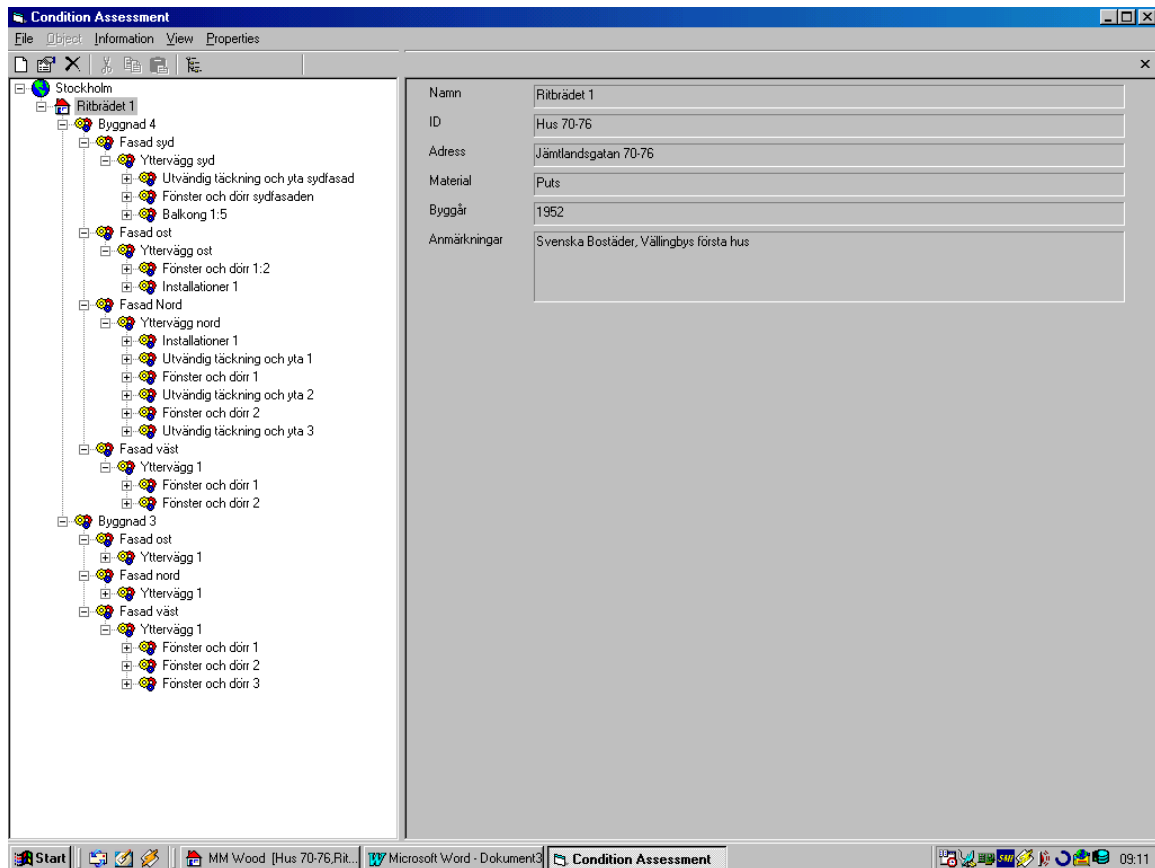
Figure 30: A schematic overview of the inspections performed at the chosen object.

The condition assessment of the object Ritbrädet 1 in Vällingby was performed on the 31st of October 2000. Assisting in this condition assessment was personal from the Swedish partner Restaurator AB. The inspection type used was a demonstration inspection. In Figure 30 part of the inspection tree is given for the object chosen. The figure shows first the two buildings, and then on the next level also the different facades. The next level given in the figure is for instance windows and the surface treatment.

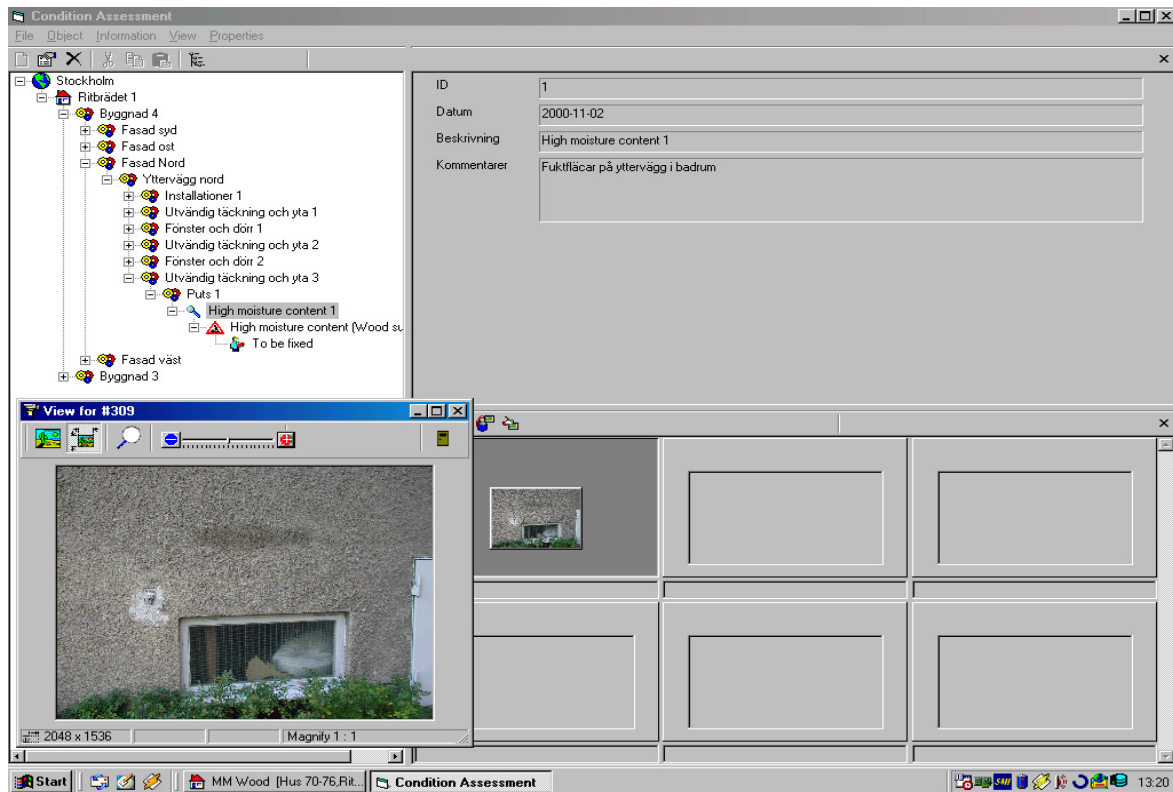
Figure 31: A schematic overview of the damage high moisture content on the north facade at house 4 in the Vällingby object.

In the demonstration inspection at Ritbrädet 1 in Vällingby the following pre-defined observations were found: Missing parts, Flaking, Deformation, Overgrowth, High moisture content, Chalking, Discoloration, Rising dampness and Cracking. For some of these observations suggested decisions are also given. Figure 31 illustrate the only major damage that was found in the inspection. The damage is high moisture content in the wall outside the bathroom on the northern facade on house 4.

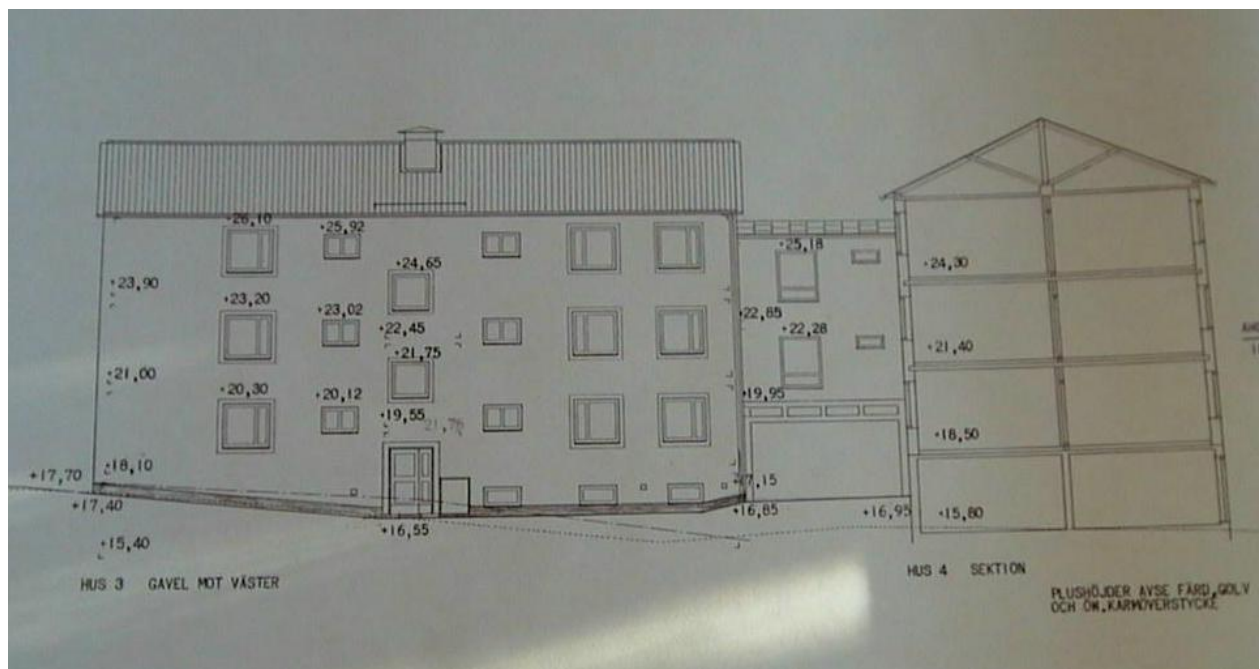
Figure 37: A drawing of the west facade of the object in Vällingby.

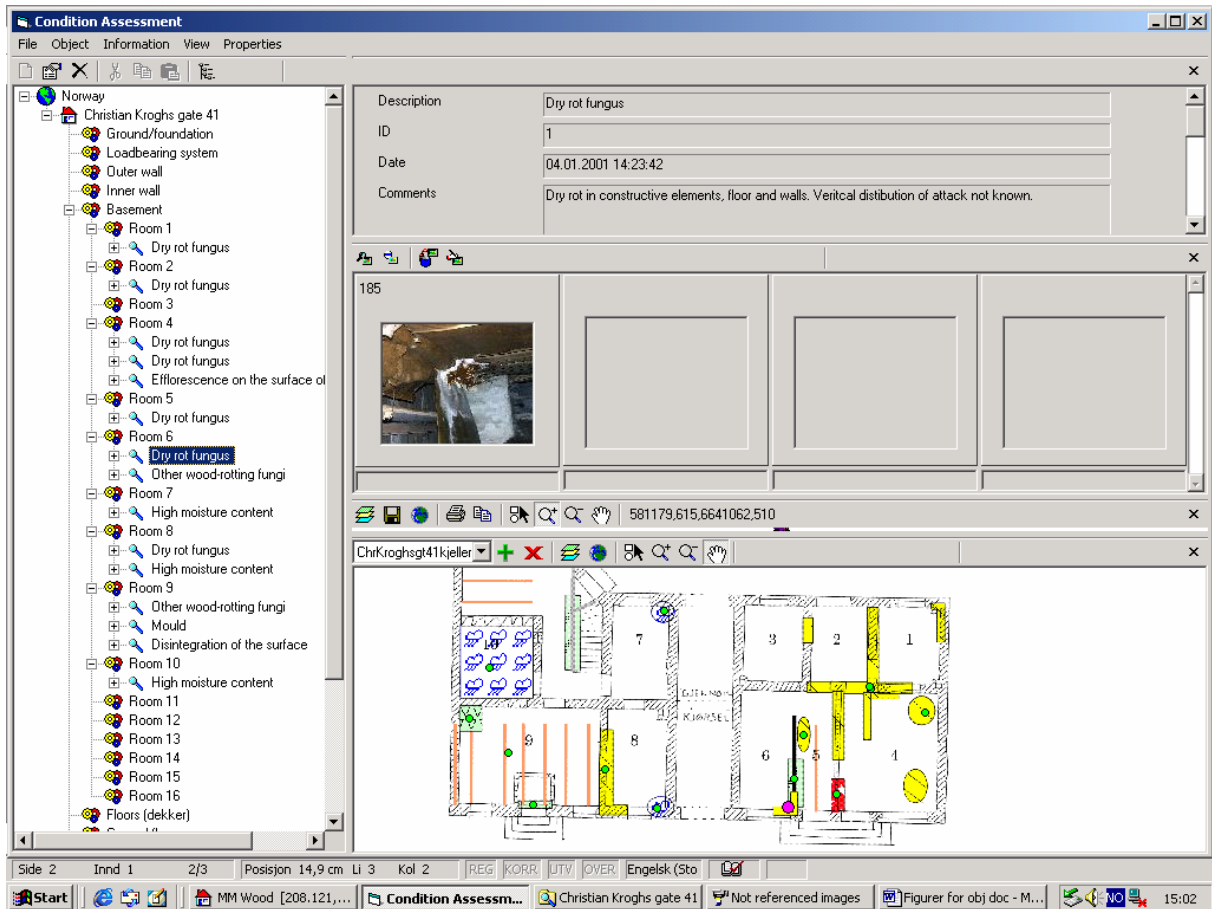
Figure 39: A schematic overview of the damage dry rot fungus in room 6 in the basement, showing photo and placement on the drawing of the basement (pink dot).

Details on one of the damages in the basement are shown in Figure 39, Figure 40, and Figure 41.

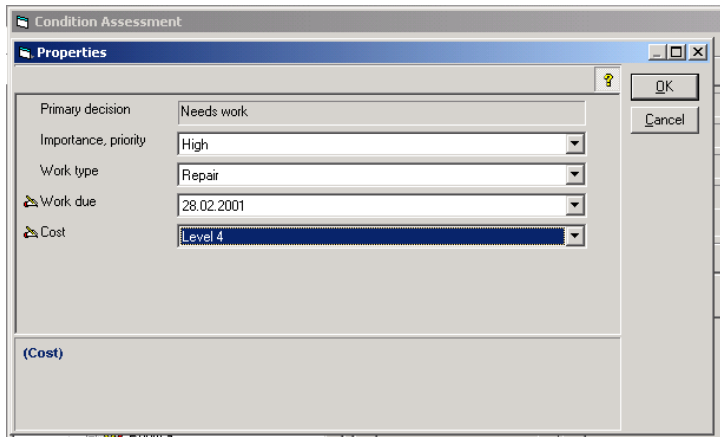
Figure 41: The figure shows the decisions taken regarding the damage described in Figure 39 and Figure 40.

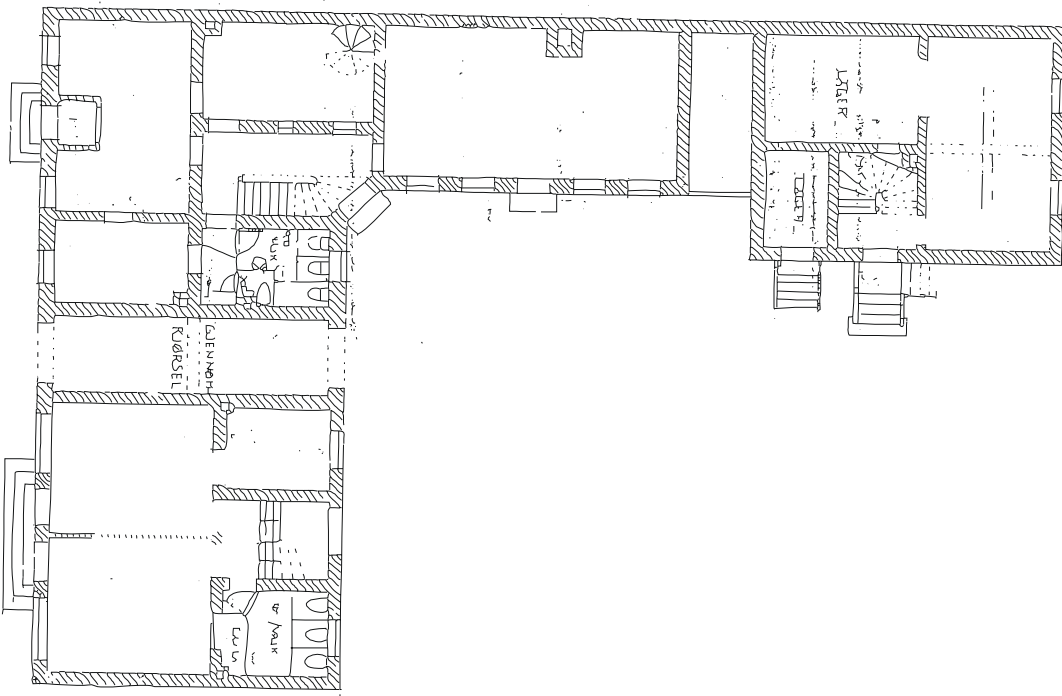
Figure 43: Drawing of ground floor of Christian Krogh's gate 41.

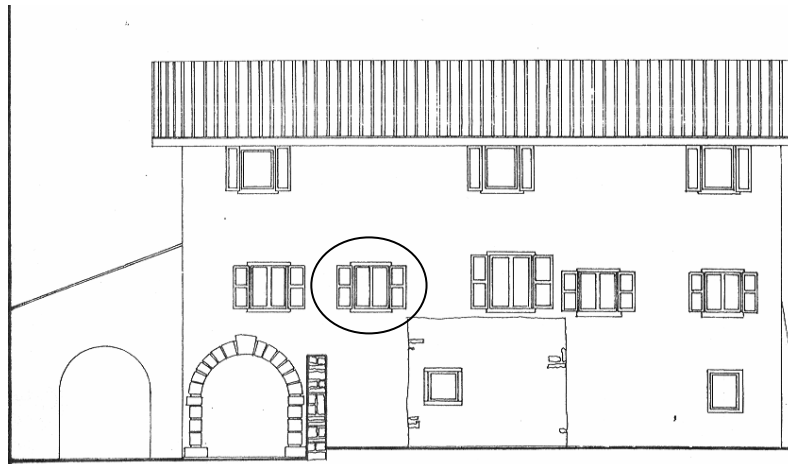
An orientation system has been chosen to identify the different building parts. The facades of the building have been divided into axis (x and y) depending on the number of floor (x) and on the number of windows (y). So, for example, Window S-2-4 means the window on the south facade, at the second floor in the fourth position, Figure 51.

Figure 51: The position of the window S-2-4

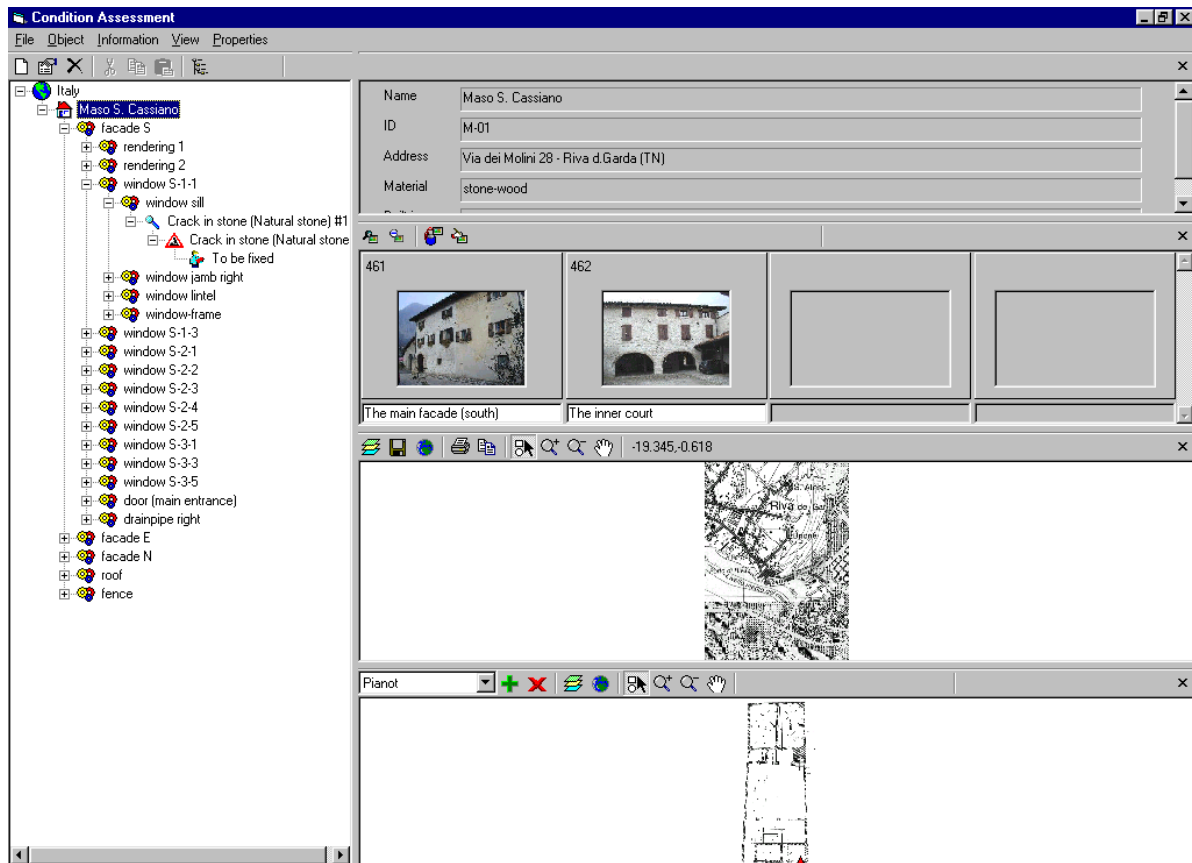
Figure 52: The Condition Assessment Module and the tree structure

Maso S. Cassiano has been divided into five main parts. Every part has been divided into sub building parts; only the parts presenting problems have been taken into account and deeply monitored. Figure 52 shows the Condition Assessment module and the chosen tree structure. On the left there is the tree structure defining the building and its parts divided into sub-building parts, while on the right there are (from the top to the bottom): the object properties, some meaningful photos of the building or of a particular building part, the map of the site and the drawings (plants, sections, details and so on).

So, the user knows that a damage (crack in stone) is present in the window sill of the window named S-1-1 (according to the chosen orientation system) of the south facade, and that this damage is to be fixed.

The tree structure as appears in the Condition Assessment Module, with a particular example (Facade south – window S-1-1) is shown in Figure 52.

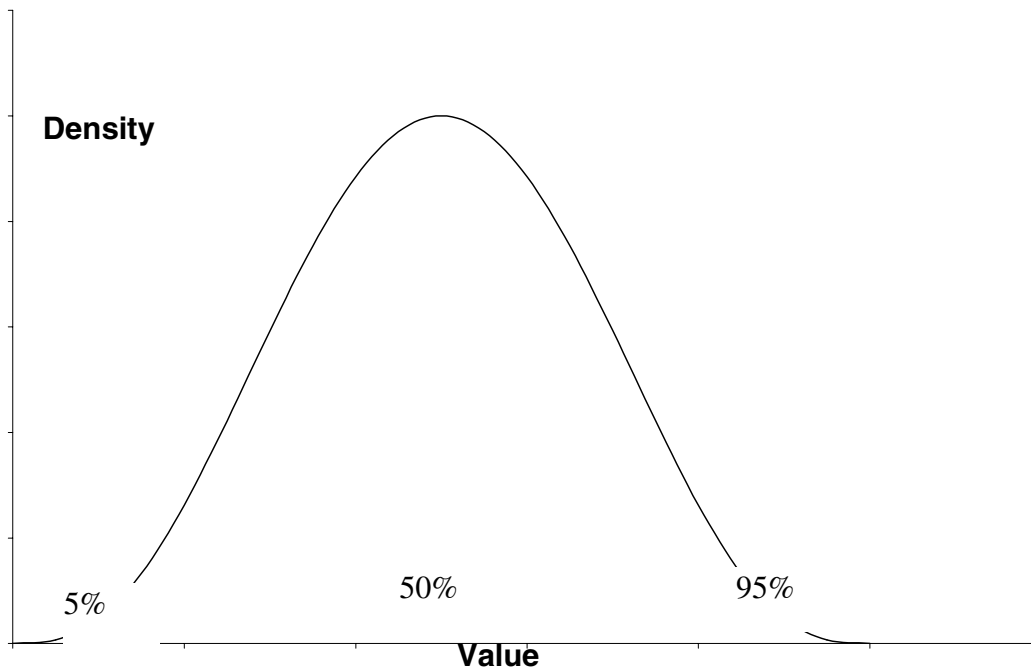
It is quite evident, that the real behaviour of a group of similar building parts cannot be characterised significantly by one single value. Hence a more detailed analysis is required, in most cases a probabilistic approach. Figure 60 shows a schematic density curve based upon experience or manufacturer's data. However, if sufficient data from experience, from testing or from manufacturer is not available, a density curve of the estimated service life can be

defined by professional estimate or by the recursive Delphi method. This is best done by setting values to the average (50%) and to the minimum and maximum values. The fractiles are partial integrals of the density function, whose total integral is 1.0 or 100% equal to all elements included.

Figure 60: Visualised typical fractiles defining density distributions.

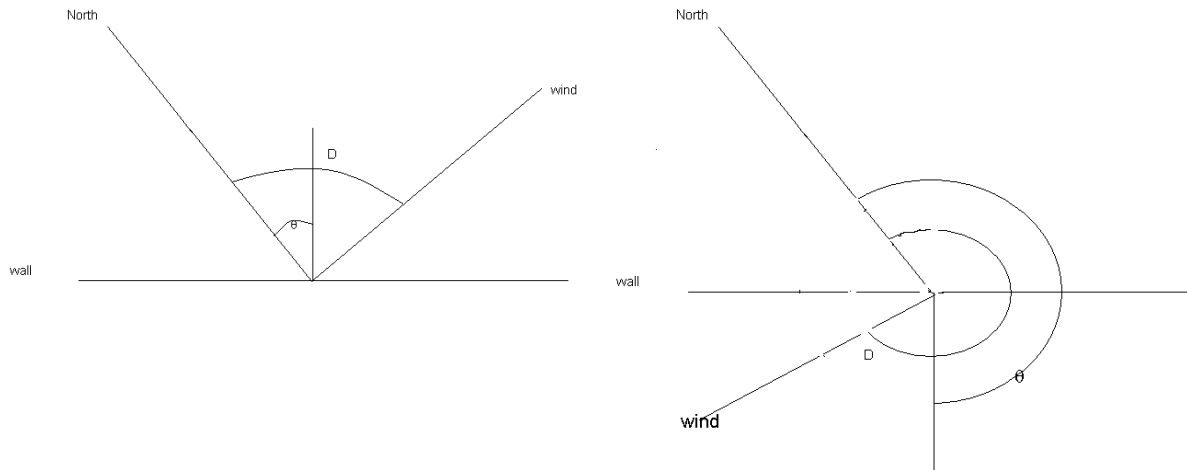
where v is the hourly mean wind speed in m/s, r is the hourly rainfall in mm, D is the hourly mean wind direction from the north, Θ is the angle between north and a line normal to the wall and the summation is taken over all hours for which $\cos(D-\Theta)$ is positive, i.e. all those occasions when the wind is blowing against the wall. Figure 61 shows an illustration of the angles for different wind directions and wall orientations.

Figure 61: Illustration of mean wind direction, D , and Θ , which is the angle between north and a line normal to the wall.

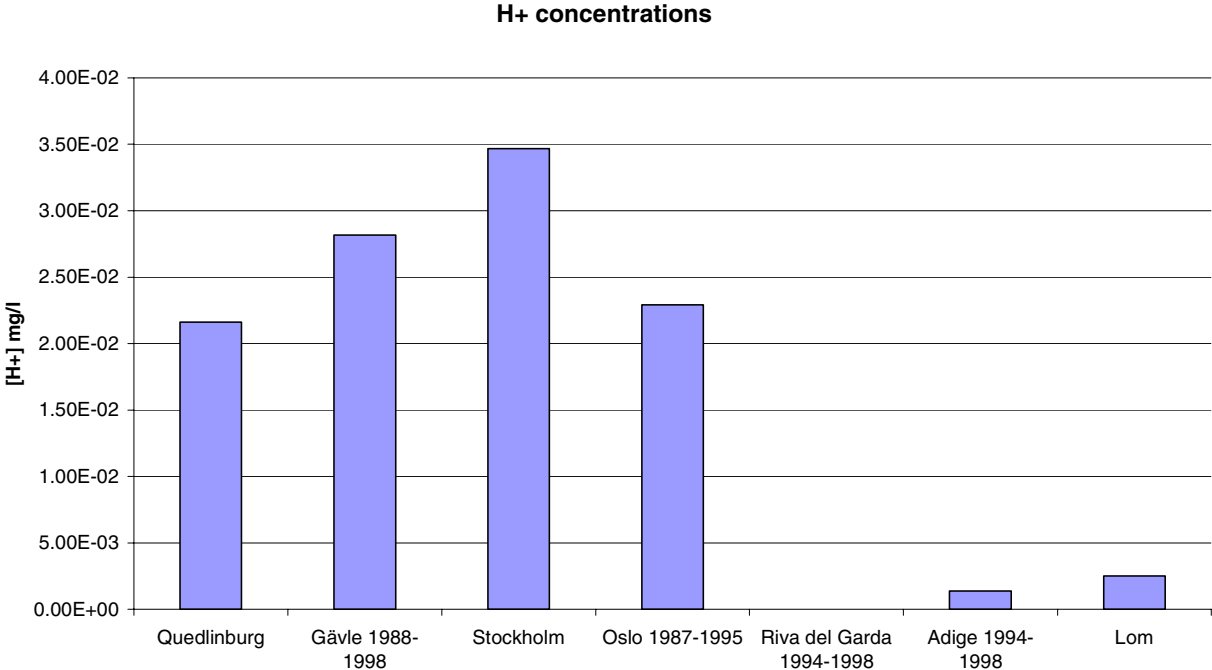
Figure 72: Pollution levels, concentration of H⁺, in the region of the demonstrator objects.

Necessary pollution data are collected by the responsible partners from measurement station as close to the object or as representative as possible. The collected data, average concentration of SO₂, µg/m³, and acidity, concentration of hydrogen in rain, H⁺, mg/l, are shown in Table 22 and Figure 72 and Figure 73.

As shown in Table 5, Figure 72, Figure 73, and Figure 74 the SO₂ and H⁺ concentration varies on both local, regional scale and European scale. Hence the service life based on pollution levels also has variation on local and regional scale.

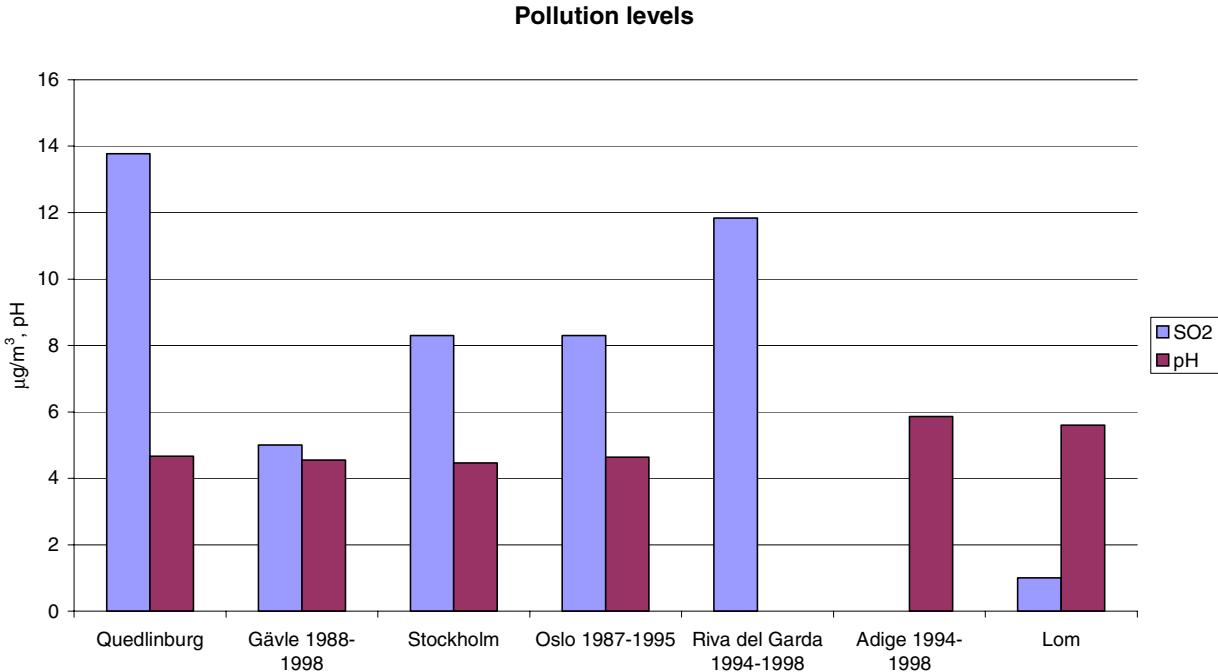
Figure 73: Pollution levels, Concentration of SO₂ and pH, in the regions of demonstrator objects.

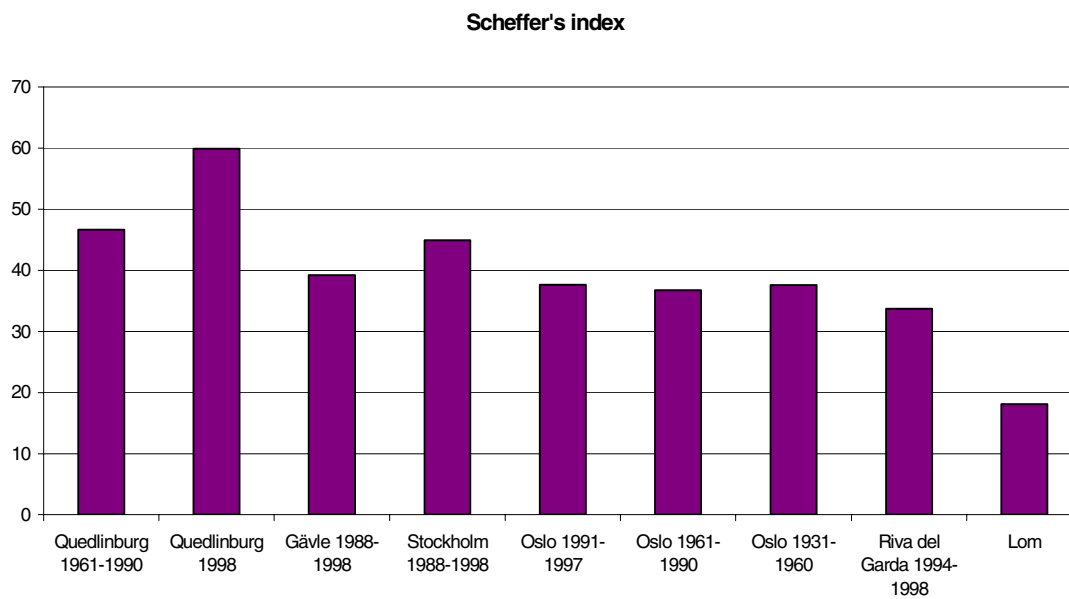
Figure 75: Scheffer's index for the area of the demonstrator objects.

Scheffer's index is calculated from the data in Table 18 and Table 19 for all demonstrator objects. The results are shown in Table 23 and Figure 75. Due to missing information of number of days with rain in Gävle, the number of days with rain for Stockholm is used in the calculation of Scheffer's index.

Following the classification proposed by Scheffer Quedlinburg, Gävle, Stockholm, and Oslo have the intermediately favourable conditions for decay, while Riva del Garda has the least favourable conditions for decay. The reference site Lom with known long lifetime for wood constructions has a Scheffer's index that is only 55% of the one in Riva del Garda. Scheffer's index is also modelled for a geographical area, where the temperature is depending on the topography. This is shown in Figure 76

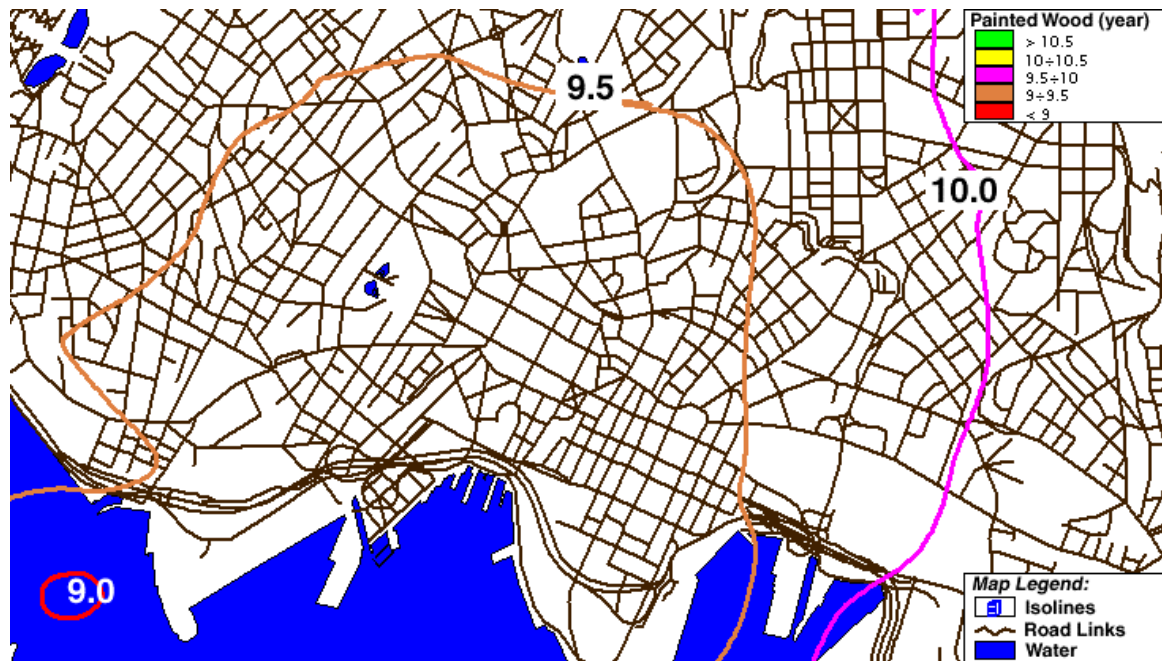
Figure 78: Service life of painted wood, centre of Oslo.

When the pollution data or meteorological data are available on a regional scale as a data field, the service life can be calculated as a field. SO₂-concentration is available as a data field in Oslo, and service life for painted wood is calculated as a field. The results are shown in Figure 77 and Figure 78. The difference in service life painted wood Oslo from Table 24 to Figure 78 is due to difference in SO₂-concentration.

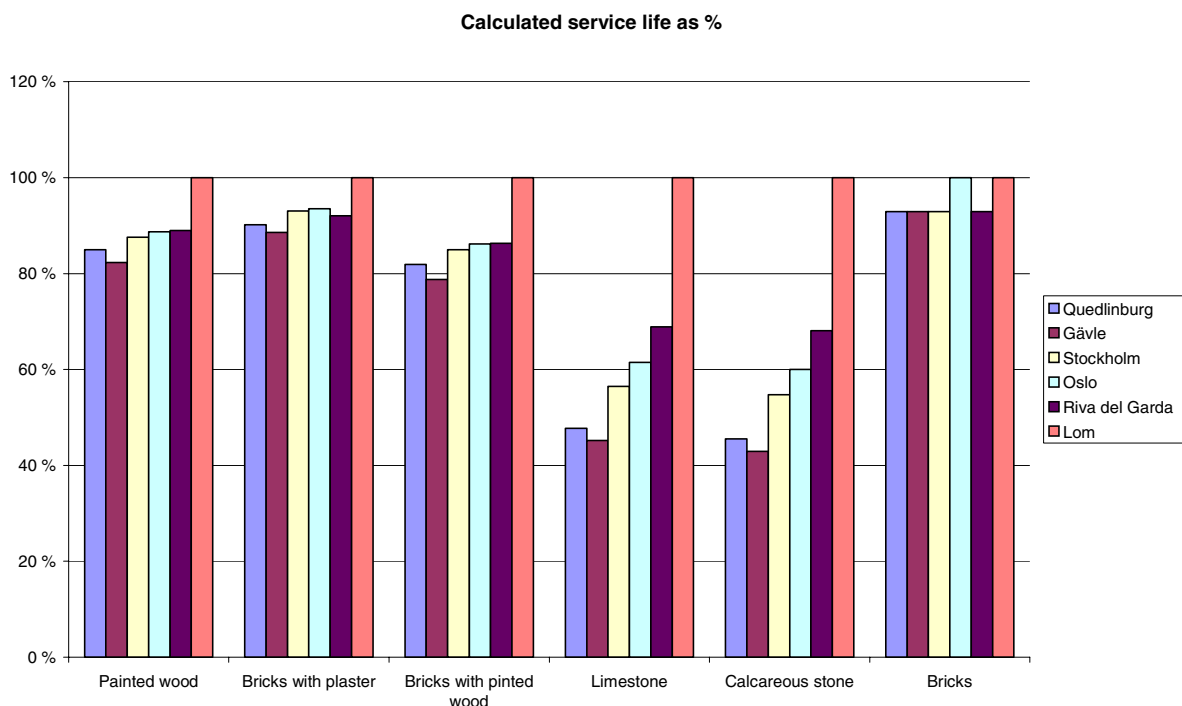
Figure 79: Calculated service life as % of service life in reference area.

As shown in Table 25 and Figure 79 the service life for bricks is reduced with less than 10%, for bricks with plaster and painted plaster with 7-21%, for painted wood 10-18%, and for limestone and calcareous stone the service life may be reduced with more than 50%.
