# Experimental study of fire exposed expanded polystyrene (EPS) insulation protected by selected coverings

Brynhild Garberg Olsø<sup>\*</sup>, Anne-Marit Haukø, Birgit Risholt

SINTEF Community, P.O. Box 4760 Torgarden, 7465, Trondheim, Norway

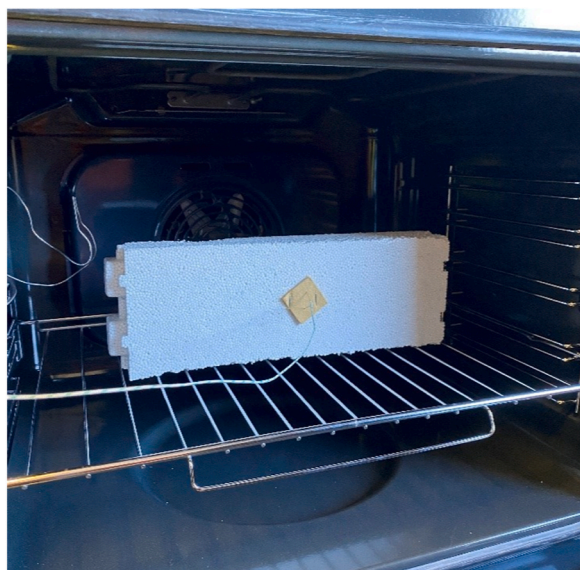
**Fig. 1.** Test setup used to determine the temperature range for structural change in the specific EPS material used in the main tests. The picture shows a sample of EPS material with a disc thermocouple attached to the side.

For the preliminary test on the EPS material, an electrical oven used for cooking purposes was utilized. The internal dimensions of the oven were 560 mm × 579 mm × 549 mm. The test involved placing a 100 mm × 300 mm × 150 mm EPS sample in the centre of the oven, allowing the hot air to circulate evenly around it. To measure the temperature rise during the test, a copper disc thermocouple type K (diameter 6.35 mm, thickness 0.3 mm) with PTFE insulated twisted wire, was positioned on the test sample surface. The test setup is shown in Fig. 1.

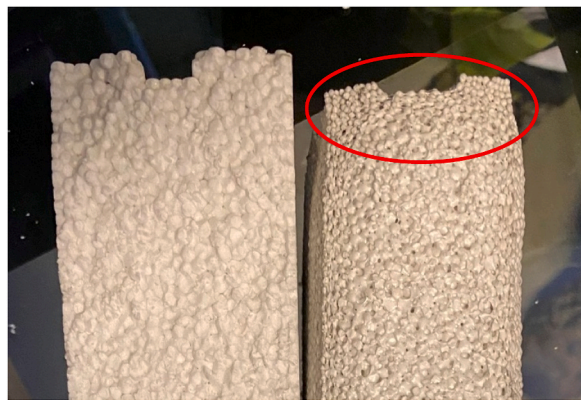
**Fig. 3.** Visual comparison of shrunken EPS material (top view). The heat affected test sample on the right is clearly smaller in size compared to the reference sample on the left. The red circle on the right highlights the area where shrinking is most distinct.

Observations and temperature measurements recorded during the test indicated that the structural changes, shown in Figs. 2 and 3, occurred in the temperature range of 95 °C–100 °C. A comparison of the test sample with an identical reference sample following the test revealed distinct structural differences. In Fig. 2 (right), the test sample exhibited inflated EPS beads on the surface, while the reference sample (left) remained unchanged. Additionally, Fig. 3 highlights the evident shrinkage of the test sample, particularly noticeable on the edges.

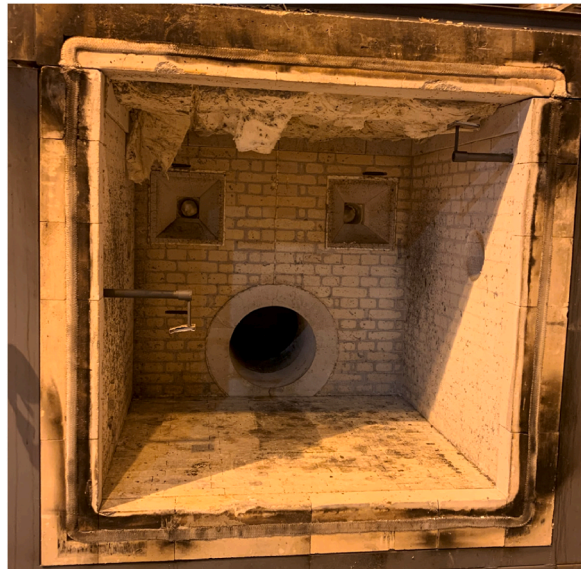
Fig. 7. Indicative fire resistance test furnace.

[24] and EN 1363-1 [25] standards. The furnace, shown in Fig. 7, possesses inner dimensions of 1550 mm × 1550 mm × 1550 mm. Vertical orientation was selected to mimic wall configurations. The furnace was fuelled with a premixture of propane gas and air, and it features three gas burners embedded in the sides of the chamber, one on the right side and two on the left side. The temperature-time relationship followed the cellulosic fire curve (ISO-834) [24], which was considered relevant for the present study as it is also used in the standardized test for coverings as per EN 14135:2004 [16]. The cellulosic fire curve represents a model of a fully developed fire in a fire compartment and is used to classify and demonstrate fire resistance in standardized fire tests.

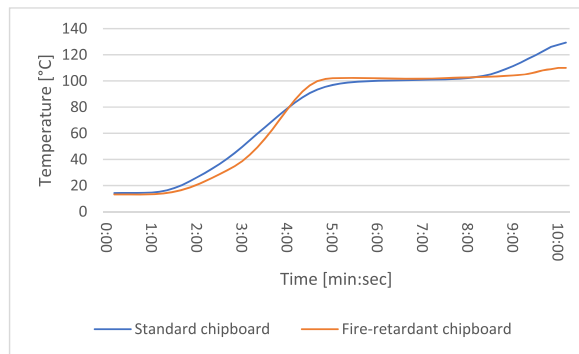
Fig. 11. Comparison of recorded temperatures for Test 1 (standard chipboard covering) and Test 2 (fire-retardant chipboard covering) based on average TC temperatures.

Figs. 9–11 show the results and a comparison of the temperature development during a 10-min fire exposure of 12 mm standard chipboard and 11 mm fire-retardant chipboard (Tests 1 and 2, respectively).

In Test 2, where the EPS insulation was covered with fire-retardant chipboard, a noticeable difference in temperature rise compared to Test 1 was observed during the first 4 min. The fire-retardant chipboard delayed the ignition and spread of fire in the initial stages of the test, resulting in lower temperature readings. However, after 4 min, the temperatures in Test 2 started to increase and eventually stabilized at around 102 °C after 5 min. It is worth noting that the surface temperature of the EPS insulation in Test 2 reached 95 °C approximately 30 s earlier than in Test 1 and maintained a slightly higher temperature towards the end of the fire tests. Towards the end of both fire tests, the temperatures rose due to burn-through of the coverings, as illustrated in Figs. 21 and 22.

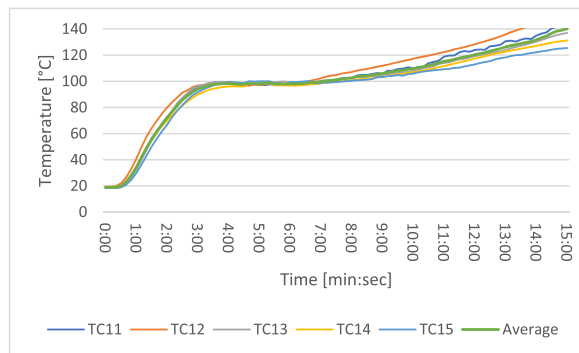
Fig. 12. Test 3–12.5 mm gypsum board. Recorded temperatures for Test 3 (single layer gypsum board covering).

The results and a comparison between recorded temperatures during fire tests for a covering of a single 12.5 mm gypsum board layer (Test 3) and a single 12 mm gypsum fibre board layer (Test 4) are shown in Figs. 12–14. Both fire tests were run for 15 min.

The single layer of gypsum board covering (Test 3) exhibited a rapid temperature development, with temperatures rising significantly after just 1 min and reaching 95 °C after approximately 3 min. Test 4, which utilized a single layer of gypsum fibre board, exhibited a much slower temperature rise, reaching 95 °C after approximately 9 min and 30 s according to the average temperature curve. However, thermocouple TC15 had a considerably lower temperature rise compared to the other four thermocouples, most likely

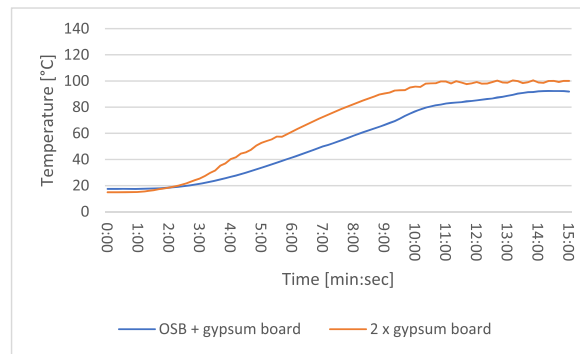
Fig. 17. Comparison of recorded temperatures for Tests 5 and 6. The coverings investigated are described in the text.

The fire tests 5 and 6, both lasting 15 min, examined different combinations of coverings. Test 5 employed a combination of a single layer of 12 mm OSB board placed directly on the EPS insulation, covered by a layer of 12.5 mm standard gypsum board. In contrast, Test 6 employed a combination of two layers of 12.5 mm standard gypsum board resulting in a total thickness of 25 mm. The temperature curves and their comparison for these fire tests are shown in Figs. 15–17.

In Tests 5 and 6, the differences in temperature development became apparent after approximately 2 min. The covering consisting of a combination of an OSB board and a gypsum board (Test 5), exhibited a considerably slower and lower temperature rise compared to Test 6. Test 5, utilizing one layer of OSB board and one layer of standard gypsum board, resulted in a gradual temperature rise but did not reach 95 °C during the 15-min fire test. In Test 6, the recorded temperatures stabilized just below 100 °C during the fire

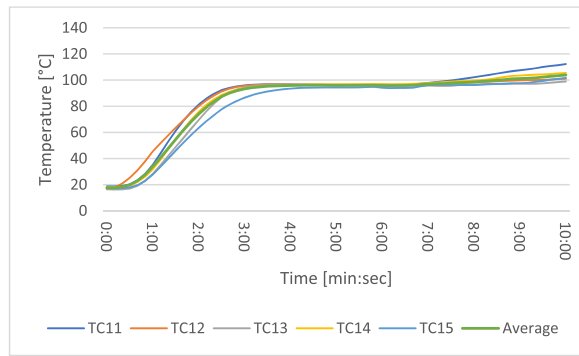
Fig. 19. Test 8 – single gypsum board on fire-retardant EPS. Recorded temperatures for a single layer of gypsum board covering fire-retardant EPS.

Figs. 18–20 show the temperature development and their comparison using coverings consisting of a single 12.5 mm gypsum layer covering standard EPS insulation (Test 7) and a single 12.5 mm gypsum layer covering fire-retardant EPS (Test 8). In both cases the test duration was 10 min.

Temperature developments during Tests 7 and 8 were very similar. However, the fire test utilizing fire-retardant EPS insulation exhibited a more consistent and lower temperature rise compared to the test performed with standard EPS.

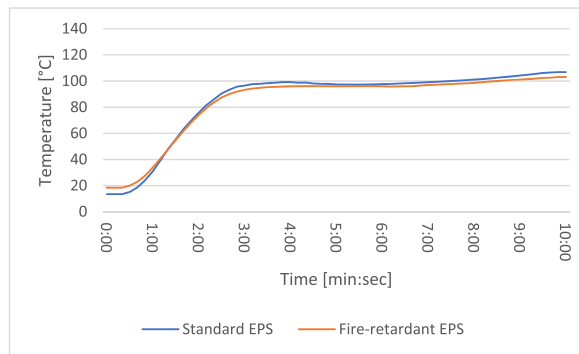
Fig. 20. Comparison of recorded temperatures for Tests 7 (single layer of gypsum covering standard EPS) and 8 (single layer of gypsum covering fire-retardant EPS).

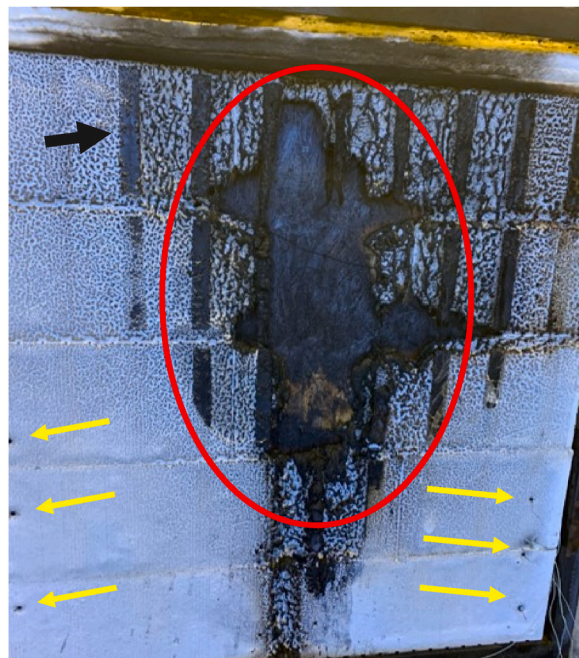
Fig. 21. Damage to the EPS insulation following Test 1 (a single layer of standard chipboard, test duration: 10 min).

Fig. 21 shows the EPS insulation test specimen after Test 1, which lasted for 10 min. In this test, the EPS insulation was protected by a single layer of 12 mm standard chipboard. The visual inspection of the specimen revealed significant damage to the EPS insulation: The covering joint was completely burned through, exposing the underlying OSB construction, as indicated by the red circle in Fig. 21. Additionally, the upper half of the EPS insulation had considerable damage and melting. In contrast, the damage to the lower half of the EPS specimen was limited to shrinkage in areas where the covering remained intact. Yellow arrows in Fig. 21 highlight local shrinkage observed around the screw holes. The regularly black vertical stripes (example shown by a thick, black arrow in the figure) are binders made of high-density polyethylene (HDPE) and polypropylene (PP) used for screw fastening purposes.

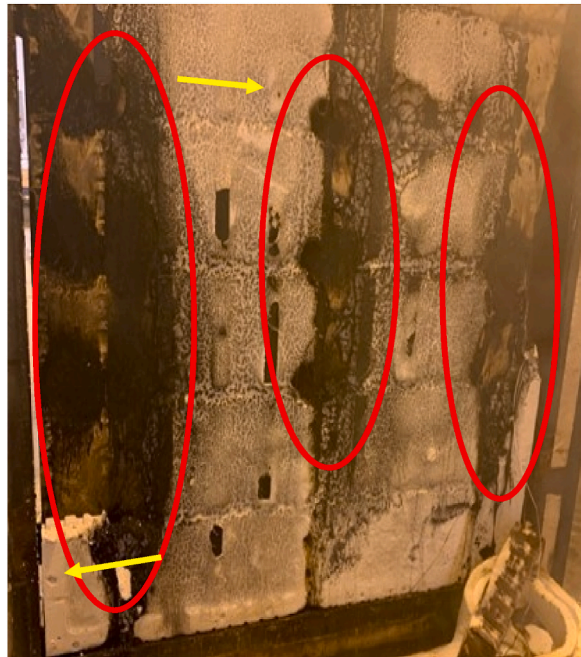
**Fig. 22.** Damage to the EPS insulation following Test 2 (a single layer of fire-retardant chipboard, test duration: 10 min).

Fig. 22 shows the EPS insulation test specimen following Test 2, which lasted for 10 min. In this test the EPS insulation was protected by a single layer of 11 mm fire-retardant chipboard. Immediate visual inspection carried out after the fire test confirmed that the covering had burned through, resulting in an involvement of the underlying EPS insulation. The damage is evenly distributed across the top and bottom of the specimen. The damage includes melted EPS and charring of the supporting OSB construction as

indicated by the red ovals in Fig. 22. Significant damage is particularly evident in the area of the covering joint, where the effects of the fire are prominent. Furthermore, local melting around the screw holes is observed as denoted by the yellow arrows in Fig. 22.

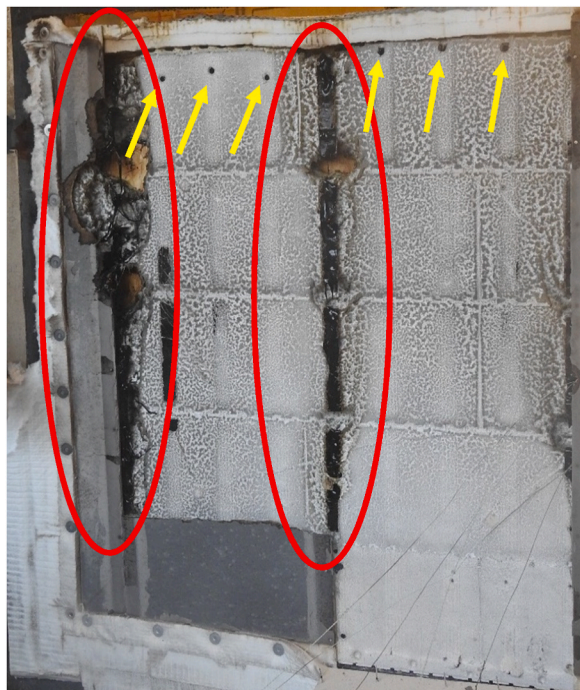
Fig. 24. Damage to EPS insulation following Test 4 (a single layer of gypsum fibre board, test duration: 15 min).

The results from Test 4, during which the EPS insulation was covered by a single layer of 12 mm gypsum fibre board, are presented in Fig. 24. The damage inflicted to the EPS material is comparatively less and more evenly distributed than in Test 3. The EPS material was primarily affected by melting rather than other forms of damage. Weak areas are apparent in the board joints, and Fig. 24 shows significant damage throughout the EPS material, especially in two of the joints. This is identified by the red ovals in the figure. Local melting around screw holes is also observed, as highlighted by the yellow arrows.

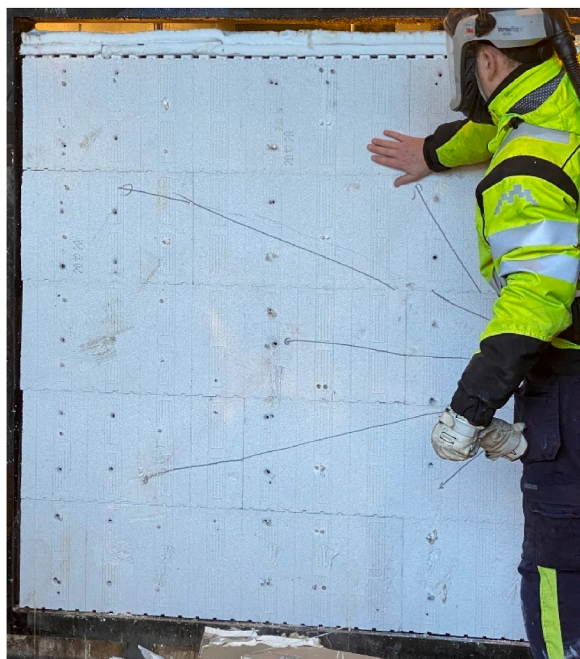
Fig. 26. Damage to the EPS insulation following Test 6 (two layers of standard gypsum board, test duration: 15 min). The lines on the specimen are pencil marks showing the location of the thermocouples.

The results from Tests 5 and 6, which involved covering the EPS insulation with two protective layers with a total thickness of 24.5 mm and 25 mm respectively, are shown in Figs. 25 and 26. The visual observations correlate well with the recorded temperatures shown in Figs. 15–17. There are no signs of shrinkage, melting, charring or surface damage to the EPS insulation surface after the 15-min test. However, localized melting was observed around the screw holes, despite the relatively low surface temperatures of the EPS. The screw holes are marked with red arrows in Fig. 25 and are clearly visible in Fig. 26. This suggests that the fastening screws possess a relatively high thermal conductivity, and that the use of screws with lower thermal conductivity or other types of fastening mechanism should be considered in future fire tests.

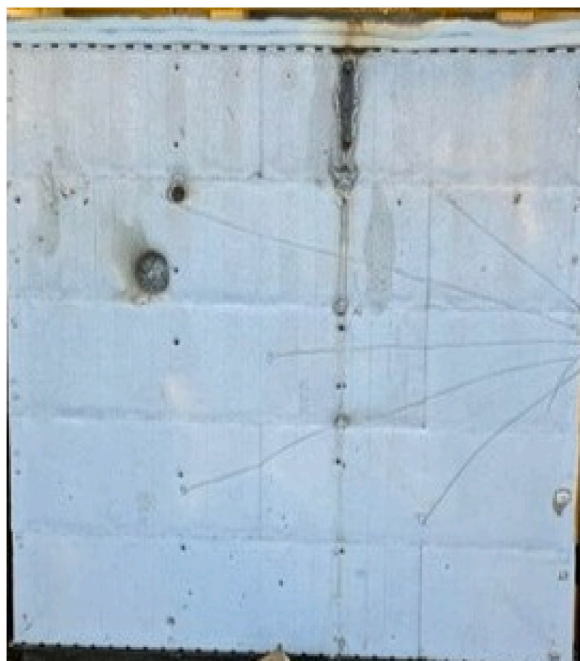
Fig. 27. Damage to the EPS insulation following Test 7 (a single layer of gypsum board, test duration 10 min).

The results from Tests 7 and 8, which involved covering standard EPS insulation and fire-retardant EPS insulation with one protective layer of 12.5 mm gypsum board, are presented in Figs. 27 and 28. The visual observations align well with the recorded temperatures shown in Figs. 18–20, indicating a stabilization of the temperature at approximately 95 °C after about 3 min, and maintaining a stable temperature of 100 °C throughout the test duration. The visual damages observed in both fire tests are similar, but the fire test involving fire-retardant EPS insulation exhibited more surface charring compared to Test 7 involving standard EPS. Both fire tests showed evidence of shrinking in the EPS insulation, especially in the transition between the EPS blocks. The simulated mechanical damage in the form of a 28 mm diameter hole in test 7 (standard EPS) and test 8 (fire retarded EPS) resulted in a damage of about 90 mm and 75 mm, respectively, as shown in Figs. 29 and 30. Weak spots were identified at the joints and screw holes in both fire tests, the spots are clearly visible in Figs. 27 and 28.

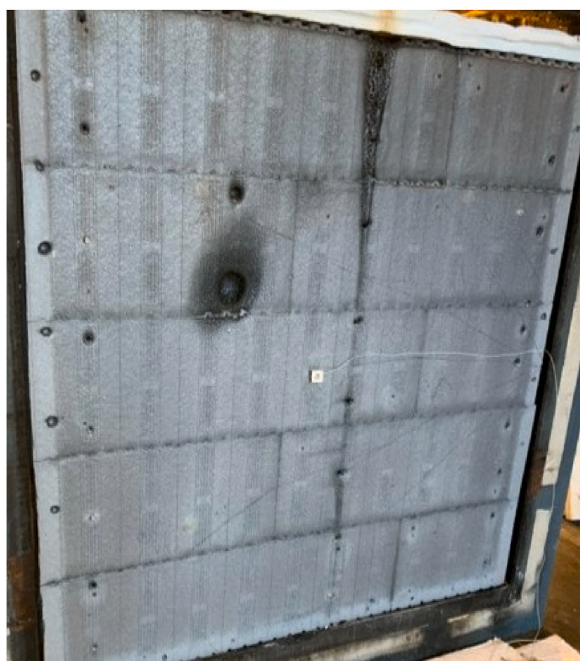
Fig. 28. Damage to the EPS insulation following Test 8 (fire-retardant EPS covered by a single layer of gypsum board, test duration 10 min).

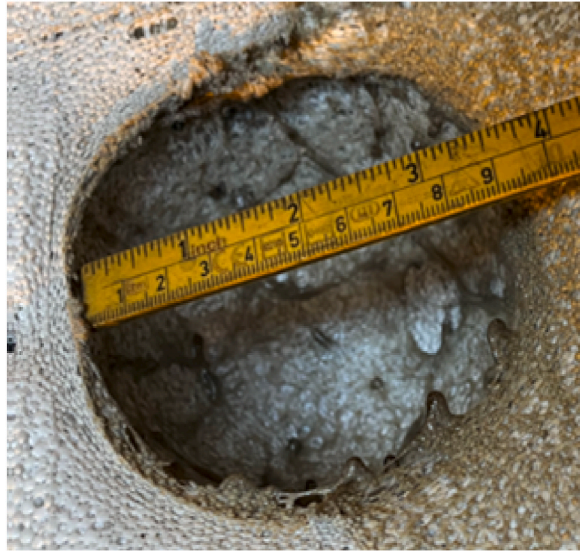
**Fig. 29.** Extent of damage to underlying EPS substrate behind 28 mm hole in the covering. Standard EPS substrate experienced an extent of damage of approximately 90 mm.

The results of Tests 7 and 8 showed that when the protective covering remained intact, the EPS insulation experienced local melting only around areas of damage and defects. The extent of damage was lower for the fire-retardant EPS (fire class E) than for the standard EPS (class F) as depicted in Figs. 29 and 30. The fire-retardant EPS used in the fire test contains graphite additives that reduce heat transfer because the graphite expands and forms a layer that can act as a thermal insulated barrier. Fire spread around areas of damage was probably prevented by a lack of oxygen ingress behind the covering. Additionally, the fire-retardant EPS exhibited more charring, and less melting compared to the standard EPS. Previous studies on the impact of rendering on EPS insulation have revealed that defects diminish the fire protection properties of the covering [2,3,19]. However, the results of Tests 7 and 8 suggest that when the covering remains securely attached to a wall, the use of EPS in wall constructions with board coverings is less vulnerable to damage caused by poor installation. The temperature rise was identical for tests with and without intentional damages and this observation indicates that minor damages will only have a local effect due to heat exposure. Hence, the effect on the remaining test specimen is negligible.

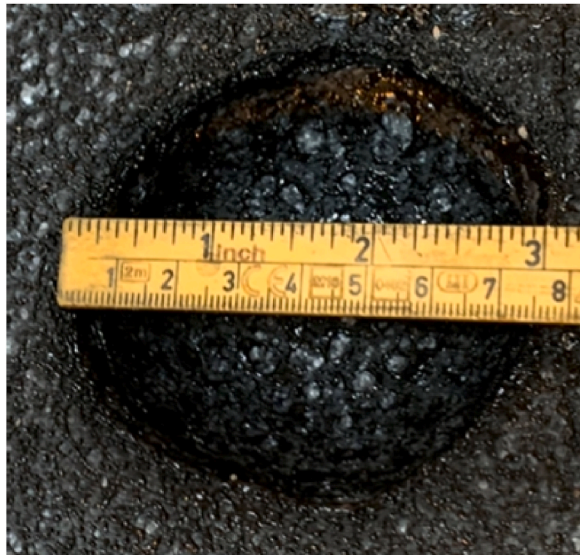
**Fig. 30.** Extent of damage to underlying EPS substrate behind 28 mm hole in the covering. Fire-retardant EPS substrate experienced an extent of damage of approximately 75 mm.
