Report 1

Case study objects in PCCH-Arctic

Selection criteria, list of the structures, and desktop data collection

PCCH-Arctic Report Nr. 1

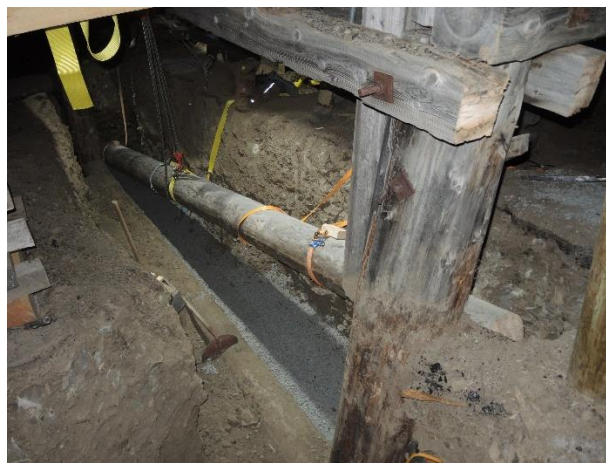
Figure 4. Reconstruction of foundation of cableway post Nr. 7, Line 5-6. Copyright: © Store Norske Spitsbergen Kulkompani.

Pictures below depict foundations of a cableway post, which were acquired during restoration project of cableway post Nr 7, Line 5-6 (Askeladden ID 87889-15).

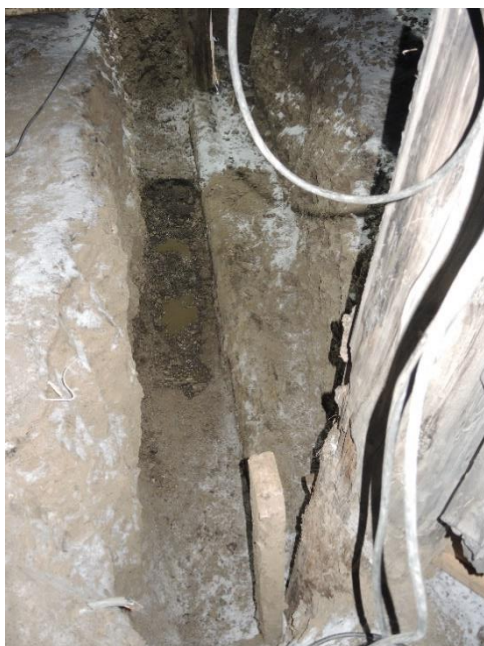
Figure 5. Reconstruction of foundation of cableway post Nr. 7, Line 5-6. Copyright: © Store Norske Spitsbergen Kulkompani.

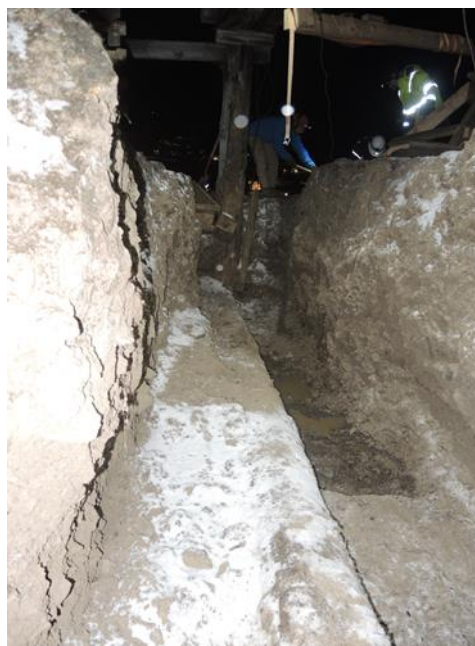
Figure 6. Reconstruction of foundation of cableway post Nr. 7, Line 5-6. Copyright: © Store Norske Spitsbergen Kulkompani.
