Large-scale fire experiments in a cross-laminated timber compartment with an adjacent corridor – Partly and fully protected with a water sprinkler system

Andreas Sæter Bøe^{a,*}, Kristian Hox^a, Ragni Fjellgaard Mikalsen^a, Kathinka L. Friquin^b

^a RISE Fire Research, Trondheim, Norway

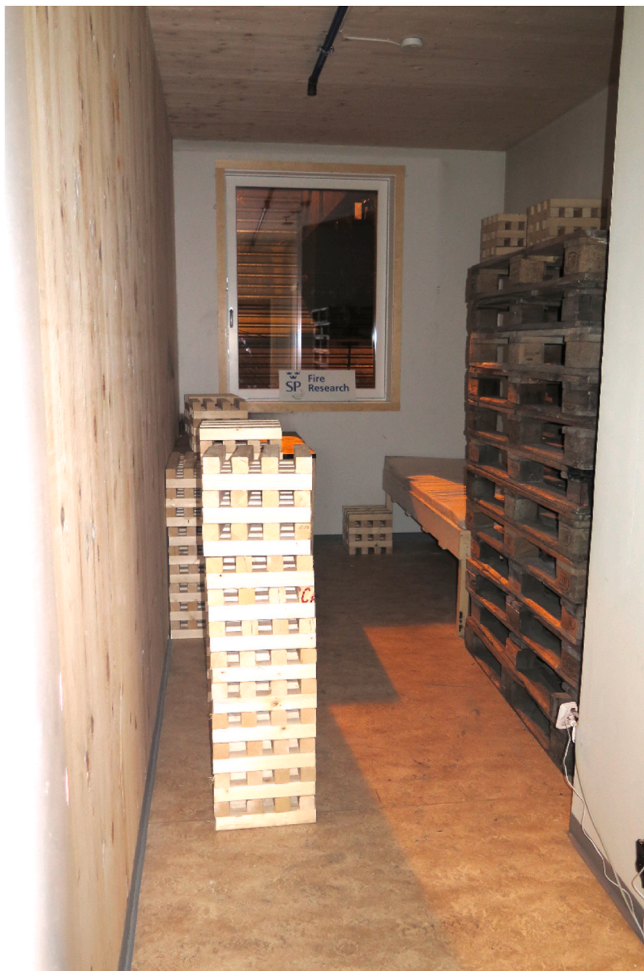
Fig. 6. Experimental setup of the compartment in Experiment 2. In the compartment, the CLT on Wall A (left) and in the ceiling were exposed. The fuel package was similar to Experiment 1 but with additional wood cribs and wood pallets (see Table 1). Photos by RISE Fire Research.

In Experiment 2, the setup was similar as in Experiment 1 but with the addition of wooden pallets and several wood cribs to ensure a variable fuel load density of 625 MJ/m², as shown in Fig. 6. A detailed list of the combustibles in the experiment is given in Table 1.

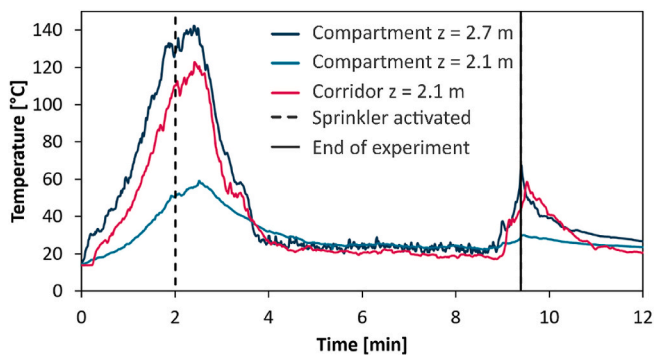
Fig. 8. Temperatures measured by TCs in compartment and corridor during Experiment 1. Location of the measurements are given in Fig. 3.

The experiment was started by igniting the heptane in the tray under the table, and the temperatures increased steadily in the compartment and the corridor after ignition, see Fig. 8. At approx. 1 min the smoke detector in both the compartment and the corridor activated. It is unknown whether the detectors were triggered by heat or smoke. At 2 min, one nozzle was activated. At this point, the temperature was 131 °C under the ceiling, in the vicinity of the nozzle. An image of the fire size at this point is given in Fig. 9. The effect of the nozzle was clearly seen half a minute later, in which the temperatures were effectively reduced in both the compartment and the corridor. This reduction prevented additional nozzles from being activated. Due to the table above the ignition source, the fire under the table was not reached by water and the sprinkler system was not able to completely extinguish the fire. However, from 4 to 9 min the temperatures in the room were kept between 20 and 25 °C and the fire was effectively controlled, see Figs. 8 and 10. At 9 min, the sprinkler system was shut down. This caused a minor increase in the temperatures until manual extinguishment was conducted at 9.5 min. A summary of the events of the experiment is given in Table 2.

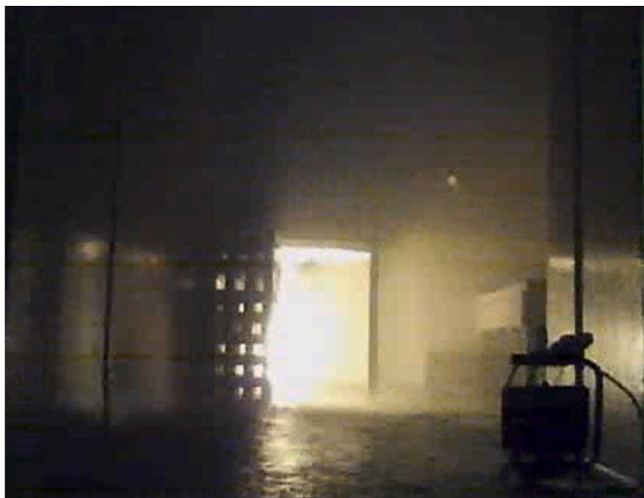
Fig. 10. The location of the fire under the table shielded the initial fire from direct water impingement. Hence, the fire was not extinguished, but controlled. Image from 08:10 (mm:ss). At this point the floor was covered by several cm of water. Photo by RISE Fire Research.

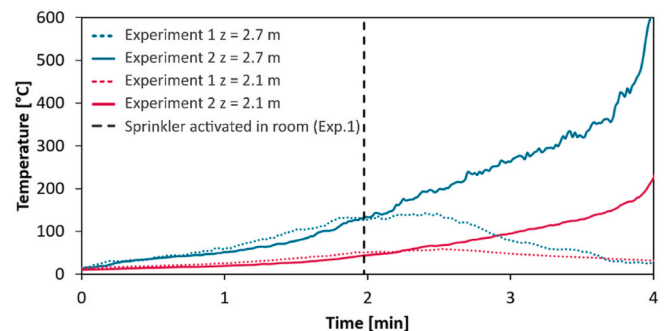
Fig. 11. A comparison of temperatures in Experiment 1 and Experiment 2 shows that the temperature development was similar for the first 2 min, i.e. the time until the sprinkler nozzle activated in Experiment 1.

Similarly as in Experiment 1, the experiment was started by igniting the heptane in the tray under the table. Details of the development are listed in Table 3. The first 2 min of the fire developed almost identical to the fire in Experiment 1, as seen in Fig. 11. The similarity was also

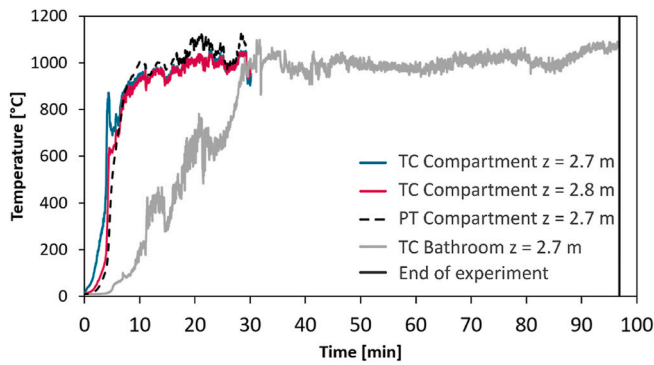
Fig. 13. Temperatures under the ceiling in the compartment. The TCs at 2.7 m and 2.1 m height in the compartment experienced strong fluctuations after 30 min and are thus not included. The PT fell down after approx. 30 min and measurements after this is not included.

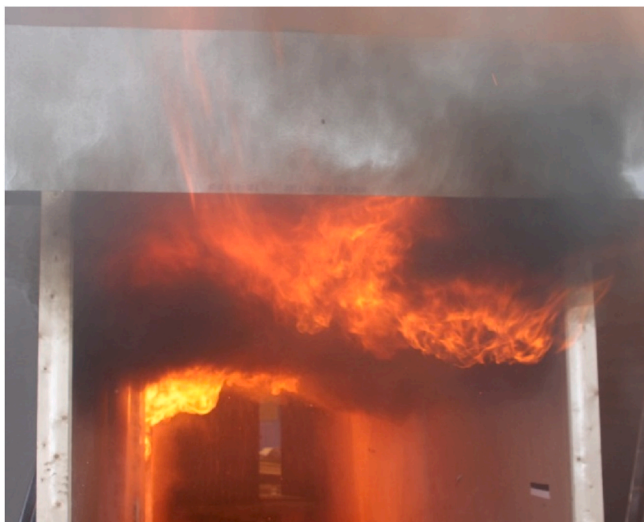
Fig. 14. Large flames quickly spread under the ceiling in the corridor. Image at approx. 6.5 min. At this point, the two sprinklers under the suspended ceiling have activated and at least one of the nozzles above the suspended ceiling. Photo by RISE Fire Research.

From approx. 5 min, large flames emerged from the door opening and into the corridor and flames spread out from the corridor at 6.5 min, see Fig. 14. Despite four nozzles activated in the corridor, in which two of them were located close to the door opening, the sprinkler system was not able to extinguish the fire, control it, nor keep the temperatures low in the corridor. The high temperatures caused ignition of the CLT ceiling and the upper parts of the walls in the corridor, as seen in Fig. 16. The areas of the CLT that were well protected are also shown here.

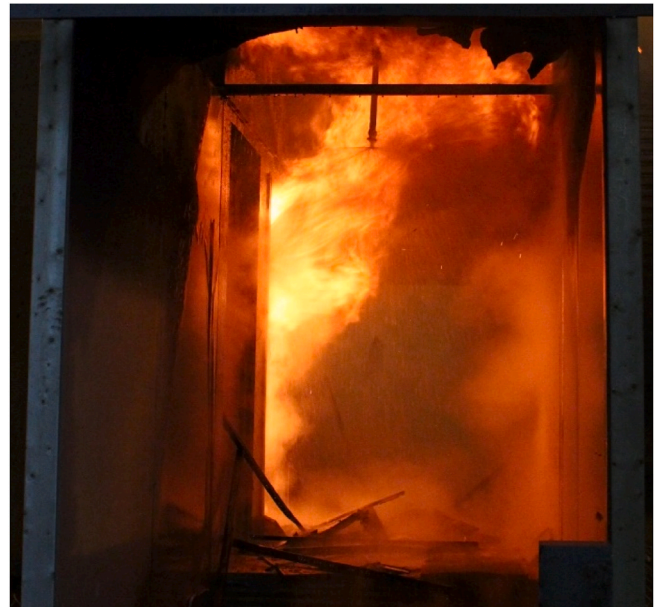
Fig. 15. Large flames emerged from the compartment into the corridor and ignited the exposed CLT ceiling and the upper parts of the walls. The suspended ceiling suffered great damage from the flames and fell down after 8.5 min, i.e., approx. 3.5 min after flames emerged into the corridor. Photo by RISE Fire Research.

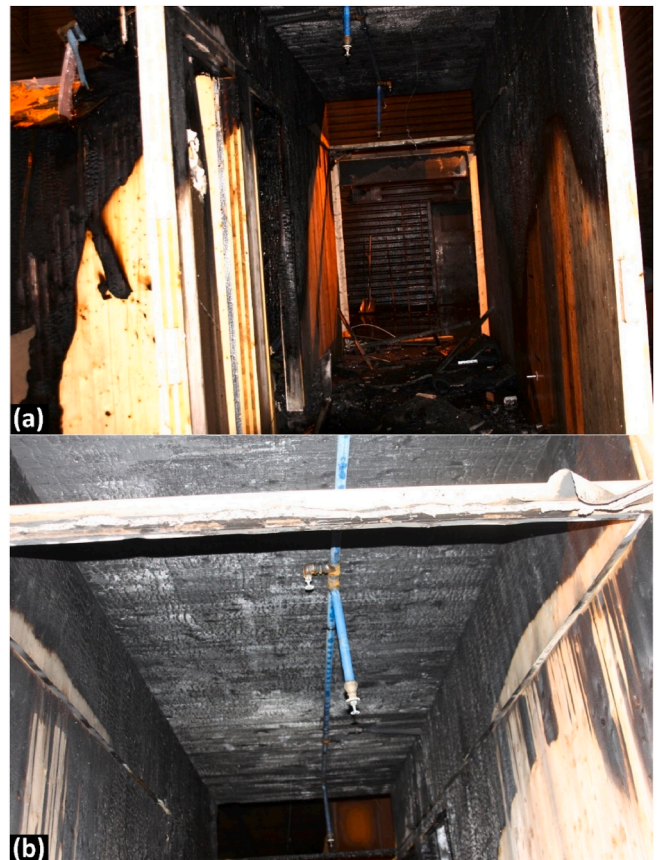
Fig. 16. (a) The corridor after the experiment. (b) The CLT ceiling and the upper walls of the corridor were heavily charred despite the activation of four sprinkler nozzles. The marks on the wall also show clearly which areas that were effectively protected by the water. Photos by RISE Fire Research.

Despite a total water flow of 187 L/min, the temperatures were not reduced significantly under the ceiling in the corridor. The increase of water pressure to 2.0 bar and a total water flow of 440 L/min, i.e., 40 mm/min, did not make any difference. The entire CLT ceiling and upper parts of the walls in the corridor were considerably charred, while the lower parts of the walls were undamaged, see Fig. 16. Manual

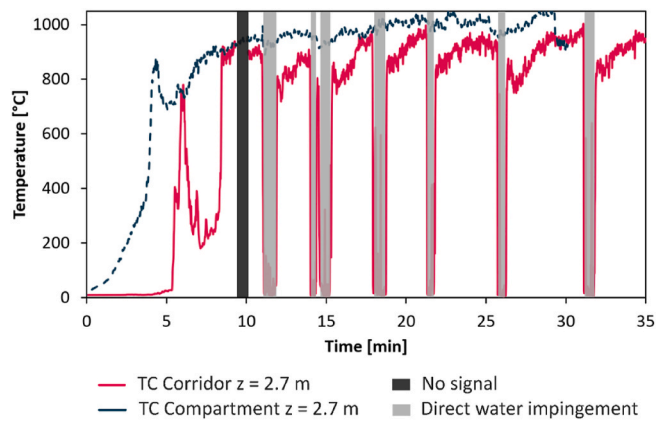
Fig. 17. Comparison of the maximum temperature in the compartment and in the corridor above the suspended ceiling. The low temperatures measured in the corridor are due to direct water impingement by manual extinguishment.

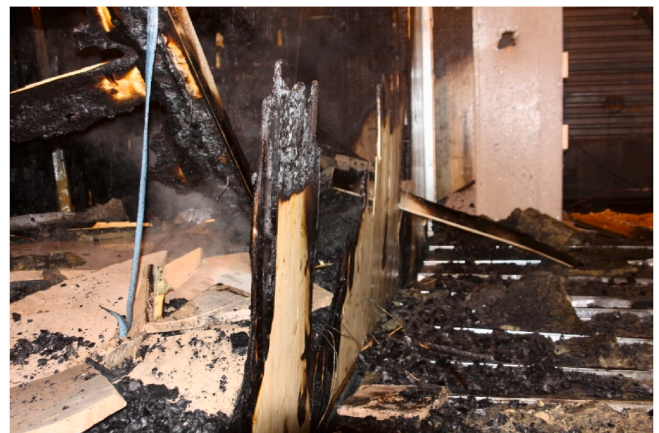
Fig. 18. Very little of the exposed CLT wall (Wall A) was remaining after the experiment. The light steel frame wall with stone wool insulation that was on the non-exposed side of the wall can be seen lying down to the right. The greyish pieces to the left are parts of the substrate layer from the collapsed ceiling. Photo by RISE Fire Research.

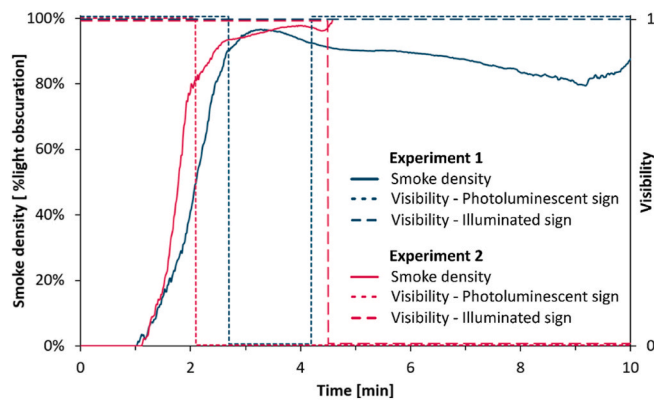
Fig. 20. Smoke density through the corridor measured by the reduction in light obscuration at height 2.05 m for Experiments 1 and 2, and observed visibility of safety way-guidance signs (visible = 1, not visible = 0) by persons located 8 m away at the other end of the corridor.

In Experiment 2, the smoke filling in the corridor behaved similarly as in Experiment 1 until the first nozzle (no. 3) in the corridor was activated, at 02:50 (mm:ss). The activation of the nozzle caused more disturbance of the smoke which reduced the visibility. The photoluminescent sign was not visible after 2 min, with 85 % light reduction, while the illuminated sign was visible until 4.5 min (98 % light reduction).

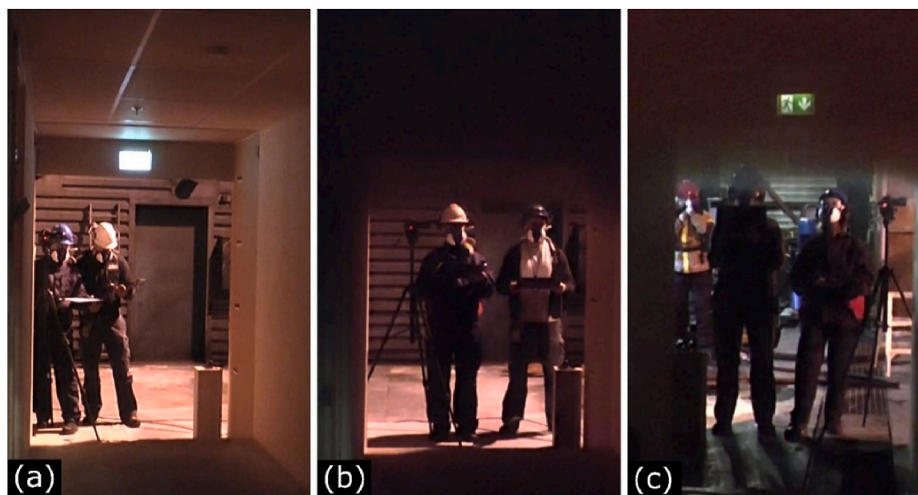
Fig. 21. Images of the visibility in the corridor in Experiment 1 during the worst visibility conditions. (a) Reference image of the visibility in the corridor. (b) View towards the photoluminescent sign and (c) view towards the illuminated sign. In Experiment 1 and the first part of Experiment 2, the visibility was only limited for the upper part of the corridor. Photos by RISE Fire Research.
