# Moisture conditions in timber frame roof and wall structures

Test house measurements for verification of  
heat-, air and moisture transfer models

Project report 273 – 2000

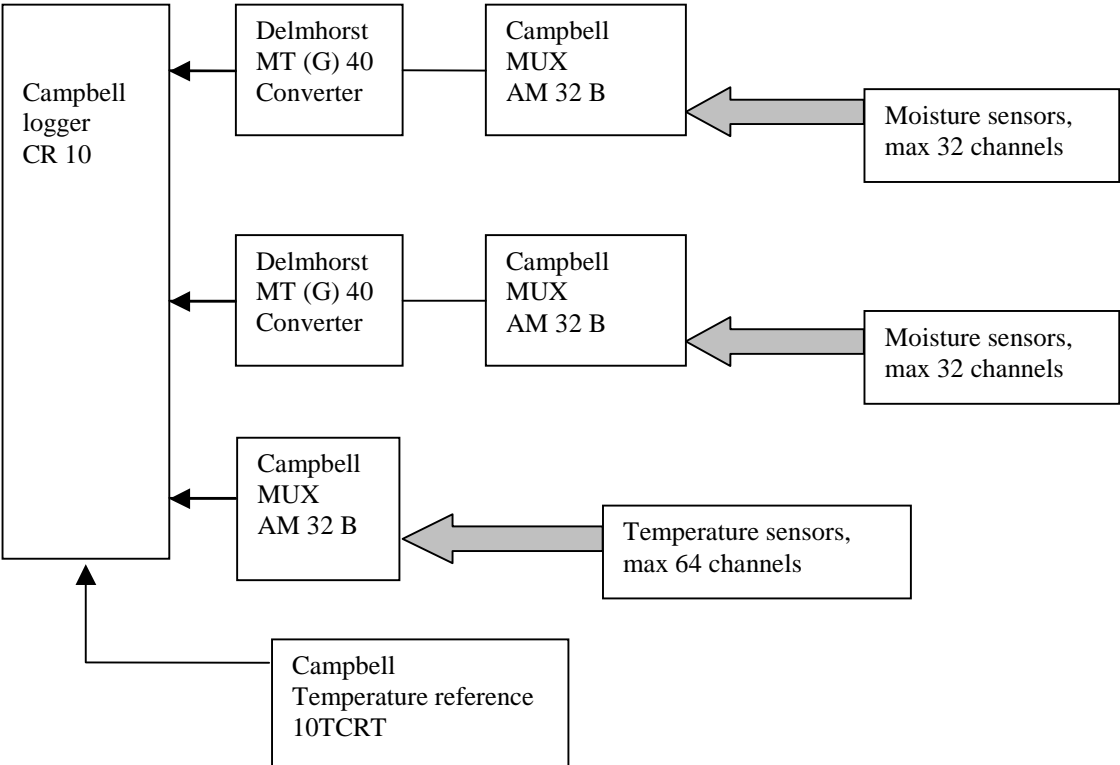
Figure 5 Connection of measurement sensors to one of the three loggers.

Because of very high electrical resistance (low levels of electrical current) coaxial cables were used for the moisture measurements to avoid that electrical noise from other electrical cables and equipment influenced the measurement signals. To convert the measurement signals (voltage) to moisture content a converter (Delmhorst MT(G) 40) was inserted between the loggers and the multiplexers. This conversion is further described in chapter 4.1. The logging system is more thoroughly described and documented in (Homb, 1998).

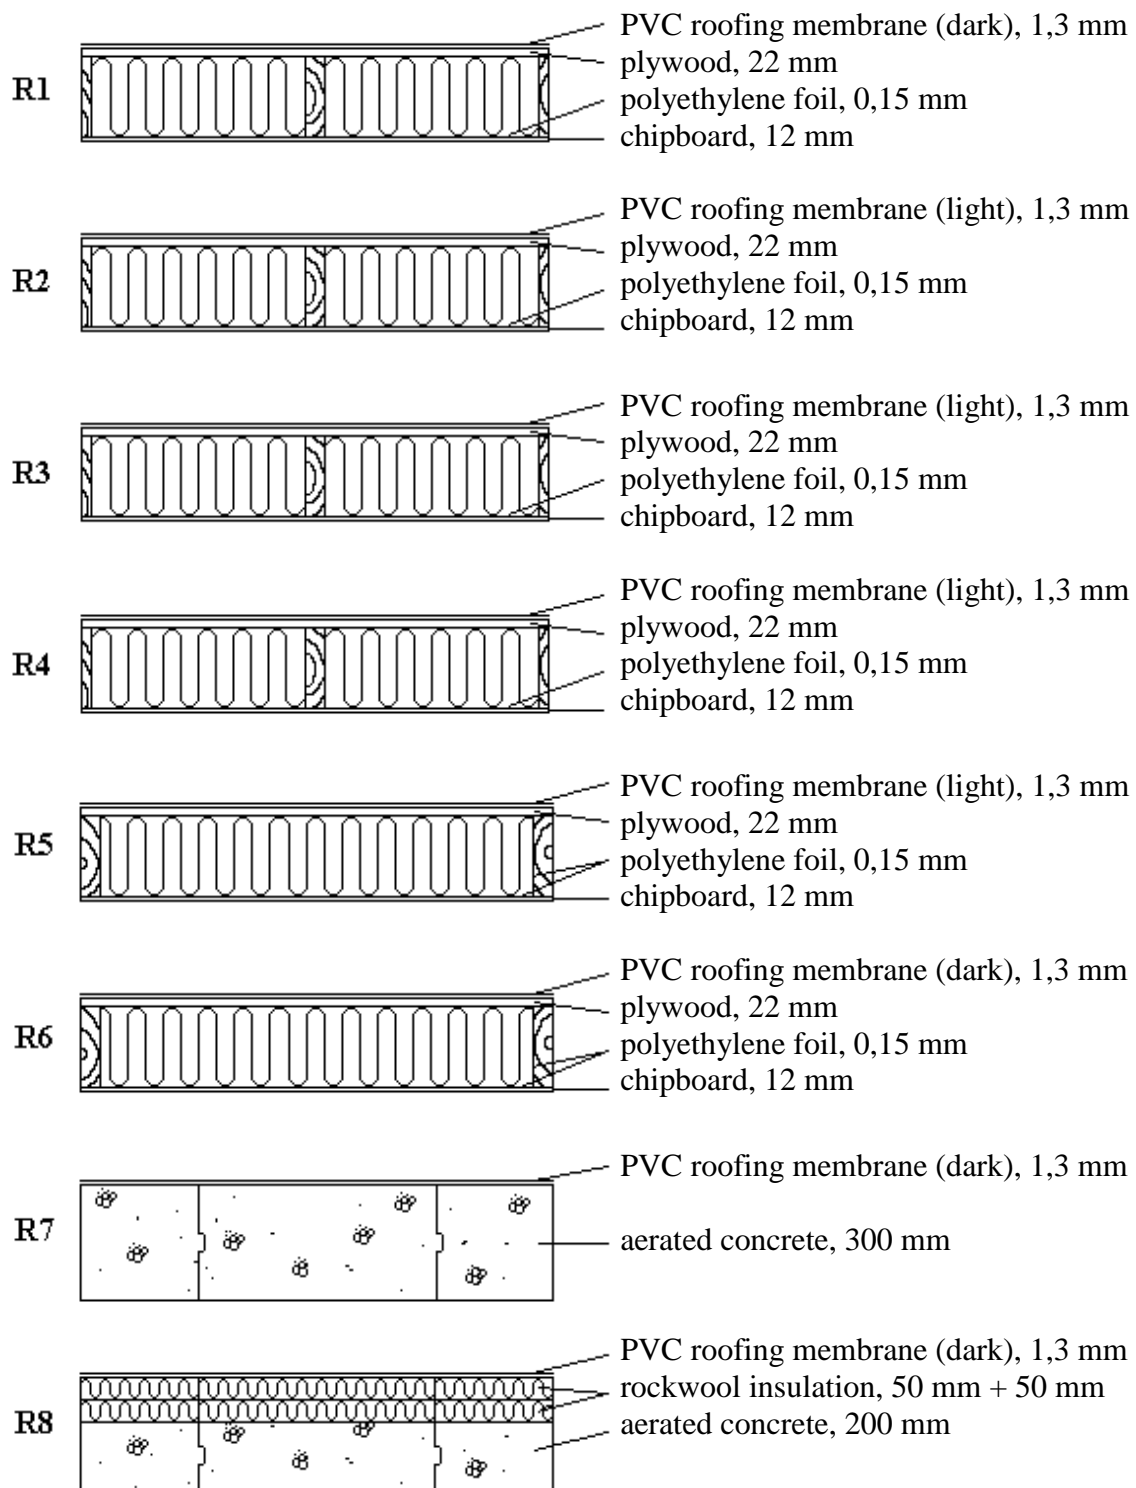
Figure 12 Roof sections. The timber frame sections are insulated with 200 mm glass fiber insulation.

The timber frame roof sections (R1-R6) consists of the following materials from the interior; 12 mm chipboard, 0,15 mm polyethylene foil, 200 mm glass fibre insulation (48x198 mm wooden rafters), 22 mm plywood and 1,3 mm PVC roofing membrane. In two of the timber frame roof sections (R5 and R6) the rafter spacing is 1.2 m to achieve 1-dimensional conditions in the middle of the section, while the other four timber frame roofs (R1-R4) have a more normal 0.6 m rafter spacing. In sections R5 and R6 the wooden rafters are separated from the rest of the section with a polyethylene foil (see Figure 12 and 18). The sections R7 and R8 consist of 300 mm and 200 mm aerated concrete respectively. R8 has a 100 mm layer of rockwool fibre insulation on the top.

Four elements (R1, R6-R8) have a dark coloured roofing membrane (emissivity  $\approx 0.9$ ), while the other four have the same roofing membrane, but the light side facing upwards (emissivity  $\approx 0.65$ ).

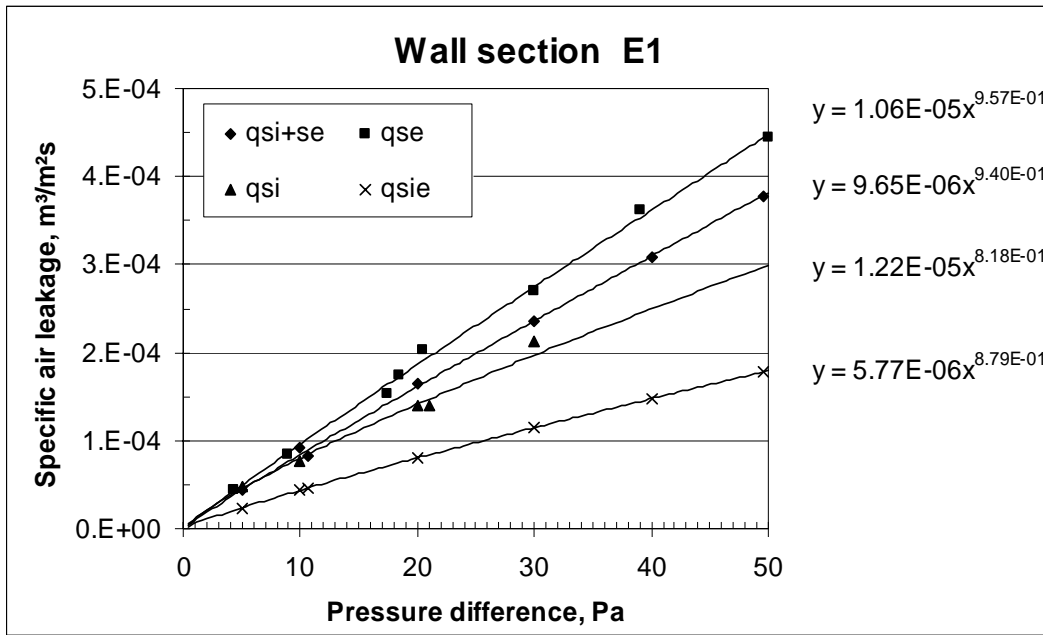
Figure 14 Example of results for specific air leakage for section E1.

On basis of these results, air leakage data for the various sections were estimated. It was assumed that there was no air leakage through the perimeter of the test sections or from the upper wall cavities to the "dummy" wall cavities in the bottom of the wall. The air leakage area used in the calculations of specific air leakage is therefore 2,88 m<sup>2</sup> (2,418m x 1,19 m) for each face of the wall. The specific air leakage through the wall section ( $q_{ie}$ ), through the interior surface ( $q_{si}$ ), through the exterior surface ( $q_{se}$ ) and the sum of these two ( $q_{se+si}$ ) were calculated. In figure 14 an example of these results are shown for section E1.

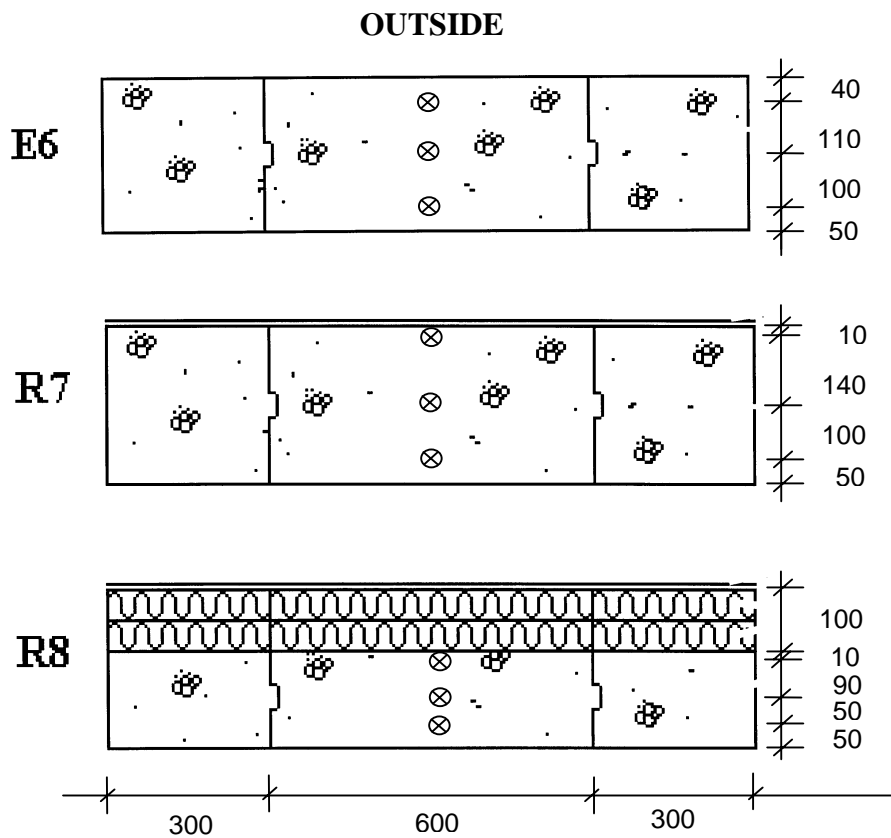
Figure 19 Location of relative humidity and temperature sensors in section E6, R7 and R8.

⊗ Location of relative humidity and temperature sensor

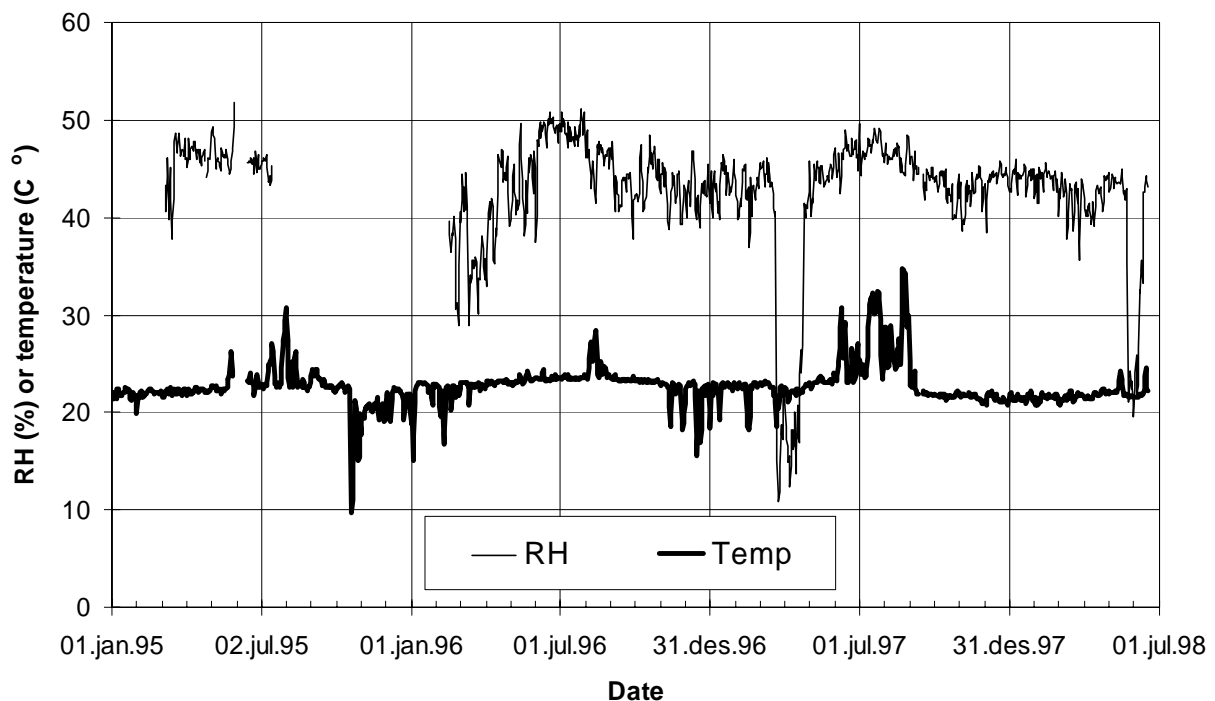
Figure 23 Indoor air temperature and relative humidity during the measurement period.

The indoor air pressure was negative compared with outdoor pressure until April 1997, when it was turned to be positive by adjusting the ventilation system. The first three heating seasons, until 6<sup>th</sup> of April 1997, the ventilating system gave a reduction in the indoor air pressure of approximately 2 Pa. The 6<sup>th</sup> of April the exhaust fan was turned off and blocked. From that date the ventilation system gave an increase in indoor air pressure of approximately 0.5 Pa.

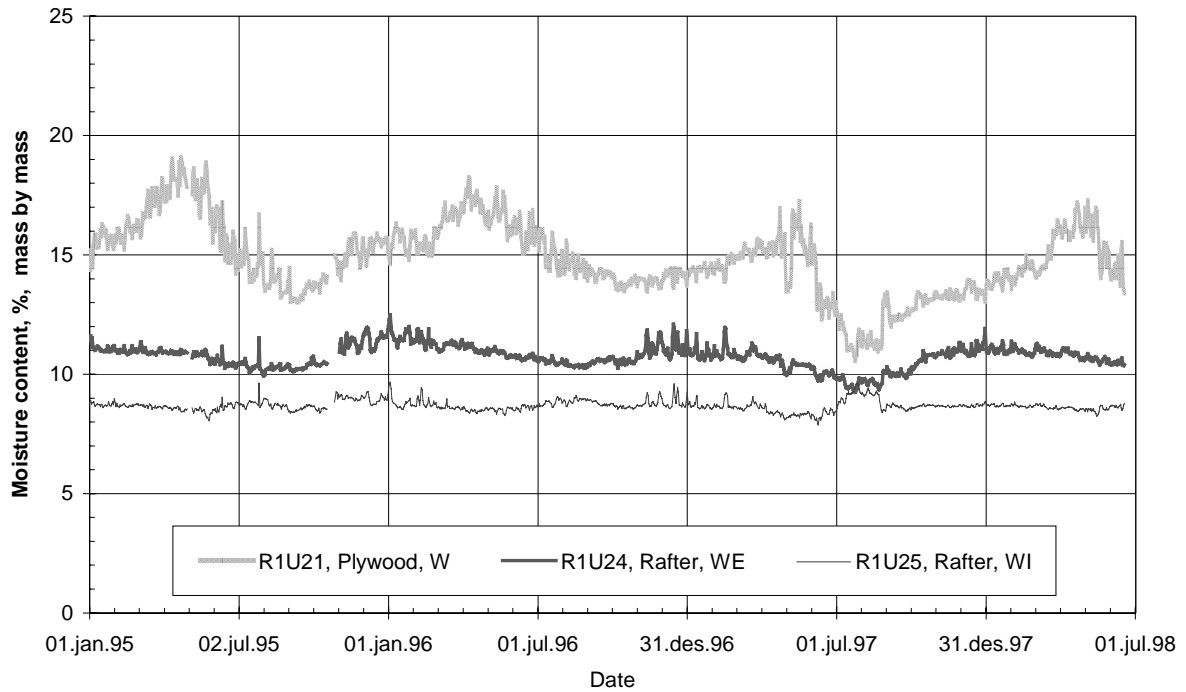
### Moisture content, Roof Section R1

Description: Ceiling of 12 mm wood chipboard, vapour barrier of 0.15 mm PE-foil, 200 mm glass-wool/198 mm x 48 mm rafters c/c 600 mm, 22 mm plywood, dark roofing membrane of 1 mm PVC
