Effect of maintenance on particulate emissions from residential woodstoves

Literature review and test results from particulate matter measurements based on Norwegian Standard NS3058-59 coupled with EC and OC analyses on an artificially aged woodstove

Commissioned by the Norwegian Environment Agency

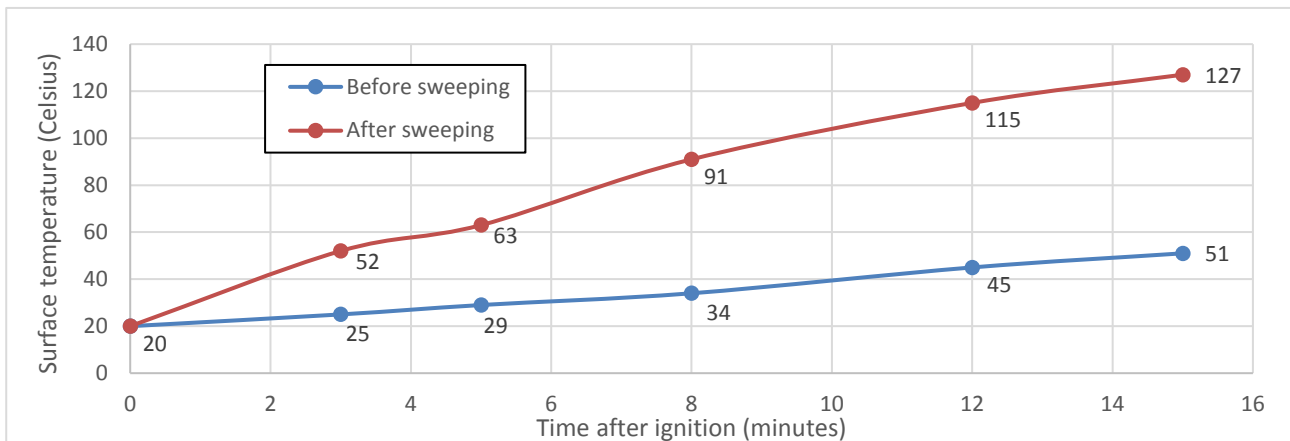
Figure 2: Example of temperature measurements by thermal camera of right side of Dovre woodstove before and after sweeping. Adapted from [9].

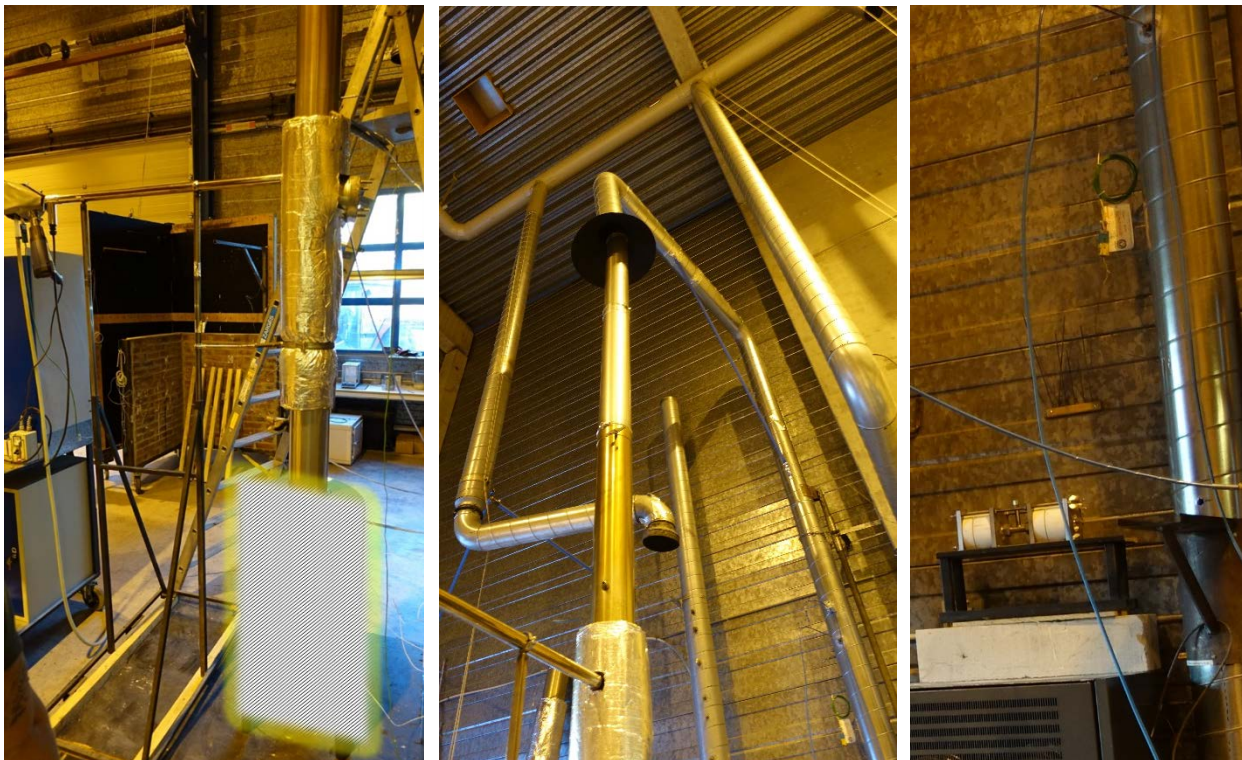
Figure 4: Experimental setup for measurements of particulate emissions with HF above the woodstove (left). The flue gas is diluted further upstream, through the hood (centre), for simultaneous FFDT sampling (right). *Note that the selected woodstove has been intentionally masked, as requested by the manufacturer.*

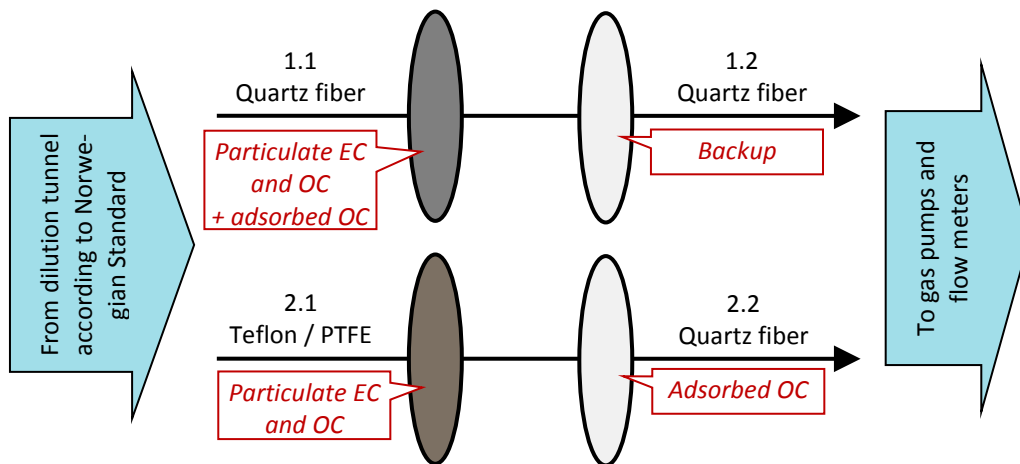
Figure 8: Schematic of the two double-filter holders used to measure particulate emissions from woodstoves allowing further analysis of EC and OC components.

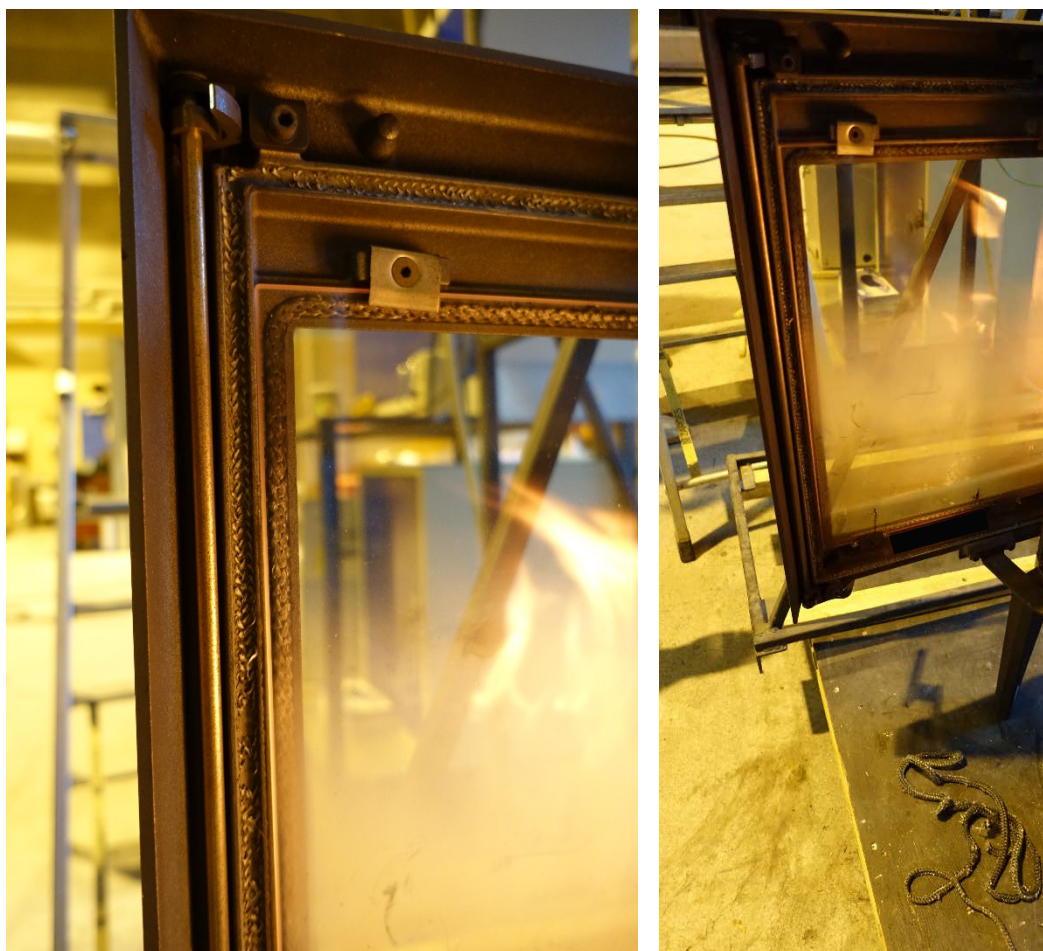
Figure 9: Woodstove door after removal of the gasket.

To best assess experimentally the effect of aging of the woodstove, it had to be modified punctually so that measurements could be performed before and after modification. From discussions with research partners and observations from the literature, it was concluded that creating a significant artificial air leak through the door was the best solution to simulate aging of the woodstove. The modification was performed by simply removing the sealing gasket originally set all around the door of the woodstove (see Figure 9). The subsequent presence of non-preheated air at undesired locations is expected to affect dramatically the combustion conditions and eventually the resulting particulate emissions. Though this measure represents a rather extreme case, it will illustrate a worst case scenario regarding air leakage into a woodstove.

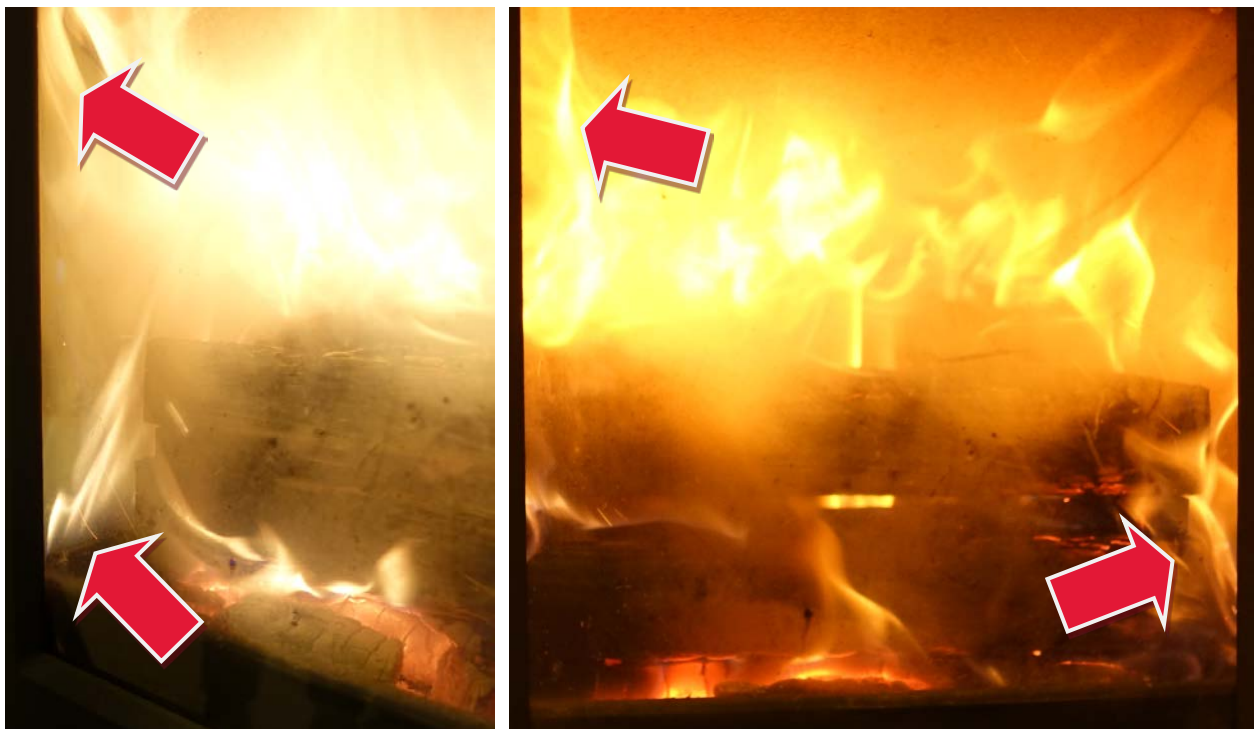
Figure 10: Pictures of test fuel burning in the woodstove burning after removal of door gasket.

As a first observation during the tests, after removal of the door gasket, the flames inside the woodstoves, usually located above the firewood, were also seen anchored nearby by the contour of the door, highlighting the air leaks artificially created. Such anchored flames are indicated by red arrows in Figure 10. As the excess air penetrating the combustion chamber was not controlled, the flames were particularly intense, yielding a relatively high burnrate for a 3-mm opening of the air regulator, which usually yields a low burn rate (3.16 kg dry wood /h versus 1.19 kg dry wood /h). This phenomenon results in producing a larger amount of heat than expected (10 kW versus 5.4 kW), though, over a shorter time period.

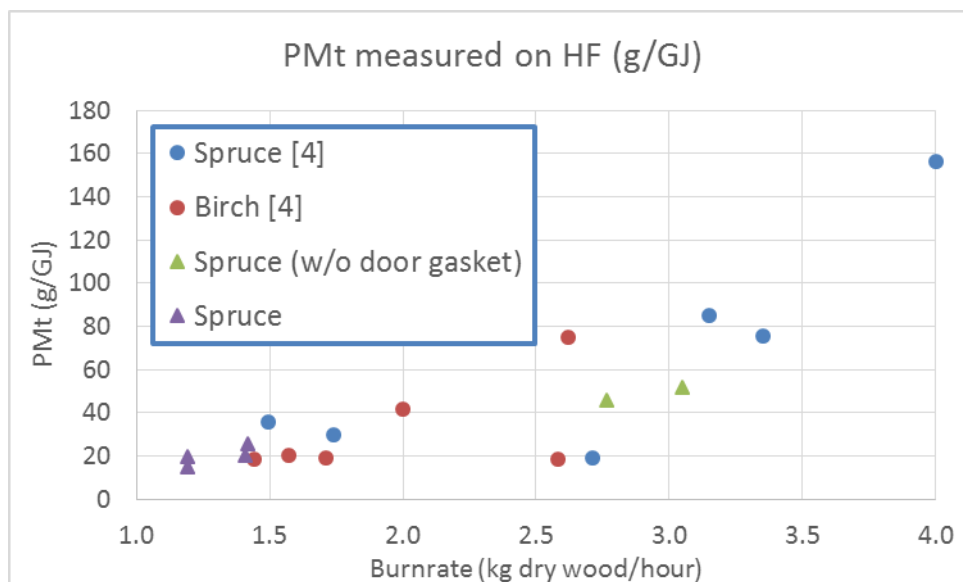
Figure 14: TSP measured on HF with a large group of tests performed prior to removing the door gasket, and after removing the door gasket (in green). All tests were performed under NS3058-59 conditions.

In Figure 14, the results from TSP measurements on HF for the tests without door gasket do not seem out of the range of the other measurements of similar burnrate. However, the TSP levels after door gasket removal are systematically higher than for any tests with spruce at lower burnrate. Note that one measurement is missing (#30 in Table 2) for the HF due to a singular leakage in the pumping system.

Comparing Figure 13 and Figure 14, there is a striking difference at low burnrate, where FFDT filters seem to capture much more TSP than the HF. The differences between the two types of measurements can be explained by the condensable gases flowing through the HF without being captured, while mostly condensing on FFDT filters at lower temperatures. The HF is kept above 70 °C to avoid adsorbing condensable gases. However, the FFDT filters are operated through the dilution tunnel under 35 °C and would allow adsorption of part of the condensable gases and/or eventually capture condensed vapours onto existing particles or particles formed by nucleation of condensable gases.

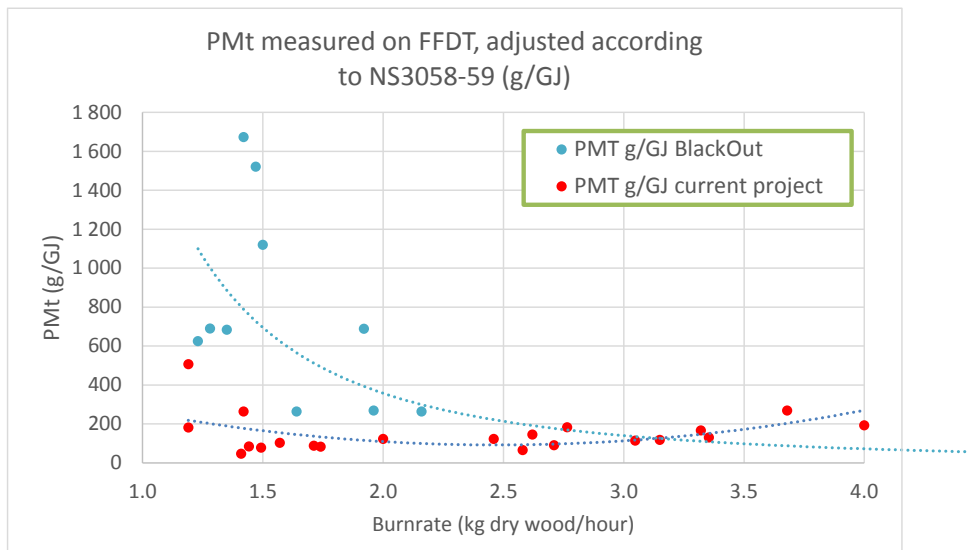
Figure 15: Comparison of PMt emissions in g/GJ, previous project BlackOut vs current project. The stove used in BlackOut was a Jøtul F3 with modern technology. In the current project, measurements were performed at a stove with even better technology and more optimized towards low emissions at low loads.

The current results for TSP was compared with the Jøtul F3 stove tested in the previous BlackOut project. As can be seen in Figure 15, the current stove is more optimized for low burn rates in terms of particle emissions.

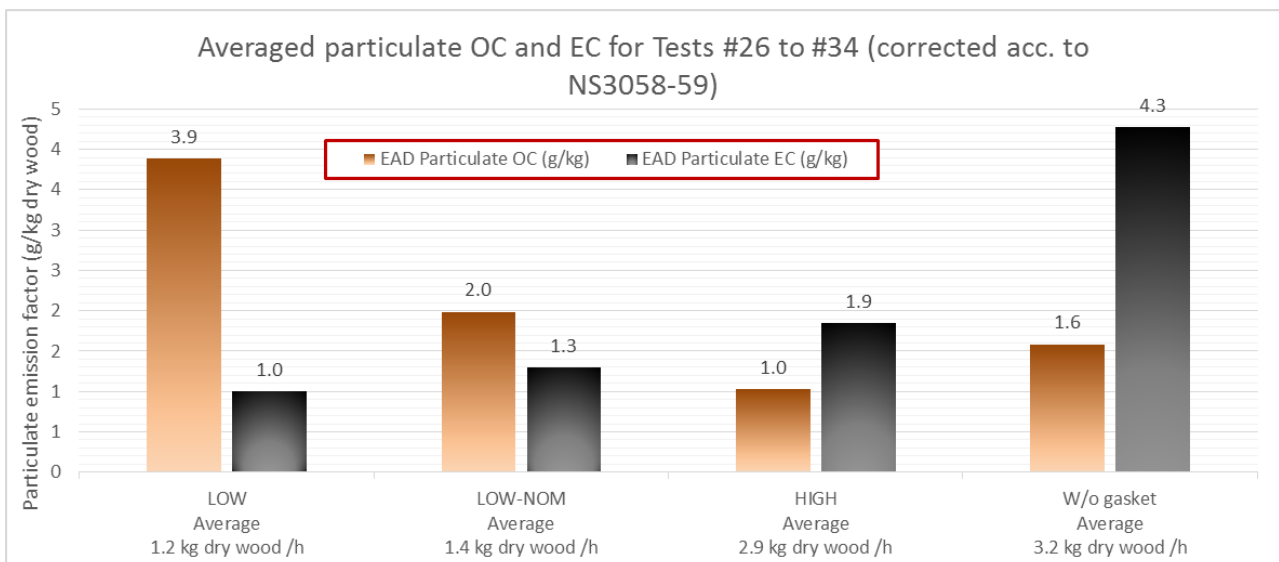
Figure 16: Averaged results from EC and OC analysis from tests #26 to #34, including those performed w/o door gasket (#30 and #31). Samples were taken at 1/4 of radius on filters.

As shown in Figure 16:

- At low burnrate ("LOW"), the OC levels are relatively high and clearly predominant over EC.

- Close to nominal conditions ("LOW-NOM"), the EC levels have increased compared to "LOW" burnrate, and the OC levels have significantly decreased on average, reducing the predominance of OC over EC.
- After removing the door gasket, which yielded higher burnrate, EC levels are ca. 2-4 times higher than at other tested burnrates, and clearly predominant over OC levels.
- Compared to a relatively similar burnrate ("HIGH"), OC levels are found 60% higher and EC levels 2.3 times higher after removing the door gasket.
- At high measured burnrates ("HIGH" and "W/o gasket"), EC levels are substantially higher than for lower burnrates, but OC levels are lower than the EC levels.

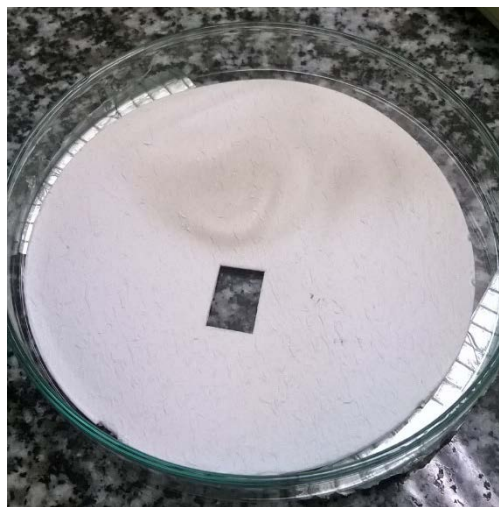
Figure 17: Example of sample for EC/OC analysis taken from one quartz filter with a trace of leakage.
