Durability of traditional clamped joints in the vapour barrier layer: experimental and numerical analysis.

Lars Gullbrekken¹, Klodian Gradeci¹, Øyvind Norvik², Petra Rüter¹ and Stig Geving²

¹SINTEF Building and Infrastructure, Høgskoleringen 7B, 7034, Trondheim, Norway

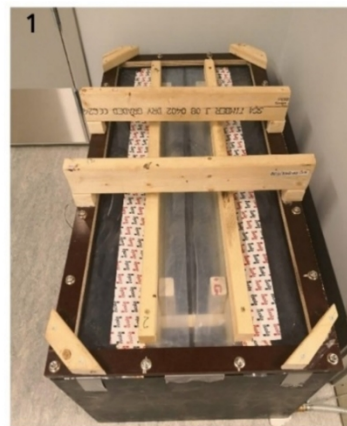
Fixing of the different samples to the airtight box.

134 The resistance to penetration of air through pinched joints in the vapour barrier was tested when the
135 measured wood moisture content was close to the target values of 7 and 14%. The samples were
136 removed from the oven and air leakage through the clamped joint was then measured as quickly as
137 possible in laboratory conditions of 22°C ±2°C and 20 % RH ± 10%. The air leakage was measured in
138 accordance to EN 12114 (EN12114 2000). The air leakage was measured at a pressure difference of
139 20, 30, 50, 70 and 90 Pa. The air leakage at 50 Pa pressure difference was calculated by linear
140 interpolation of the measured values. The airtight box used for the moistening of the samples was also
141 used for the air leakage measurements. The PE-foil of the samples was positioned between a sealing
142 gasket on the airtight box and a sealing gasket on a wooden frame fixed with bolts with a specific

143 clapping force (see **Error! Reference source not found.**). The airtightness of the airtight box was
144 accounted for by measuring the air leakage at 50 Pa pressure difference with an airtight PE-foil as a
145 sample. This was done prior to the different test sequences.

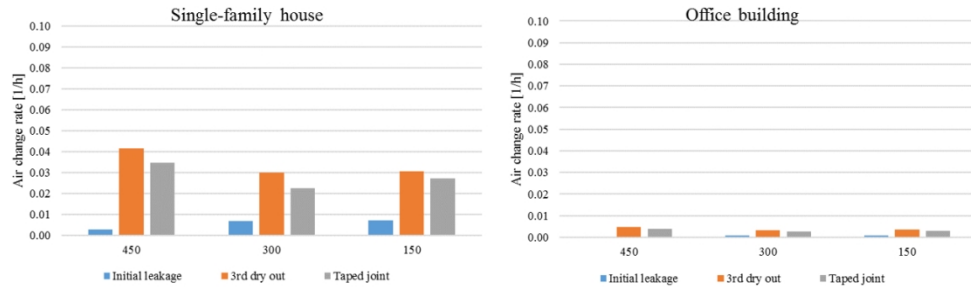
Estimation of air change rate of the single-family house and office building using assumptions in the presented in section 2.

203 **Error! Reference source not found.** and **Error! Reference source not found.** show the estimated
204 air change rate of the two case buildings based on the measurements of the initial air leakage, after the
205 third dry out, and after taping the joints using the assumptions in the previously described in Section
206 2.1. Note that the results assume no air leakage through the roof, floor, penetrations, and connections
207 between building parts. The code for the samples is explained as follows e.g. 450 is the center to
208 center distance between the fasteners in mm, correspondingly. The results generally indicate lower air
209 change rates for the office building compared to the single-family home. One explanation is a
210 different relation between the area of exterior walls and volume for the two buildings. Screws with a
211 centre to centre distance of 450 mm provided the largest calculated contribution to the air change rate.

212 However, the estimated air change rates at 50 Pa pressure difference through the joints of the vapour
213 barrier has a minor contribution compared to the requirements in the Norwegian building regulations.
214 The measured air change rate at 50 Pa pressure difference of a specific building consists of several
215 other air leakage sources among them air leakage through other building parts such as the roof,
216 window and floor as well as penetrations through the roof and wall assemblies. As further stated,
217 there are uncertainties concerning the long-term durability of these clamped joints. Previous research
218 shows that an airtight vapour barrier is important in avoiding condensation problems in roofs
219 (Janssens, A., Hens H. 2003). Further, Aho et al. (2008) state that an airtight building envelope, and
220 hence the use of a vapour barrier, is an essential element of the envelope assembly to avoid local
