Experimental Study of the Charring of I-Joists and Recession of Combustible Insulation in Light Timber Frame Assemblies with Comparison to Eurocode 5

Abstract. Design models are commonly used in fire safety design of light timber frame assemblies. Parameters for use in the models are available for rectangular members with mineral wool, wood fibre or cellulose insulation and for assemblies with I-joists and mineral wool. For assemblies where I-joists and combustible insulations are combined, design parameters are missing. Five fire experiments with two I-joist types and four combustible insulation products have been conducted. The aim was to study charring of I-joist flanges and recession rates of combustible insulations and in addition, to compare their behaviour to the new and existing models of Eurocode 5. Charring rates for the flanges were 0.40–0.76 mm/min and 0.54–1.72 mm/min for the protected and post-protected phase, respectively. Rates decreased with increasing flange size. Charring rates for flanges of solid wood and LVL were comparable. The results show that lateral charring of I-joist flanges can be significant in the protected phase. The tested insulation products show

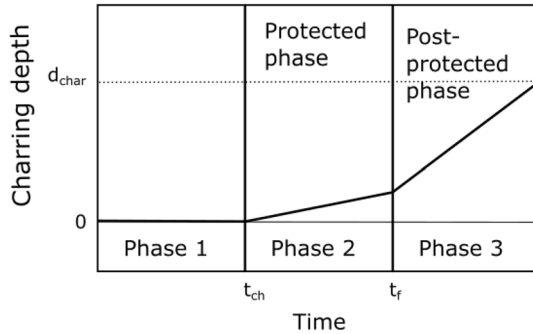
Figure 1. Charring of timber protected by a cladding material. d_{char} represents the final charring depth, while t_{ch} and t_f indicate the start of charring and fall-off of cladding, respectively. Figure based on EN 1995-1-2 [1].

In the design methods described in EN 1995-1-2 [1], the charring behaviour of the wood is considered in three phases, see Figure 1. In Phase 1, no charring occurs as the cladding protects the timber from direct heat exposure and the temperature on the timber surface has not reached 300°C. Phase 2, also known as the protected phase, begins when the timber has started to char, i.e., the surface of the timber has reached 300°C, but is still protected by the cladding. Phase 3, the post-protected phase, starts when the cladding falls off and the timber members become directly exposed to the fire. To calculate the charring depth of the different phases, additional coefficients for the protected and post-protected phase are added.

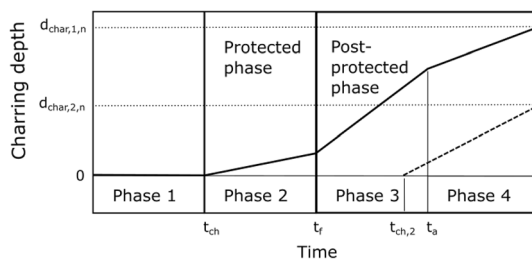
Figure 2. Charring of timber protected by a combustible cavity insulation. t_{ch} and $t_{ch,2}$ represents the start of charring of the exposed and lateral side, respectively. t_r is the time for fall-off of cladding, and t_a is the time when charring is reduced due to a sufficiently thick char layer. $d_{char,1,n}$ and $d_{char,2,n}$ represents the final charring depth for the exposed side and the lateral side, respectively. Figure based on EN 1995-1-2 [1].

This model includes four different charring phases, see Figure 2. In Phase 1, no charring occurs, while Phase 2 considers charring behind the cladding. Phase 3 is after fall-off of the cladding and an increased charring rate is seen. Phase 3 is followed by Phase 4, which is recognised by a reduced charring rate compared to Phase 3. The reduced charring rate is caused by formation of a sufficiently thick char layer to slow down the heat transport into the char front, approximately 25 mm. Phase 2 is neglected if fall-off of the cladding occurs before charring of the protected wood has started. Similarly, if a sufficiently thick char layer forms in

Phase 2, Phase 3 is neglected. On the other hand, if the final charring depth does not reach a sufficiently thick layer to reduce charring, Phase 4 is not considered. The start time of charring from the lateral sides may occur in Phase 2, 3 or 4, depending on the insulation properties and the fall-off time for the cladding.

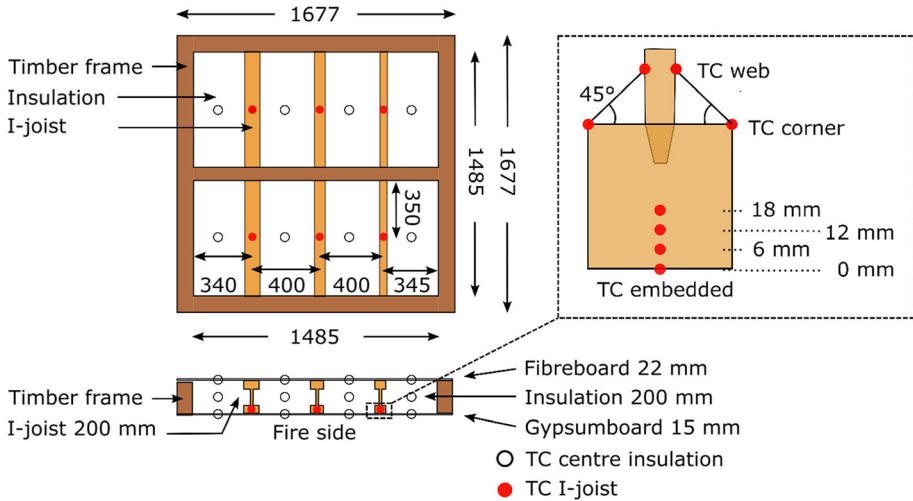
Figure 3. Build-up of test specimen in plan and cross-section, and position of thermocouples. Dimensions in mm.

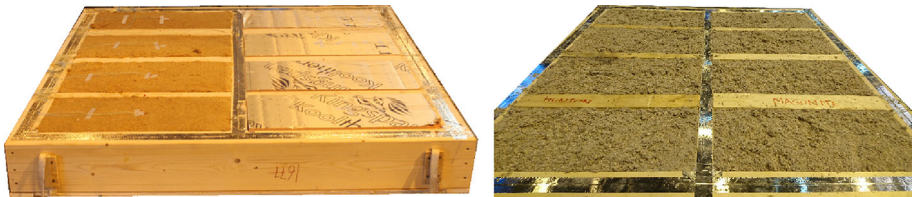
Figure 4. Left: Test specimen filled with wood fibre batt on the left half side and phenolic foam batt on the right half side. Right: Test specimen filled with wood fibre loose-fill insulation (manually packed) between the Hunton I-joists (left) and Masonite I-joists (right). The fibreboard is not installed.

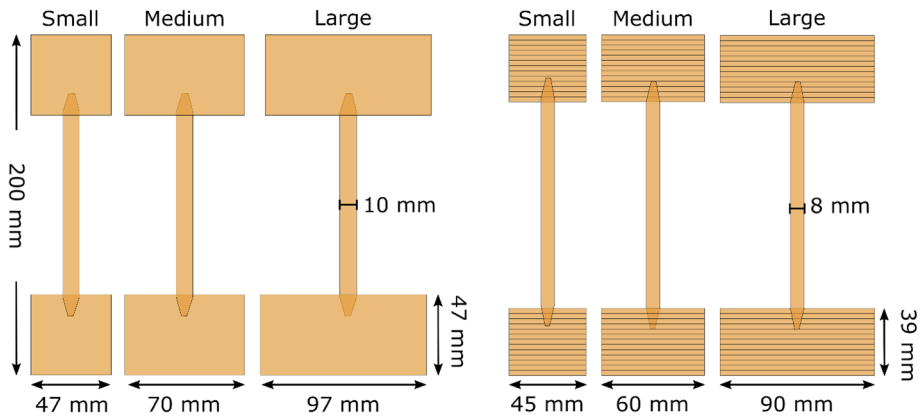
Figure 6. Left: I-joists from Masonite with solid flanges. Right: I-joists from Hunton with LVL flanges.

2.1.2. *I-Joist and Insulation Types* I-joists from two different manufacturers, Masonite and Hunton, were used. They had different materials in the flange and

web and different dimensions, see Figure 6 and Table 1. All tested I-joists had a total depth of 200 mm. The moisture content was measured for all I-joists using a calibrated moisture meter and varied from 11.7% to 13.3%. Two different I-joist products were used as the charring of wood can vary with the wood species, density, moisture or type of engineered timber used in the flange [6].

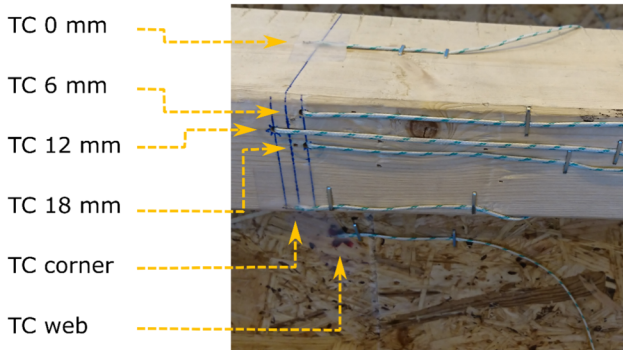
Figure 7. The bottom flanges of the I-joists (fire-exposed side) are instrumented by eight TCs, where six of them are shown in the image. View from the fire exposed side.

insulations. All TCs were of type K (Chromel and Alumel conductors [33]), with an exposed twisted junction of ca. 1.5 mm. Each I-joist was instrumented with eight TCs, see Figures 3 and 7. Four TCs were used to measure the temperature at 0 mm, 6 mm, 12 mm and 18 mm into the bottom flange from the fire exposed side. The embedded TCs were inserted into the side of the flange in 2 mm large holes, drilled in a drill press stand. The depth of the holes reached to the centre of the flange width. In addition, the surface temperature on the top corners of the bottom flange and on the web was monitored. The TCs on the web were attached to the surface by staples and was located at a 45° angle from the corner. The TCs on the corner of the flange were positioned at the top corner of the bottom of the flange, i.e., at 40.5 mm and 47 mm depth for Hunton and Masonite I-joists, respectively. The reason why 40.5 mm was used instead of 39 mm was a small deviation between the measured flange height and the height given by the Hunton I-joist datasheet, see Table 1.

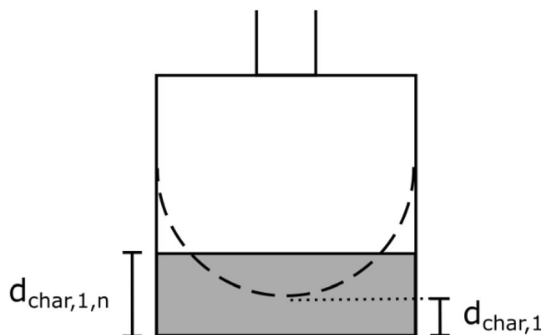
Figure 8. The remaining measured height in the experiment corresponds to the natural charring depth $d_{char,1}$, while the charring depth of the design models corresponds to $d_{char,1,n}$.

For a gypsum board thickness of 15.4 mm used in these experiments, k_2 becomes 0.938. β_0 is the one-dimensional charring rate of 0.65 mm/min [1]. k_n converts the actual charring depth ($d_{char,1}$) to a notional charring depth ($d_{char,1,n}$) and converts the residual cross-section to a rectangular shape, as seen in Figure 8. k_s is the

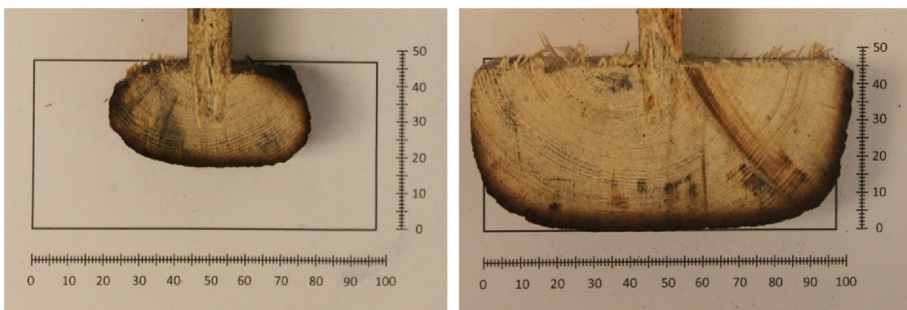
Figure 13. The protective effect given by the gypsum board is shown by comparing two flanges from Test 1, where the left flange experienced a gypsum board fall-off at 22 min, while the right flange was protected by the gypsum board throughout the test (to 45 min). The rectangular shape is the original flange size. Numbers are in mm.

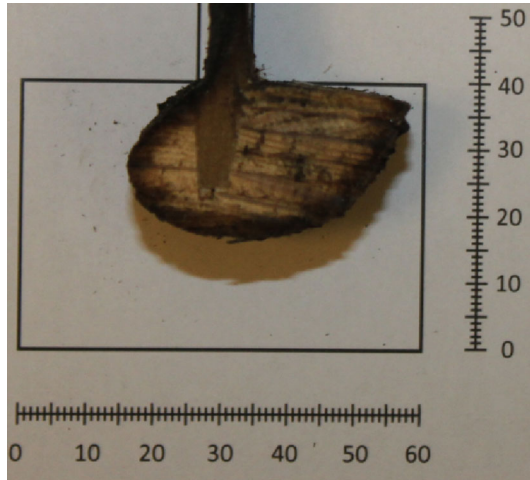
Figure 14. Example of a medium-sized Hunton flange in Test 5 with a highly irregular shape. The flange experienced insulation fall-down during the test on one side, resulting in the irregular shape. The rectangular shape is the original flange size. Numbers are in mm.

In Test 5, several flanges had a non-symmetrical remaining area, particularly the top corners of the flange (Figure 14). This can be explained by the fact that three of seven insulation batts fell down during the test. However, none of the flanges lost both adjacent insulation batts. The fall-down happened after the lateral side had been fully exposed, so the fall-down did not affect the calculated recession rate of the insulation. However, the fall-down caused the inner side flange, where the web was attached, to be exposed. This caused an increased charring of the upper corner area, as seen in Table 6 and Figure 14.
